## WELL SYSTEM INSPECTION

N7341 County Rd XX, Holmen, WI, 54636

*Date of Inspection: 4/2/2026*

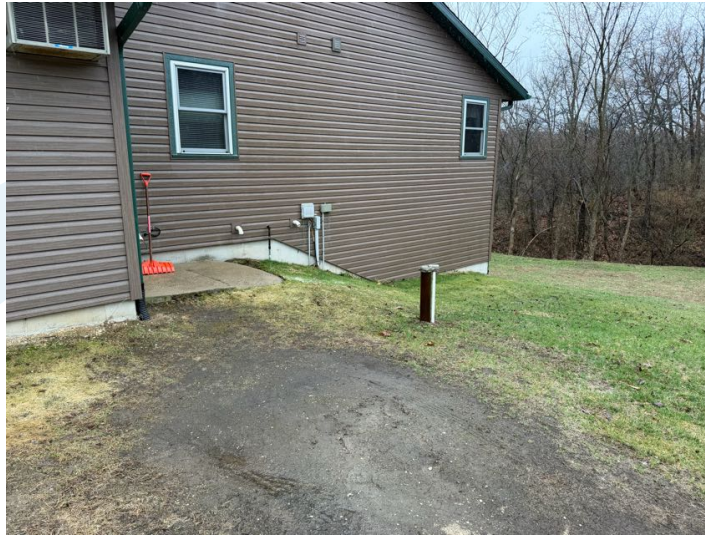
- Northside of the home

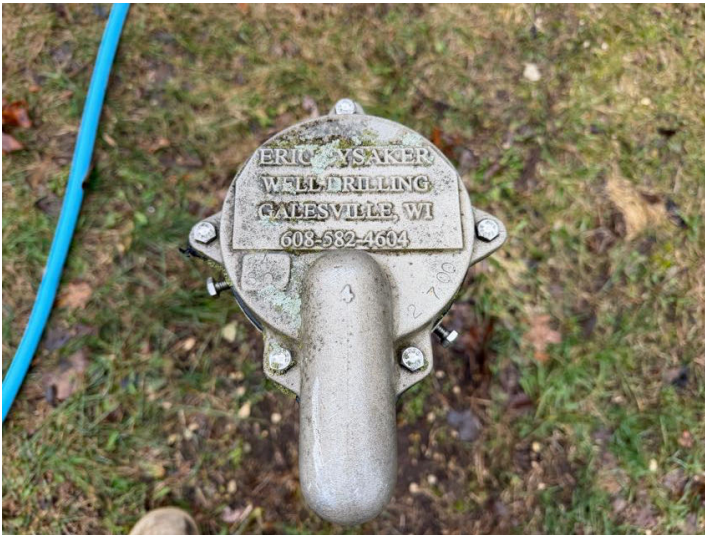
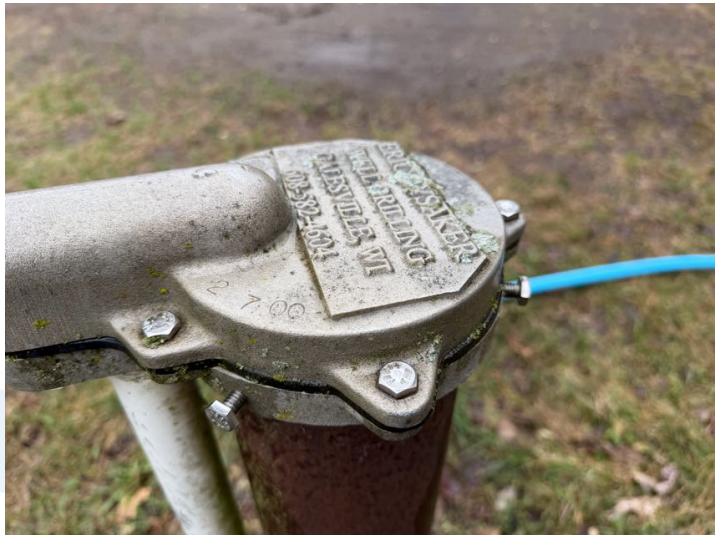
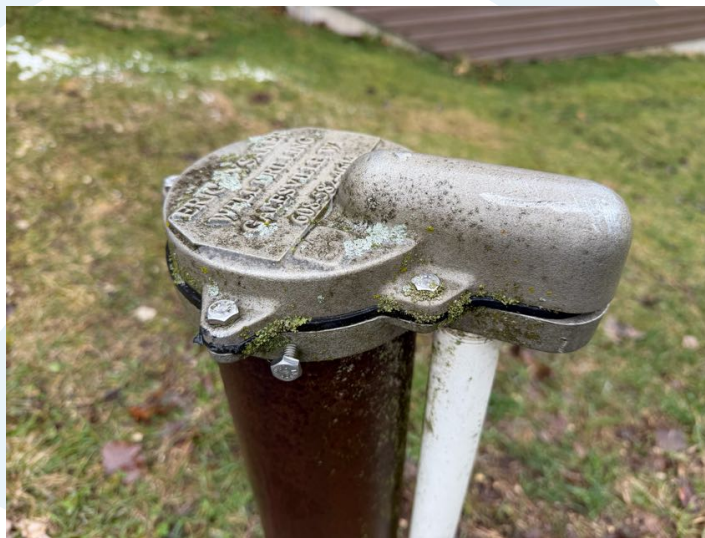
- The well cap appeared to be in satisfactory condition with no visible damage or signs of wear. The well cap was visibly intact, functioning correctly as intended and in satisfactory condition at the time of the inspection, ensuring proper well protection.

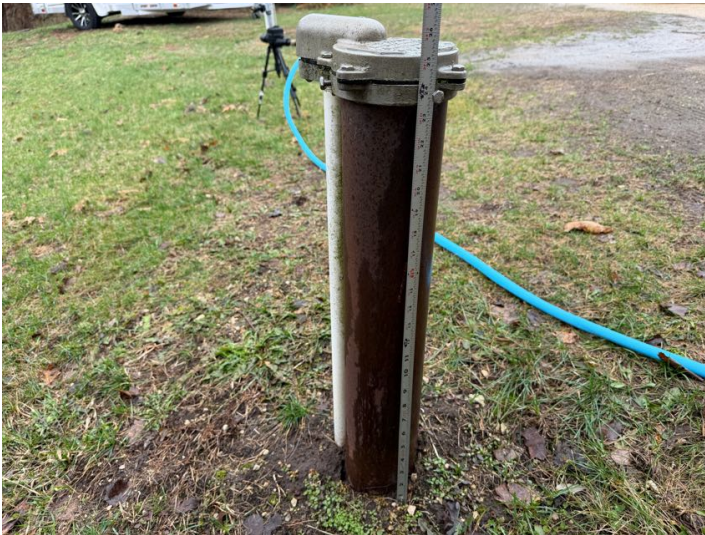
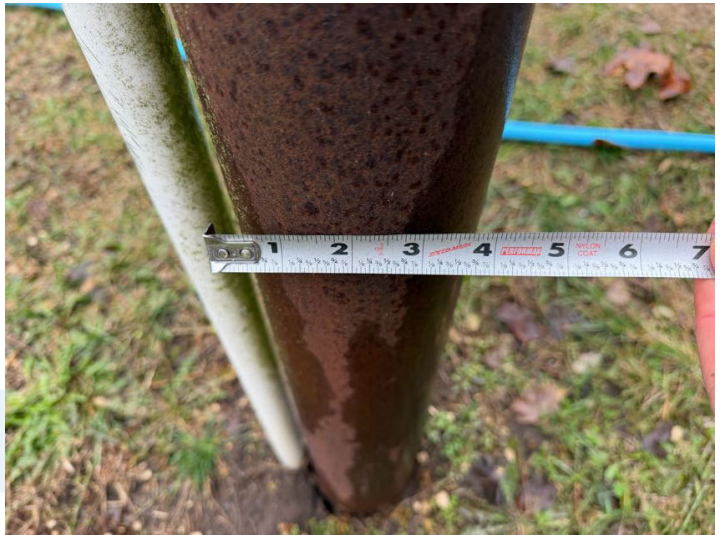
Specifications: 12" above grade:Yes

Materials: 4" Steel

- The visible well casing was in good condition at the time of the evaluation and compliant with Wisconsin code regulations. There were no signs of damage or deterioration, ensuring the well's structural integrity and functionality.

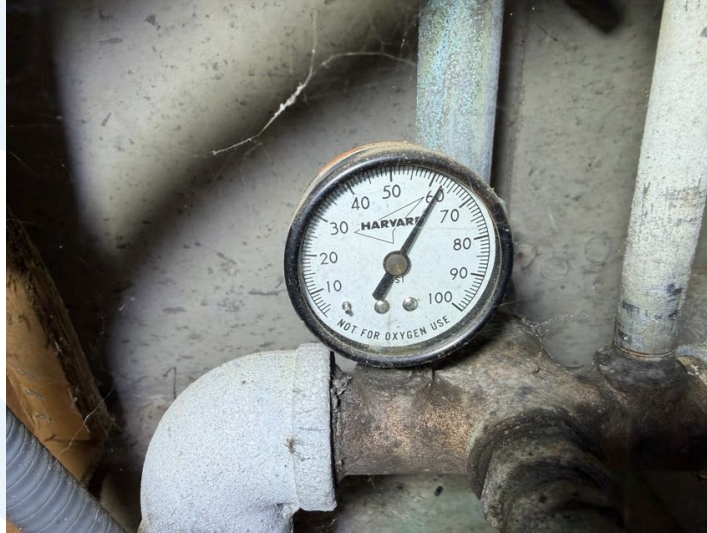
Details: Recorded Water Pressure: 60 psi

- During the inspection, the well water pressure was found to be satisfactory and operating within the designated limit switch range. This indicates that the pressure levels are stable and properly regulated, meeting the expected standards for optimal performance. No issues were noted regarding the pressure during this evaluation.

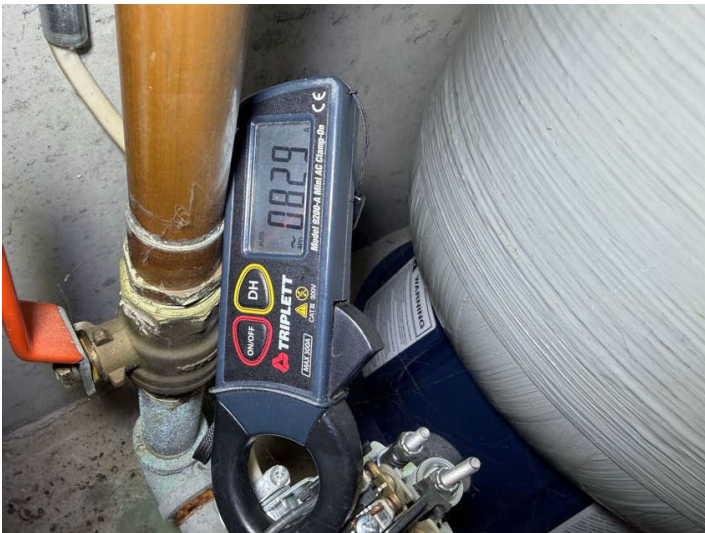
- Well pumps generally consume between 5 and 9 amps, depending on factors such as the pump's horsepower and the depth of the well. If the amperage exceeds this typical range, it may indicate that the pump is experiencing issues or is failing. In such cases, a thorough evaluation of the pump is recommended.
- During the inspection, the well pump was drawing the expected amperage, consistent with its horsepower and well depth. The pump operated smoothly without irregularities, and based on current performance, it appears to be in satisfactory condition. No immediate issues were observed during the evaluation.

Amperage upon startup

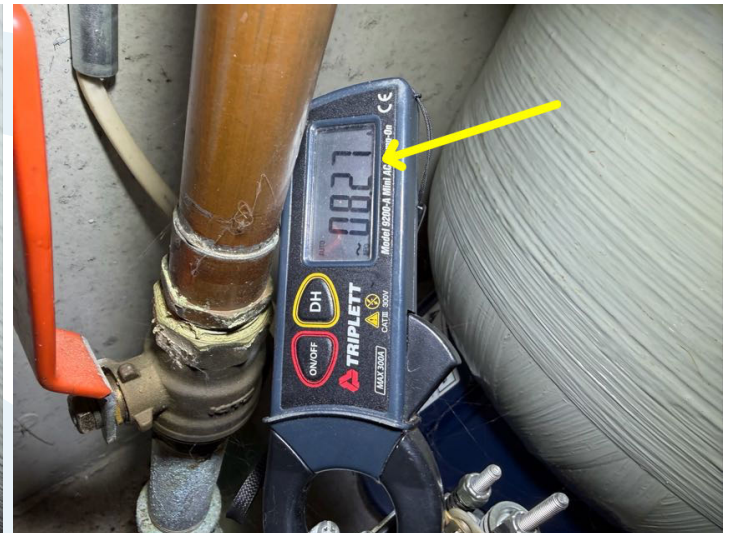
Amperage while running

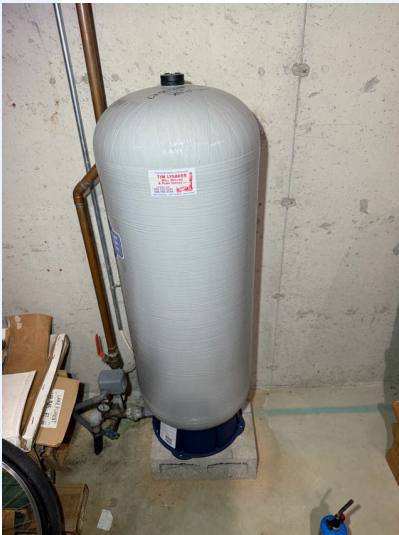
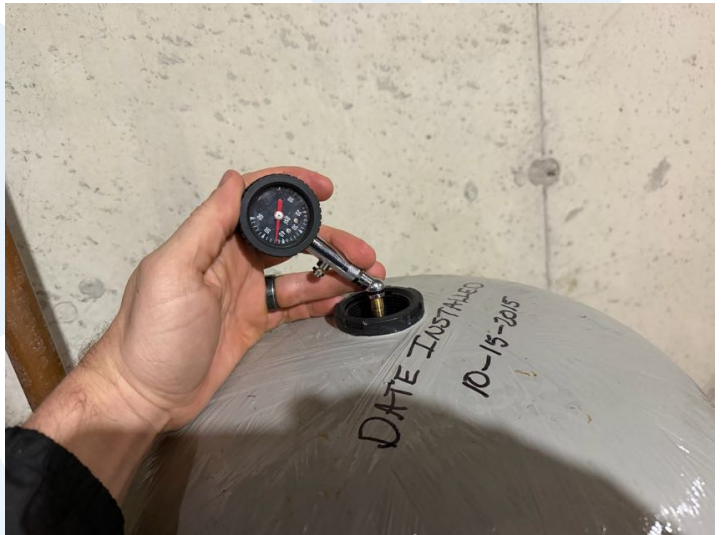
Specifications Bladder style pressure tank noted. This style tank can be made of steel or fiberglass and maintain 100% separation between the air pre-charge in the tank and the water in the system. The bladder style tank is substantially more efficient and delivers greater water pressure than any other style of pressure tank that exists and is the highest longevity of all well pressure tanks by design. • Pressure Tank Volume: 35 gallons

- the pressure tank is operating correctly and in good condition. It maintains optimal water pressure and cycles properly with the pump. The tank shows no signs of leaks, corrosion, or damage, ensuring reliable performance and a steady water supply for the property.

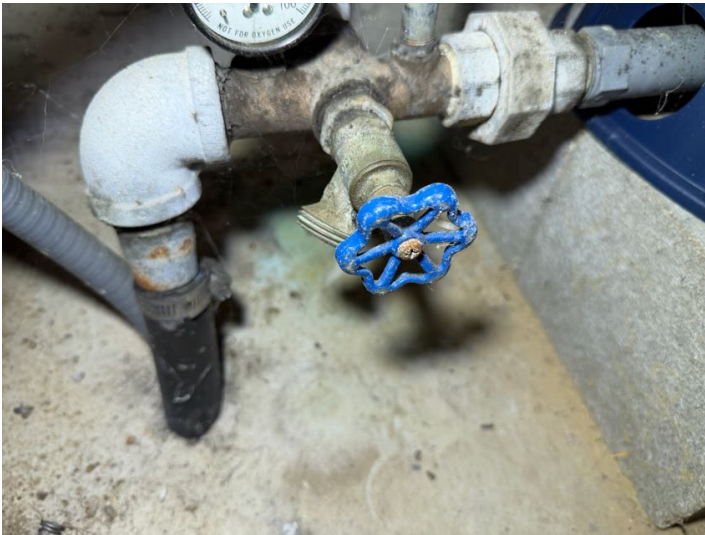
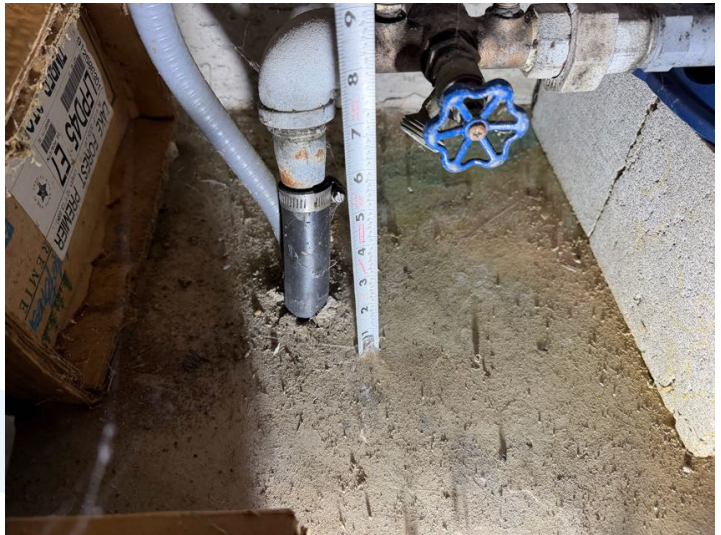
Materials: Sample faucet comply: No

- The sample faucet on the well was installed less than 12 inches from the floor, which does not comply with WI Code NR 812.34. To meet regulations and ensure proper functionality, the faucet should be repositioned to the correct height. Prompt repair is needed to bring it into compliance
- The sample faucet on the well was found to be threaded and not smooth, which does not meet WI Code NR 812.34 standards. For proper operation and to comply with regulations, the faucet should be repaired or replaced to ensure a smooth surface, preventing potential contamination and ensuring accurate water sampling.

| NON COMPLIANT ITEMS | | |
|---|---|---|
| Page 11 Item: 16 | Sample faucet Observations | <ul style="list-style-type: none"> <li>• The sample faucet on the well was installed less than 12 inches from the floor, which does not comply with WI Code NR 812.34. To meet regulations and ensure proper functionality, the faucet should be repositioned to the correct height. Prompt repair is needed to bring it into compliance</li> <li>• The sample faucet on the well was found to be threaded and not smooth, which does not meet WI Code NR 812.34 standards. For proper operation and to comply with regulations, the faucet should be repaired or replaced to ensure a smooth surface, preventing potential contamination and ensuring accurate water sampling.</li> </ul> |

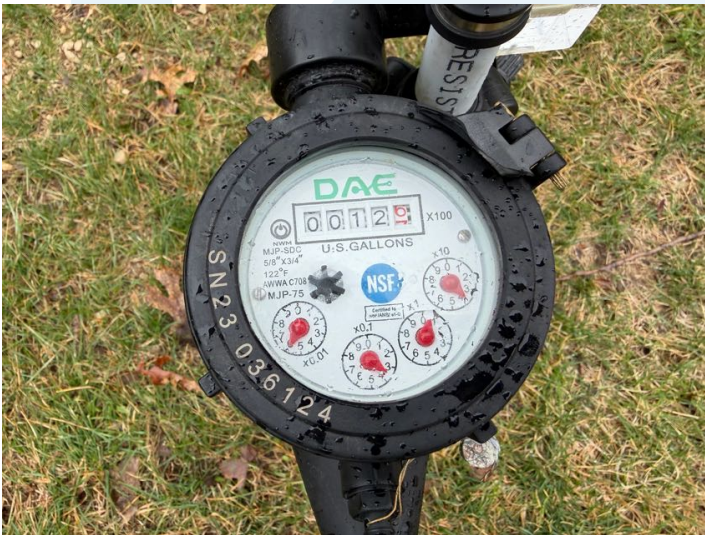
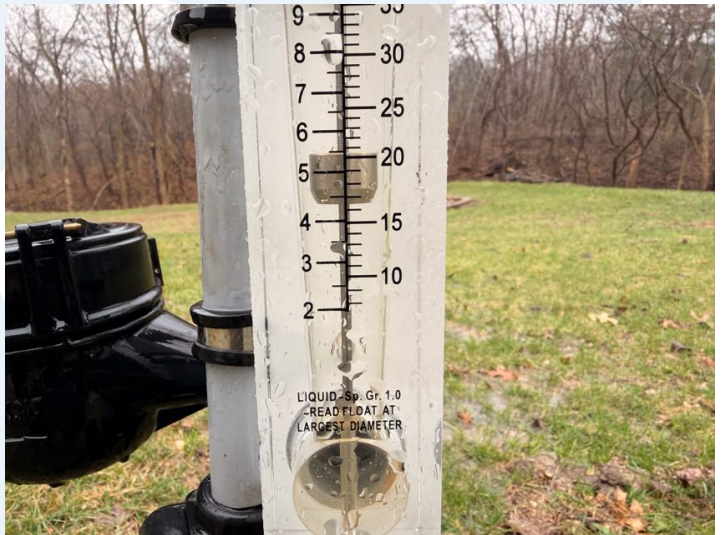
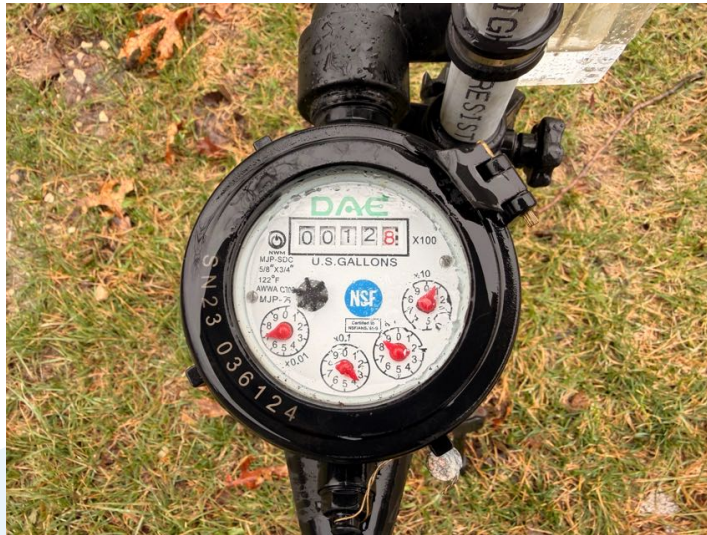
6 GPM

- The optimal flow rate for a how is in between 5-8 gallons per minute. Older well pumps may produce low flow rates. An acceptable flow rate balances system efficiency and water demand. Factors like pump size, casing diameter, depth, and well conditions significantly influence flow rates, affecting overall performance and reliability.
- The well flow test was performed and yielded a satisfactory result, with a flow rate of 6 gallons per minute. This flow rate meets the necessary standards, indicating that the well is operating effectively and providing an adequate water supply.
