## RESIDENTIAL INSPECTION REPORT

7345 W Warnimont Ave  
Milwaukee, WI 53220

10/09/2026

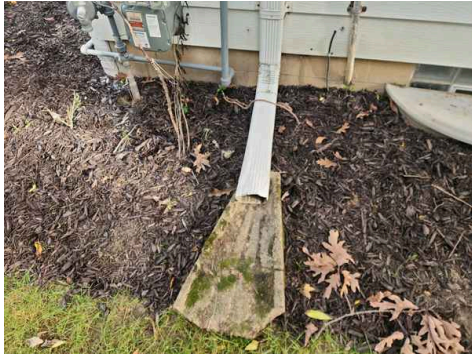
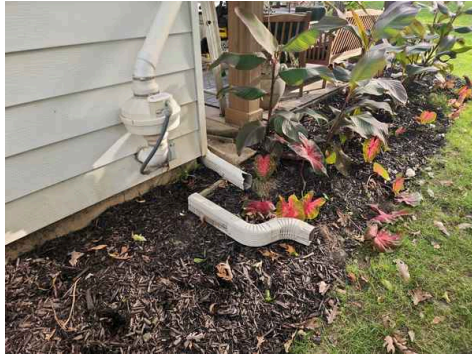
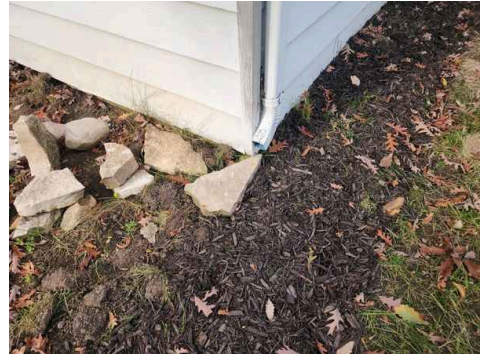
One or more downspouts drain too close to the home's foundation. Water pooling on the walkway can freeze, creating a slippery hazard. This can also result in excessive moisture in the soil at the foundation, which can lead to foundation/structural movement. Recommend a qualified contractor adjust downspout extensions to drain at least 6 feet from the foundation.

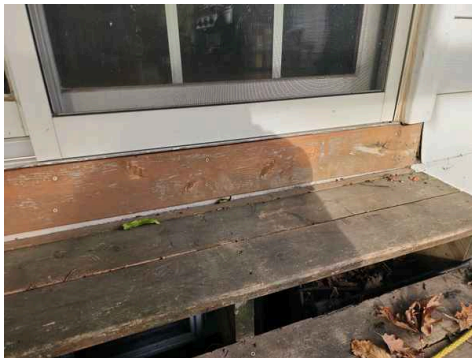
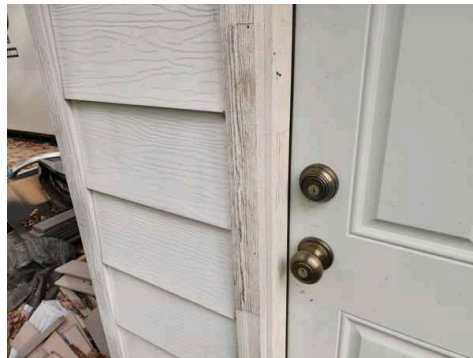
Exterior door trim and/or sills should be painted or stained to preserve the wood. Any damaged or rotted wood should be replaced as needed.

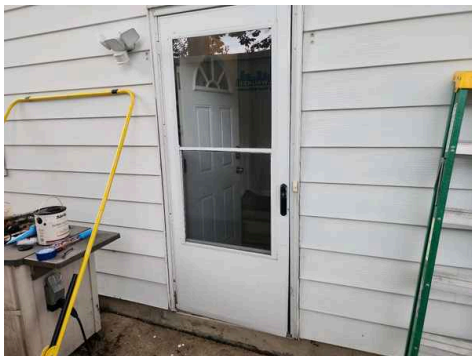
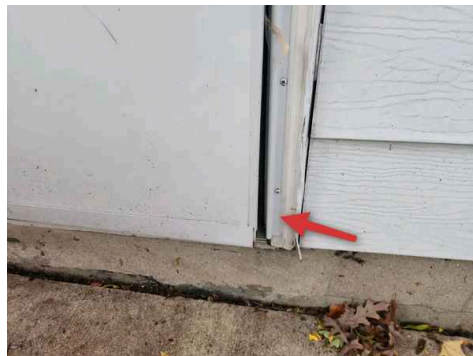
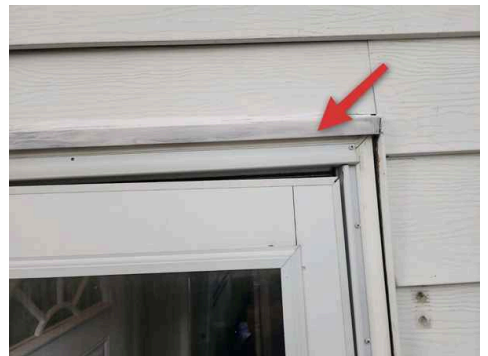
The exterior storm door did not close properly. Noticeable gaps were present between the door and frame when closed, which may allow drafts, moisture, and insects to enter. Recommend adjustment or repair by a qualified contractor as needed.

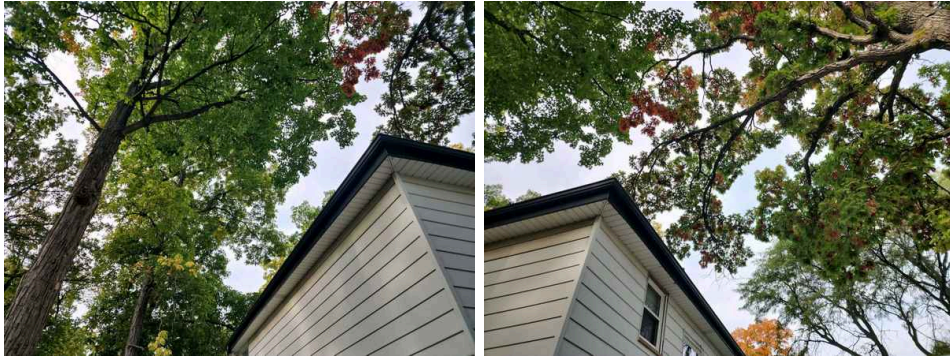
## 3.7.1 Vegetation, Grading, Drainage &amp; Retaining Walls

**TREE OVERHANG**

Trees observed overhanging the roof. This can cause damage to the roof and prevent proper drainage. Recommend a qualified tree service trim to allow for proper drainage.

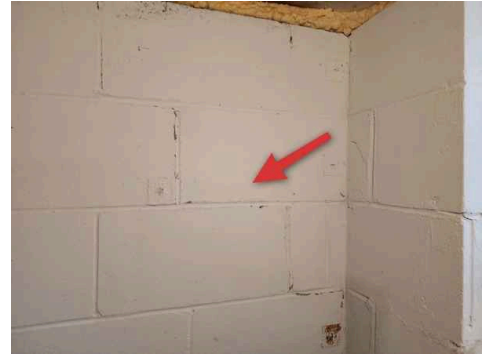
## 4.2.1 Foundation

**STEP CRACKS**

Stair step or stepped cracks were observed in concrete block walls or brick walls like this one. They are telling you that settlement of some type is happening. It could also be caused by possible upheaval of the foundation. Sometimes the settlement or upheaval is minor. Other times, the crack can grow to 1/2 inch or more in width. Monitor the width of these cracks and call in a structural engineer early in the process to get a professional assessment.

Contact a qualified professional.

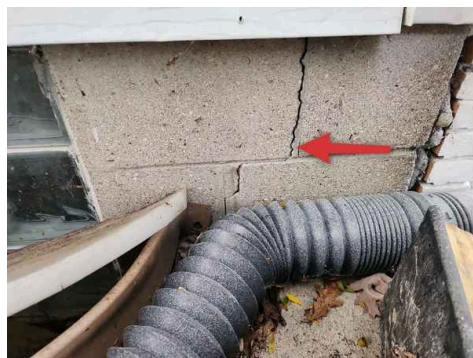
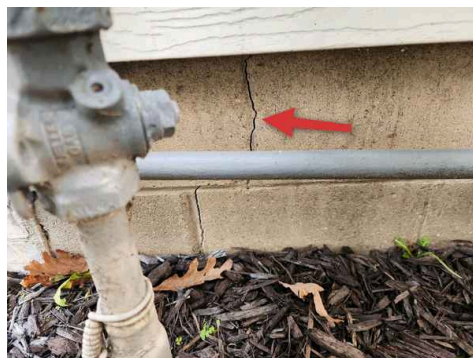
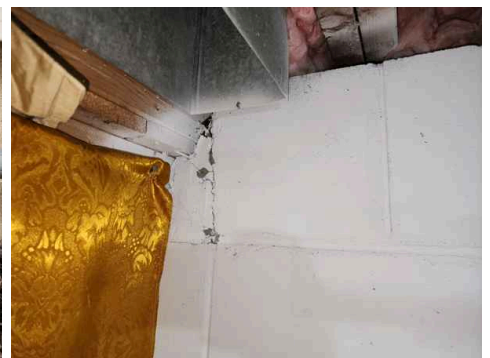
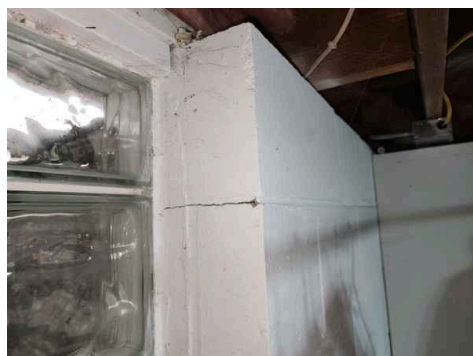
## 4.2.2 Foundation

**FOUNDATION CRACKS - MINOR**

Minor cracking was noted at the foundation. This is common as concrete ages and shrinkage surface cracks are normal. Recommend monitoring for more serious shifting/displacement.

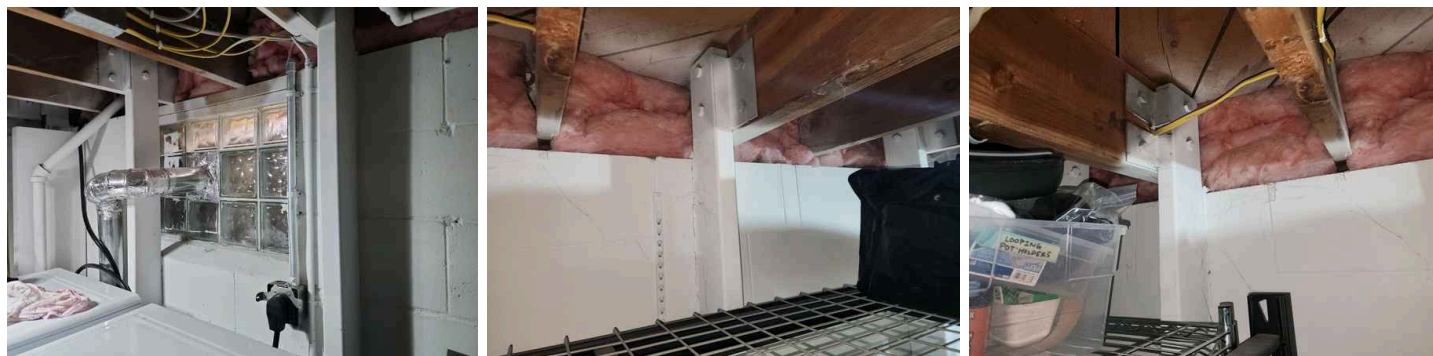
## 4.2.3 Foundation

**SHORING BEAMS**

Foundation shoring beams were observed on one or more basement walls. While this is a common fix for bowed walls, the fix can be temporary. Constant monitoring is recommended. A guarantee of the work may or may not be transferable to a new owner. Recommend contact with the contractor that performed the work as to such a guarantee transfer. Also recommend a structural engineer to further evaluate the shoring beam installation meeting today's standards.

Contact a qualified professional.

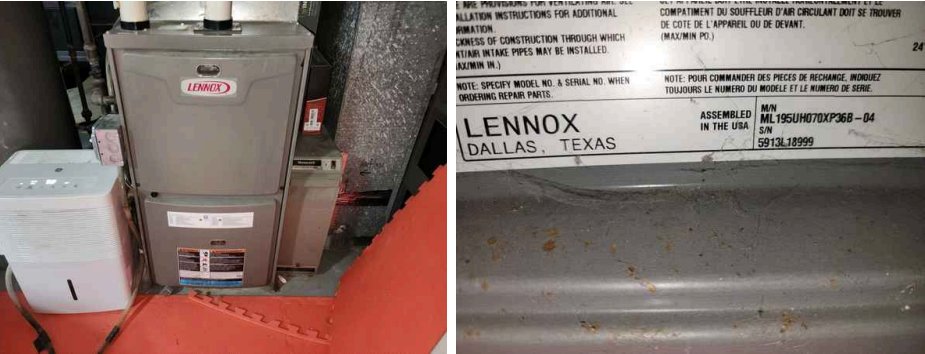
| <b>General: Deferred Cost Furnace</b><br>Furnace forced air 10-25 years old or older is a maintenance issue to consider down the road. | | |

| <b>General: Annual Service</b><br>The heating system requires annual service. This should be a regular maintenance item to assure safe, reliable heat. | | |

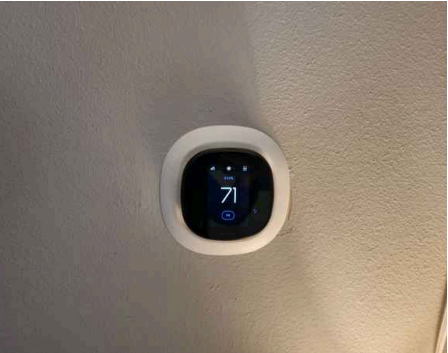
| <b>General: Set Back Thermostat</b><br>The heating system is controlled by a set back" thermostat. Set back thermostats, if set up correctly, helps reduce heating costs. |

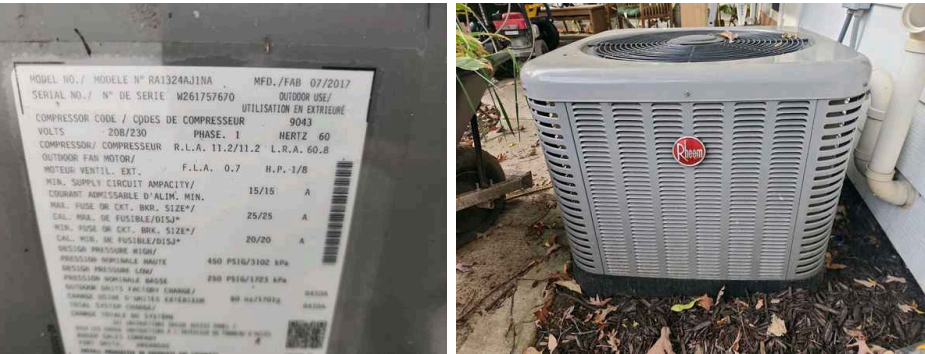
**General: Deferred Cost**  
A/C Unit: 8 to 12 years old and older is a maintenance issue to consider down the road.

**General: Annual Service**  
Recommend HVAC Tech examine/clean/service/evaluate the Air Conditioning system.

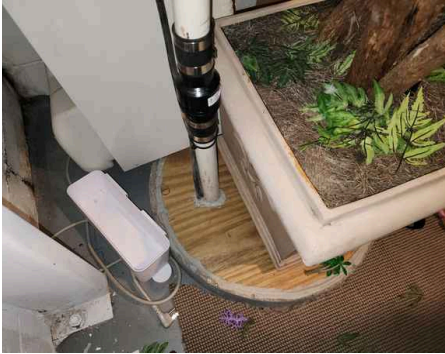
Sump pumps 5 yrs. or older is a maintenance issue to consider down the road.

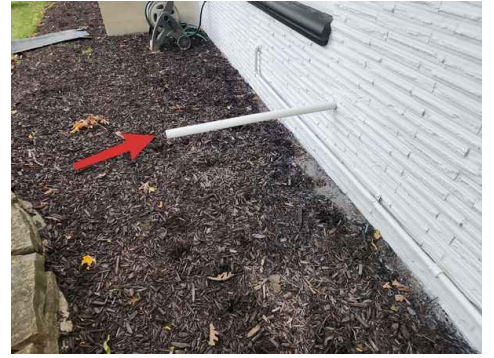
## 7.7.1 Sump Pump/Palmer Valve

**DISCHARGE LINE EXTEND**

The discharge line of the sump pump should be redirected/extended at least 10ft from the homes foundation.

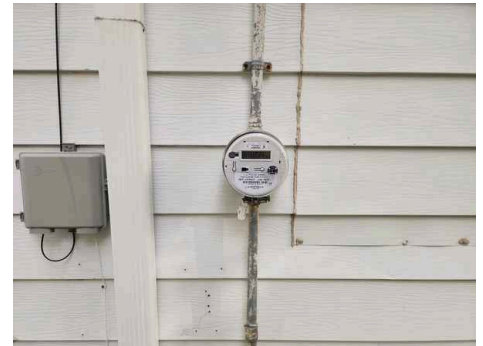
Overhead, Copper

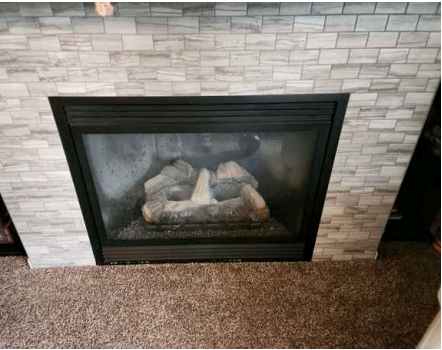
**General: Type**  
Gas, Zero Clearance

**General: Vent/Flues/Chimneys**  
Metal Flue-Multi-wall

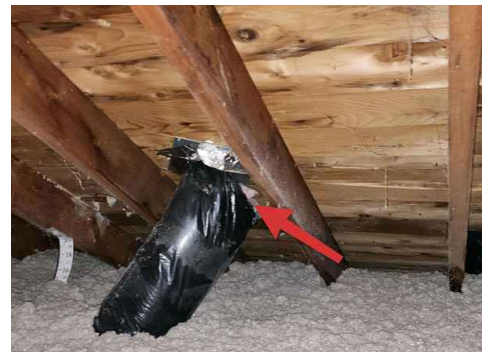
**DUCTS LOOSE**

Ductwork in the attic is loose or disconnected. Recommend repair.

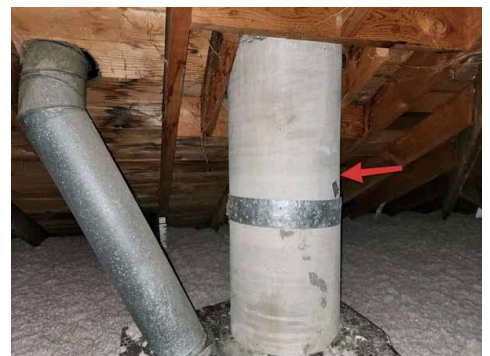
## 10.5.2 Exhaust Systems

**CHIMNEY VENT POSSIBLE ASBESTOS**

Suspected asbestos-containing insulation was observed around the chimney flue in the attic. The composition of this material could not be confirmed during the inspection. Recommend evaluation and testing by a qualified asbestos professional before disturbing or removing the material.

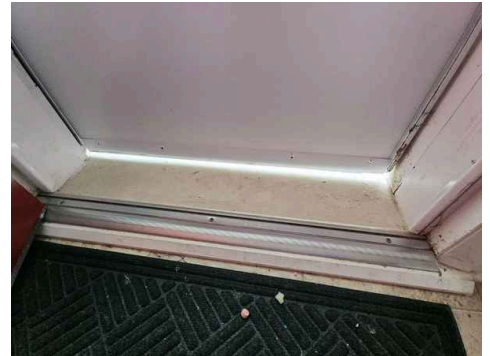
## 11.2.2 Doors

**NOTICEABLE GAP**

A gap was observed along the top of the storm door when closed. The door operated properly at the time of the inspection; however, the gap may allow drafts, insects, and moisture entry. Recommend adjustment or repair as needed.
