## APEX RESIDENTIAL INSPECTIONS COPY

**1000 Stinocher St  
Solon, IA 52333**

Wade Mulford  
07/21/2026

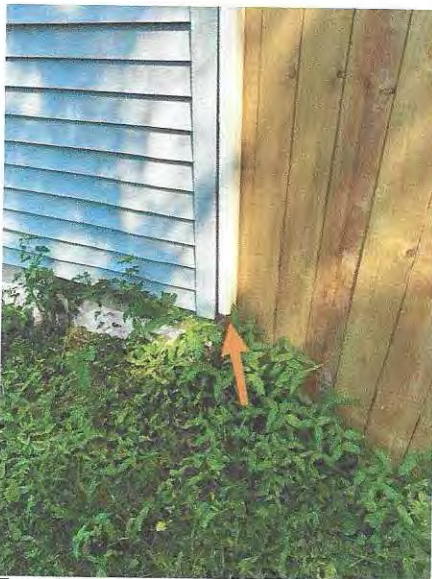
East Corner

One or more downspouts drain too close to the home's foundation. This can result in excessive moisture in the soil at the foundation, which can lead to foundation/structural movement. Recommend downspout extensions to drain at least 6 feet from the foundation.

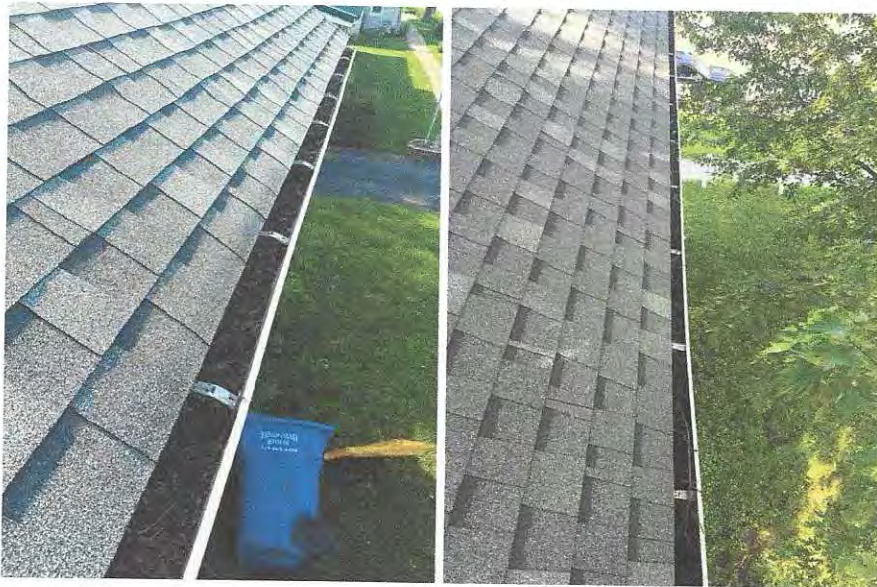
Debris has accumulated in the gutters. Recommend cleaning to facilitate water flow. Here is helpful [DIY Video](#) on how to clean out gutters.

*Will Clean Out*

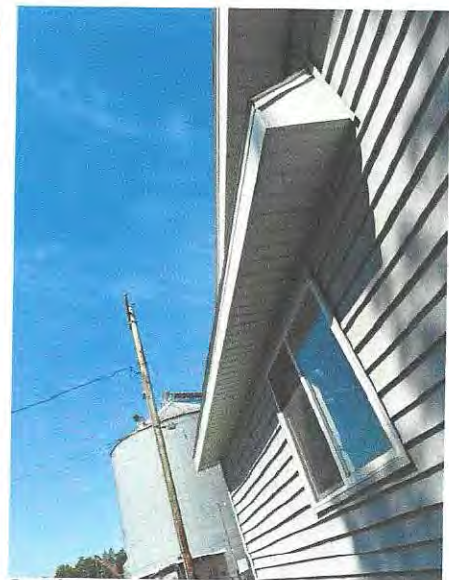
Southeast

There are no gutters present on the structure. Gutters are recommended because they collect rain water from the roof and direct it away from the building.

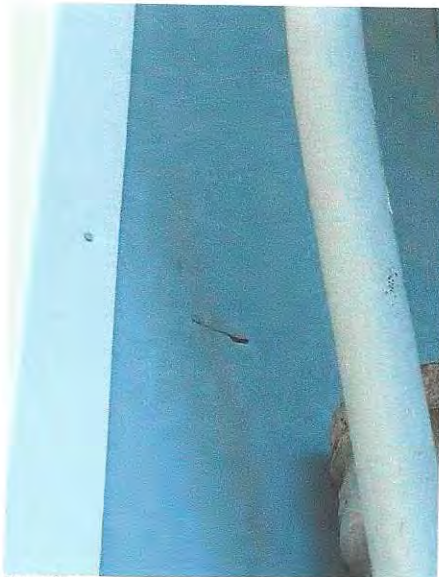
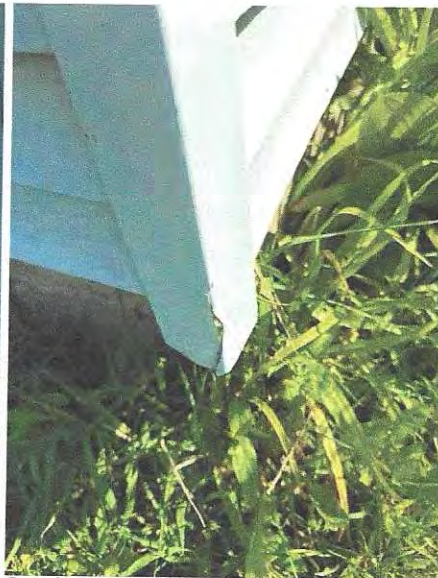
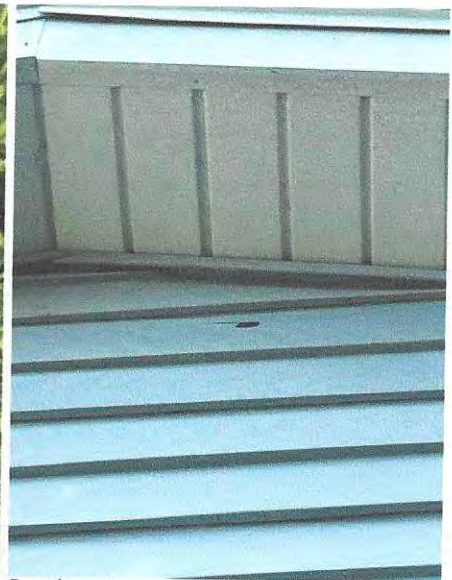
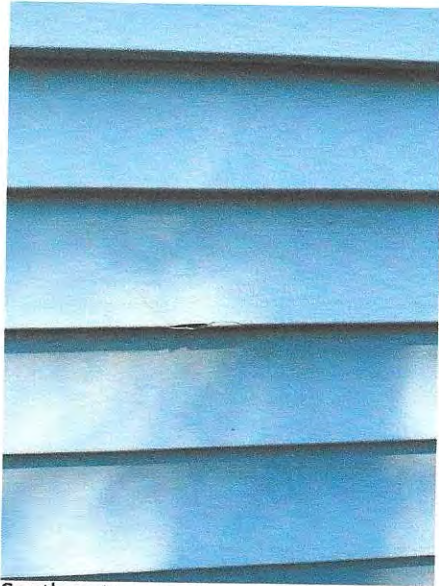
Cracked or damaged siding was observed, which may allow moisture infiltration and compromise the home's exterior protection. Recommend repairing or replacing the damaged siding to maintain the integrity and weatherproofing of the structure.

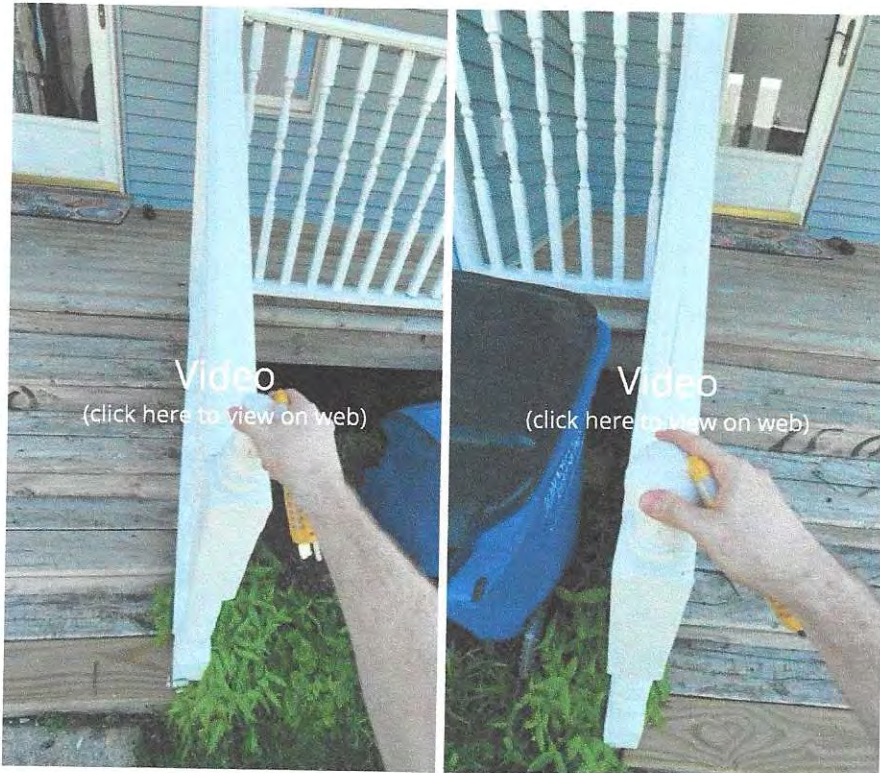
Loose handrail discovered along stairs during testing. This creates a fall hazard for occupants using the stairs. The handrail brackets should be tightened and reinforced. Consider having a handyman secure all mounting points to ensure proper support.

*Tightened*

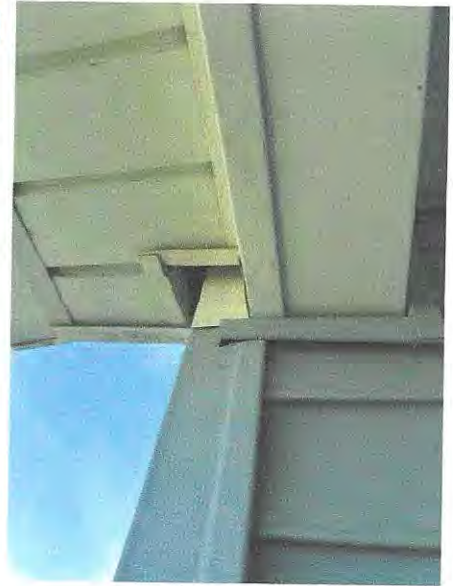
A gap was observed between the siding and soffit during exterior inspection. This opening can allow water infiltration and pest entry into the wall cavity and attic space. The gap should be sealed with appropriate caulk or flashing material to prevent moisture damage and unwanted animal access.

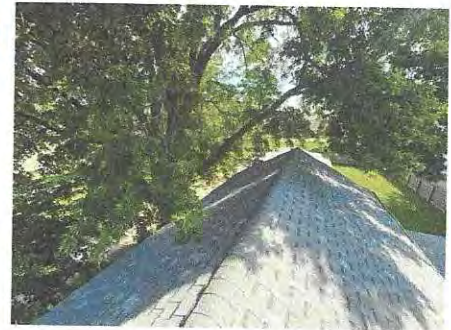
A tree overhang was observed over the roof. Overhanging branches can potentially cause damage to the roof covering, especially during storms or high winds. Additionally, leaves and debris from the tree may accumulate on the roof or in gutters, leading to potential water damage. It is recommended to trim the overhanging branches to prevent future damage and reduce the risk of clogged gutters.

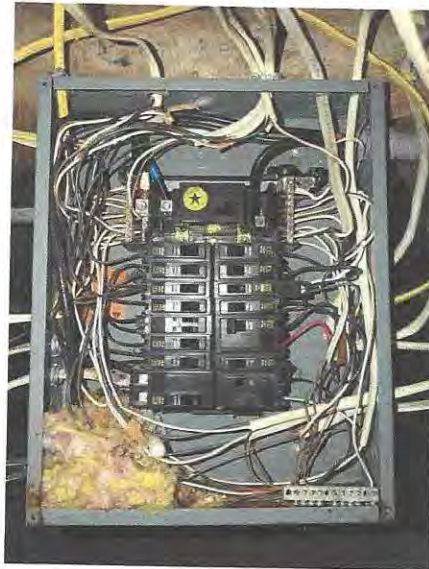
**Main & Subpanels, Service & Grounding, Main Overcurrent Device: Main Panel Location**  
 Crawlspace

**Main & Subpanels, Service & Grounding, Main Overcurrent Device: Panel Capacity**  
 100 AMP

**Main & Subpanels, Service & Grounding, Main Overcurrent Device: Panel Manufacturer**  
 Square D

**Main & Subpanels, Service & Grounding, Main Overcurrent Device: Panel Type**  
 Circuit Breaker

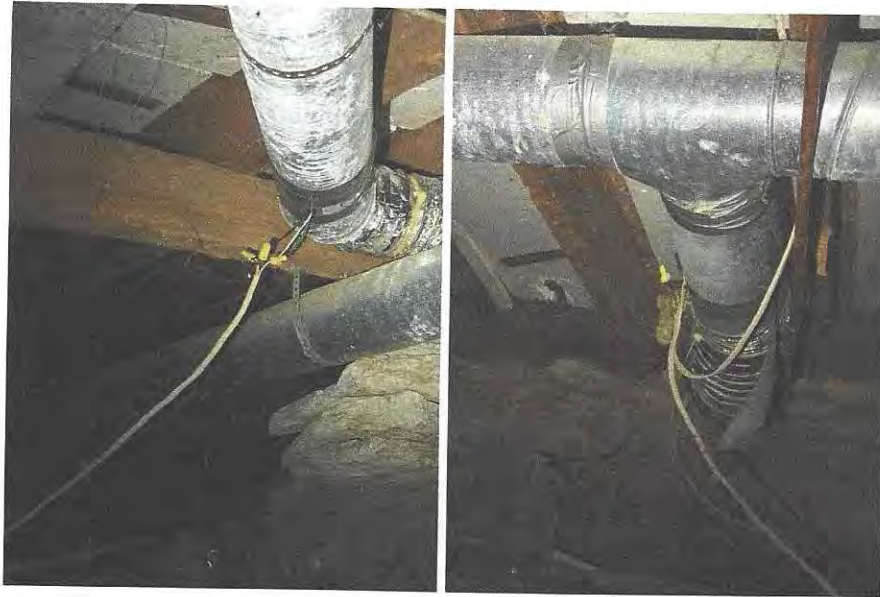
Exposed wiring was observed without an appropriate junction box. This condition poses a potential safety hazard, as it exposes electrical connections to damage, moisture, and accidental contact. It is essential to install a junction box to properly enclose the wiring and ensure safety in compliance with electrical codes.

*Removed*

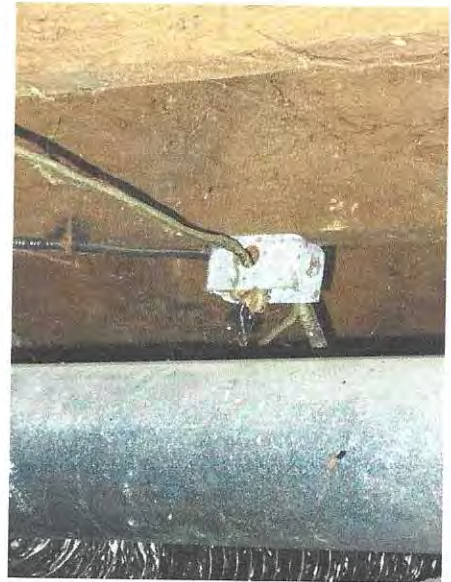
A junction box was found without a cover, leaving exposed wiring and electrical components. This creates a potential safety hazard, as it increases the risk of electrical shock or accidental contact. Installing a proper cover on the junction box is necessary to ensure safety and compliance with electrical standards.

*Repaired*

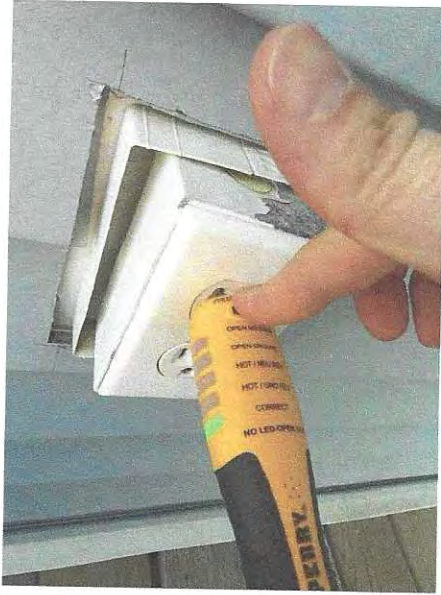
Exterior electrical receptacles require ground fault circuit interrupter (GFCI) protection to prevent electrical shock hazards. This safety feature interrupts electrical current if a ground fault is detected, significantly reducing the risk of electrocution in wet or outdoor environments. Professional electrical evaluation and installation of GFCI outlets is recommended to ensure proper safety standards are met.

*Repaired*

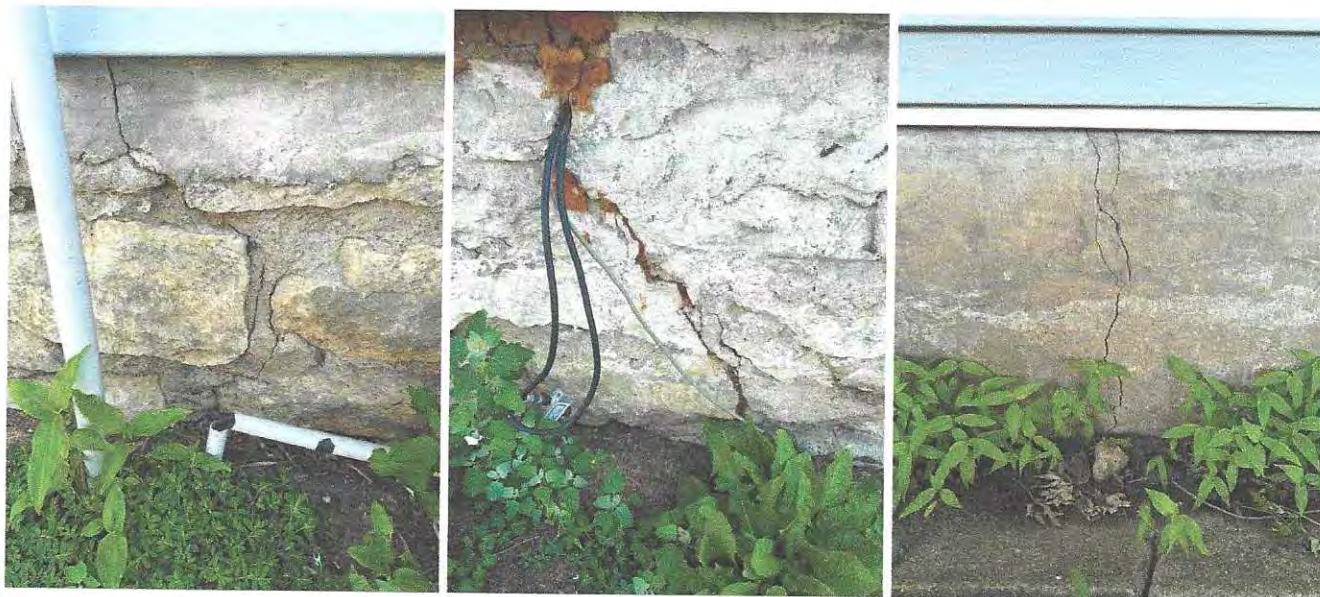
Cracking noted at the foundation, which is typically consistent with soil movement and may be exacerbated by hydrostatic pressure from water buildup around the foundation. This pressure can cause shifts that lead to further cracking, potentially affecting structural components, foundation, and slabs. It is recommended to have a structural engineer or foundation specialist evaluate the cracks and provide a report on the appropriate course of action and remedy.

*Repaired*

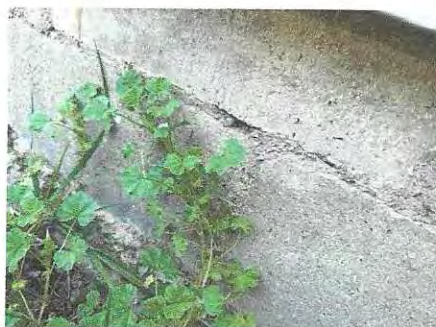
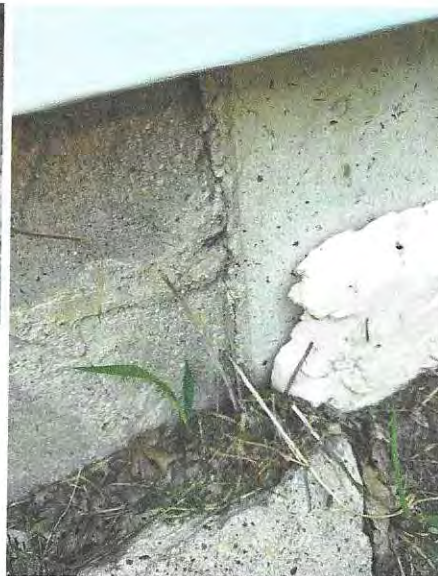
Mortar joints between masonry units in the foundation are deteriorating and showing signs of wear, separation, or erosion. Deteriorating joints compromise the foundation's ability to shed water and maintain structural integrity. A masonry contractor should evaluate the extent of deterioration and recommend appropriate repointing or repair to prevent water infiltration and further damage.

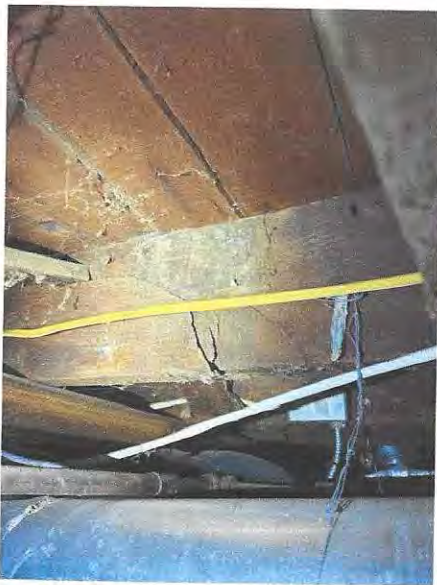
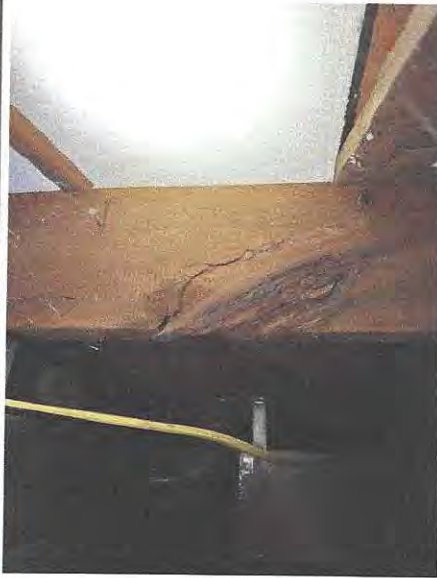
One or more floor joists are in need of repair due to signs of damage, such as sagging, cracking, or weakening. This can affect the structural integrity of the floor and may lead to further issues if not addressed. It is recommended to have the floor joists evaluated and repaired by a qualified professional to ensure the safety and stability of the structure.

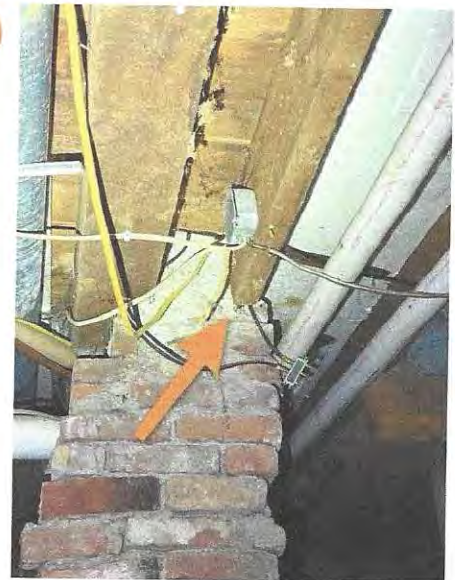
A structural beam in the basement is not properly tied into the foundation, which may compromise the stability of the structure. This could lead to shifting or inadequate load support over time. It is recommended to have a qualified contractor evaluate and properly secure the beam to ensure structural integrity.

Repaired

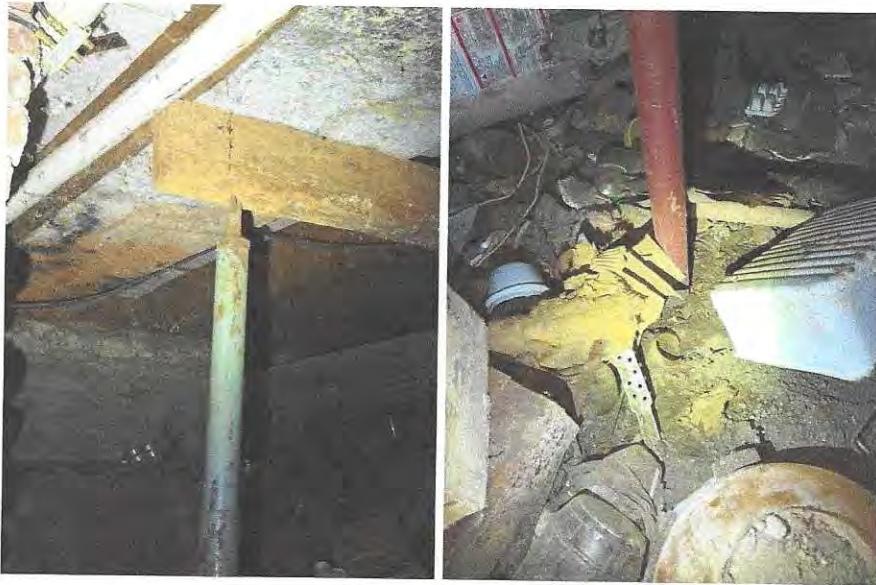
The floor structure is supported using methods that do not meet standard building practices for adequate load distribution and stability. Inadequate or improper support can compromise the structural integrity of the floor system and potentially lead to sagging, movement, or failure over time. A structural engineer should evaluate the current support system and recommend appropriate reinforcement or replacement to ensure safe, code-compliant support.

Repaired

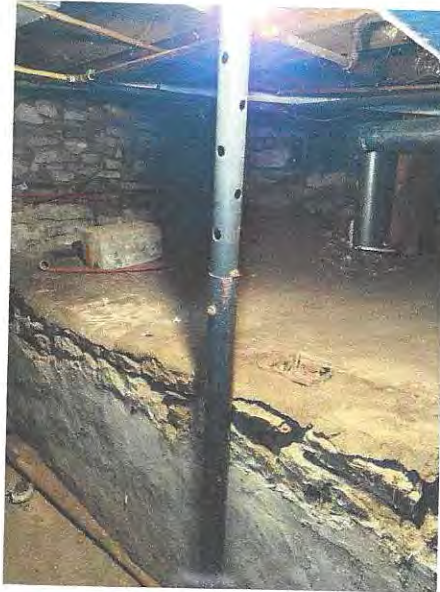
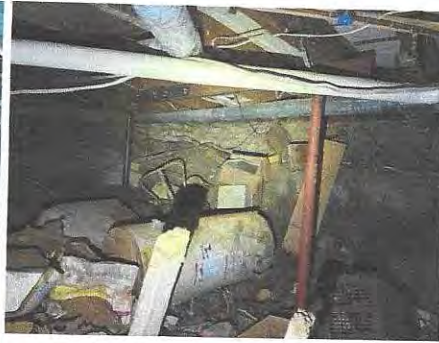
A split jack support is being used instead of a solid support jack for the floor structure. Split jacks lack the load-bearing capacity and stability of solid supports, potentially compromising structural integrity. This condition should be evaluated and corrected by a structural professional to ensure the floor system is properly supported and safe.

Repaired

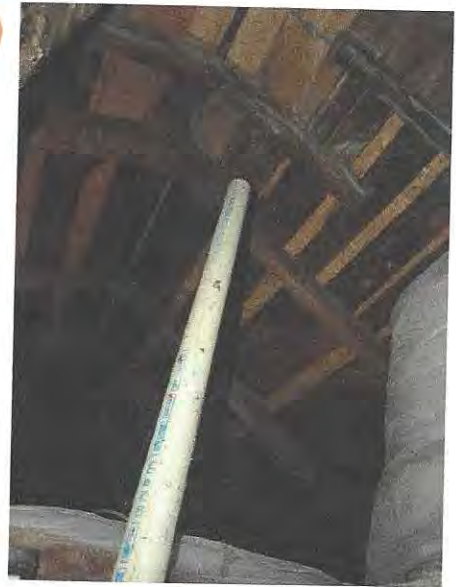
The plumbing vent system terminates into the attic rather than extending through the roof to the exterior. Plumbing vents must exit above the roofline to allow sewer gases to safely disperse outdoors. Venting into the attic can cause moisture accumulation, odors, and potential damage to attic framing and insulation. A licensed plumbing contractor should reroute the vent pipe to properly penetrate the roof and terminate above the roofline.

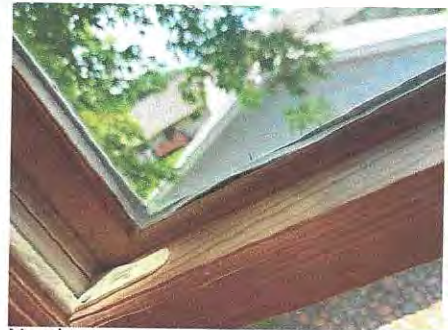
Northeast

The inner seal of the window is loose, which can allow air infiltration and reduce the window's insulating effectiveness. This condition was observed during inspection of the window assembly. A loose seal may lead to drafts, increased energy costs, and potential water infiltration if not addressed. A window repair professional should evaluate the seal and either re-secure or replace it as needed.

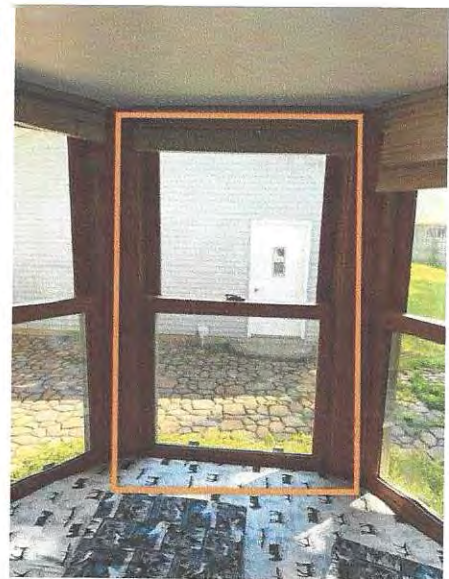
The window does not operate properly and slams shut unexpectedly during use. This indicates a problem with the window hardware, balance system, or frame alignment. Have a window repair professional evaluate and repair or replace the window to ensure safe and reliable operation.

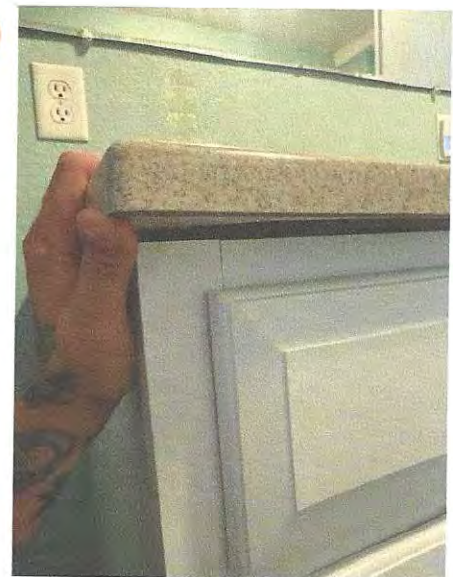
The vanity countertop is loose, likely due to improperly secured fasteners or worn supports. This can lead to instability and potential damage to the surrounding area. It is recommended to tighten the connections or re-secure the countertop to ensure stability and proper function.

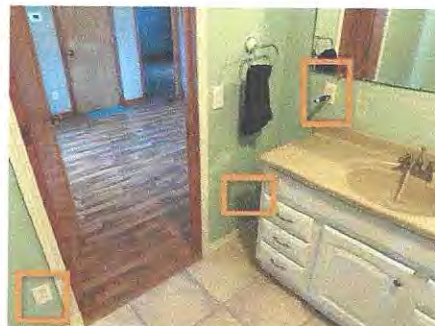
No GFCI protection present in one or more locations. Recommend licensed electrician upgrade by installing ground fault receptacles in all locations.

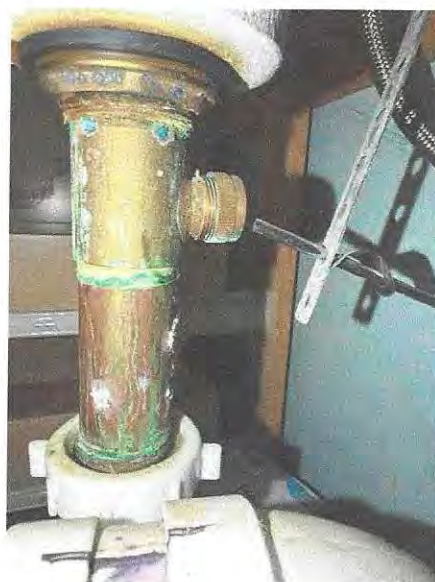
During the inspection, I observed corrosion on the supply fittings. This can lead to shorter lifespan of the supply line. Recommend further evaluation and fixing.

*Repaired*

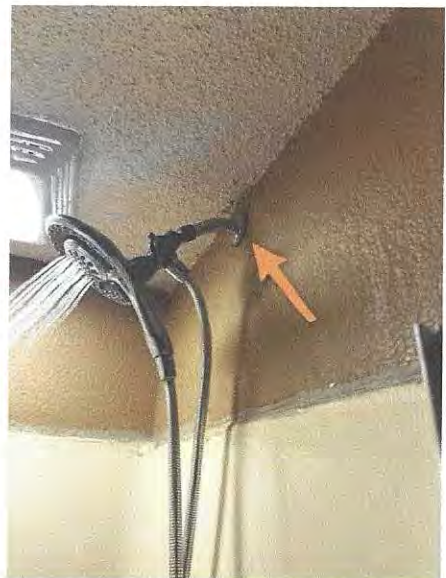
The shower fixture is unsecured, which may be due to loose connections or improper installation. This can lead to instability, leaks, and potential water damage. It is recommended to secure the fixture properly to ensure safe and reliable operation.

*Repaired*

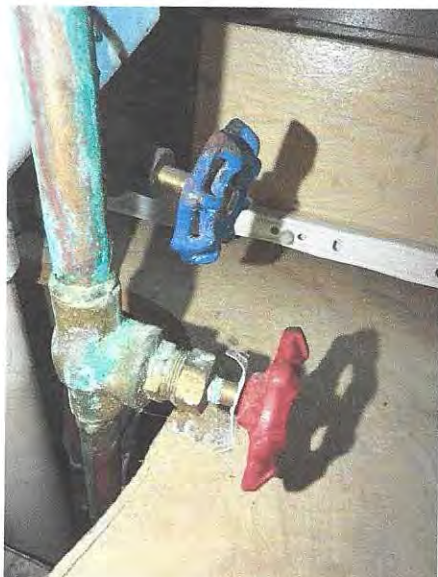
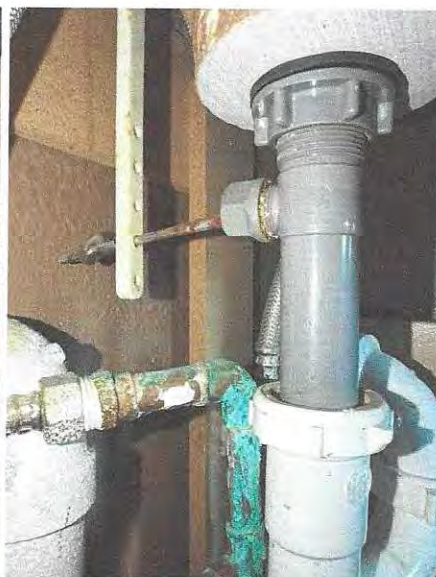
During the inspection, I observed corrosion on the supply fittings. This can lead to shorter lifespan of the supply line. Recommend further evaluation and fixing.

*Repaired*

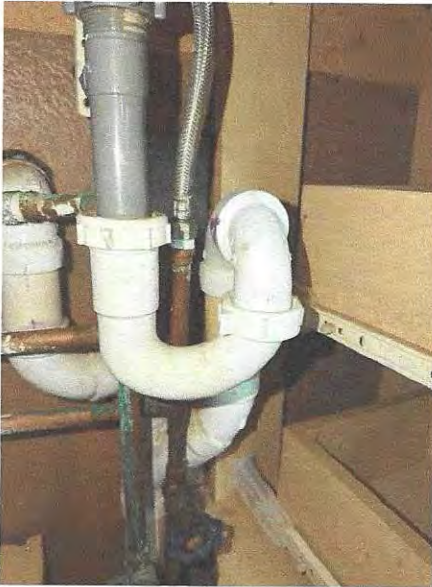
S-traps are an outdated plumbing design that lacks a proper venting mechanism. This configuration can prevent proper drainage and potentially allow sewer gases to enter living spaces.

*Same*

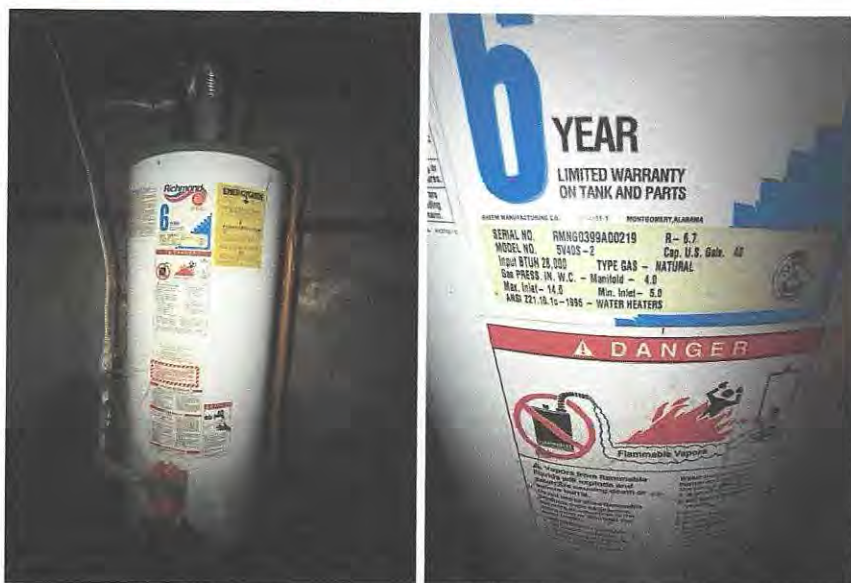
## Hot Water Systems, Controls, Flues & Vents: Hot Water System Life Expectancy

20+ Years (Replacement Recommended), 15-20 Years

I recommend flushing & servicing your water heater tank annually for optimal performance. Water temperature should be set to at least 120 degrees F to kill microbes and no higher than 130 degrees F to prevent scalding.

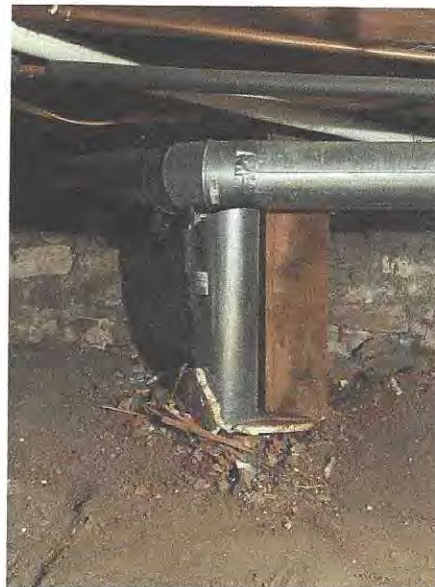
One of the ducts was observed to be improperly supported, which may lead to sagging, disconnection, or restricted airflow over time. Recommend securing the duct with proper support brackets or hangers to ensure stability and maintain efficient system performance.

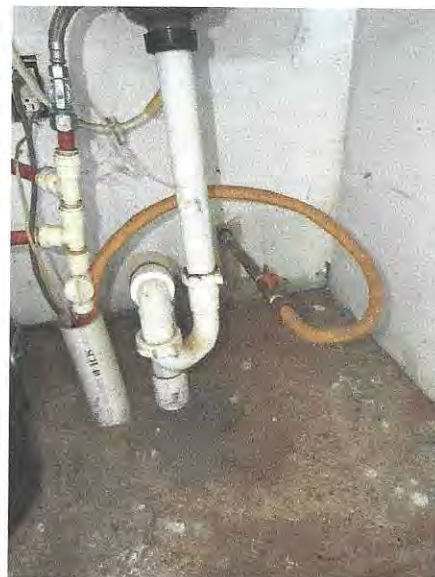
CSST gas piping systems require direct bonding in accordance with manufacturer installation instructions and current fuel gas code standards (e.g., IFGC Section 310.2 or equivalent). Without proper bonding (typically a #6 AWG copper conductor clamped to rigid gas piping or a CSST fitting and connected to the electrical grounding system), the thin-walled tubing is more susceptible to perforation from electrical energy, such as that induced by a nearby lightning strike. This can potentially result in gas leakage, fire, or explosion hazards. Recommend installing ground

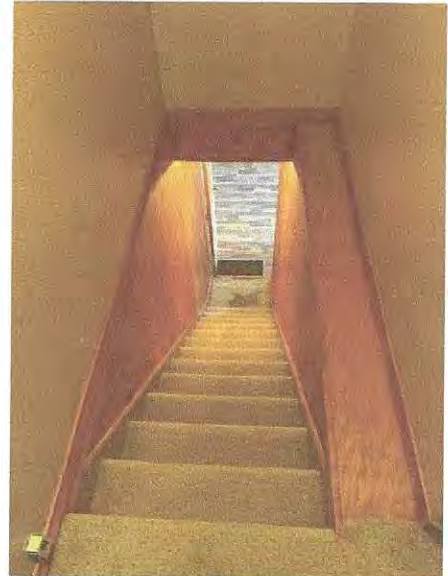
The interior staircase is missing a handrail, which is a critical safety feature for preventing falls and providing support while ascending or descending. Without a handrail, the staircase may pose a safety risk, particularly for children, elderly individuals, or those with mobility issues. Installing a handrail is recommended to ensure the safety and functionality of the stairs.

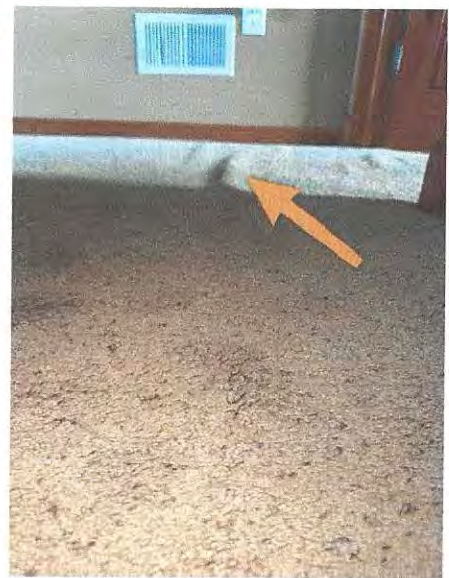
Upstairs Area Between Bedrooms

One or more areas of carpet inside the home were noted to be loose and not properly secured to the subfloor. This condition may present a trip hazard and can worsen with use. Re-securing or re-stretching is recommended.

*New carpet*

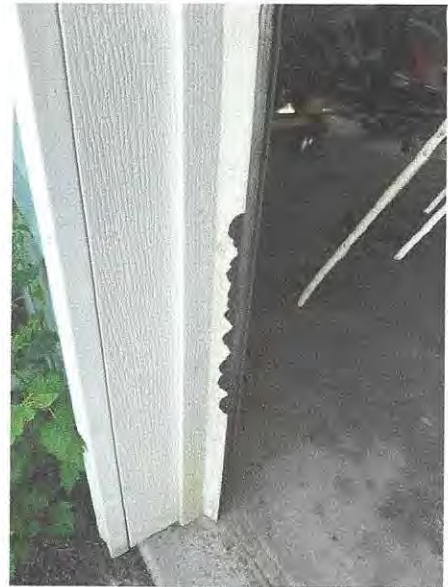
The garage door is missing weatherstripping or the existing weatherstripping is damaged. Proper weatherstripping is essential to prevent drafts, moisture, dust, and insects from entering the garage. Without it, the garage may experience temperature fluctuations, higher energy costs, and potential water damage during rain. It is recommended to install or replace the weatherstripping around the edges of the door to improve energy efficiency and protect the garage from the elements.

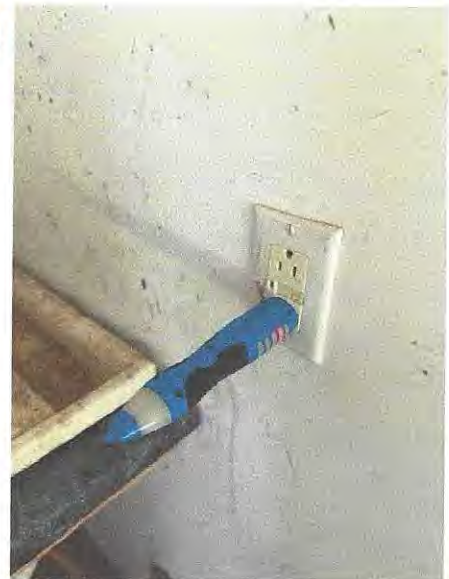
An ungrounded GFCI outlet without the proper "No Equipment Ground" labeling is a safety concern and a violation of the National Electrical Code (NEC). While GFCI outlets can function without a ground wire by detecting ground faults through current imbalances, the labeling is required to inform users that the outlet lacks a proper equipment ground. This omission could lead to misuse of the outlet with devices that require grounding for safe operation, increasing the risk of electric shock or damage to appliances.
