WOOD DESTROYING PESTS AND ORGANISMS INSPECTION REPORT

Building Address:	Date of Inspection	Number of Pages
1215 E. Mardell Ave., Orange, CA 92866	10/02/2026	7

Report # W16786
Lic. Registration # PR 4805
Escrow #

General Description: Single Family Residence, 1 Story, Frame and Stucco, Composition Roof

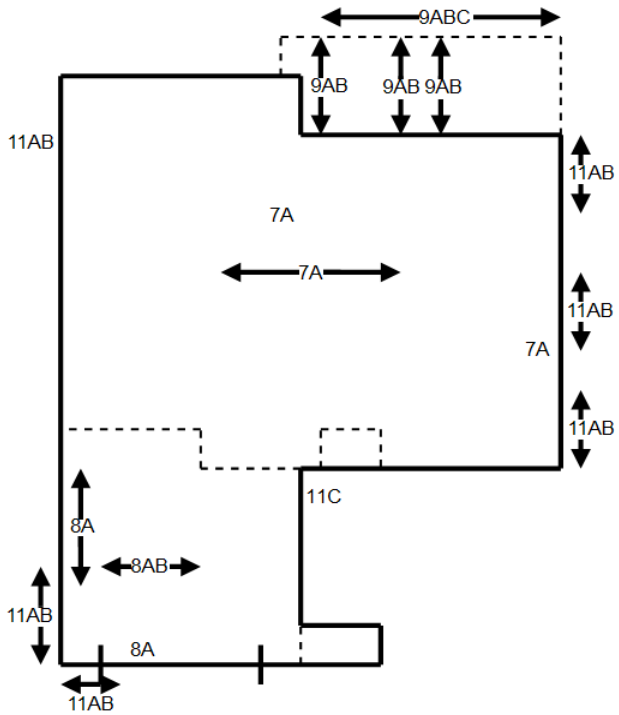
This Diagram is not to scale

7A PRICE: $1,950.00 (Section I)
FINDINGS: Evidence of dry-wood termite infestations at wood members as indicated on the diagram.
RECOMMENDATION: Vacate the premises and seal the structure for fumigation with Vikane Gas. Remove or cover accessible evidence of infestation. Fumigation warranteed for two years. Fumigation awareness notice must be signed prior to fumigation. See fumigation notice for terms and liabilities.

8A PRICE: See 7A (Section I)
FINDINGS: Evidence of dry-wood termite infestations at wood members as indicated on the diagram.
RECOMMENDATION: Vacate the premises and seal the structure for fumigation with Vikane Gas. Remove or cover accessible evidence of infestation. Fumigation warranteed for two years. Fumigation awareness notice must be signed prior to fumigation. See fumigation notice for terms and liabilities.

8B PRICE: $3,550.00 (Section I)
FINDINGS: Evidence of termite damaged wood members noted at time of inspection at rafters as indicated on the diagram.
RECOMMENDATION: Reinforce termite damaged wood members as necessary.

9A PRICE: See 7A (Section I)
FINDINGS: Evidence of dry-wood termite infestations at wood members as indicated on the diagram.
RECOMMENDATION: Vacate the premises and seal the structure for fumigation with Vikane Gas. Remove or cover accessible evidence of infestation. Fumigation warranteed for two years. Fumigation awareness notice must be signed prior to fumigation. See fumigation notice for terms and liabilities.

9B PRICE: See 8B (Section I)
FINDINGS: Evidence of termite damaged wood members noted at time of inspection at joists, fascias, and roof sheathings as indicated on the diagram.
RECOMMENDATION: Repair or cut and replace termite damaged wood members as necessary. Only one coat of painting is included in this estimate.

9C PRICE: See 8B (Section I)
FINDINGS: Dry-rot wood members found at time of inspection at roof sheathings as indicated on the diagram.
RECOMMENDATION: Cut and replace,scrape off and patch and/or cut off dry-rot damaged wood members as necessary. Only one coat of painting is included in this estimate.

11A PRICE: See 7A (Section I)
FINDINGS: Evidence of dry-wood termite infestations at wood members as indicated on the diagram.
RECOMMENDATION: Vacate the premises and seal the structure for fumigation with Vikane Gas. Remove or cover accessible evidence of infestation. Fumigation warranteed for two years. Fumigation awareness notice must be signed prior to fumigation. See fumigation notice for terms and liabilities.

11B PRICE: See 8B (Section I)
FINDINGS: Evidence of termite damaged wood members noted at time of inspection at fascias and roof sheathings as indicated on the diagram.
RECOMMENDATION: Repair or cut and replace termite damaged wood members as necessary. Only one coat of painting is included in this estimate.

11C PRICE: See 8B (Section I)
FINDINGS: Dry-rot wood members found at time of inspection at doors and door jambs as indicated on the diagram.
RECOMMENDATION: Cut and replace,scrape off and patch and/or cut off dry-rot damaged wood members as necessary. Only one coat of painting is included in this estimate. Install kickplate to prevent future damage.
