WOOD DESTROYING PESTS AND ORGANISMS INSPECTION REPORT

Building No.	Street	City	Zip	Date of Inspection	Number of Pages
416	Colusa Ave	Chowchilla CA	93610	7-8-26	6

COMPLETE W.D.O. REPORT

416 Colusa Ave, Chowchilla CA 93610

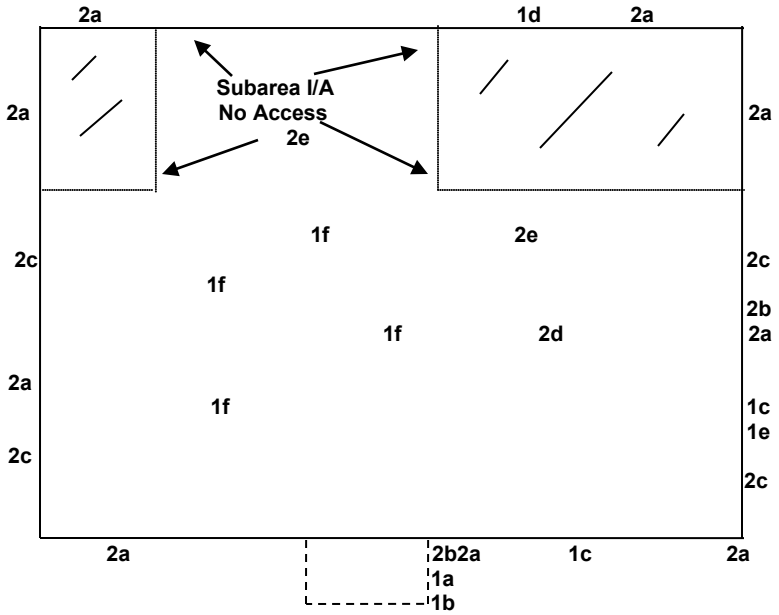
Drawing Not to Scale

1a. **Finding:** Fungus damage was noted in the roof sheathing as noted on the diagram.

1b. **Finding:** Fungus damage was noted in the rafter tails as noted on the diagram.

1c. **Finding:** Fungus damage was noted in the exterior window frame and sill as noted on the diagram.

1d. **Finding:** Fungus damage was noted in the exterior siding as noted on the diagram.

1e. **Finding**: Evidence of Drywood Termites was noted in the exterior windowsill and adjacent wall areas as noted on the diagram.

1f. **Finding:** Surface fungus was noted in the subfloor and floor joists in the subarea of the home as noted on the diagram.

2a. **Finding:** Delaminating wood, weathering, cracking and peeling paint was noted in the exterior wood surfaces of the home and patio cover as noted on the diagram.

2b. **Finding:** Water staining and damage was noted in the underside of the roof sheathing as noted on the diagram.

2c. **Finding:** Buckling or damage was noted in the exterior stucco as noted on the diagram.

2d. **Finding:** Earth to wood contact was noted at the base of the pier posts in the subarea of the home as noted on the diagram.

2e. **Finding:** Cellulose debris in the form of old vegetation and wood construction scraps were noted in the subarea of the home as noted on the diagram.

Recommendation: Repair or replace the fungus damaged portions of the sheathing.

Recommendation: Cut out the fungus infected or damaged portions of the rafters and repair re-enforce as needed.

Recommendation: Repair or replace the fungus damaged portions of the window frame and sill

Recommendation: Repair or replace the fungus damaged portions of the exterior siding

Recommendation: Vacate, tent and fumigate the structure with a Vikane Gas (Sulfural Fluoride) for the control of drywood termites. Remove or mask all accessible termite fecal pellets.

Recommendation: Scrape off the surface fungus where possible and treat the wood in the area with Timor, (Octoborate) for the control of fungus

Recommendation: Engage a painter or contractor to inspect the home exterior and to repair, replace, sand, seal, and paint the exterior wood surfaces where needed to help protect against the elements.

Recommendation: Engage a roofer to inspect the roof and to make any necessary repairs.

Recommendation: Engage a contractor to inspect the areas and to make any necessary corrective actions including to repair or seal the stucco as needed to help prevent water entry.

Recommendation: Excavate or elevate the pier posts and place them on concrete to break the direct earth to wood contact.

Recommendation: Remove all cellulose debris large enough to rake from the subarea of the home.
