WOOD DESTROYING PESTS AND ORGANISMS INSPECTION REPORT

Building Address:	Date of Inspection	Number of Pages
4057 Ladera Vista Rd., Fallbrook, CA 92028	09/04/2026	6

Report # W22023
Lic. Registration # PR 10079
Escrow #

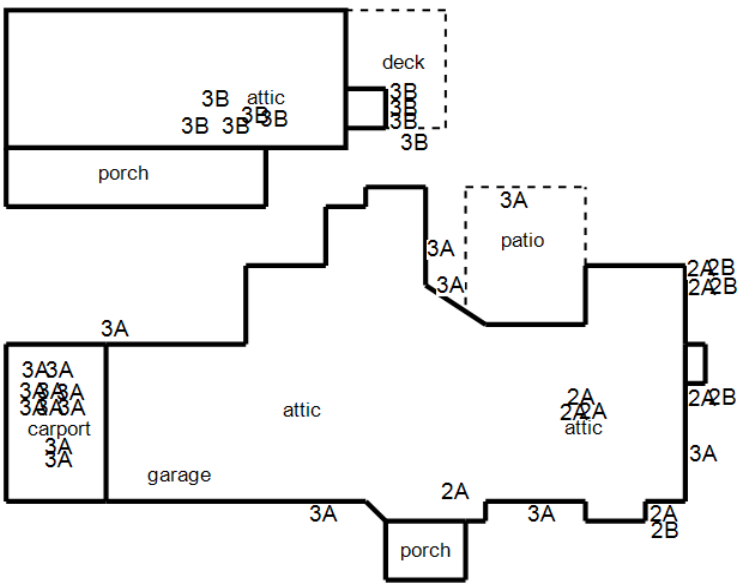
This Diagram is not to scale

2A PRICE: $800.00 (Section I)
FINDINGS: Evidence of drywood termite infestation noted at roof eaves, shiplap, and attic as indicated by 2A on the diagram.
RECOMMENDATION: Chemically treat visible and accessible infestations. Remove or cover accessible pellets. 4-year guarantee.

2B PRICE: $4,750.00 (Section I)
FINDINGS: Evidence of termite damage noted at roof eaves as indicated by 2B on the diagram.
RECOMMENDATION: Repair or replace termite damage at roof eaves. Diverse will apply one (1) coat of primer or similar matching paint to newly replaced/repaired wood member(s) at no additional charge. 4-year guarantee.

3A PRICE: See 2B (Section I)
FINDINGS: Fungus damage and/or dry-rot noted at roof eaves, rafter, joist, and shiplap as indicated by 3A on the diagram.
RECOMMENDATION: Replace fungus damage and/or dry-rot at roof eaves, rafter, joist, and shiplap. Diverse will apply one (1) coat of primer or similar matching paint to newly replaced/repaired wood member(s) at no additional charge. 4-year guarantee.

3B PRICE: Not Estimated (Section I)
FINDINGS: Fungus damage and/or dry-rot noted at trim, door, rail, and subfloor as indicated by 3A on the diagram.
RECOMMENDATION: Replace fungus damage and/or dry-rot at trim, door, rail, and subfloor. Contractor to correct.
