WOOD DESTROYING PESTS AND ORGANISMS INSPECTION REPORT

Building No.	Street	City	Zip	Date of Inspection	Number of Pages
2035	Idyllwild	Arroyo Grande	93420	09/25/2026	1 of 5

Report #: 114749

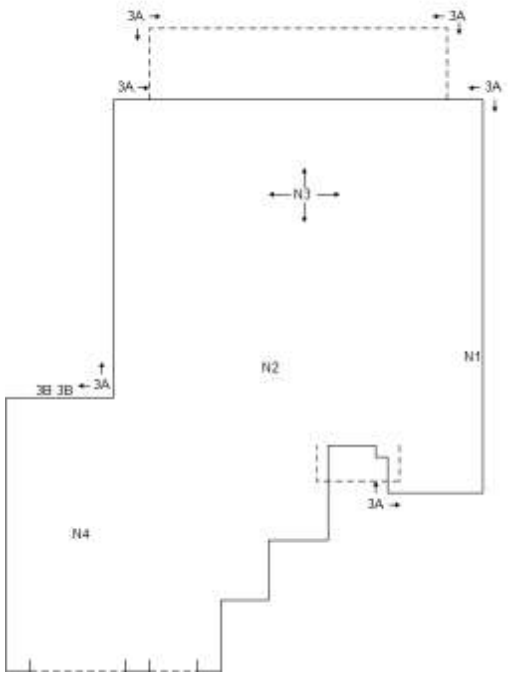
Complete Inspection Report
Diagram not to scale-Finding locations approximate

Finding: 3A Fungus damage was found at the fascia of the eave area.
Recommendation: Replace the fungus damaged portions of fascia as needed.
Price: $2,652.00

Finding: 3B Fungus damage was found at the exterior door frame.
Recommendation: Replace the damaged portions of the door frame as necessary.
Price: $306.00
