WOOD DESTROYING PESTS AND ORGANISMS INSPECTION REPORT

Building Address:	Date of Inspection	Number of Pages
1412 W. Nectarine Av., Lompoc, CA 93436	09/28/2026	6

Report # W16311
Lic. Registration # PR 8447
Escrow #

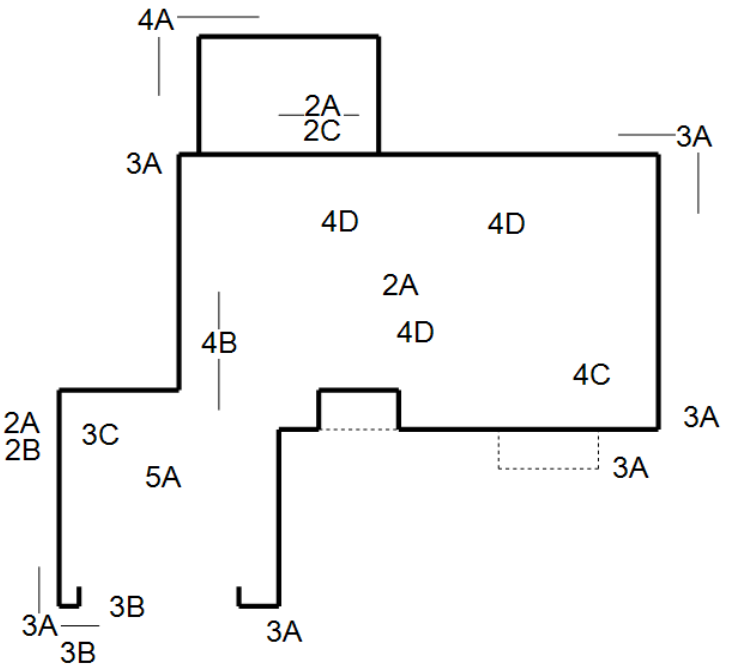
This Diagram is not to scale

2A PRICE: $2,290.00 (Section I)
FINDINGS: Evidence of drywood termite infestation at the door framing, fascia, heater closet, and the attic framing as indicated on the diagram.
RECOMMENDATION: Vacate the premises and seal the structure for fumigation of drywood termites with Vikane Gas. Remove or cover accessible evidence of infestation. Fumigation guaranteed for FIVE YEARS. Treatment type during guarantee will be the sole judgement of 805 Termite Control. Fumigation awareness notice must be signed prior to fumigation. See fumigation notice for terms and liabilities.

2B PRICE: See 3C (Section I)
FINDINGS: Drywood termite damage was found at the door trim and the door jamb.
RECOMMENDATION: Remove and replace or reinforce damage wood members. Painting is included, color may not be an exact match.

2C PRICE: See 3A (Section I)
FINDINGS: Drywood termite damage was found at the fascia.
RECOMMENDATION: Remove and replace or reinforce damage wood members. Painting is included, color may not be an exact match.

3A PRICE: $1,930.00 (Section I)
FINDINGS: Fungus damage was noted at the fascia.
RECOMMENDATION: Remove and replace damaged wood members with new material. Painting is included, color match may not be exact.

3B PRICE: $450.00 (Section I)
FINDINGS: Fungus damage was noted at the corbel.
RECOMMENDATION: Remove and replace damaged wood members with new material. Painting is included, color match may not be exact.

3C PRICE: $1,650.00 (Section I)
FINDINGS: Fungus damage was found at the garage pedestrian door and jamb.
RECOMMENDATION: Remove and replace the door with a new pre-hung door of like kind and quality.

4A PRICE: $175.00 (Section II)
FINDINGS: Earth to wood contact was noted at the siding.
RECOMMENDATION: Correct the earth to wood contact by lowering the soil.

4D PRICE: $350.00 (Section II)
FINDINGS: Cellulose debris noted at the time of inspection in sub area.
RECOMMENDATION: Clean out cellulose debris of rakable size and remove from premises.
