WOOD DESTROYING PESTS AND ORGANISMS INSPECTION REPORT

ADDRESS OF INSPECTED PROPERTY:	REPORT #:	DATE OF INSPECTION:	NUMBER OF PAGES:
4219 Artesia Blvd, Torrance,CA 90504	**192588**	08/11/2026	Page 1 of 7

General Description:
1 Story Stucco Residence Unfurnished and Unoccupied with a Composition Shingle Roof on Concrete Slab Foundation

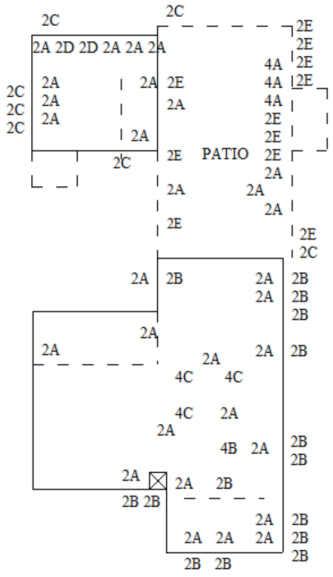
Note : Diagram Not to Scale

2A: Evidence of drywood termites
2B: Evidence of drywood termite damage
2C: Evidence of drywood termite damage
2D: Evidence of drywood termite damage
2E: Evidence of drywood termite damage
4A: Roof Damage
4B: Evidence of shower leakage
4C: Rodent Infestation
See Findings description on the following pages.
