WOOD DESTROYING PESTS AND ORGANISMS INSPECTION REPORT

Building No.	Street	City	Zip	Date of Inspection	Number of Pages
1835	Orville Avenue	Cambria	93428	05/05/2026	1 of 6

Report #: 113147

Complete Inspection Report

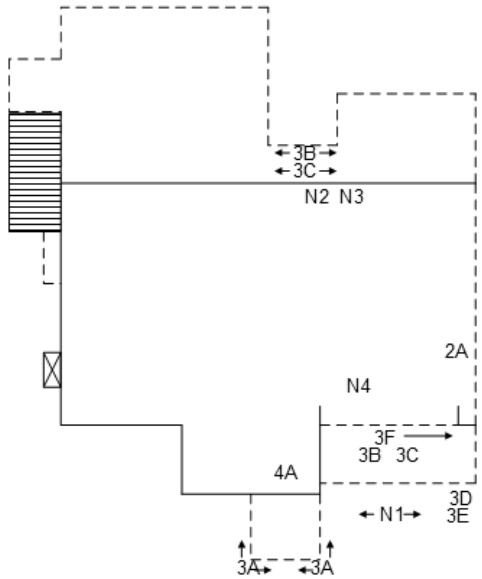
Diagram not to scale
Finding locations approximate

Finding: 2A
Evidence of Drywood Termite infestation was found at the attic and appears to extend into inaccessible areas of the structure.

Finding: 3A
Fungus damage was found at the exterior wood trim.

Finding: 3B
Fungus growth was found at the decking planks.

Finding: 3C Fungus damage was found at the deck joist.
Recommendation: Remove and replace the damaged portions of the deck joist as needed to eliminate the fungus infection and damage.
Price: $1,530.00

Finding: 3D Fungus damage was found at the handrail post.
Recommendation: Remove and replace the damaged portions of the handrail post as needed to eliminate the fungus infection and damage.
Price: $306.00

Finding: 3E Fungus damage was found at the deck fascia of the eave area.
Recommendation: Replace the fungus damaged portions of deck fascia as needed.
Price: $204.00

Finding: 3F Fungus damage was found at the roof sheathing of the eave area.
Recommendation: Replace the fungus damaged portions of roof sheathing as needed.
Price: $612.00

Recommendation:
Seal the structure and fumigate with a gas lethal to Drywood Termites (Sulfuryl Fluoride). All occupants and pets must vacate the structure until the fumigation is complete. This company will exercise reasonable caution, but cannot be held responsible for damage to plants, TV antennas or roofing due to the fumigation. Further terms and instructions will be supplied upon request or upon scheduling of the fumigation. Information may also be obtained from the fumigation page on our website at www.keytermite.com
Fumigations are guaranteed for 5 years from the date completed

Recommendation:
Replace the damaged portions of the trim as necessary.

Recommendation:
Remove the surface growth with a wire brush. Chemically treat the infected wood members with disodium octaborate tetrahydrate.

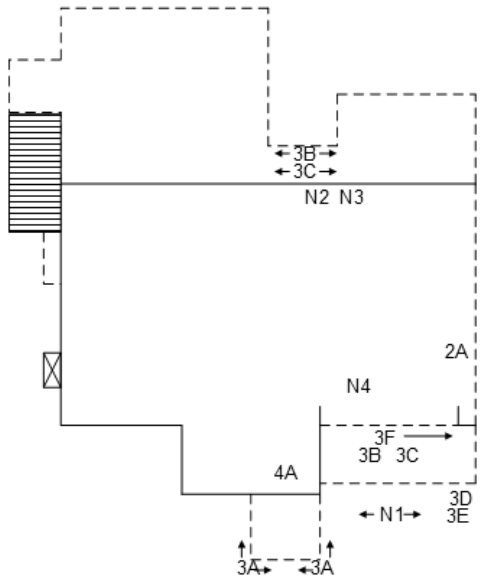
Diagram not to scale
Finding locations approximate

Finding: 2A
Evidence of Drywood Termite infestation was found at the attic and appears to extend into inaccessible areas of the structure.

Finding: 3A
Fungus damage was found at the exterior wood trim.

Finding: 3B
Fungus growth was found at the decking planks.

Finding: 3C Fungus damage was found at the deck joist.
Recommendation: Remove and replace the damaged portions of the deck joist as needed to eliminate the fungus infection and damage.
Price: $1,530.00

Finding: 3D Fungus damage was found at the handrail post.
Recommendation: Remove and replace the damaged portions of the handrail post as needed to eliminate the fungus infection and damage.
Price: $306.00

Finding: 3E Fungus damage was found at the deck fascia of the eave area.
Recommendation: Replace the fungus damaged portions of deck fascia as needed.
Price: $204.00

Finding: 3F Fungus damage was found at the roof sheathing of the eave area.
Recommendation: Replace the fungus damaged portions of roof sheathing as needed.
Price: $612.00

Recommendation:
Seal the structure and fumigate with a gas lethal to Drywood Termites (Sulfuryl Fluoride). All occupants and pets must vacate the structure until the fumigation is complete. This company will exercise reasonable caution, but cannot be held responsible for damage to plants, TV antennas or roofing due to the fumigation. Further terms and instructions will be supplied upon request or upon scheduling of the fumigation. Information may also be obtained from the fumigation page on our website at www.keytermite.com
Fumigations are guaranteed for 5 years from the date completed

Recommendation:
Replace the damaged portions of the trim as necessary.

Recommendation:
Remove the surface growth with a wire brush. Chemically treat the infected wood members with disodium octaborate tetrahydrate.
