WOOD DESTROYING PESTS AND ORGANISMS INSPECTION REPORT

Building Address:	Date of Inspection	Number of Pages
434 E. Carroll Ave, Glendora, CA 91741	08/05/2026	5

Report # W10195
Lic. Registration # PR 6352
Escrow #

General Description: Single story home with attached garage

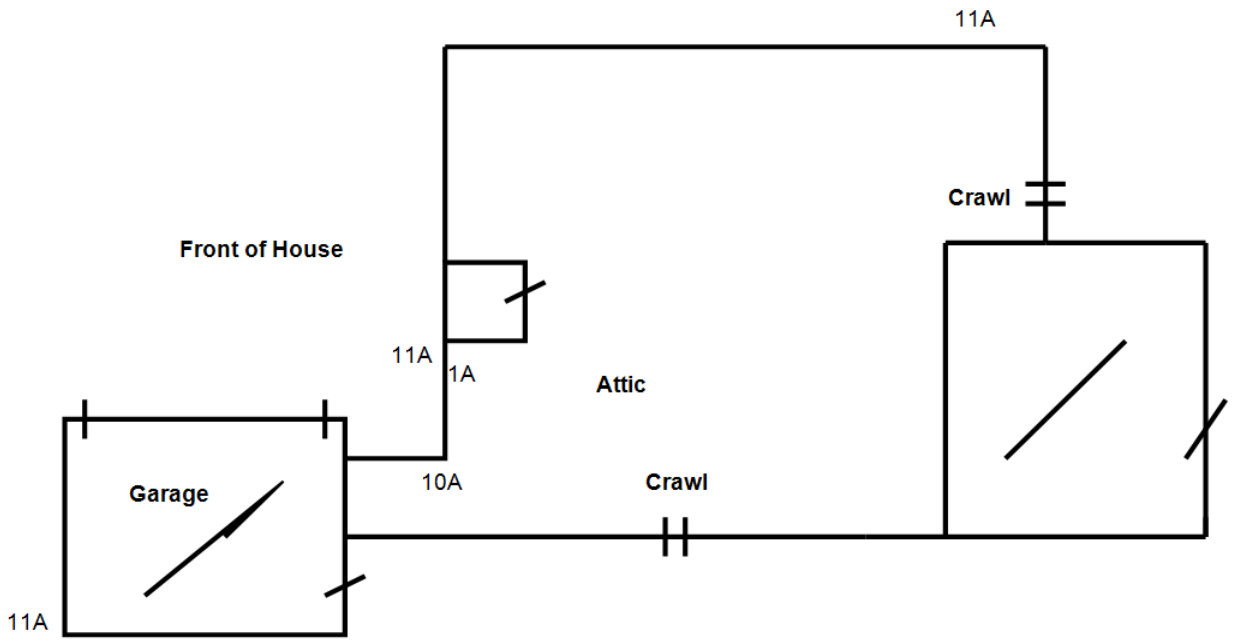
This Diagram is not to scale

1A PRICE: Informational (Section I)
FINDINGS: Excessive moisture condition noted at sub area foundation wall.
RECOMMENDATION: Contact proper tradesman to repair plumbing leaks and any water damage from same.

10A PRICE: Informational (Section I)
FINDINGS: Evidence of termite damaged wood members noted at interior bedroom wood floor.
RECOMMENDATION: Others to replace damaged wood members and correct cause of any adverse conditions. If additional adverse conditions are found during repairs, further inspection is recommended and a supplemental report indicating any infection, adverse conditions or repairs will be made.

11A PRICE: Informational (Section I)
FINDINGS: Stucco cracks noted at exterior walls.
RECOMMENDATION: Contact proper tradesman to correct as necessary.
