PROPERTY INSPECTION REPORT

FOUR POINT
HOME INSPECTION INC.

7325 Navajoa Ave
Inspection Prepared For: Jacob Juarez
Agent: -
Date of Inspection: 8/31/2026
Year Built: 2006 Size: 1228
Weather: Warm/Dry

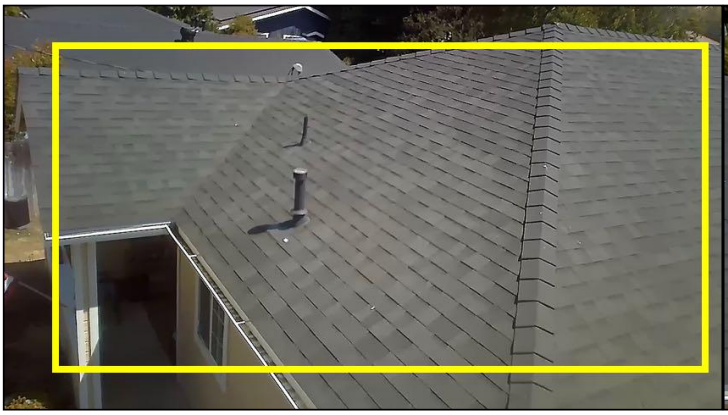
-LAYERS

The roof had one layer of asphalt shingles installed at the time of the inspection.

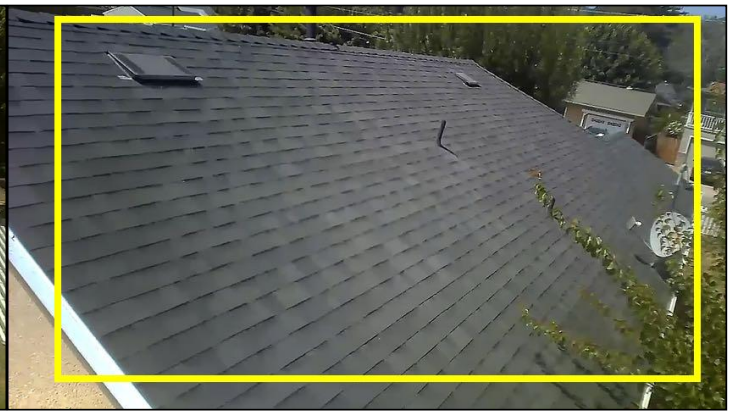
-EXTERIOR ROOF STRUCTURE

The inspector observed no deficiencies in the condition of the roof structure exterior.

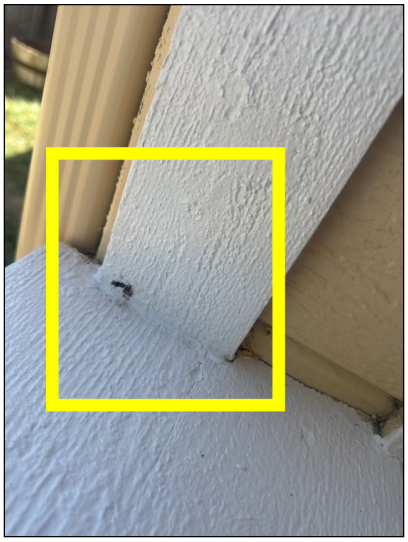
Materials: Exterior trim was constructed of wood.
Observations:
• At the time of the inspection, the Inspector observed few deficiencies in the condition of exterior trim. Notable exceptions are listed.
• ***Maintenance Needed:*** Trim had gaps that should be filled with an appropriate sealant by a qualified contractor to help prevent moisture and insect entry.
• Moisture damage, wood rot, observed. Refer to pest report for further details and repair damage as needed.

Maintenance Needed: Trim had gaps that should be filled with an appropriate sealant by a qualified contractor to help prevent moisture and insect entry.

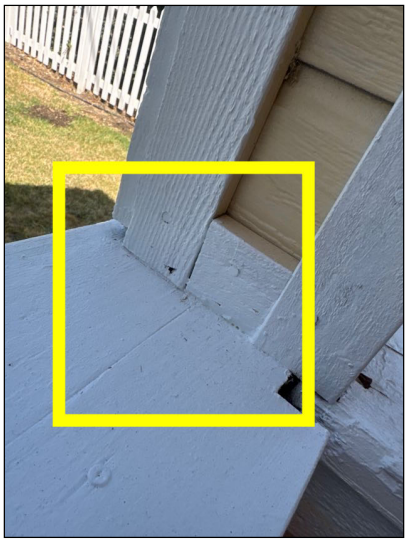
Moisture damage, wood rot, observed.

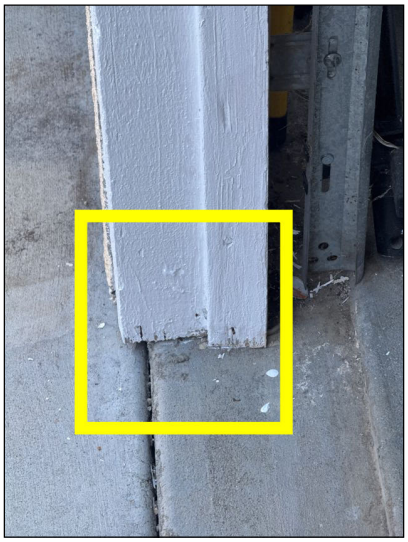
Moisture damage, wood rot, observed.

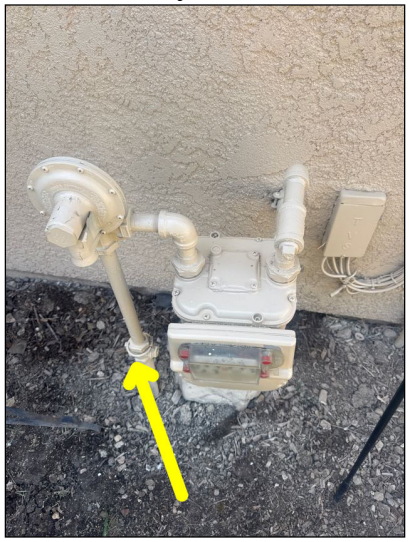
Main gas shut off to the home.

• The gas shut-off appeared to be in serviceable condition at the time of the inspection. Shut-offs were not operated, but were visually inspected.

• The home was located in an area known to experience significant earthquakes having a gas shut off tool readily available in an emergency is a recommended safety improvement.

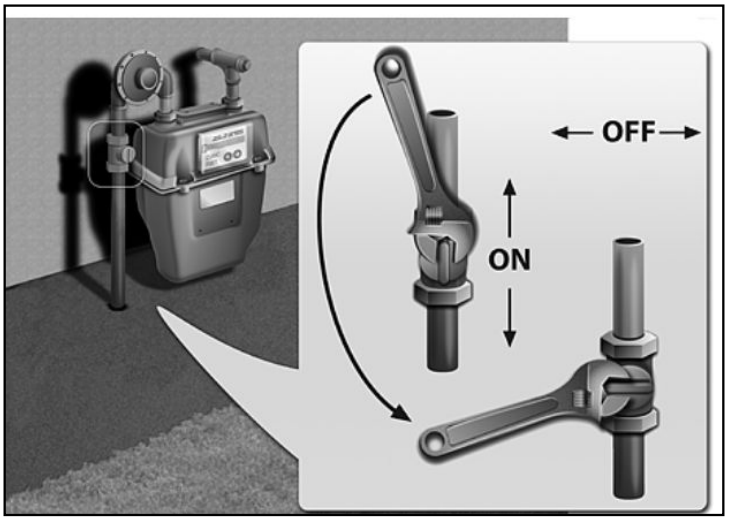
Basic operation of the gas shut off valve is shown above.

Having a gas shut off tool readily available in an emergency is a recommended safety improvement.

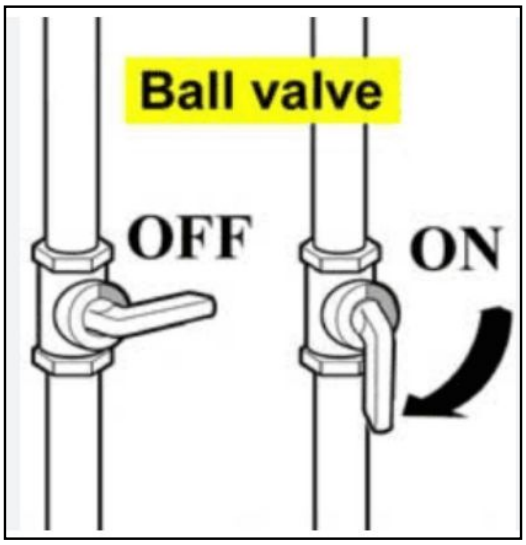
Main water shut off to the home where the main water line enters the home.

The basic operation for a ball valve shut off is pictured above.

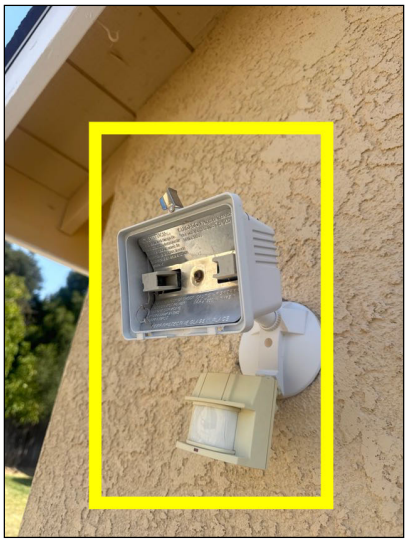
Some exterior lighting was loose to the wall and could expose electrical components to moisture intrusion. The inspector recommends all fixtures are properly fastened and sealed to the wall by a qualified electrical contractor.

Exterior lighting was installed in a manner that left energized electrical components exposed to moisture intrusion. This condition will deteriorate electrical connections and is a potential fire hazard. The inspector recommends correction by a qualified electrical contractor.

An exterior light fixture was damaged at the time of the inspection. This condition may be a potential fire hazard. The Inspector recommends correction by a qualified electrical contractor.

Exterior lighting was loose/not flush to the wall and could expose electrical components to moisture intrusion. front door

Exterior lighting was installed in a manner that left energized electrical components exposed to moisture intrusion.

An exterior light fixture was damaged at the time of the inspection.

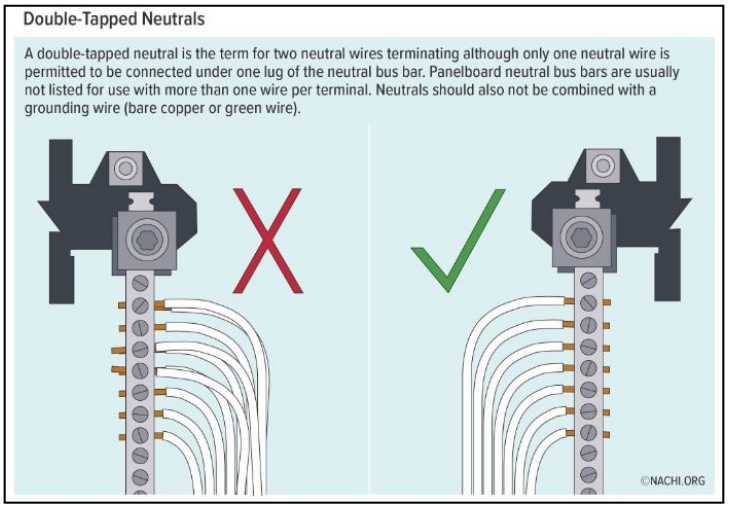
-GENERAL CONDITION

At the time of the inspection, the Inspector observed few deficiencies in the condition of circuit wires in the electrical service panel. Notable exceptions are listed.

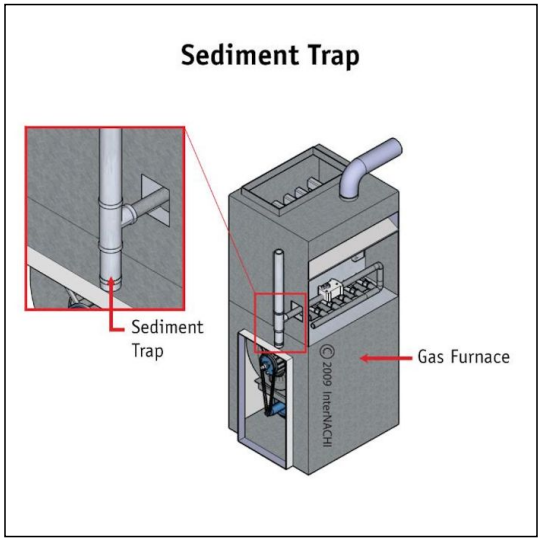
Unit #1

At the time of the inspection, the Inspector observed no deficiencies in the condition of the shut off valve or visible gas supply pipes.

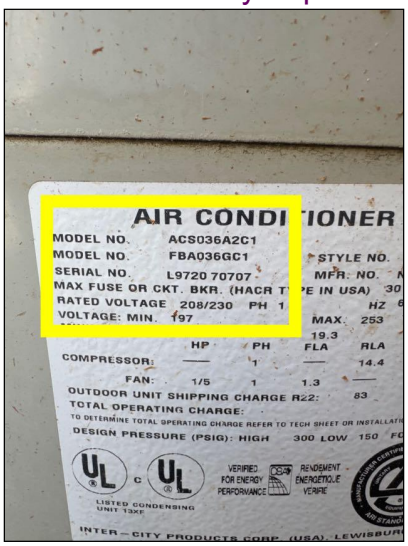
The electrical disconnect for the air conditioning condenser unit was not within line of sight as is required. The Inspector recommends installation of an electrical disconnect which complies with generally-accepted modern safety standards. All work should be performed by a qualified HVAC or electrical contractor.

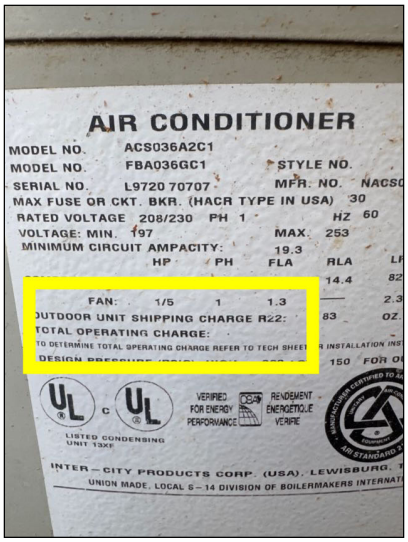
AC model and serial number

Monitor R22 Refrigerant: The AC unit uses R-22 refrigerant

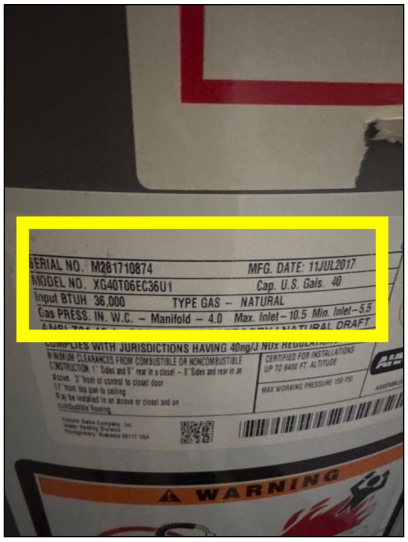
Unit#1

Manufacture:Rheem

Manufacture Date: 2017

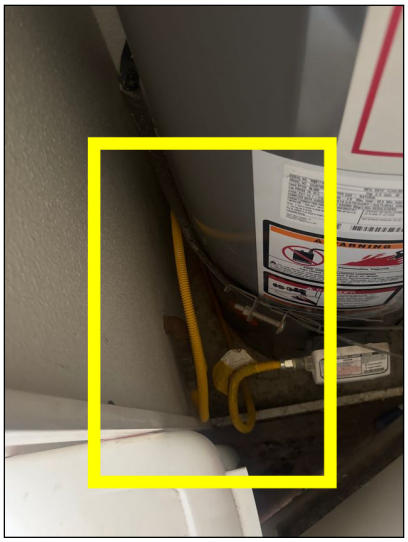
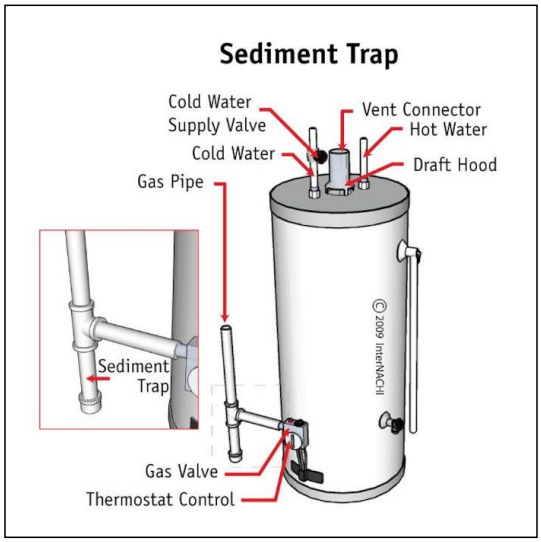
Recommended Improvement: The gas supply pipe contained no sediment trap. The purpose of a sediment trap is to prevent sediment or debris particulates from entering and clogging the water heater gas valve, which can cause the water heater to shut down. You may wish to consult with local contractor concerning the advisability of installing a sediment trap in the gas line.

Improvement: The gas supply pipe contained no sediment trap.

The purpose of a sediment trap is to prevent sediment or debris particulates from entering and clogging the water heaters gas valve

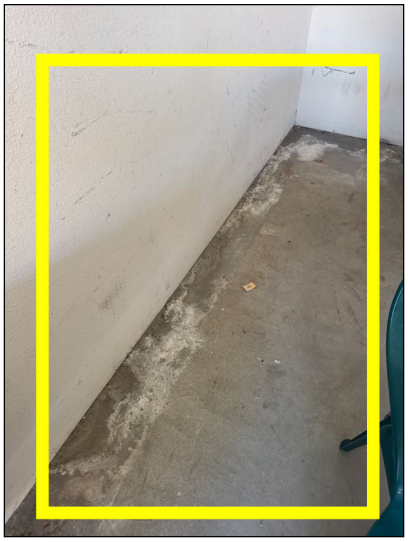
At the time of the inspection, the Inspector observed no deficiencies in the condition of the garage floor.

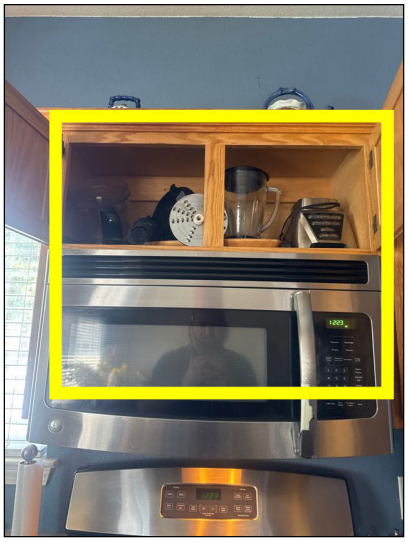
10. Vent Condition

Hood Type: The range hood did not exhaust to the outside but re-circulated air through cleanable filters.

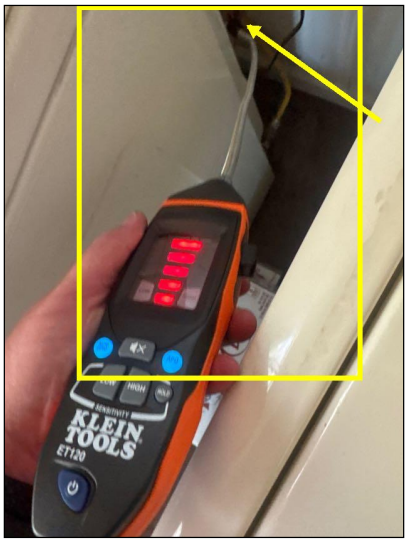
-VENT CONDITION

A dryer exhaust duct connection was installed in the laundry room. A visual examination will not detect the presence of lint accumulated inside the vent, which is a potential fire hazard. The Inspector recommends that you have the dryer duct cleaned at the time of purchase and annually in the future to help ensure that safe conditions exist. Lint accumulation can occur even in approved, properly installed exhaust duct. All work should be performed by a qualified contractor.

At the time of the inspection, the Inspector observed no deficiencies in the condition of the dryer exhaust duct.

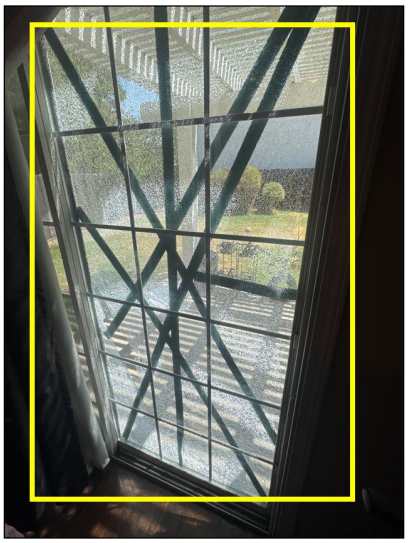
10. Doors

Observations:
• At the time of the inspection, the Inspector observed no deficiencies in the condition of interior doors in this bedroom.
