Inspection Report

Property Address:
9350 Via Cielo
Atascadero CA 93422

8/17/2026

Harper Homes: Home Inspection Services

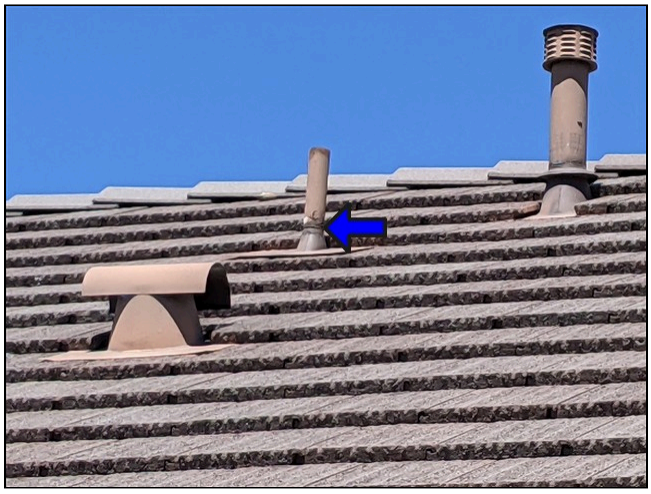
2.2 Item 1(Picture)

2.2 CHIMNEYS AND ROOF PENETRATIONS
Comments: Action Required

MAINTENANCE NEEDED
Plumbing vents need resealed at the roof.

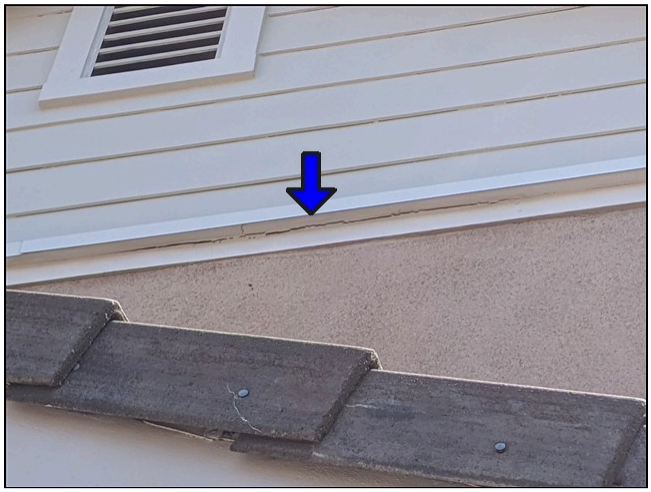
2.4 Item 1(Picture)

(1) FURTHER EVALUATION
Moisture damage noted at the rear right fascia corner, left gable trim and right gable trim. Recommend further evaluation by a structural pest control operator and make repairs as prescribed.

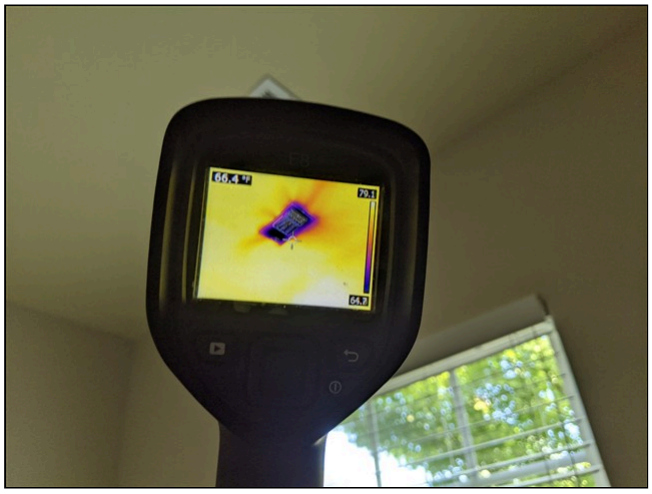
5.4 COOLING AND AIR HANDLER EQUIPMENT

Comments: Appears Serviceable

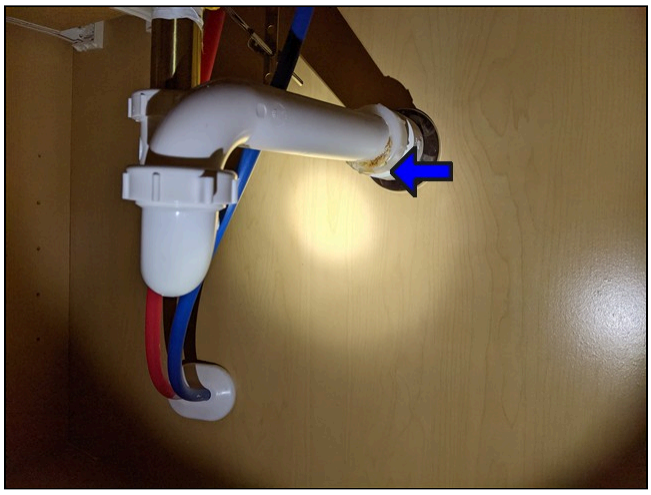
8.2.C Item 1(Picture)

REPAIR NEEDED
Leak noted on the drain line in the cabinet under the left sink and repairs should be made before further use.
