WOOD DESTROYING PESTS AND ORGANISMS INSPECTION REPORT

Building Address:	Date of Inspection	Number of Pages
41900 Green Tree Rd., Temecula, CA 92592	10/09/2026	6

Report # W11978

General Description:
2 story, raised foundation, detached garage, tile roof

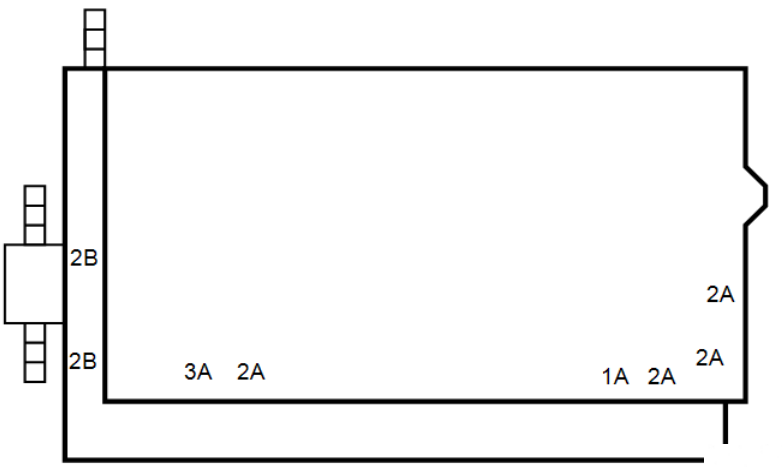
1A (Section I)
FINDINGS: Evidence of subterranean termite infestation at the cellulois debris as indicated on the diagram.
RECOMMENDATION: Pressure "ROD" treat, trench application or low pressure spot spray as necessary. Break accessible sub tubes.

2A (Section I)
FINDINGS: Evidence of drywood termite infestation at the laundry room wall and subfloor as indicated on the diagram.
RECOMMENDATION: Vacate the premises and seal the structure for fumigation with Vikane fumigant. Remove or cover accessible evidence of infestation. Fumigation warranteed for three years. Occupants fumigation notice and pesticide disclosure must be signed prior to fumigation. See fumigation notice for terms and liabilities.

2B (Section I)
FINDINGS: Evidence of drywood termite infestation at the porch header and support post as indicated on the diagram.
RECOMMENDATION: Vacate the premises and seal the structure for fumigation with Vikane fumigant. Remove or cover accessible evidence of infestation. Fumigation warranteed for three years. Occupants fumigation notice and pesticide disclosure must be signed prior to fumigation. See fumigation notice for terms and liabilities.

3A (Section I)
FINDINGS: Surface fungus condition visible at time of inspection at the second story fascia as indicated on the diagram.
RECOMMENDATION: Scrape and chemically treat fungus condition. Patch any minor surface damage found during treatment.

3B (Section I)
FINDINGS: Fungus damage noted at the garage fascia, roof sheathing and jamb at time of inspection as indicated on the diagram.
RECOMMENDATION: Remove and replace as necessary.
