WOOD DESTROYING PESTS AND ORGANISMS INSPECTION REPORT

Building No.	Street	City	ZIP	Date of Inspection	Number of Pages
556	Carmella Drive	Arroyo Grande	93420	10/16/2026	4

Report # : 10389
Registration # : PR9432
Escrow # :
☐ CORRECTED REPORT

GENERAL DESCRIPTION:	Inspection Tag Posted:
One-story single family residence, stucco, composition roof, vacant, attached garage	Garage
	Other Tags Posted:

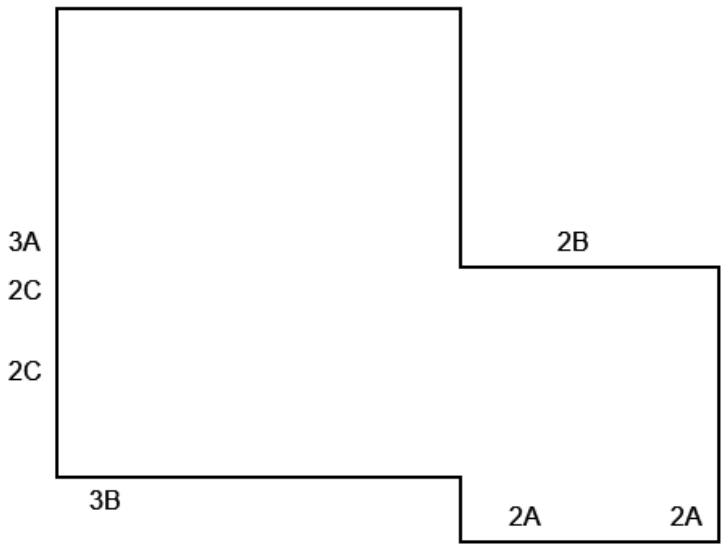
Diagram Not To Scale

FINDING: Evidence of drywood termites was noted at/in garage framing.
RECOMMENDATION: Remove or cover accessible drywood termite fecal pellets.
RECOMMENDATION: Fumigate the structure with a gas lethal to drywood termites, with Vikane or Zythor (Sulfuryl Fluoride). Remove or cover drywood termite fecal pellets in accessible areas. Owner / agent to prepare for fumigation as per list of instructions to be furnished by this company. The structure must be vacated until release for re-entry by the licensed fumigator. 3 year warranty upon completion date.

FINDING: Drywood termite damage was found at the belly band.
RECOMMENDATION: Remove and replace or reinforce damaged wood members. painting is included, color may not be an exact match.

FINDING: Drywood termite damage was found at the blocking.
RECOMMENDATION: Remove and replace or reinforce damaged wood members. painting is included, color may not be an exact match.

FINDING: Fungus damage was found at the fascia.
RECOMMENDATION: Remove and replace or reinforce damaged wood members. painting is included, color may not be an exact match.

FINDING: Fungus damage was found at the wood siding/ trim board.
RECOMMENDATION: Remove and replace or reinforce damaged wood members. painting is included, color may not be an exact match.
