WOOD DESTROYING PESTS AND ORGANISMS INSPECTION REPORT

Building Address:	Date of Inspection	Number of Pages
5539 N. Willard Ave, San Gabriel, CA 91776	09/25/2026	5

Report # W11563
Lic. Registration # PR 5972
Escrow #

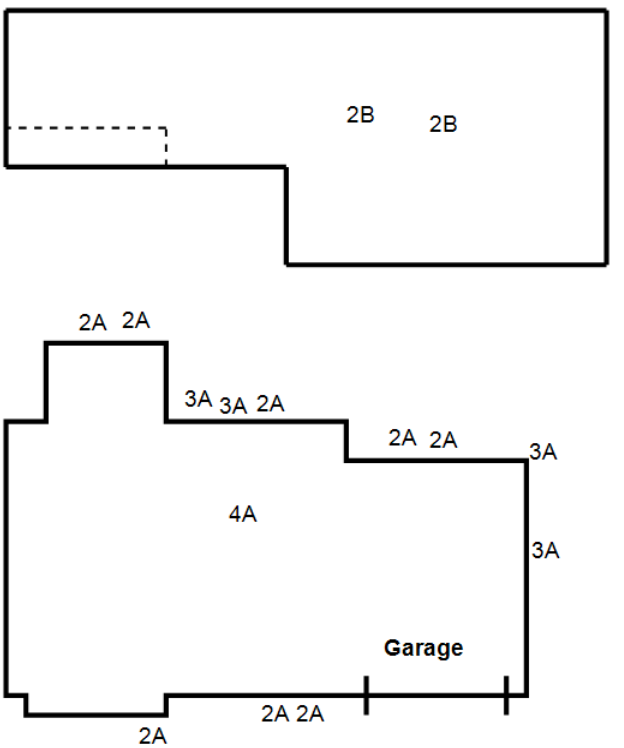
This Diagram is not to scale

NOTE: Excessive Moisture noted at sub area front unit.

2A PRICE: $2,500.00 (Section I)
FINDINGS: Evidence of drywood termite infestations at eaves (rafter tails and sheathing).
RECOMMENDATION: Vacate the premises and seal the structure for fumigation with Vikane Gas. Remove or cover accessible evidence of infestation. Fumigation warranteed for two years. Fumigation awareness notice must be signed prior to fumigation. See fumigation notice for terms and liabilities.

2B PRICE: See 2A (Section I)
FINDINGS: Evidence of drywood termite infestations at attic of back unit.
RECOMMENDATION: Vacate the premises and seal the structure for fumigation with Vikane Gas. Remove or cover accessible evidence of infestation. Fumigation warranteed for two years. Fumigation awareness notice must be signed prior to fumigation. See fumigation notice for terms and liabilities.

3A PRICE: $375.00 (Section I)
FINDINGS: Dry-rot wood members found at time of inspection at rafter tails.
RECOMMENDATION: Cut back or repair with wood filler dry-rot damaged wood members as necessary. No painting is included in this estimate.

4A PRICE: $75.00 (Section II)
FINDINGS: Cellulose debris noted at time of inspection in sub area.
RECOMMENDATION: Clean-out cellulose debris and remove from premises.
