WOOD DESTROYING PESTS AND ORGANISMS INSPECTION REPORT

Building No.	Street	City	ZIP	Date of Inspection	Number of Pages
3636	Mount Alvarez	San Diego	92111	10/26/2026	5

GENERAL DESCRIPTION:
Two story, single family residence, vacant, slab foundation, composition roof, attached garage.

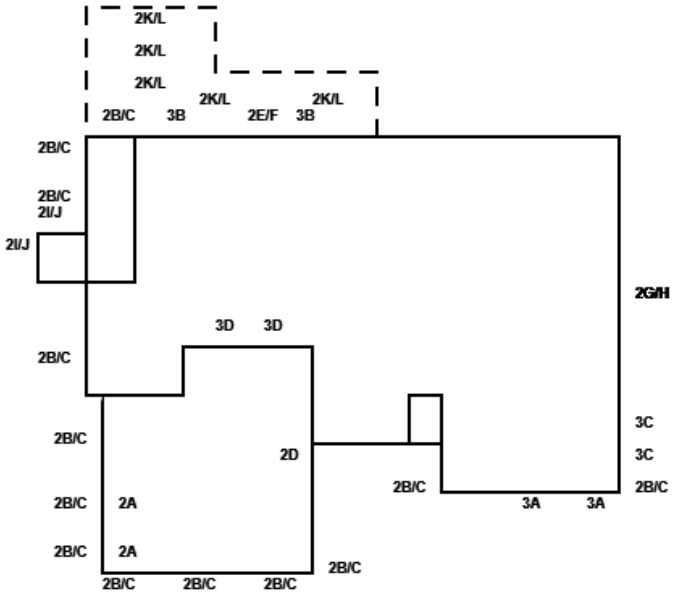
Diagram Not To Scale

2A - Drywood
Evidence of **Termite Activity** noted in the garage.

2B - Drywood
Evidence of **Termite Activity** noted at the fascia.

2C - Drywood
Evidence of **Termite Damage** noted at the fascia.

2D - Drywood
Evidence of **Termite Activity** noted at the clean out cover.

2E - Drywood
Evidence of **Termite Activity** noted at the roof sheathing.

2F - Drywood
Evidence of **Termite Damage** noted at the roof sheathing.

2G - Drywood
Evidence of **Termite Activity** noted at the rafter tails.

2H - Drywood
Evidence of **Termite Damage** noted at the rafter tails.

2I - Drywood
Evidence of **Termite Activity** noted at the rim board / railing.

2J - Drywood
Evidence of **Termite Damage** noted at the rim board / railing.

2K - Drywood
Evidence of **Termite Activity** noted at the patio cover.

2L - Drywood
Evidence of **Termite Damage** noted at the patio cover.

3A - Fungus / Dryrot
Evidence of **Fungus Damage** noted at the end beams.

3B - Fungus / Dryrot
Evidence of **Fungus Damage** noted at the rafter tails.

3C - Fungus / Dryrot
Evidence of **Fungus Damage** noted at the deck boards.
