WOOD DESTROYING PESTS AND ORGANISMS INSPECTION REPORT

Building Address:	Date of Inspection	Number of Pages
264 Vanderbilt Dr., Oxnard, CA 93036	11/10/2026	6

Report # W10194

General Description:
Single story occupied wood framed raised stucco single family residence with a composition roof and an attached garage

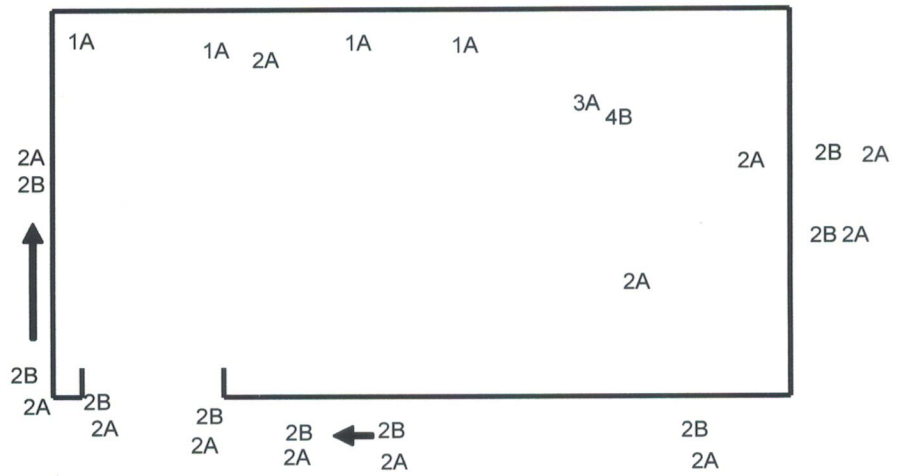
This Diagram is not to scale

1A PRICE: $984.00 (Section I)
FINDINGS: Cellulose debris with evidence of subterranean termites was noted at subarea as indicated on diagram.
RECOMMENDATION: Remove Cellulose debris of a size which can be raked from sub area. Drill, pressure rod and/or treat the subarea adjacent to the cellulose debris with a register termiticide for the control of Subterranean Termites. Low pressure spot spray as necessary. Scrape and break down all accessible Subterranean tubing. Two year warranty.

2A PRICE: $2,082.00 (Section I)
FINDINGS: Evidence of Drywood Termite infestation at subarea, garage door jamb, bedroom, wall trim, window trim, fascia as indicated on the diagram.
RECOMMENDATION: Vacate the premises and seal the structure for fumigation with Vikane Gas (Chloropicrin used as a warning agent with Vikane gas fumigant) for the control of Drywood Termites. Remove or cover accessible evidence of infestation. Fumigation warranteed for 3 years. DM Termite and Pest Control will NOT be liable for damage to: plants, paint, roofs, antennae etc. Fumigation awareness notice must be signed prior to fumigation. See fumigation notice for terms and liabilities.

2B PRICE: $4,110.00 (Section I)
FINDINGS: Evidence of termite damaged wood members noted at time of inspection at window trim, fascia, wall trim, garage door jamb as indicated on the diagram.
RECOMMENDATION: Remove and replace or sister wood members as necessary. Repair remaining damage with epoxy filler and primer as necessary. Ready for paint. No painting is included in this estimate.

3A PRICE: See 2B (Section I)
FINDINGS: Dry-rot wood members found at time of inspection at garage door jambs, window trims and fascia as indicated on the diagram.
RECOMMENDATION: Remove and replace and/or repair dry-rot damaged wood members as necessary. Scrape and treat fungus as needed. Primer wood as needed. No painting is included in this estimate.

3B PRICE: See 2B (Section I)
FINDINGS: Dry-rot wood members found at time of inspection at subarea subfloor and floor joists as indicated on the diagram.
RECOMMENDATION: Remove and replace and/or repair dry-rot damaged or sister wood members as necessary. Scrape and treat fungus as needed. Primer wood as needed. No painting is included in this estimate.

4B PRICE: Unknown (Section II)
FINDINGS: Water stains noted subfloor and floor joists in the subarea at time of inspection as indicated on diagram. No active dripping or visible wetness was observed at the time of inspection. Recommend evaluation by an appropriate licensed contractor and corrcetion as necessary.
RECOMMENDATION: Owner/Agent to contact proper tradesman/contractor to inspect for cause of water stains and correct as needed as indicated on the diagram..
