WOOD DESTROYING PESTS AND ORGANISMS INSPECTION REPORT

#: 20260285

BUILDING NO.	STREET	CITY	ZIP	Date of Inspection	NUMBER OF PAGES
645	ASILO	ARROYO GRANDE	93420	10/05/2026	1 of 7

Central Coast Termite, Inc.
P.O. Box 1614
Nipomo, CA 93444
805-929-8500 support@centralcoasttermite.com
PR7147

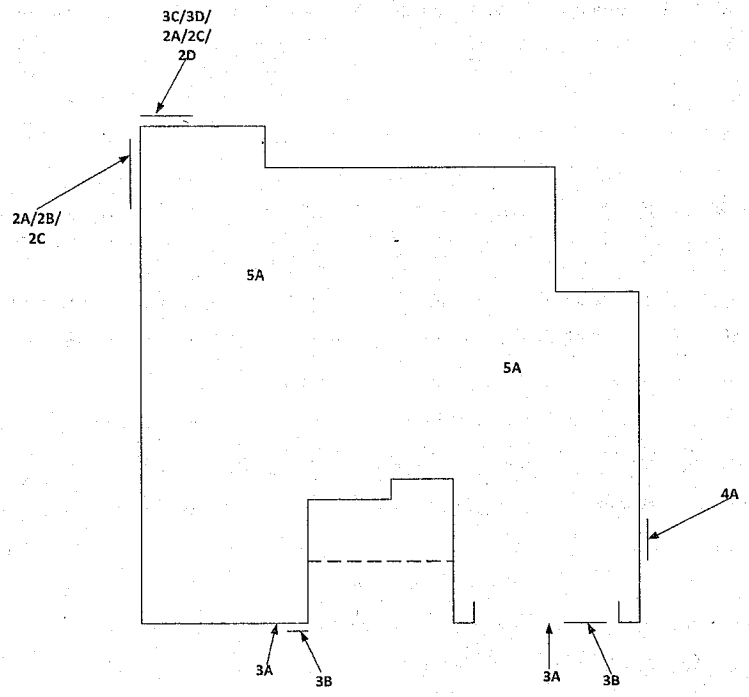
Drywood termite infestation was found in wood members at the Eaves and appears to extend into inaccessible areas.

Drywood termite damage found at the fascia.

Drywood termite damage found at the rafter tails.

Drywood termite damage was found at the roof sheathing

Fungus damage was found at the 4x12 beams , due to exposure to weather.

Fungus damage was found at the fascia due to exposure to weather.

Fungus damage was found at the rafter tails , due to exposure to weather.

Fungus growth and damage was found at the roof sheathing

NOTE: Stucco cracks were noted, see the diagram. No signs of water intrusions were present at the time of this inspection. Periodic inspections advised.

RECOMMENDATION: Seal the structure and fumigate with a gas lethal to drywood termites, Vikane (Sulfuryl Flouride). The structure must be vacant until the fumigation is complete. This company will exercise all due caution, but cannot be held responsible for damage to plants, TV antennas or roofing due to fumigation. TWO year warranty with a live Drywood Termite infestation found. Treatment type is the sole judgement of Central Coast Termite
RECOMMENDATION 2A-1: Remove or cover accessible drywood termite fecal pellets.

RECOMMENDATION: Remove and replace the damaged wood members with new material or repair with wood filler and paint.
Roofing material and or rain gutters may need to be removed and reinstalled. If any additional damage is found or if the roofing material or rain gutters are not re-usable, a supplemental report and / or estimate will be made. This bid is to replace only the damaged areas of the fascia. Full runs of fascia can be bid upon request.

RECOMMENDATION: Remove and replace, reinforce or repair, the damaged wood members as needed with todays widths and grades.

RECOMMENDATION: Remove enough roof covering to replace or repair the damaged wood members, and re-lay the existing roof covering. Blocking material may be added to the eave area to support the new roof sheathing. If additional damage is found or the existing roofing material is not reusable, a supplemental report with estimated costs will be issued.

RECOMMENDATION: Remove and replace the damaged wood members with new material. Where needed an approved fungicide may be applied by a Licensed Pest Control Representative.

RECOMMENDATION: Remove and replace or repair the damaged wood members with new material. Where needed an approved fungicide may be applied an by a Licensed Pest Control Representative.
Roofing material and or rain gutters may need to be removed and reinstalled. If any additional damage is found or if the roofing material or rain gutters are not re-usable, a supplemental report and / or estimate will be made. This bid is to replace only the damaged areas of the fascia. Full runs of fascia can be bid upon request.

RECOMMENDATION: Remove enough roof covering to replace the damaged wood members, and re-lay the existing roof covering. Blocking material may be added to the eave area to support the new roof sheathing. If additional damage is found or the existing roofing material is not reusable, a supplemental report with estimated costs will be issued.
