WOOD DESTROYING PESTS AND ORGANISMS INSPECTION REPORT

Building Address:	Date of Inspection	Number of Pages
12474 Oakfort Court, San Diego, CA 92131	09/22/2026	6

Report # W8030
Lic. Registration # PR 6709
Escrow #

General Description:
Two story stucco/wood sided residence with attached garages and lightweight tile roof on slab foundation.

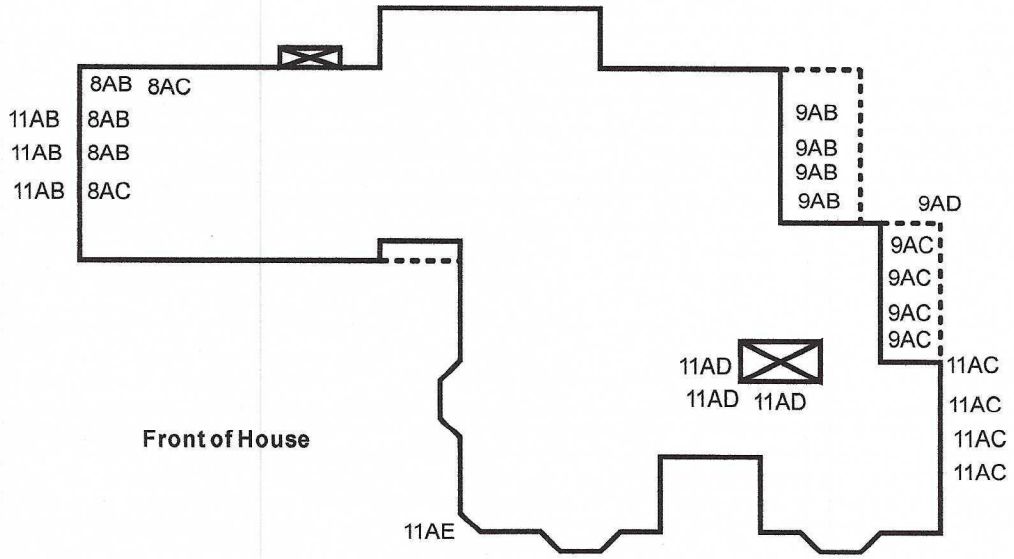
This Diagram is not to scale

8A (Section I)
FINDINGS: Evidence of drywood termite infestation at garage exposed framing as indicated on the diagram.
RECOMMENDATION: Vacate the premises and seal the structure for fumigation with Vikane Gas. Remove or cover accessible evidence of infestation. Fumigation warranteed for two years. Fumigation awareness notice must be signed prior to fumigation. See fumigation notice for terms and liabilities.

8B (Section I)
FINDINGS: Evidence of termite damaged wood members noted at time of inspection at garage exposed framing as indicated on the diagram.
RECOMMENDATION: Replace, repair and or reinforce termite damaged wood members as necessary. Painting is included in this estimate.

9A (Section I)
FINDINGS: Evidence of drywood termite infestation at attached patio cover as indicated on the diagram.
RECOMMENDATION: Vacate the premises and seal the structure for fumigation with Vikane Gas. Remove or cover accessible evidence of infestation. Fumigation warranteed for two years. Fumigation awareness notice must be signed prior to fumigation. See fumigation notice for terms and liabilities.

9B (Section I)
FINDINGS: Evidence of termite/fungus damaged wood members noted at time of inspection at 2x2 shade strips as indicated on the diagram.
RECOMMENDATION: Replace termite damaged wood members as necessary. Painting is included in this estimate.

9C (Section I)
FINDINGS: Dry-rot wood members found at time of inspection at 2x6 patio cover joists (x6) as indicated on the diagram.
RECOMMENDATION: Replace dry-rot damaged wood members as necessary. Painting is included in this estimate.

9D (Section I)
FINDINGS: Evidence of termite/fungus damaged wood members noted at time of inspection at patio cover post as indicated on the diagram.
RECOMMENDATION: Replace termite damaged wood members as necessary. Painting is included in this estimate.

11A (Section I)
FINDINGS: Evidence of drywood termite infestation at eaves as indicated on the diagram.
RECOMMENDATION: Vacate the premises and seal the structure for fumigation with Vikane Gas. Remove or cover accessible evidence of infestation. Fumigation warranteed for two years. Fumigation awareness notice must be signed prior to fumigation. See fumigation notice for terms and liabilities.

11B (Section I)
FINDINGS: Evidence of termite damaged wood members noted at time of inspection at planter shelf corbeled supports as indicated on the diagram.
RECOMMENDATION: Repair termite damaged wood members as necessary. Painting is included in this estimate.

11C (Section I)
FINDINGS: Evidence of termite damaged wood members noted at time of inspection at fascia as indicated on the diagram.
RECOMMENDATION: Replace and or repair termite damaged wood members as necessary. Painting is included in this estimate.

11D (Section I)
FINDINGS: Evidence of termite/fungus damaged wood members noted at time of inspection at chimney trim as indicated on the diagram.
RECOMMENDATION: Replace termite/fungus damaged wood members as necessary. Painting is included in this estimate.

11E (Section I)
FINDINGS: Dry-rot wood members found at time of inspection at window trim as indicated on the diagram.
RECOMMENDATION: Replace dry-rot damaged wood members as necessary. Painting is included in this estimate.
