WOOD DESTROYING PESTS AND ORGANISMS INSPECTION REPORT

Building Address:	Date of Inspection	Number of Pages
1525 Awlsbury Cir., Fullerton, CA 92833	04/08/2026	6

Citywide Termite Control

Report # W12198
Lic. Registration # PR 9057
Escrow #

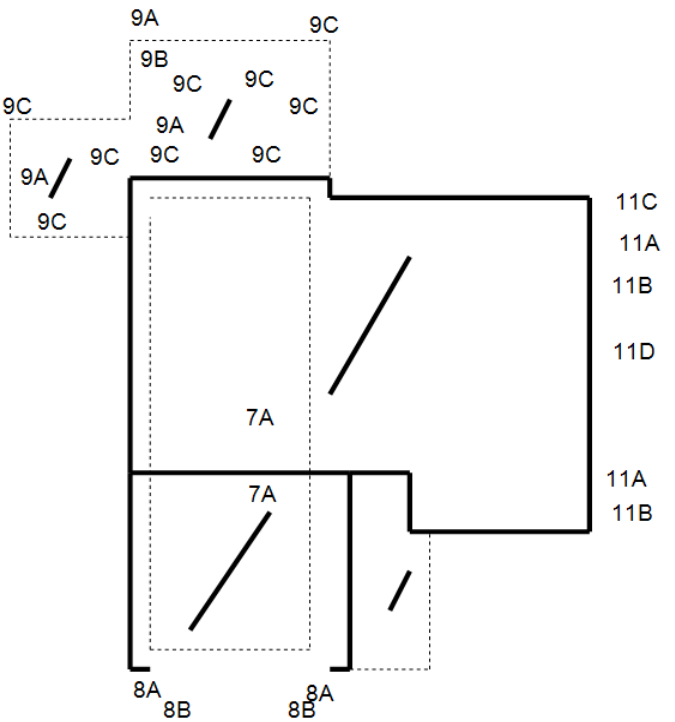
This Diagram is not to scale

7A PRICE: $3,100.00 (Section I)
FINDINGS: Evidence of drywood termite infestation at rafters, framing as indicated on the diagram.
RECOMMENDATION: Vacate the premises and seal the structure for fumigation with Vikane Gas. Remove or cover accessible evidence of infestation. Fumigation warranteed for two years. Fumigation awareness notice must be signed prior to fumigation. See fumigation notice for terms and liabilities.

8A PRICE: See 7A (Section I)
FINDINGS: Evidence of drywood termite infestation at siding, trim as indicated on the diagram.
RECOMMENDATION: Vacate the premises and seal the structure for fumigation with Vikane Gas. Remove or cover accessible evidence of infestation. Fumigation warranteed for two years. Fumigation awareness notice must be signed prior to fumigation. See fumigation notice for terms and liabilities.

8B PRICE: $380.00 (Section I)
FINDINGS: Evidence of drywood termite damaged wood members noted at time of inspection at siding, trim as indicated on the diagram
RECOMMENDATION: Repair termite damaged wood members as necessary. No painting is included in this estimate.

9A PRICE: See 7A (Section I)
FINDINGS: Evidence of drywood termite infestation at rafters, lattice, post, framing as indicated on the diagram.
RECOMMENDATION: Vacate the premises and seal the structure for fumigation with Vikane Gas. Remove or cover accessible evidence of infestation. Fumigation warranteed for two years. Fumigation awareness notice must be signed prior to fumigation. See fumigation notice for terms and liabilities.

9B PRICE: $1,520.00 (Section I)
FINDINGS: Evidence of drywood termite damaged wood members noted at time of inspection at rafters, lattice, post, framing as indicated on the diagram
RECOMMENDATION: Replace termite damaged wood members as necessary. No painting is included in this estimate.

9C PRICE: $10,000.00 (Section I)
FINDINGS: Dry-rot wood members found at time of inspection at rafters, lattice, post, framing, blocking, decking, siding, handrail as indicated on the diagram.
RECOMMENDATION: Replace dry-rot damaged wood members as necessary. No painting is included in this estimate.

11A PRICE: See 7A (Section I)
FINDINGS: Evidence of drywood termite infestation at fascia, rafters, eaves as indicated on the diagram.
RECOMMENDATION: Vacate the premises and seal the structure for fumigation with Vikane Gas. Remove or cover accessible evidence of infestation. Fumigation warranteed for two years. Fumigation awareness notice must be signed prior to fumigation. See fumigation notice for terms and liabilities.

11B PRICE: See 9C (Section I)
FINDINGS: Evidence of drywood termite damaged wood members noted at time of inspection at fascia, rafters, eaves as indicated on the diagram
RECOMMENDATION: Repair termite damaged wood members as necessary. No painting is included in this estimate.

11C PRICE: See 9C (Section I)
FINDINGS: Surface fungus condition visible at time of inspection at fascia, eaves as indicated on the diagram.
RECOMMENDATION: Scrape and chemically treat fungus condition. Patch any minor surface damage found during treatment.

11D PRICE: Informational (Section II)
FINDINGS: Stucco cracks noted at time of inspection at walls, foundation as indicated on the diagram.
RECOMMENDATION: Contact proper tradesman to correct as necessary.
