WOOD DESTROYING PESTS AND ORGANISMS INSPECTION REPORT

Building No.	Street	City	Zip	Date of Inspection	Number of Pages
804	Bambi Ct	Arroyo Grande	93420-4401	11/12/2026	1 of 9

Report #: 4863

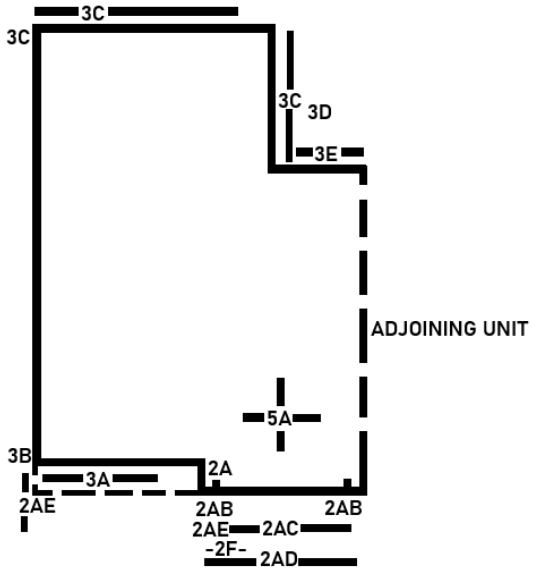
Diagram Not To Scale

Evidence of drywood termites was noted in the garage framing, garage jamb, garage trim, fascia, beam end and siding. Infestation appears to extend into inaccessible areas.

Drywood termite damage was noted to the garage jamb on the exterior

Drywood termite damage was noted to the garage trim on the exterior

Drywood termite damage was noted to the fascia on the exterior

Finding: 2E Drywood termite damage was noted to the beam end on the exterior

Finding: 2F Drywood termite damage was noted to the siding on the exterior

Finding: 3A Fungus/Dryrotdamage was noted to the porch overhang (beam, joists and blocking) on the exterior

Finding: 3B Fungus/Dryrot damage was noted to the eave sheathing on the exterior

Finding: 3C Fungus/Dryrot damage was noted to the fascia on the exterior
Recommendation: With the customer's agreement Valley Shield Termite and Pest Solutions inc will repair, reinforce or remove and replace the damaged area in accordance with state and local building codes. Areas of repair are guaranteed for 1 year and is non-renewable. NOTE: ALL NEW WOOD REPAIRS DONE BY VALLEY SHIELD TERMITE AND PEST SOLUTIONS INC WILL BE PRIME PAINTED OR PRE PRIMED MATERIAL. VALLEY SHIELD TERMITE AND PEST SOLUTIONS INC WILL FINISH PAINT FOR AN ADDITIONAL FEE ALONG WITH MATCHING PAINT PROVIDED BY CUSTOMER PRIOR TO START OF REPAIRS.
Price: $1,145.00

Finding: 3D Fungus/Dryrot damage was noted to the rafter tail on the exterior
Recommendation: With the customer's agreement Valley Shield Termite and Pest Solutions inc will repair, reinforce or remove and replace the damaged area in accordance with state and local building codes. Areas of repair are guaranteed for 1 year and is non-renewable. NOTE: ALL NEW WOOD REPAIRS DONE BY VALLEY SHIELD TERMITE AND PEST SOLUTIONS INC WILL BE PRIME PAINTED OR PRE PRIMED MATERIAL. VALLEY SHIELD TERMITE AND PEST SOLUTIONS INC WILL FINISH PAINT FOR AN ADDITIONAL FEE ALONG WITH MATCHING PAINT PROVIDED BY CUSTOMER PRIOR TO START OF REPAIRS.
Price: $179.00

Finding: 3E Fungus/Dryrot damage was noted to the siding on the exterior
Recommendation: With the customer's agreement Valley Shield Termite and Pest Solutions inc will repair, reinforce or remove and replace the damaged area in accordance with state and local building codes. Areas of repair are guaranteed for 1 year and is non-renewable. NOTE: ALL NEW WOOD REPAIRS DONE BY VALLEY SHIELD TERMITE AND PEST SOLUTIONS INC WILL BE PRIME PAINTED OR PRE PRIMED MATERIAL. VALLEY SHIELD TERMITE AND PEST SOLUTIONS INC WILL FINISH PAINT FOR AN ADDITIONAL FEE ALONG WITH MATCHING PAINT PROVIDED BY CUSTOMER PRIOR TO START OF REPAIRS.
Price: $459.00

Finding: 5A All or portions of the garage could not be inspected due to storage and/or the type of construction.
Recommendation: Owner to make the area accessible. Owner to call for periodic inspections.
Price: Further Inspection

REC: A Tarp and fumigate the structure with an approved fumigant in accordance with the manufacturer's label. See the "OCCUPANT'S CHEMICAL NOTICE" section of this report for more information on the material being used. The fumigation is guaranteed for 3 years and can be extended with an annual premium of 11% (Min. of $119) of the original agreement.

REC: B The infestation appears to be localized and, at the owner's or agent's request, can be locally treated using an approved termiticide in accordance with the manufacturer's label. See the "OCCUPANT'S CHEMICAL NOTICE" section of this report for more information on the material being used. Local treatment is guaranteed to the area treated for 1 year and is non-renewable. "LOCAL TREATMENT IS NOT INTENDED TO BE AN ENTIRE STRUCTURE TREATMENT METHOD. IF INFESTATIONS OF WOOD-DESTROYING PESTS EXTEND OR EXIST BEYOND THE AREA(S) OF LOCAL TREATMENT. THEY MAY NOT BE EXTERMINATED."

With the customer's agreement Valley Shield Termite and Pest Solutions inc will repair, reinforce or remove and replace the damaged area in accordance with state and local building codes. Areas of repair are guaranteed for 1 year and is non-renewable. NOTE: ALL NEW WOOD REPAIRS DONE BY VALLEY SHIELD TERMITE AND PEST SOLUTIONS INC WILL BE PRIME PAINTED OR PRE PRIMED MATERIAL. VALLEY SHIELD TERMITE AND PEST SOLUTIONS INC WILL FINISH PAINT FOR AN ADDITIONAL FEE ALONG WITH MATCHING PAINT PROVIDED BY CUSTOMER PRIOR TO START OF REPAIRS.

Recommendation: With the customer's agreement Valley Shield Termite and Pest Solutions inc will repair, reinforce or remove and replace the damaged area in accordance with state and local building codes. Areas of repair are guaranteed for 1 year and is non-renewable. NOTE: ALL NEW WOOD REPAIRS DONE BY VALLEY SHIELD TERMITE AND PEST SOLUTIONS INC WILL BE PRIME PAINTED OR PRE PRIMED MATERIAL. VALLEY SHIELD TERMITE AND PEST SOLUTIONS INC WILL FINISH PAINT FOR AN ADDITIONAL FEE ALONG WITH MATCHING PAINT PROVIDED BY CUSTOMER PRIOR TO START OF REPAIRS.
