WOOD DESTROYING PESTS AND ORGANISMS INSPECTION REPORT

Building No.	Street	City	Zip	Date of Inspection	Number of Pages
1200	Bay Oaks Drive	Los Osos	93402	10/30/2026	1 of 5

Report #: 114987

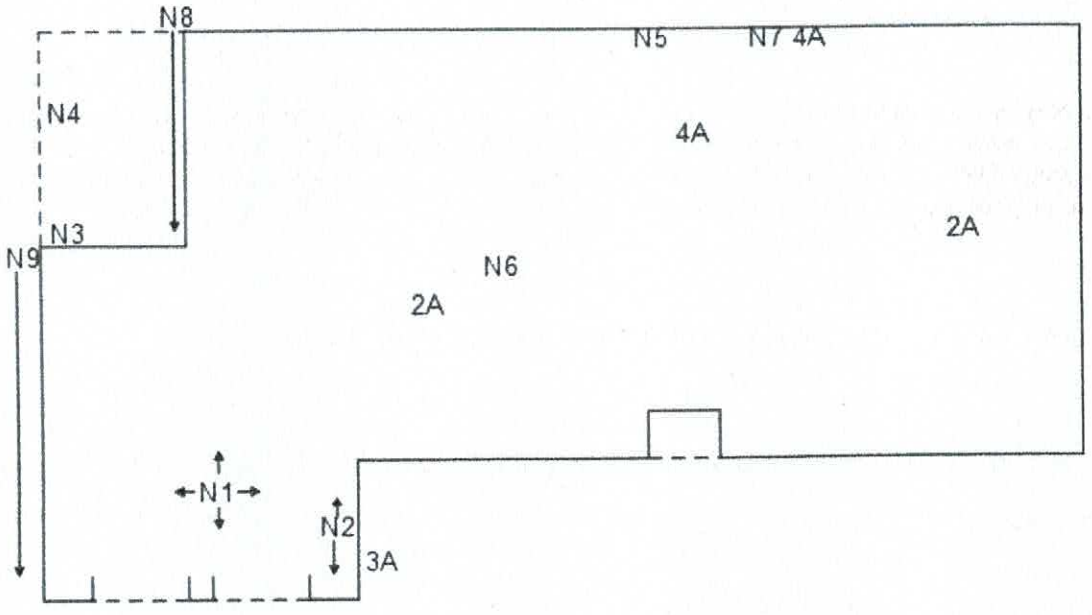
Diagram not to scale-Finding locations approximate

Finding: 2A — Evidence of Drywood Termite infestation was found at the attic and appears to extend into inaccessible areas of the structure.

Finding: 3A — Fungus damage was found at the roof sheathing of the eave area.

Finding: 4A — The toilet in the master and hall bathrooms were found to be loosely bolted to the floor. This creates a potential source of leakage.

Recommendation: Seal the structure and fumigate with a gas lethal to Drywood Termites (Sulfuryl Fluoride). All occupants and pets must vacate the structure until the fumigation is complete. This company will exercise reasonable caution, but cannot be held responsible for damage to plants, TV antennas or roofing due to the fumigation. Further terms and instructions will be supplied upon request or upon scheduling of the fumigation. Information may also be obtained from the fumigation page on our website at www.keytermite.com
*****Fumigations are guaranteed for 5 years from the date completed*****

Recommendation: Replace the fungus damaged portions of roof sheathing as needed.

Recommendation: Reset the toilet using a new wax seal and bolts. Additional costs may apply if the toilet flange is found to be damaged or if existing supply line/valve cannot be reused.
