HOME INSPECTION REPORT

636 E. Olson Street, Blair, WI

Report Number:
26-2944

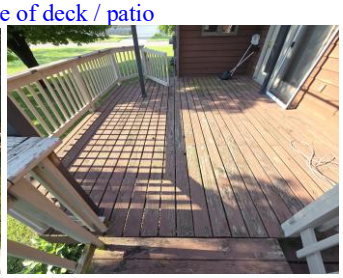
Deck, steps, and front porch have damaged wood and need stain or paint
Bottom step is missing on rear side of deck / patio
