Home Inspection Report

1600 Starbridge Dr
Brookfield, WI 53045

Inspected by:
Jim Weirick
Dobiash and Associates, Inc.

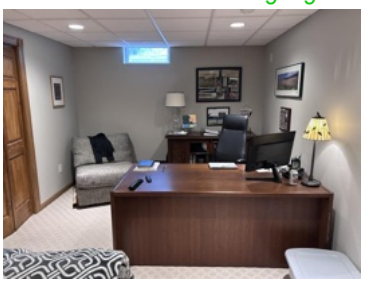
Sump Pump: Submerged

Signs of past seepage: No signs of any serious moisture

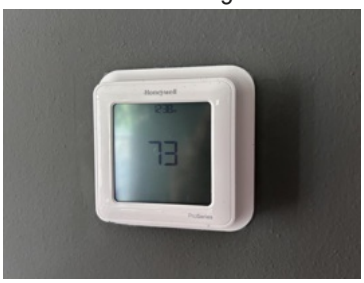
Type: Forced air Capacity: 100 KBTU
Area Served: Whole building Approximate Age: 2019
Fuel Type: Natural gas

Not Inspected — Heat Exchanger: Unable to visually inspect heat exchanger.

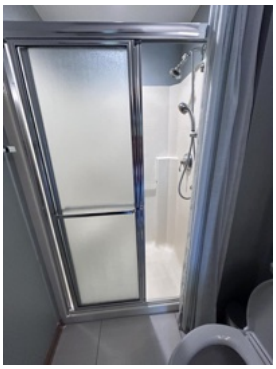
Not Present
Windows:
Electrical: 120V GFCI
Lights: Light in exhaust fan hood is not functioning.
Good
Sink/Basin:
Good
Shower/Surround: One piece surround

Good — Ventilation: Electric ventilation fan - Light in ceiling exhaust fan is not functioning.

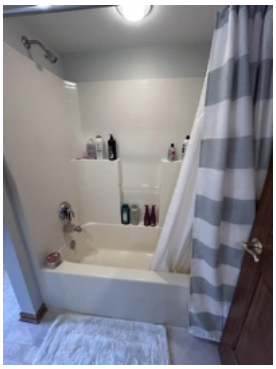
HVAC Source: Heating system register, Electric space heater - Electric space heater did not seem to operate when tested by thermostat.

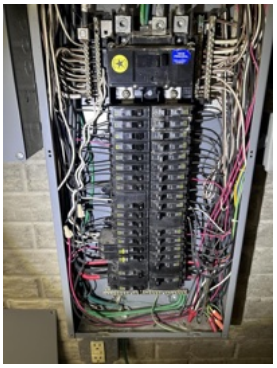
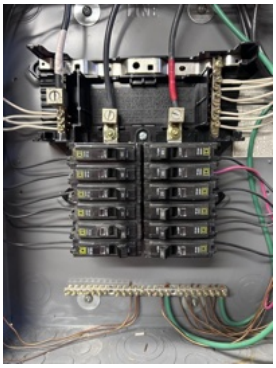
Basement Electric Panel

Good — Manufacturer: Square D

Good — Main Breaker Size: 200 Amps

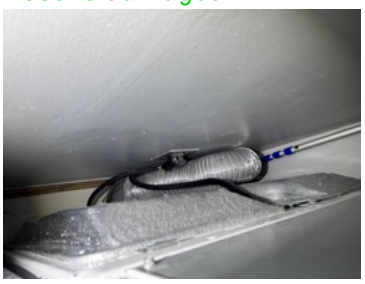
Dryer Vent: Metal flex - Vent hood is damaged.

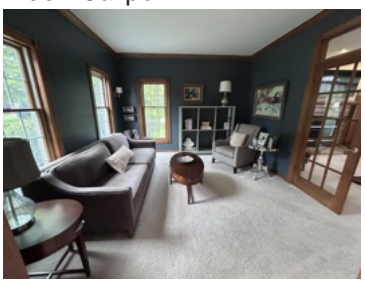
Ceiling: There is a small amount of water damage at the ceiling near the fireplace.

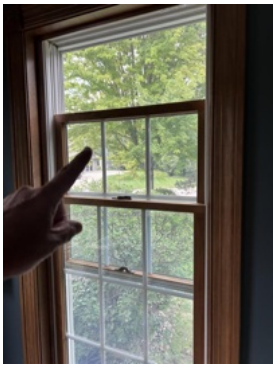
Windows: Wood double hung - Upper sash at NW window falls when lock is released.

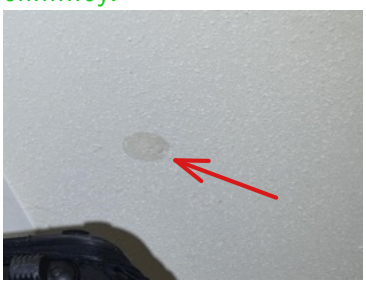
Closet: Small water stain is present at the closet ceiling. Unable to determine the cause or source of moisture, however this area appears to be adjacent to the fireplace chimney.

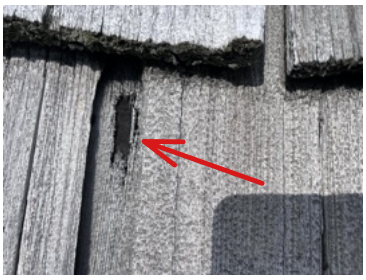
Recommend Further Evaluation Material: Wood shake - There are numerous holes in the wood shakes between the upper layer shakes that are exposing the interlayment. Roof is nearing the end of its useful life. Recommend having a qualified technician evaluate roof in order to offer an estimate of remaining life expectancy, and/or the cost to replace.

Roof Surface Material: Wood shake - There are numerous holes in the wood shakes between the upper layer shakes that are exposing the interlayment. Roof is nearing the end of its useful life. Recommend having a qualified technician evaluate roof in order to offer an estimate of remaining life expectancy, and/or the cost to replace.

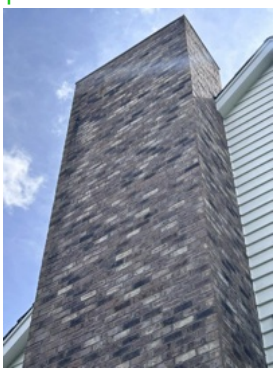
Gutters: Aluminum
Downspouts: Aluminum - Connected to buried drain hubs. Downspout at Northwest corner of building needs to be reconnected.

Chimney: Brick - Chimney cap/crown doesn't meet current standards. Cap is rusting.

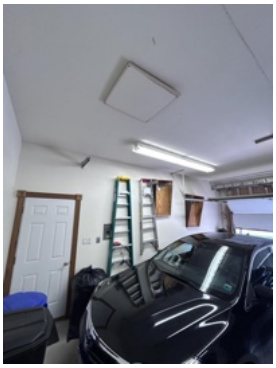
Ceiling: Attic scuttle in garage ceiling likely does not meet current fire separation standards.

Floor/Foundation: Poured concrete - Potential tripping hazard where garage slab meets the driveway.

Acceptable/Satisfactory — Garage Doors: Insulated steel - Bottom panel of overhead door is rusting.
