HOME INSPECTION REPORT

3725 Cliffside Drive, La Crosse, WI

Report Number:
26-2968

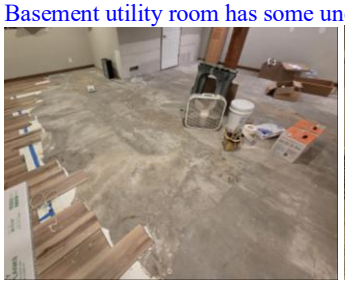
BASEMENT FAMILY ROOM

Basement family room floor has previous water damage – replace
Basement bedroom carpet is missing and walls are in need of painting / finishing
Basement utility room has some uncovered light switches, outlets, and junction boxes – replace covers

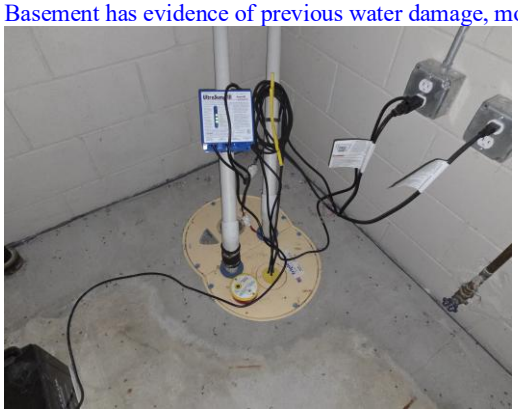
GENERAL COMMENTS
Basement has evidence of previous water damage, monitor and take corrective action if needed
