112 E. Henry Clay St, W/hitefish Bay, WI 53217

Inspection Date: 10-02-2026

Report Number: 021026-900

House to Home Inspections
804 N. Grand Ave.
Waukesha, WI 53188

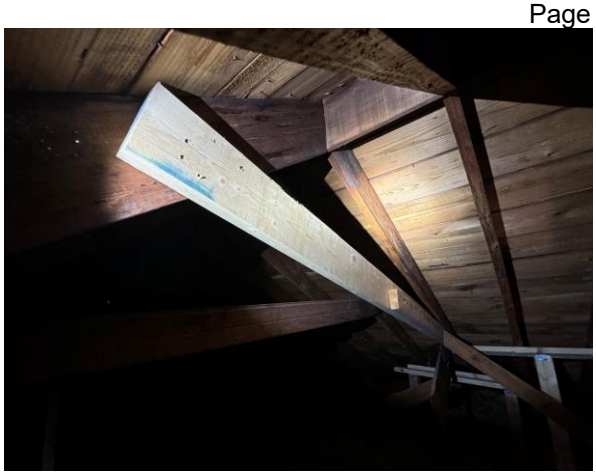
Picture 4: Loose, unsheathed electrical wiring in the cabinet under the kitchen sink

Picture 5: Main bathroom fan is being exhausted through the gable vent. This is not standard practice

Picture 6: Old birds nest in the attic. Recommend removal

Picture 7: There are several non standard repairs that have been done in the attic

Picture 8: There are several non standard repairs that have been done in the attic

Picture 9: There are several non standard repairs that have been done in the attic

Picture 10: There are several non standard repairs that have been done in the attic
