W180 N9801 Riversbend Circle W, Germantown, WI 53022

Report Number: 110926-1300

House to Home Inspections
804 N. Grand Ave.
Waukesha, WI 53188

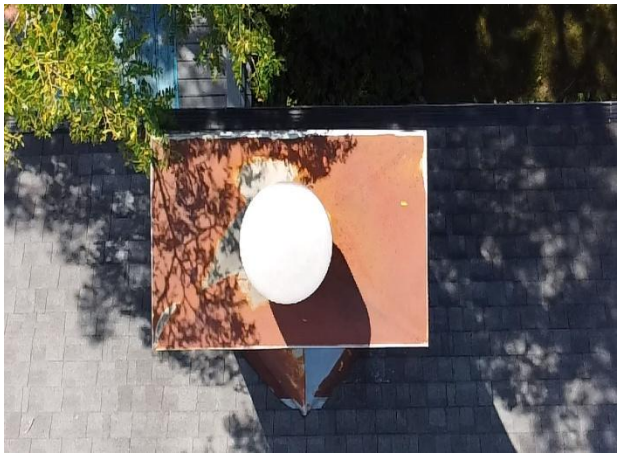
Picture 4: Lifting flashing on the west side of the roof
