INSPECTION AT A GLANCE

3026 S 45th St | Milwaukee, WI 53219

Megan Stencel | Inspector Nick Shirley | November 6, 2026

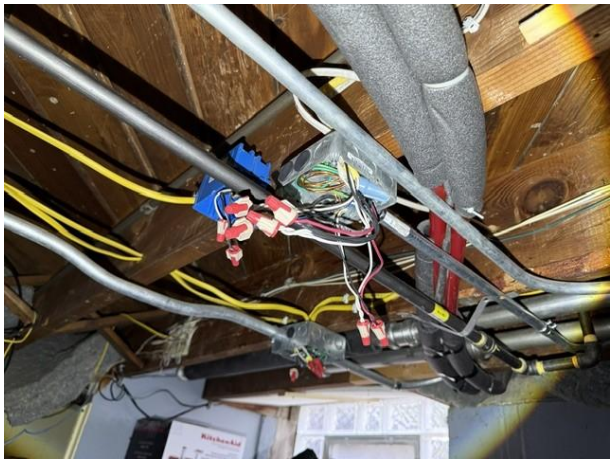
- Install GFCI protection at exterior house and garage receptacles where missing.
- Multiple ceiling-mounted junction boxes in the basement laundry room lack covers, exposing wiring. Have a qualified electrician install proper covers and repair splices if needed.

Photo 13: Uncovered junction boxes in the laundry.

2 Electrical safety
Have an electrician enclose the basement laundry splices and cover the boxes. Add GFCI protection where missing at exterior house and garage outlets.
Safety | Photos 5, 13; pp. 12, 25
