544 W. Chestnut St, Burlington, WI 53105

Prepared For: Robert Bourdo

Inspection Date: 10-30-2026

Report Number: 301026-900

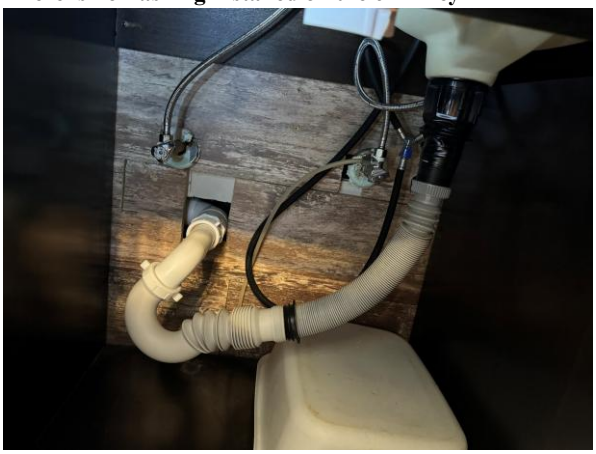
- **There is improper plumbing installed under the lower unit kitchen sink**
  - **There is improper plumbing installed under the lower unit bathroom sink**

Picture 50: Improper plumbing installed under the lower unit kitchen sink
