Homescape Inspections
826 Orange Ave, Suite 400
San Diego, CA 92118
(619)865-1084

Report #: LAW 01-30-26 Inspector: Kevin Brenden

Dwelling Address: 7087 Camino Degrazia #141
San Diego, CA 92111

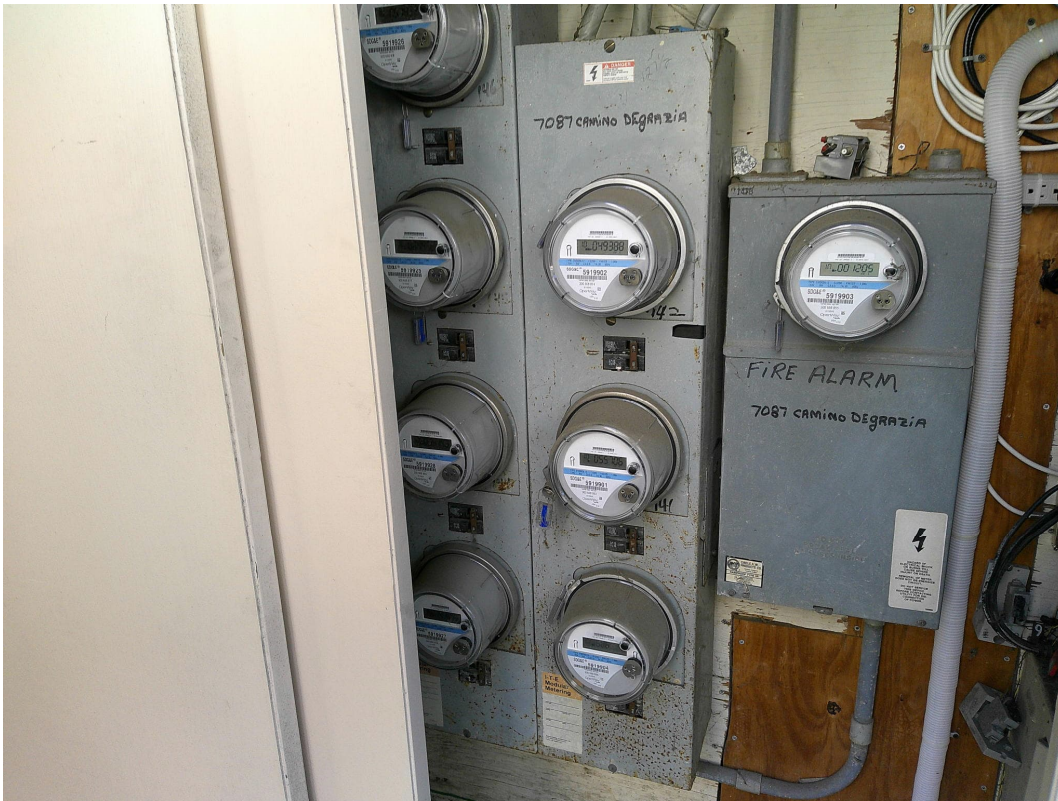
Step #	Component	Comments
39	Service	Inspected-Appears Serviceable. Service Type:+Underground; Number of conductors:+3; Voltage:+240 V / 120 V; Amps:+100; Main panel ground present.
40	Main Panel	Inspected-Appears Serviceable. Location:+Outside Garage.

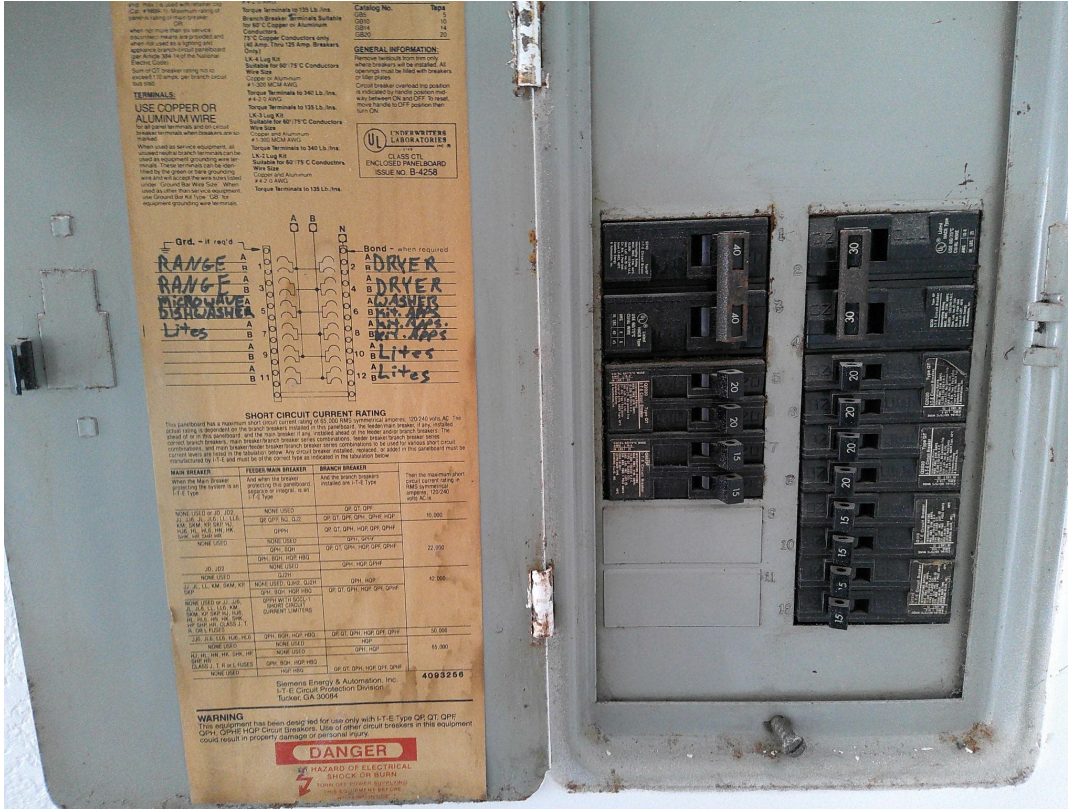
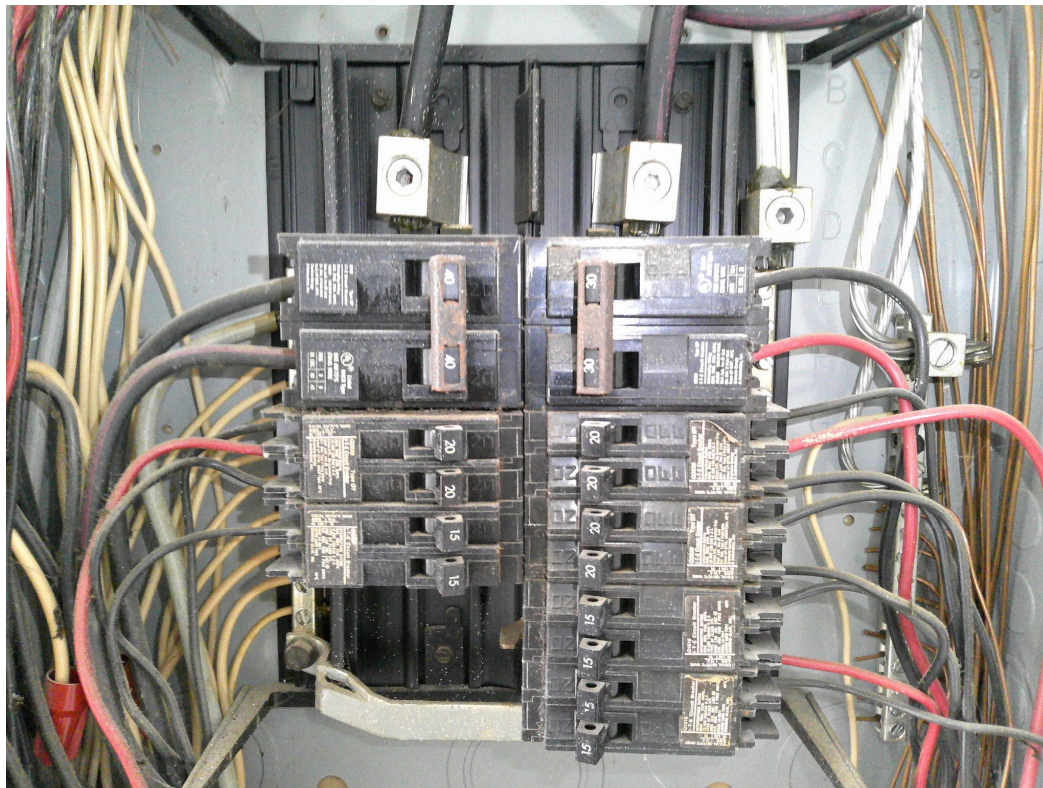
43 Panel Notes **Repairs Recommended. Overcurrent protection devices inspected - type: +Breakers. Recommend further evaluation and repairs by a qualified professional (Licensed Electrician). (2) (4)**

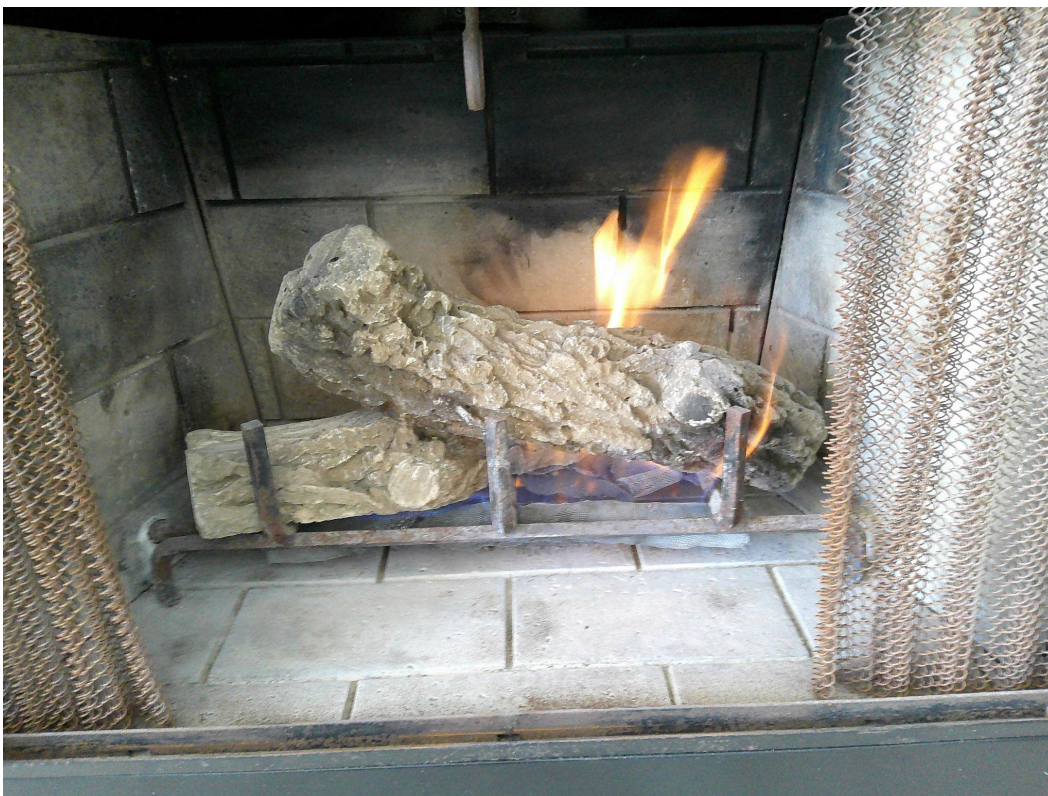
Step #	Component	Comments
52	Fireplace(s)	Inspected-Appears Serviceable. Location:+living room; Type:+Prefabricated; Gas piping:+appears serviceable; Gas valve:+appears serviceable; Damper:+appears serviceable. Fireplace operated as designed at the time of inspection.

Damper was operational.

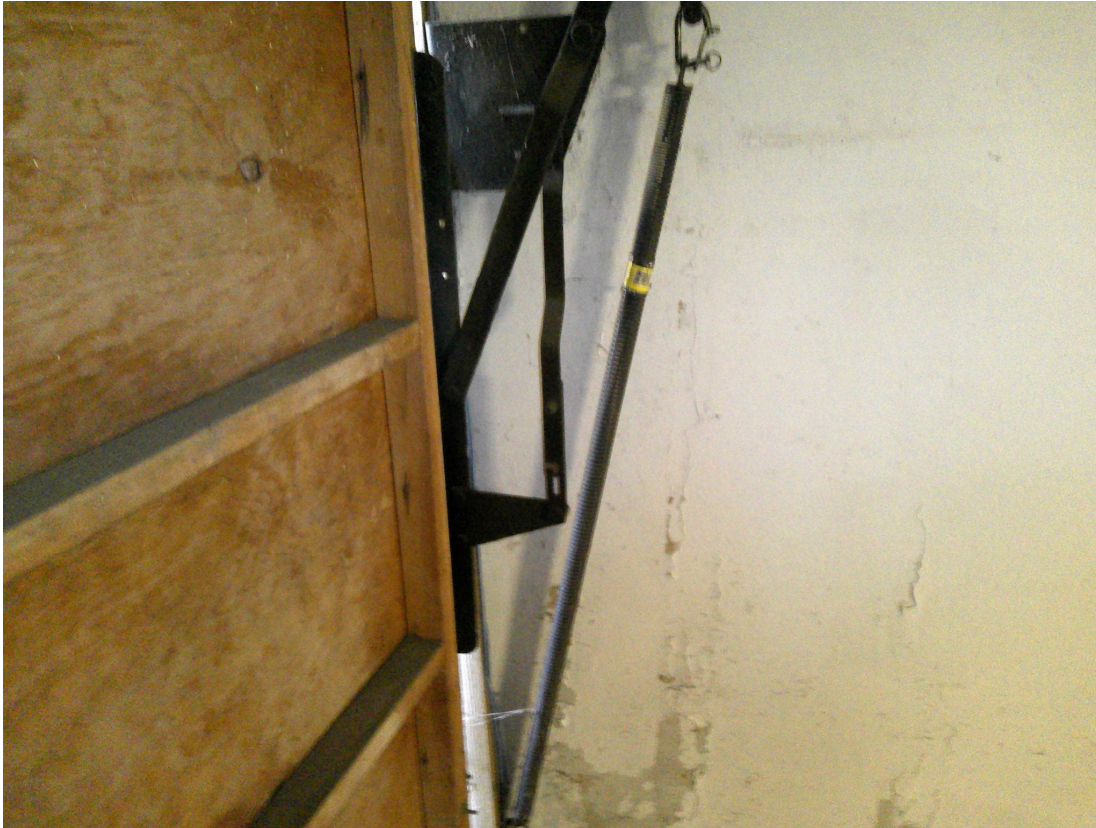
| 63 | Automatic Opener | Inspected-Appears Serviceable. Electronic sensors present; Electronic sensors appear serviceable. Garage door opener was tested and was operational at the time of inspection. This is not an exhaustive test and does not predict the future performance of the of the garage door openers. * |

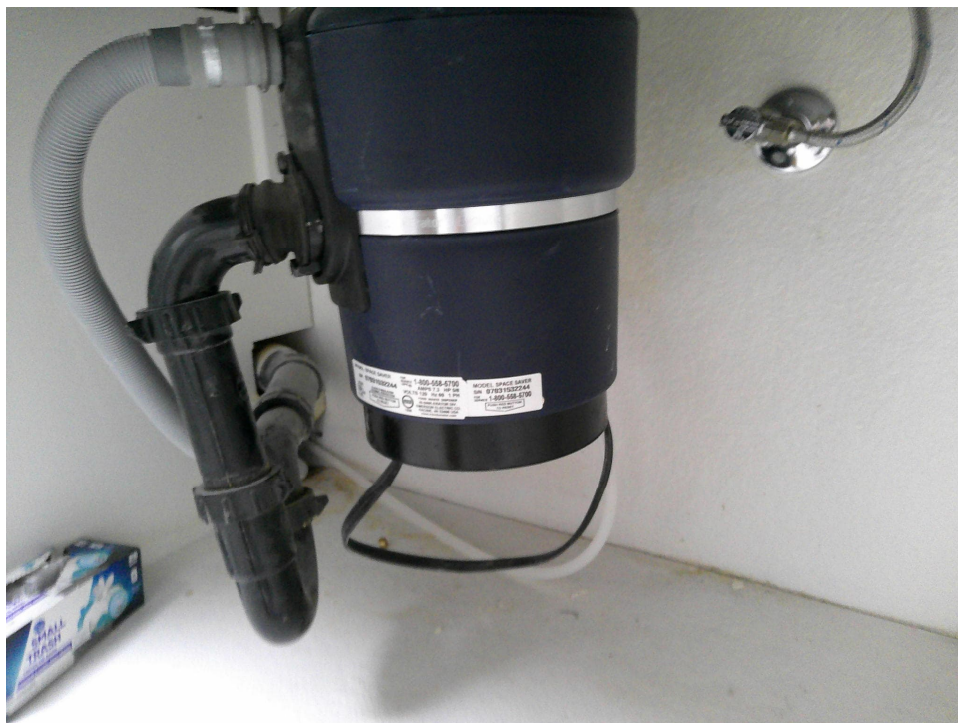
Step #	Component	Comments
66	Kitchen Sink(s)	Inspected-Appears Serviceable. Faucet appears serviceable; Plumbing under sink appears serviceable.
67	Kitchen (general)	Inspected-Appears Serviceable. Counter type:+Quartz; Cabinets appear serviceable; Counters appear serviceable; Floors appear serviceable.
68	Disposal	Inspected-Appears Serviceable. Wiring appears serviceable. The disposal wiring appeared to be serviceable at the time of the inspection.

The food waste disposer was tested and functioned properly at the time of inspection. This is not an exhaustive test and does not verify the efficiency of the unit.

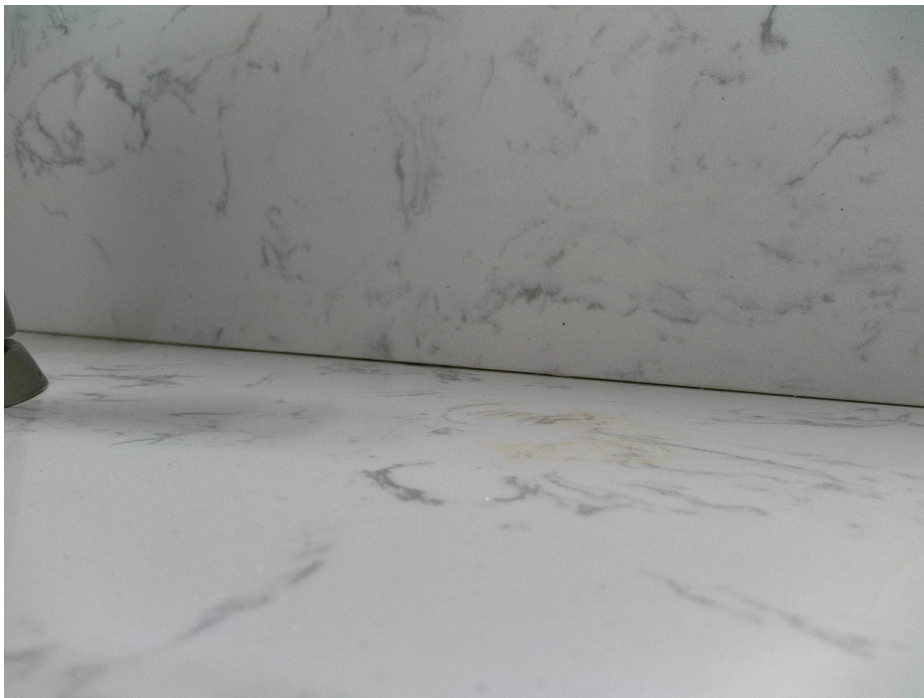
73.2a Sink #2

Improper piping at the bathroom sink(s) drain. (2)
