## USA Home Inspectors

## Home Inspection Report

**782 W Renette Ave**

Inspected On: Wed, Feb 25 2026 at 9:00AM

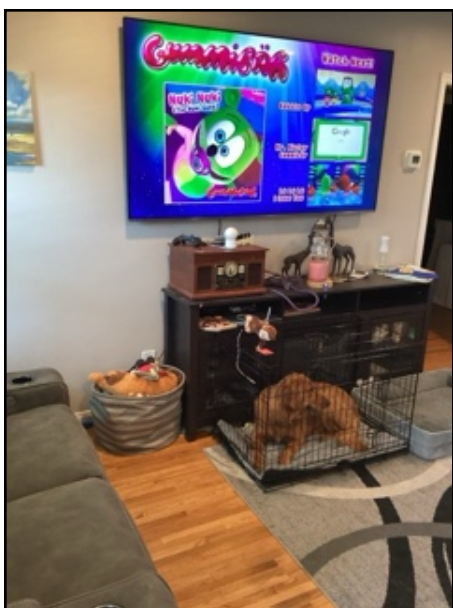
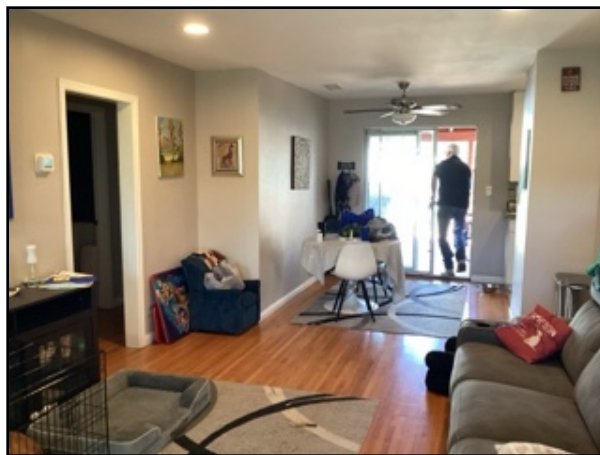
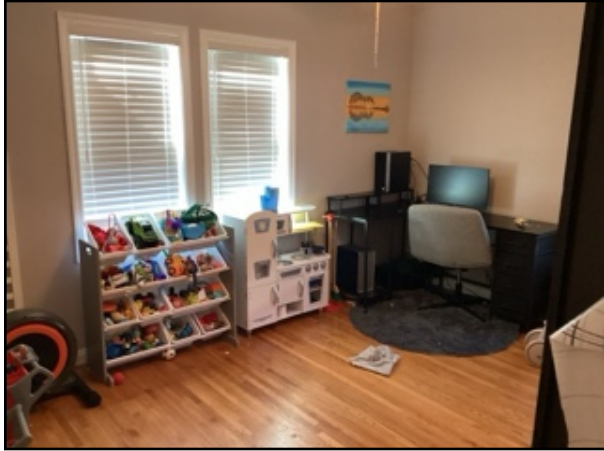
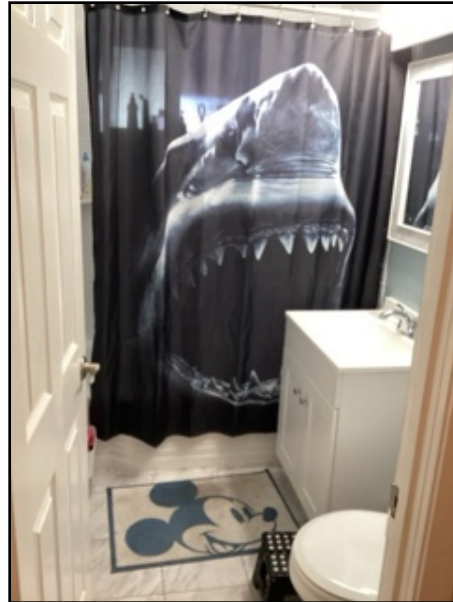
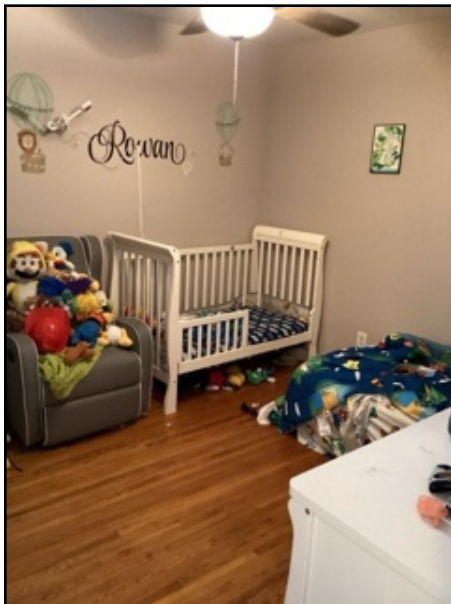
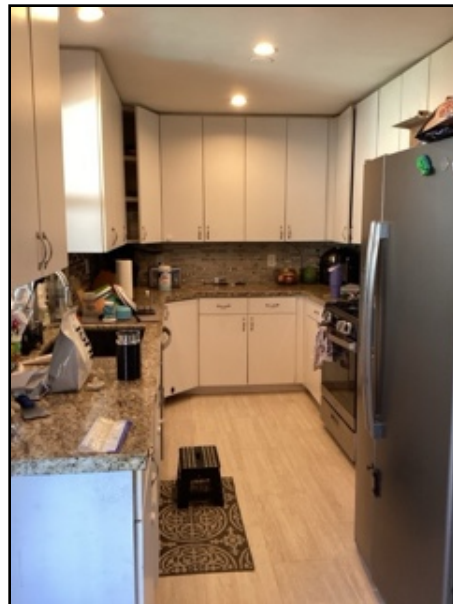
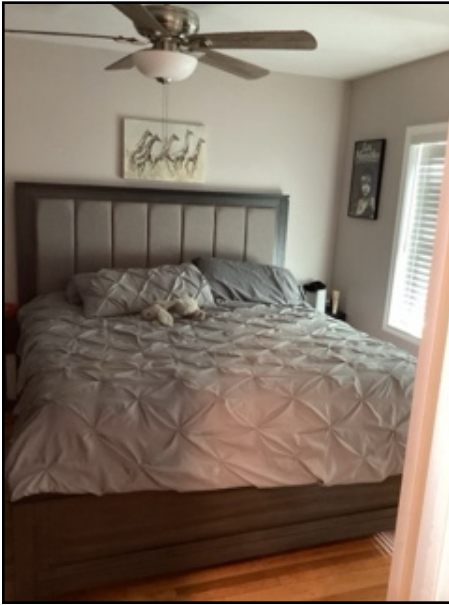
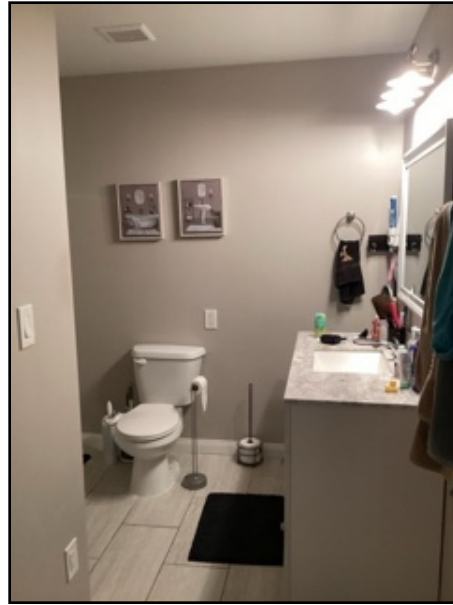
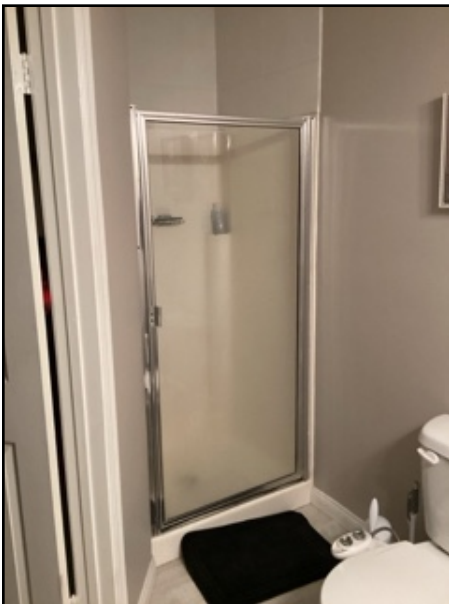
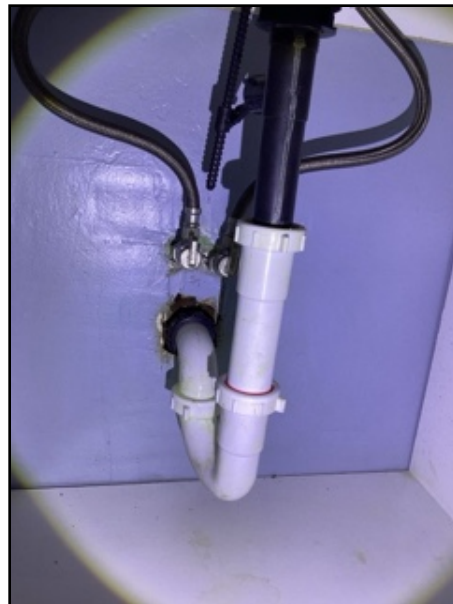
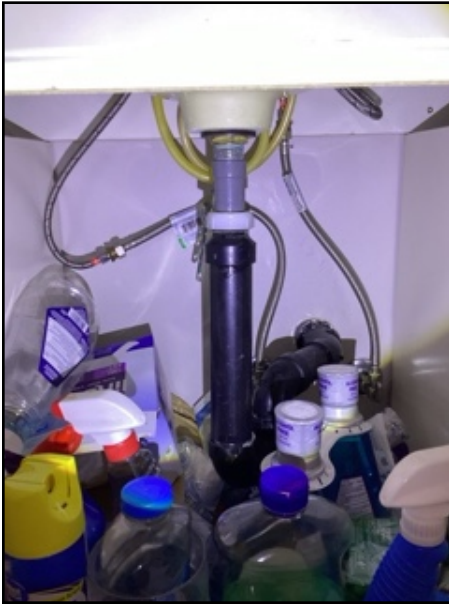
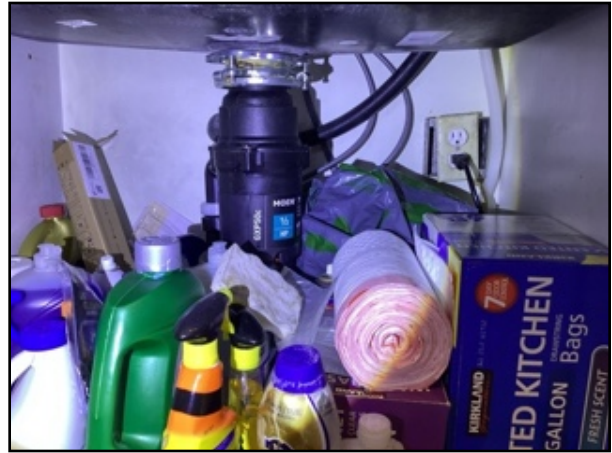
Personal property present at time of inspection, some areas and systems are not fully visible due to current occupants personal items.

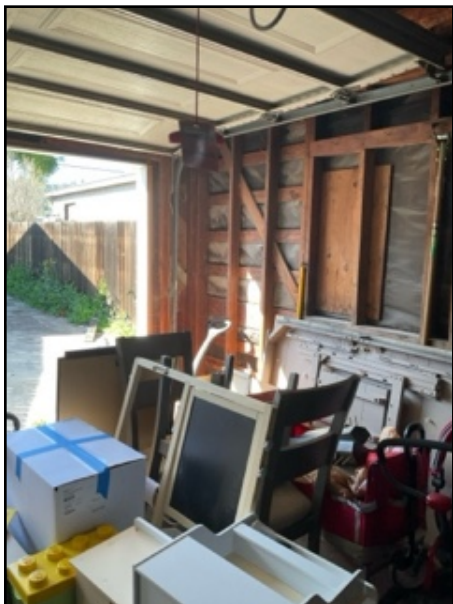
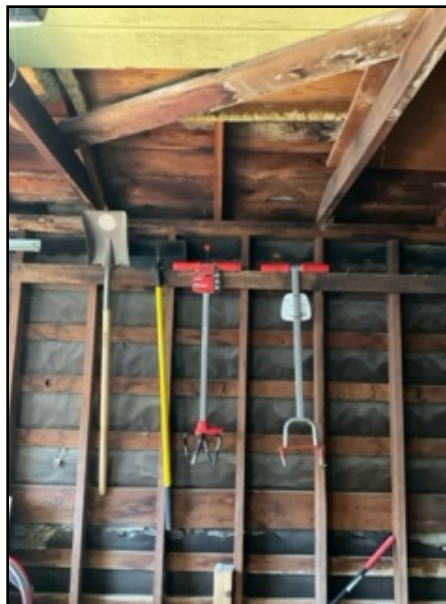
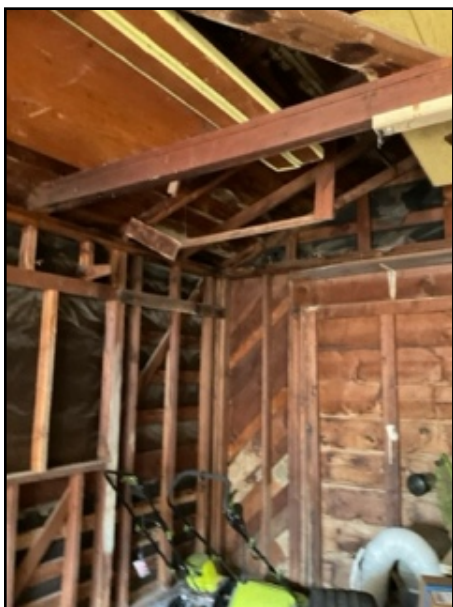
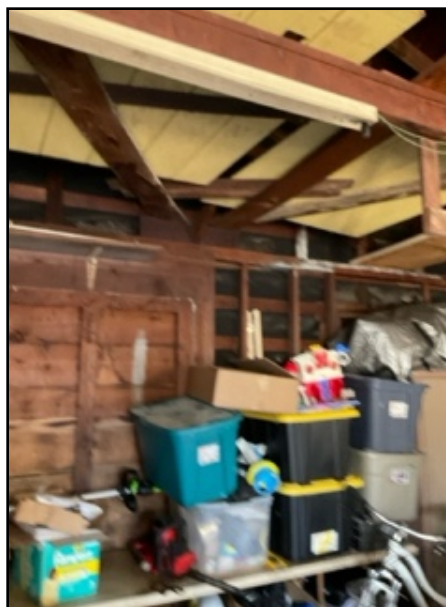
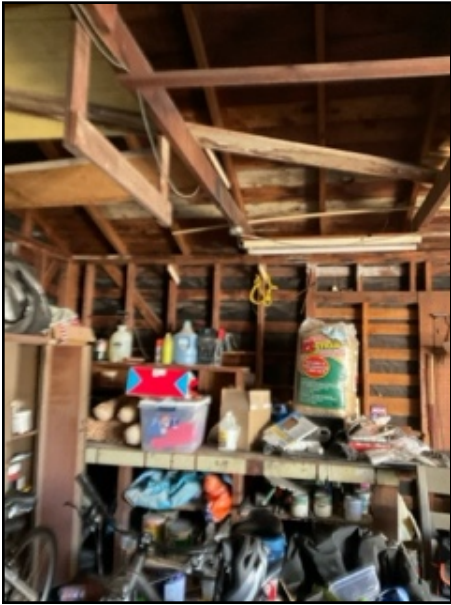
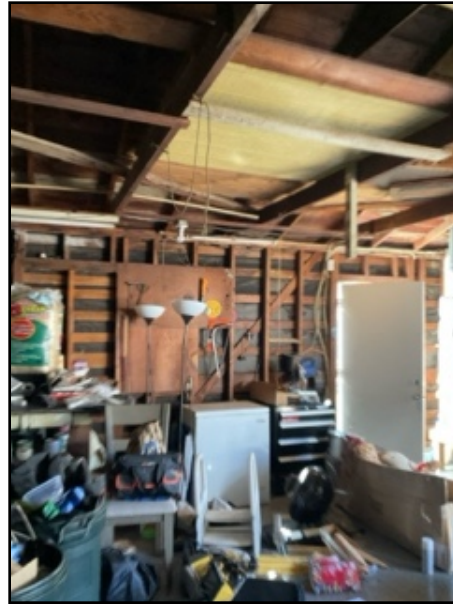
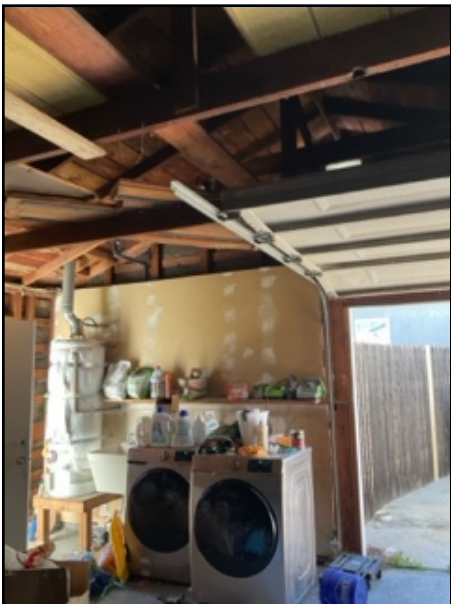
Comment 18:

Personal belongings stored in garage prevented inspection of some aspects of the garage.

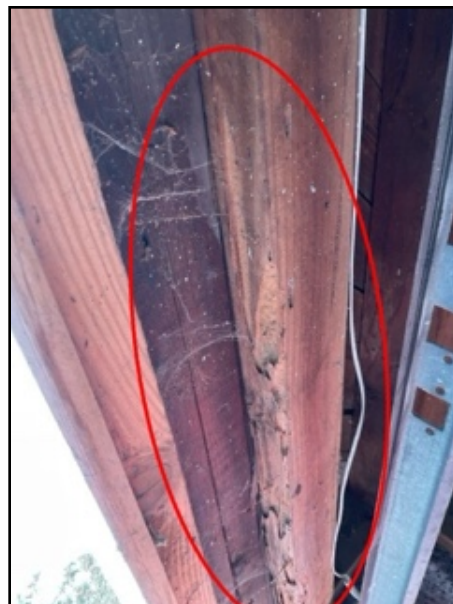
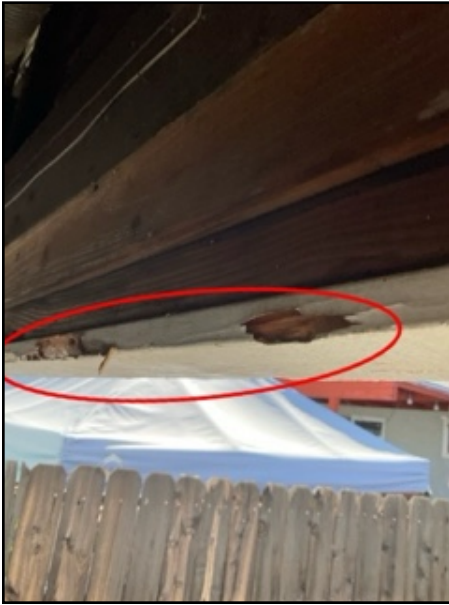
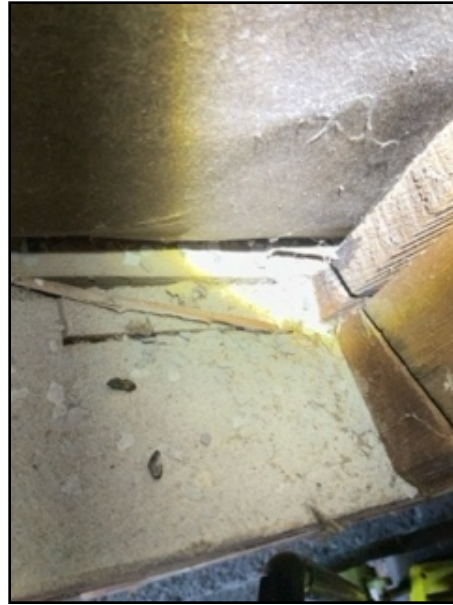
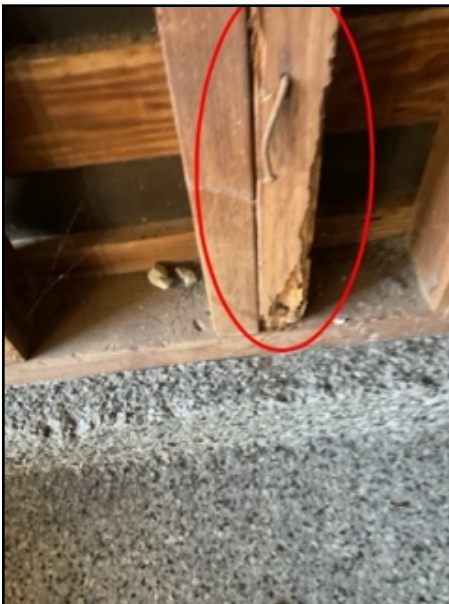
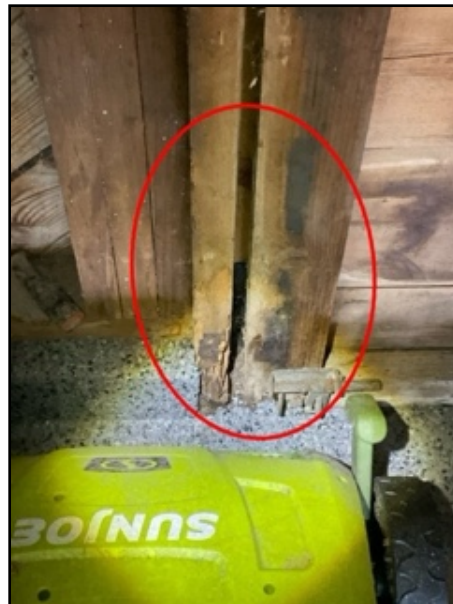
Comment 20:  
FURTHER EVALUATION REQUIRED: Evidence of possible wood destroying organisms/dry rot noted around garage trim, and framing in garage at various locations.

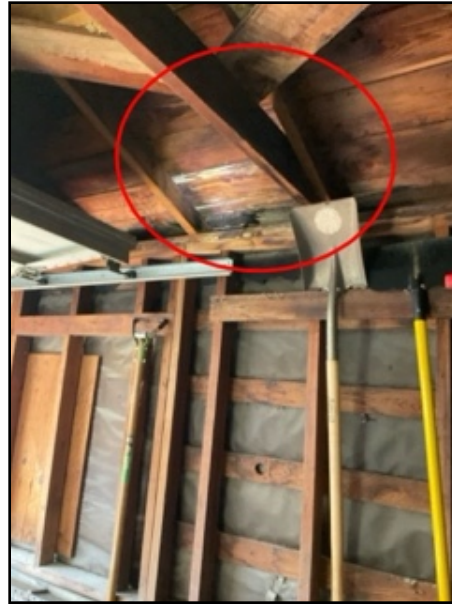
Figure 21-2

FURTHER EVALUATION REQUIRED: Water stains noted at various locations on roof sheeting in garage. Inspector notes roof is at the end of its life and is torn and missing shingles. Inspector notes it is not raining at time of inspection. Have a more qualified professional to evaluate.

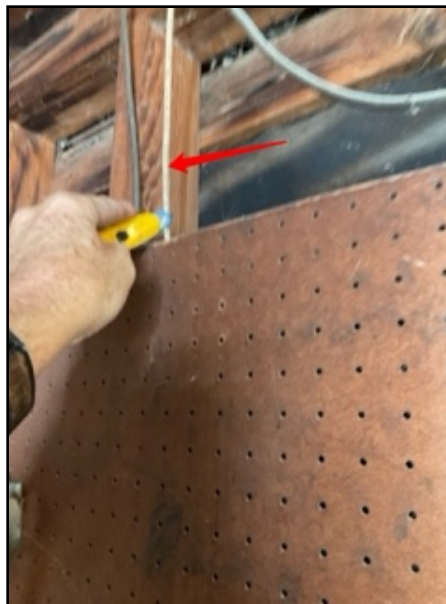
Figure 24-2

FURTHER EVALUATION REQUIRED: Active knob and tube wiring noted in garage. Have a more qualified professional to evaluate.

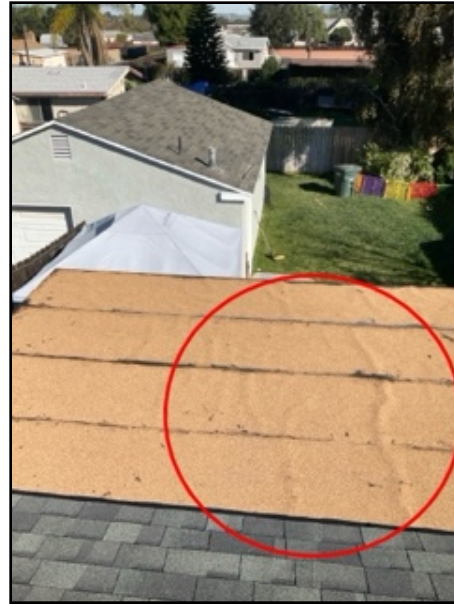
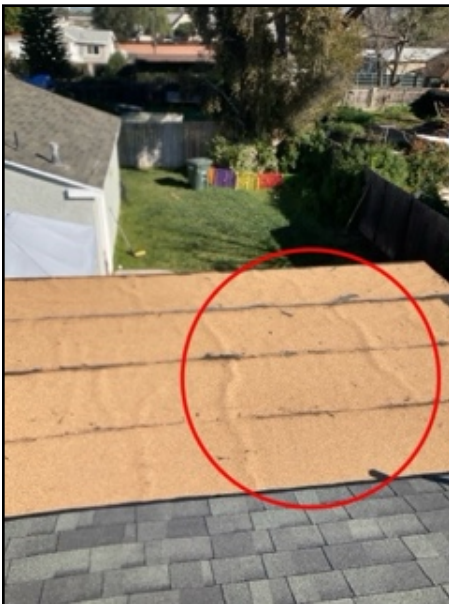
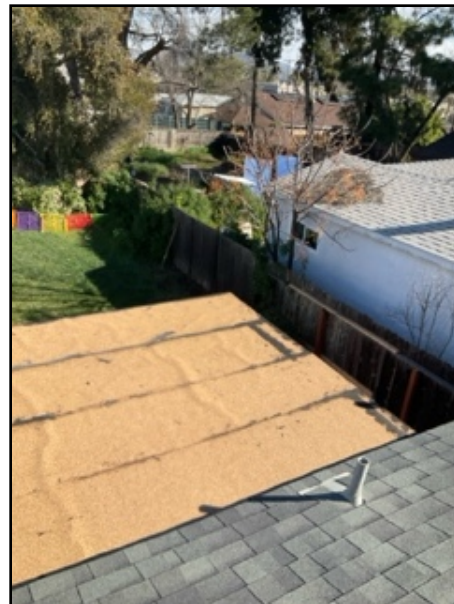
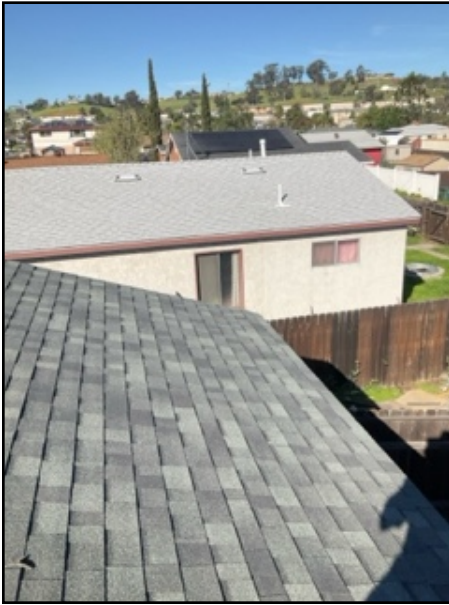
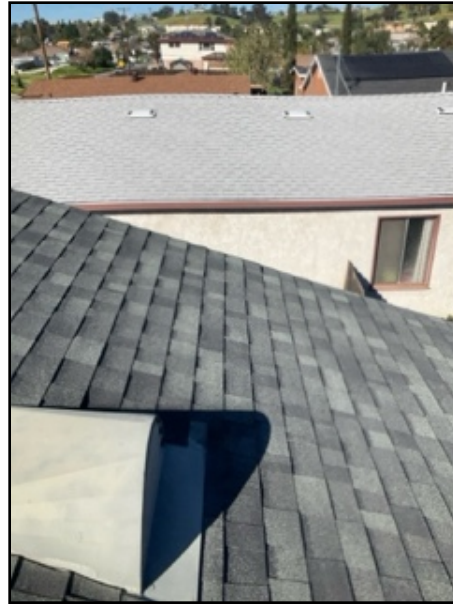
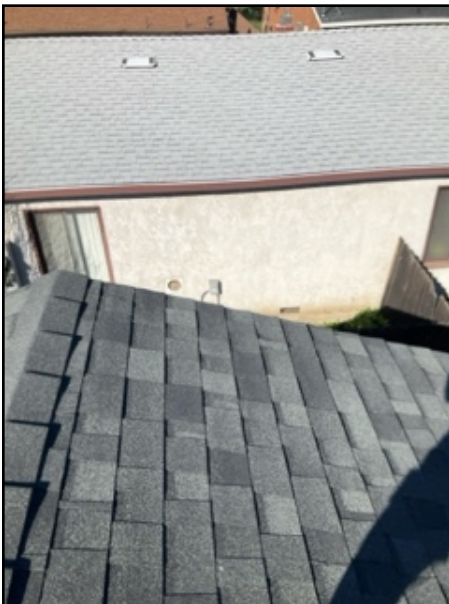
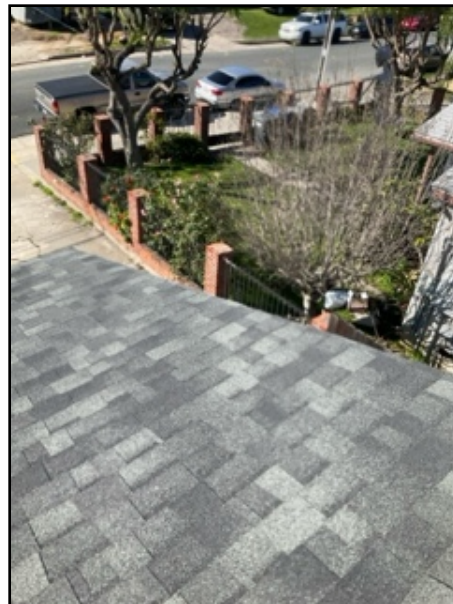
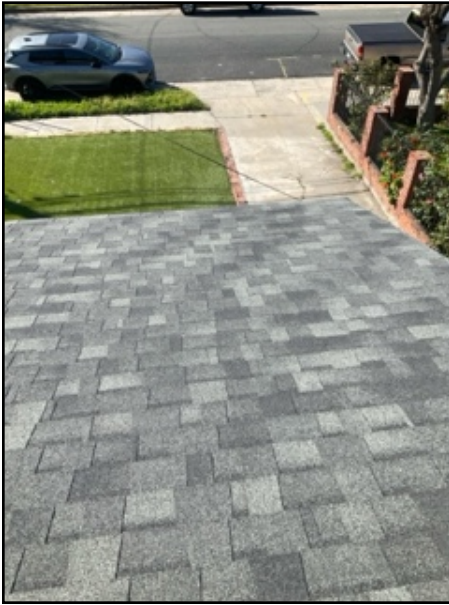
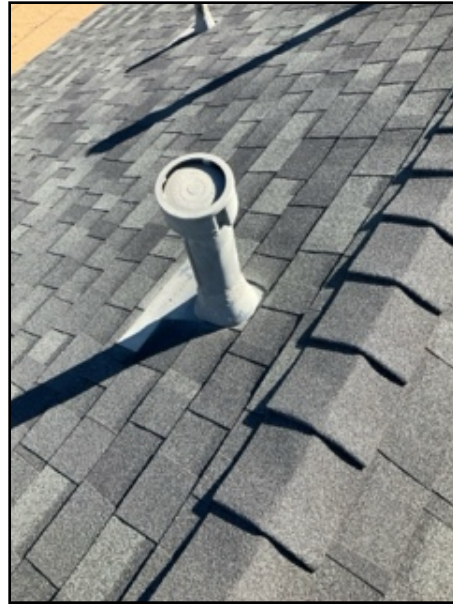
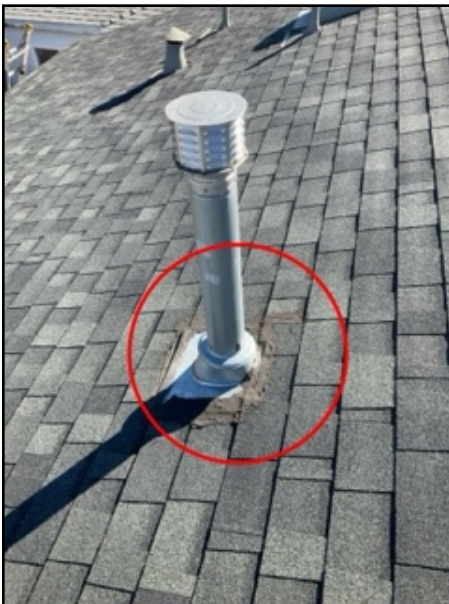
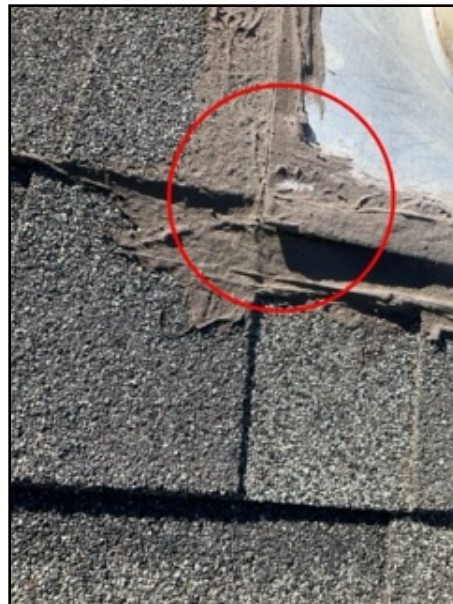
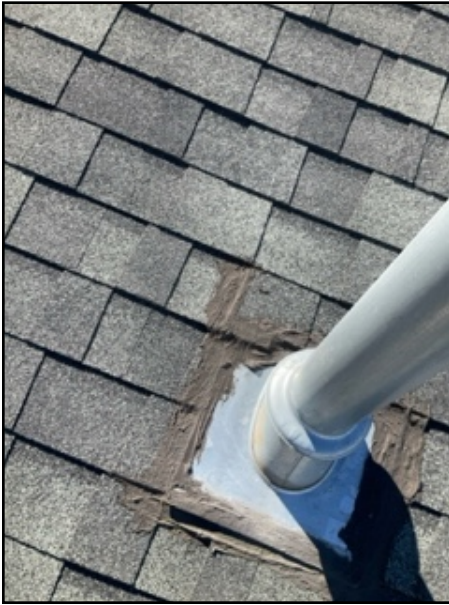
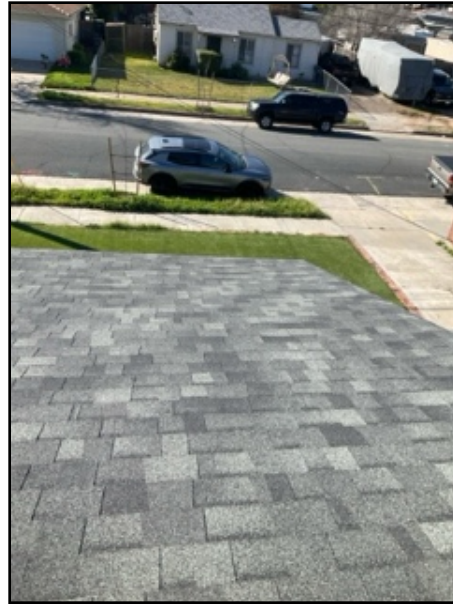
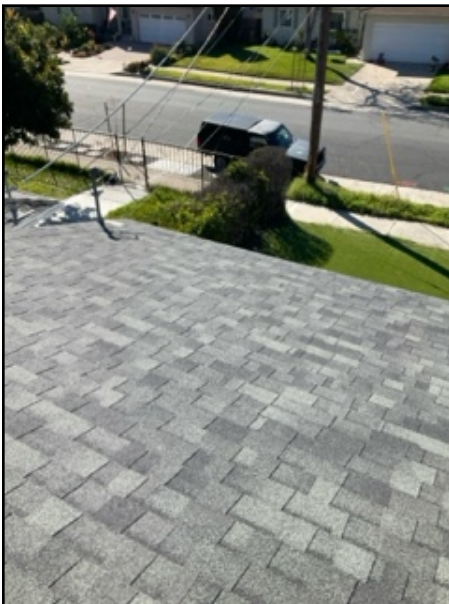
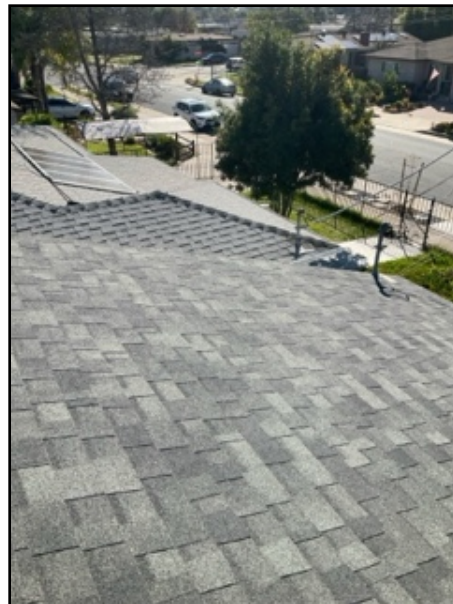
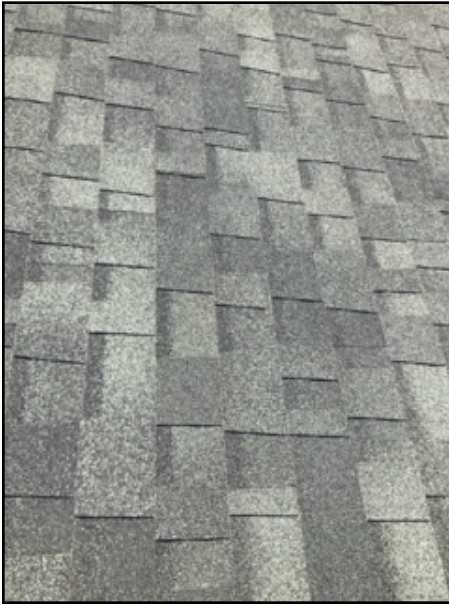
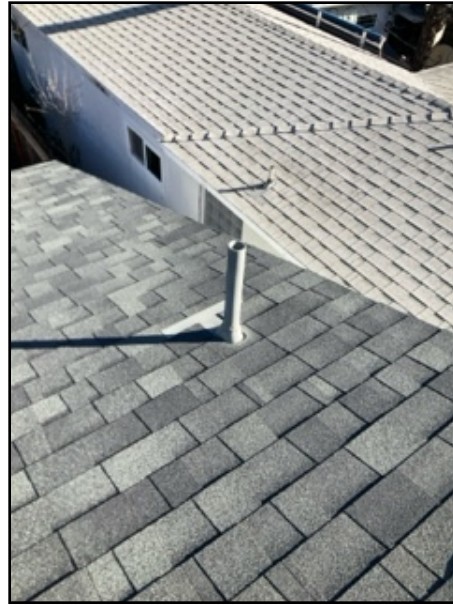
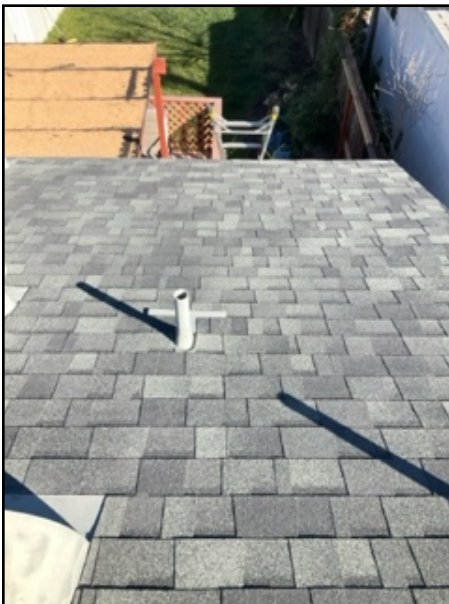
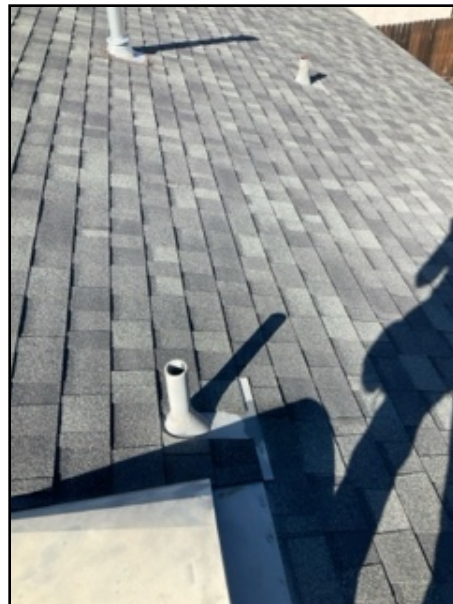
REPAIR OR REPLACE: Fiberglass noted as showing around edges of asphalt shingles on north side. Metal flashing noted as incorrectly installed over ducting. Metal flashing noted as lifting up. Rolled roofing over patio cover noted as delaminating. Previous repairs noted on patio cover. Have a more qualified professional to evaluate and repair.

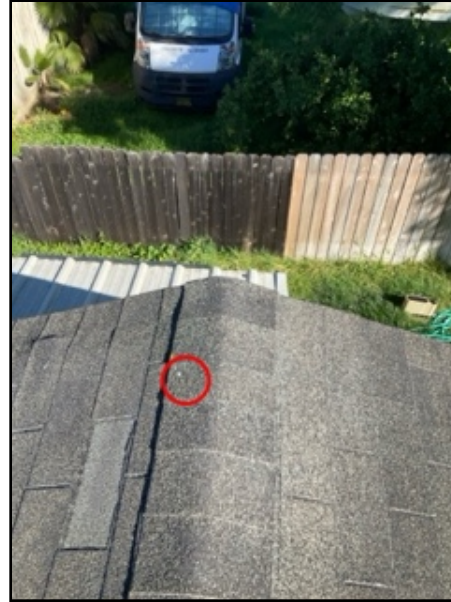
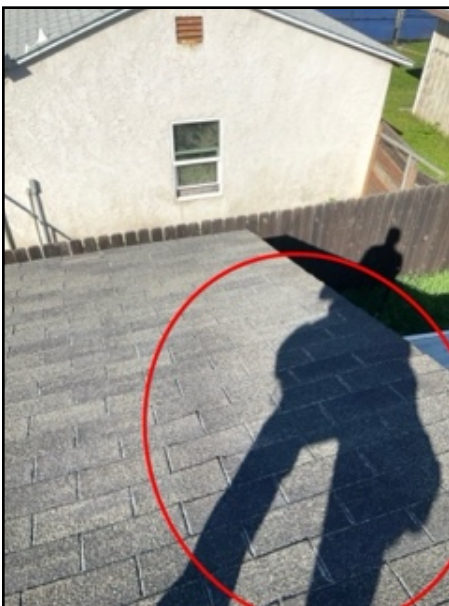
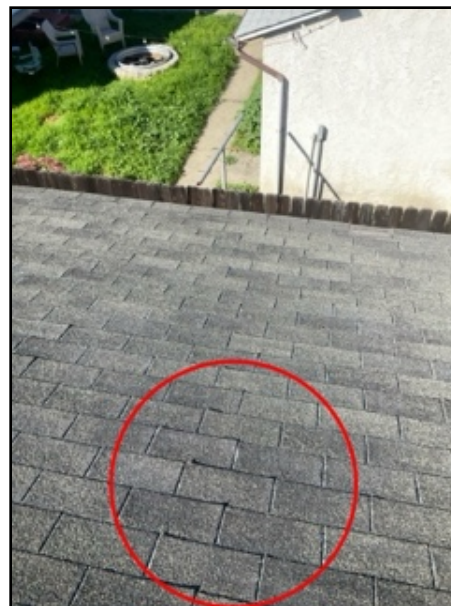
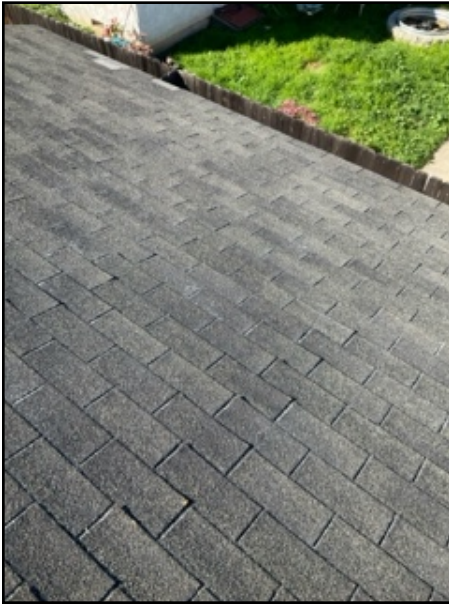
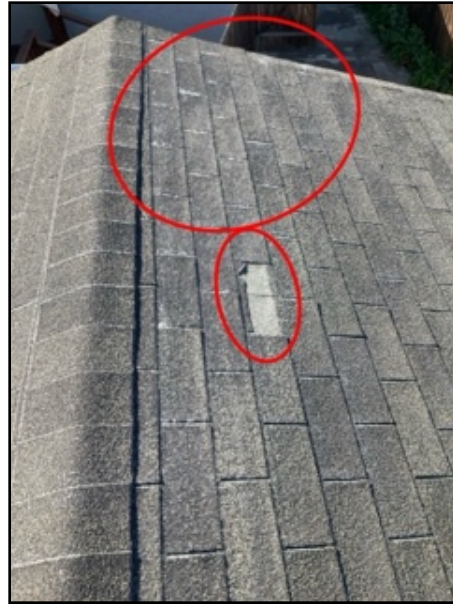
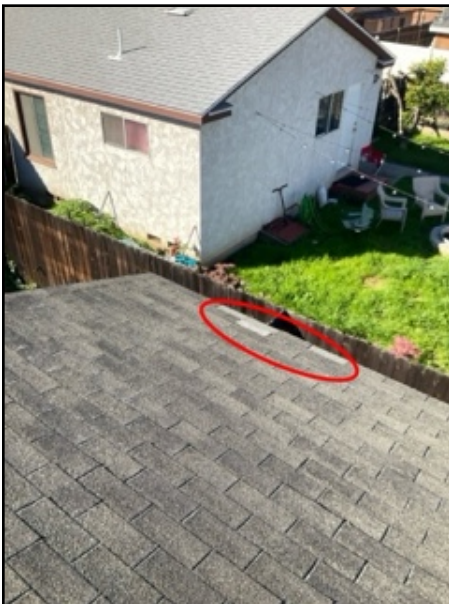
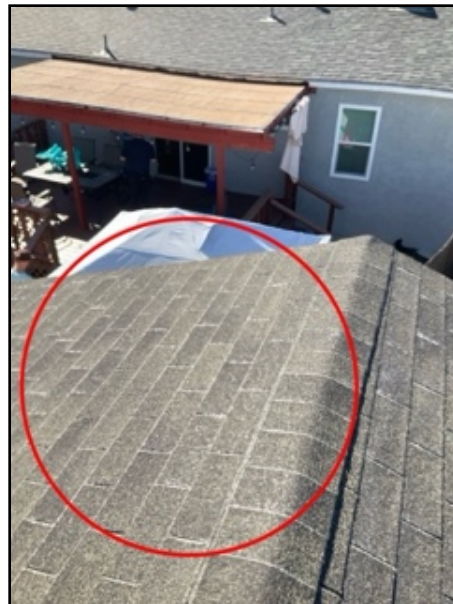
**REPAIR OR REPLACE:** Asphalt shingles over roof at garage noted as torn and deteriorated. Multiple shingles noted as missing. Asphalt granular loss noted on shingles. Fiberglass noted as showing around edges. Asphalt shingles noted as brittle. Exposed nails noted at various locations. Have a more qualified professional to evaluate and repair.

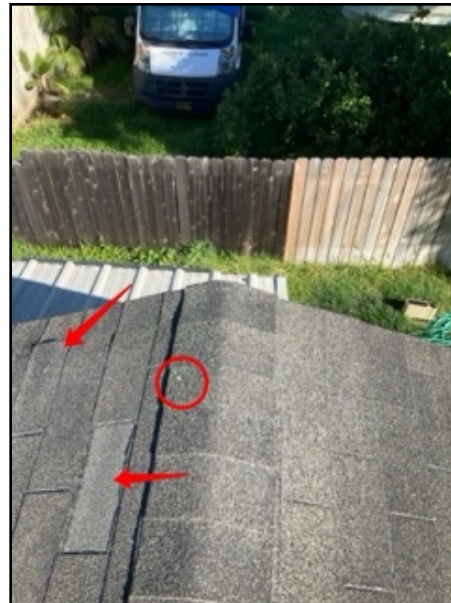
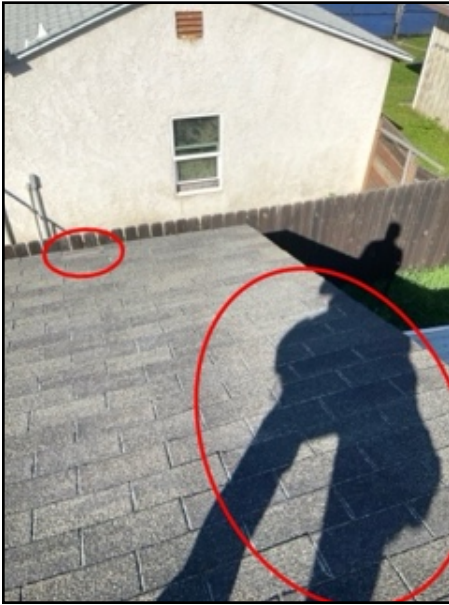
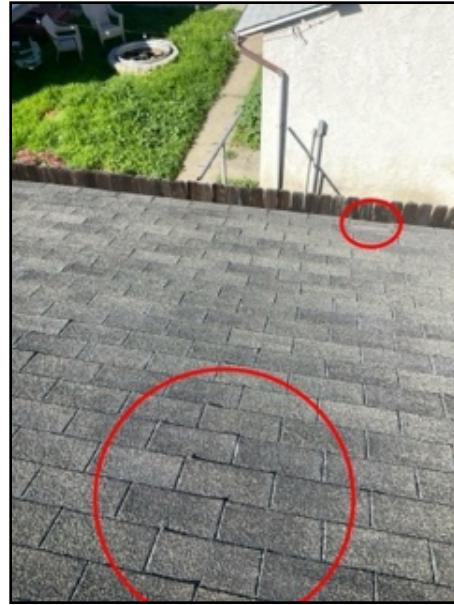
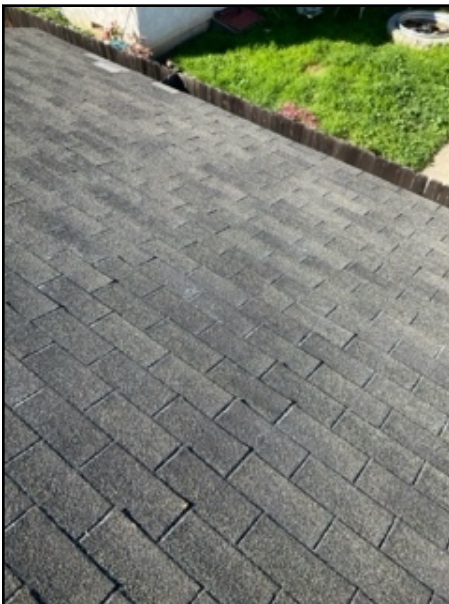
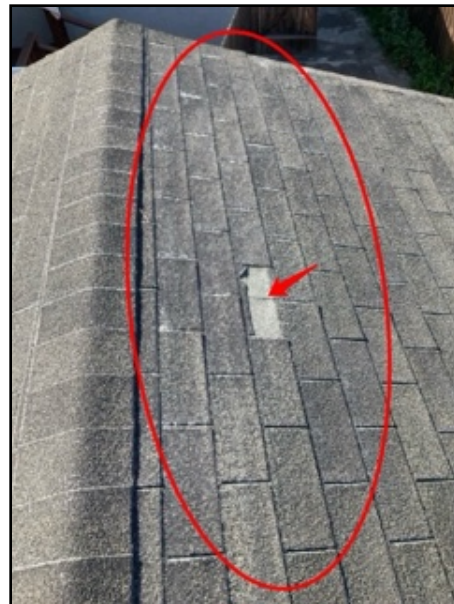
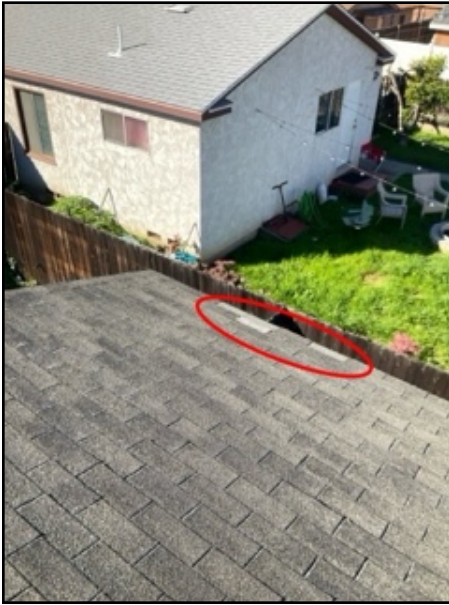
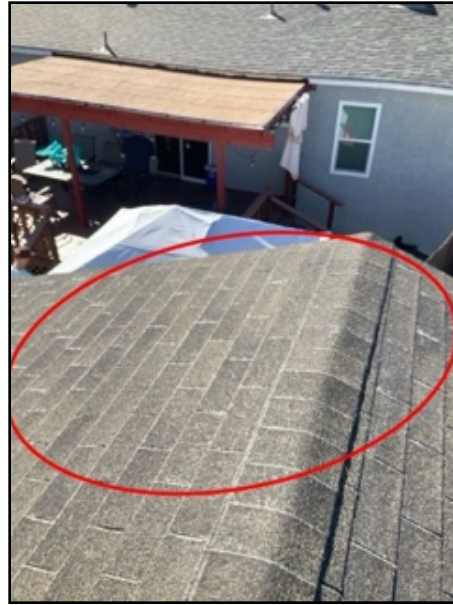
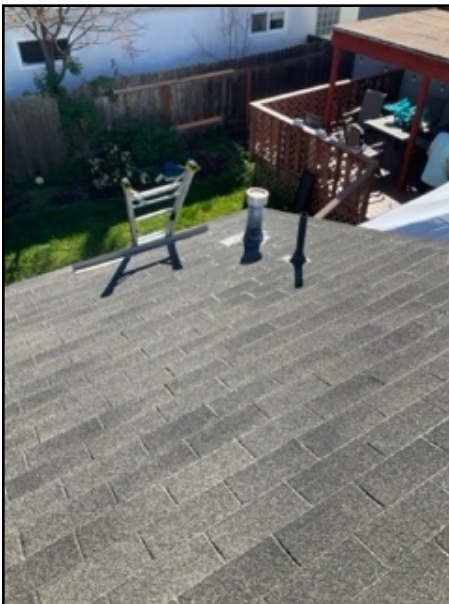
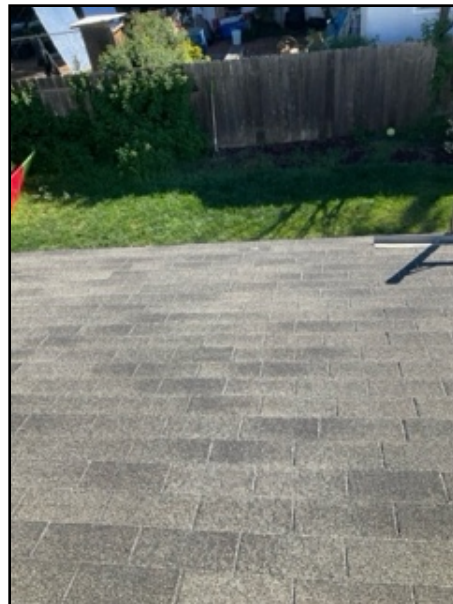
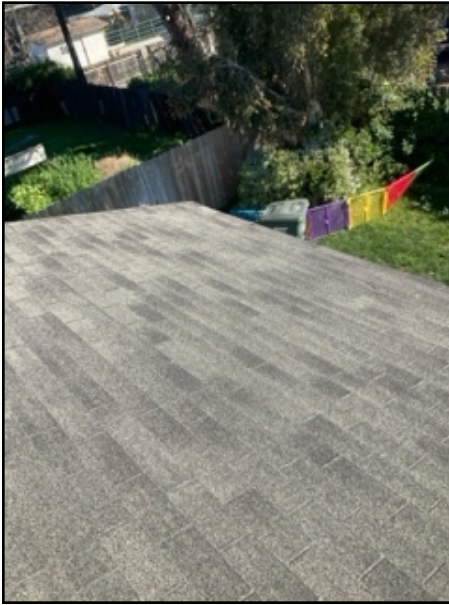
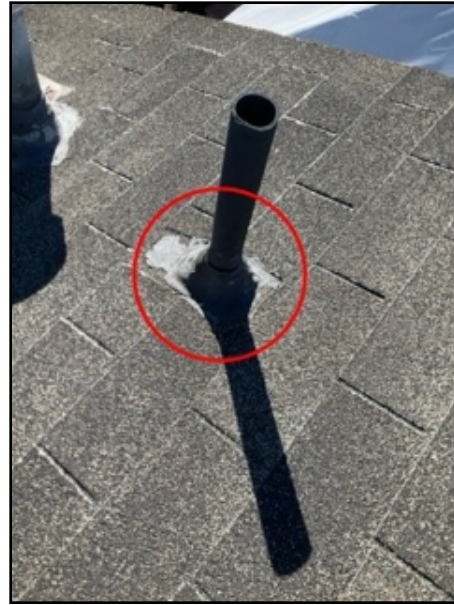
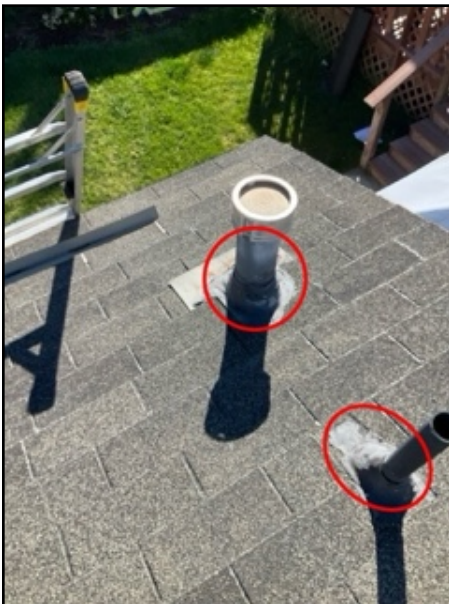
REPAIR OR REPLACE: Asphalt shingles over roof at garage noted as torn and deteriorated. Multiple shingles noted as missing. Asphalt granular loss noted on shingles. Fiberglass noted as showing around edges. Asphalt shingles noted as brittle. Exposed nails noted at various locations. Mastic around vent pipes noted as cracked and deteriorated. Have a more qualified professional to evaluate and repair.

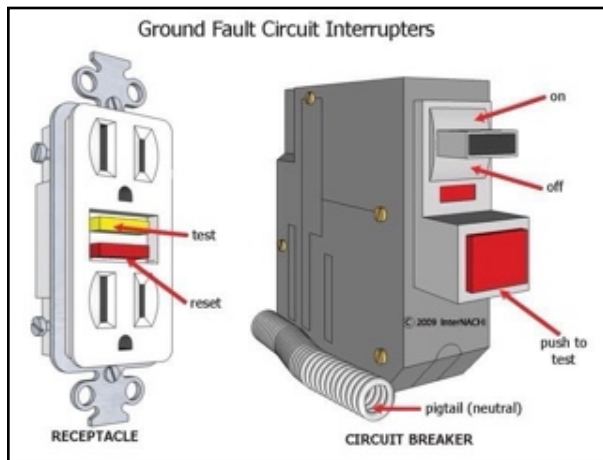
Figure 32-1

Although it may not have been required when this home was originally built, whenever outlets are replaced it is required to have GFCI outlets installed near water/ high humidity sources such as exterior, bathrooms and kitchens. It is beyond the scope of this report to check building code requirements for GFCI installation at each location. Client may choose to upgrade any non-protected outlets for additional safety.

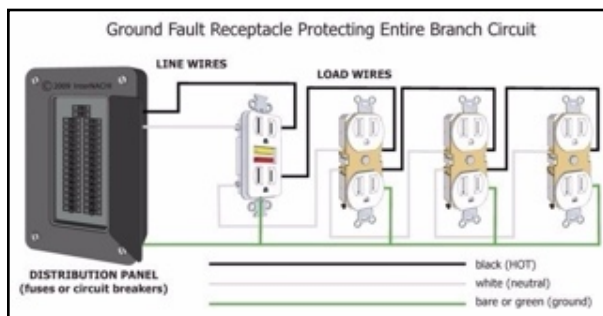
Figure 33-1

GFCI outlets protect all downstream outlets in the circuit. A push button reset is NOT required at each location. It is outside the scope of this inspection to locate the push button reset for outlets that are required to be protected as set forth in the IRC.

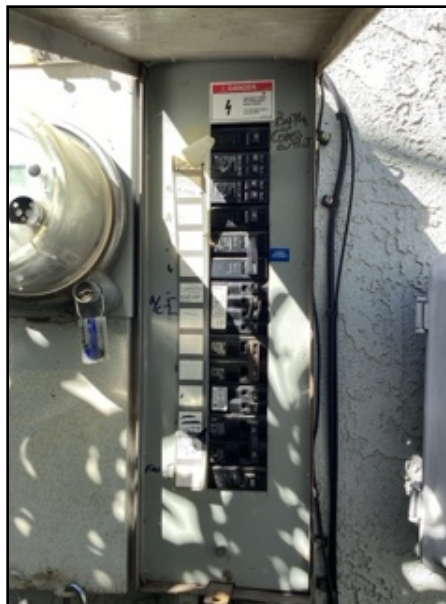
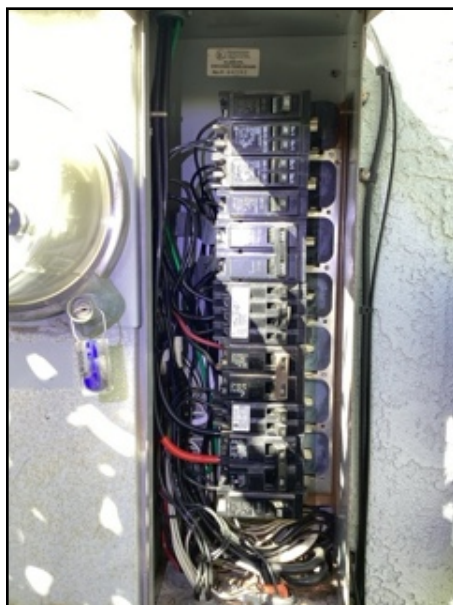
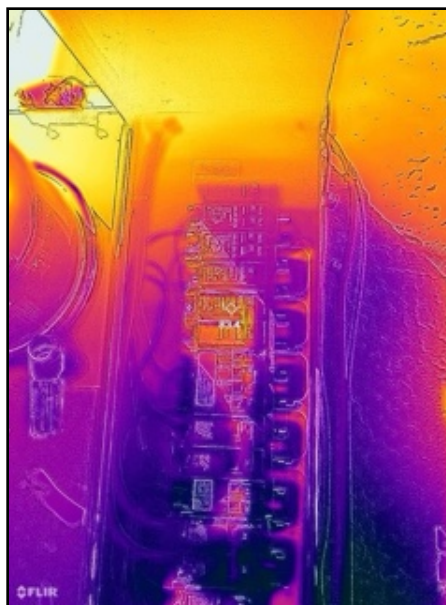
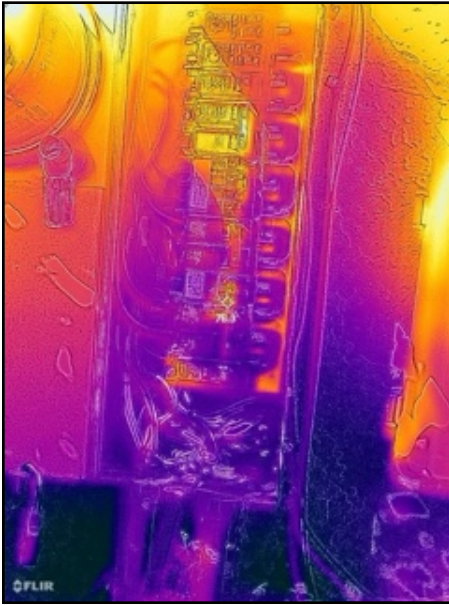
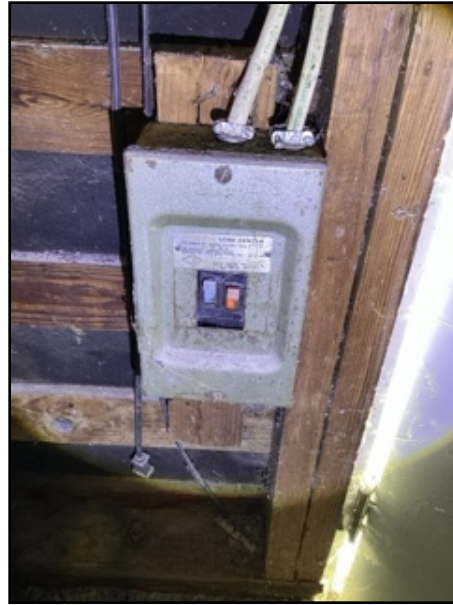
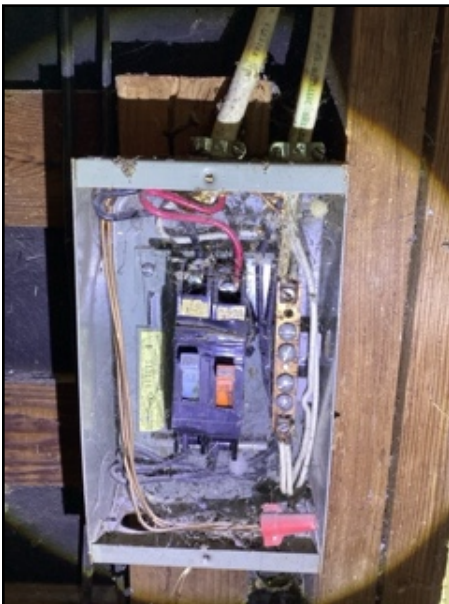
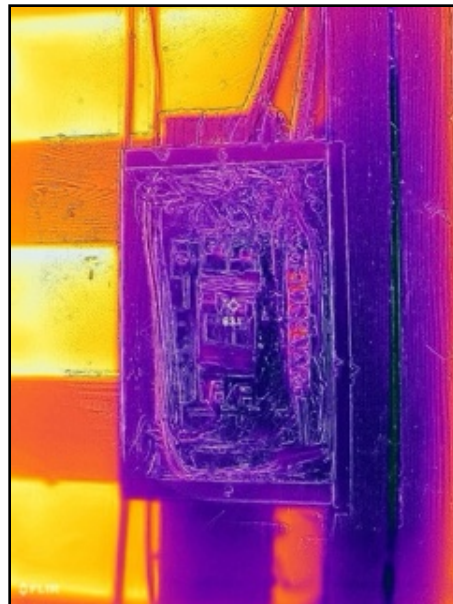
**Comment 34:**  
Service panel inspection pictures. A thermal scan was conducted and no significant hot spots were noted.

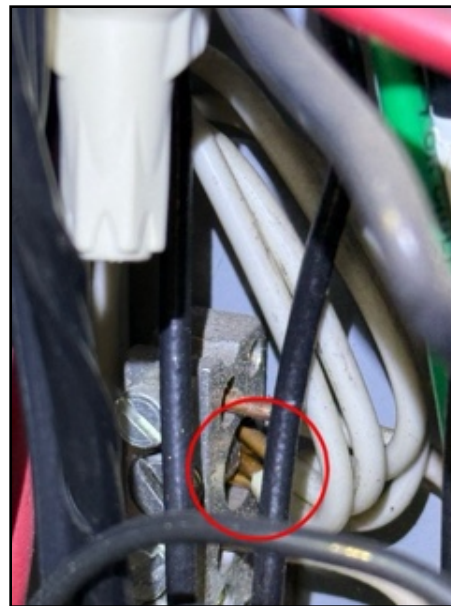
Figure 37-2

**REPAIR OR REPLACE:** No two or more neutral wires should generally not be terminated under the same screw on a busbar in a panel. While some panels may allow for multiple ground wires to be terminated under one screw, this is not typically the case for neutral wires. Electrical codes and professionals suggest that each neutral wire should have its own individual terminal to prevent potential issues like overheating, arcing, or voltage fluctuations.

\* **Voltage Fluctuations:** A loose connection or a wire not properly secured under the screw can cause voltage fluctuations in the affected circuit, potentially impacting the performance of connected devices.

\* **Neutral Imbalance:** In a multi-wire branch circuit, two hot wires sharing a neutral can lead to neutral imbalance, especially if the loads on each hot wire are not equal. This can cause the neutral to carry more current than it is designed for, leading to

Have a qualified electrician to evaluate and repair.

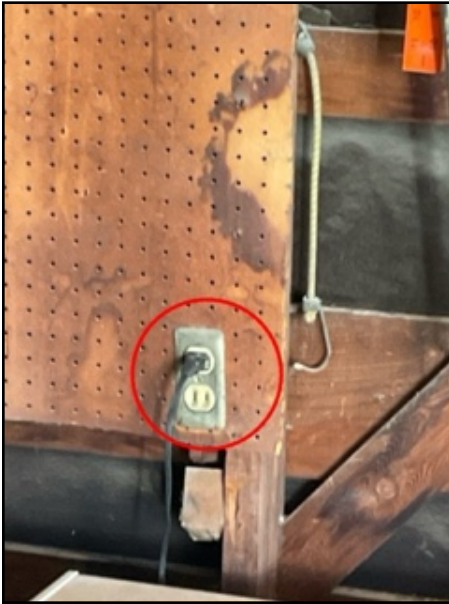
Figure 38-1

Parts of the electrical system are not grounded. While grounding may not have been required at the time of construction, ungrounded outlets must match the panel configuration in order to ensure that adequate safety precautions have been taken. Two-pronged outlets, individual grounding at three-pronged outlets, or the installation of GFCI protection is adequate in the appropriate circumstances.

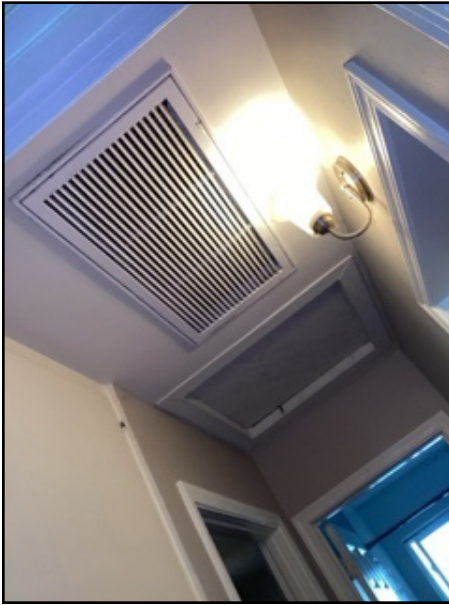
Figure 39-1

**REPAIR OR REPLACE:** Bedroom hallway noted as missing smoke detector.

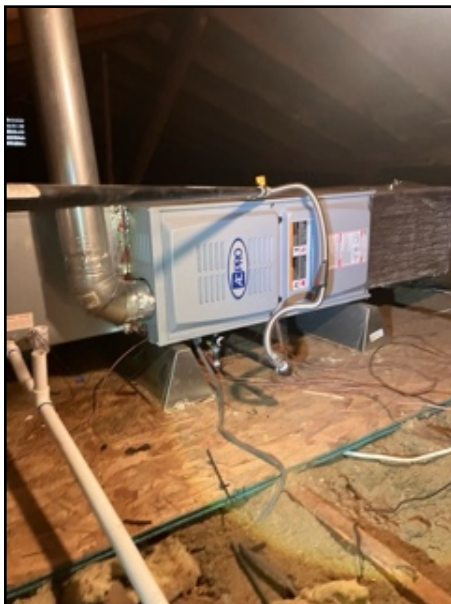
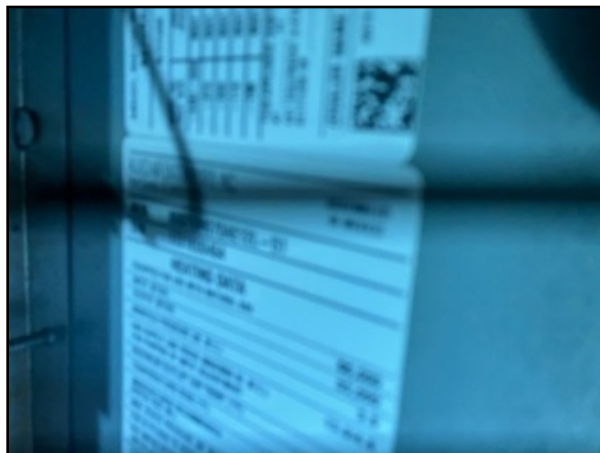
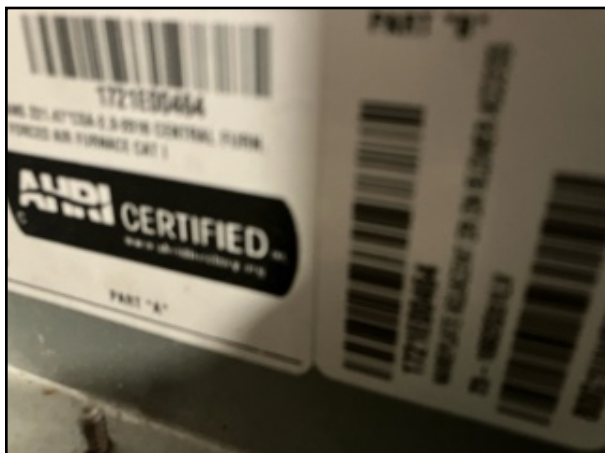
Comment 47:  
Heater data plate picture.
