## USA Home Inspectors

## Home Inspection Report

**782 W Renette Ave**

Inspected On: Wed, Feb 25 2026 at 9:00AM

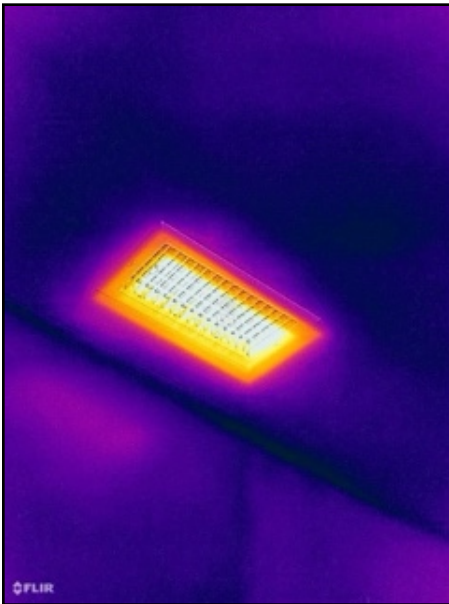
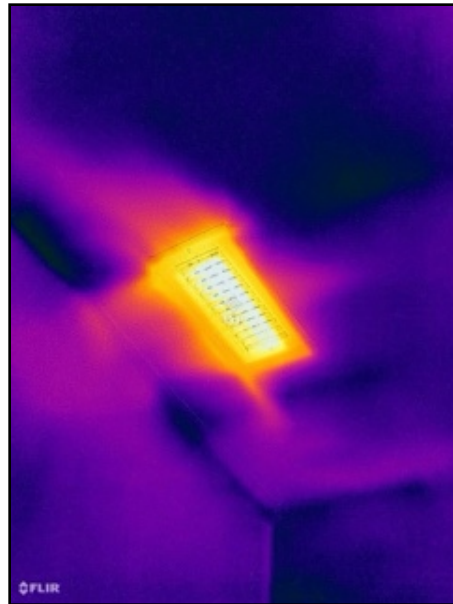
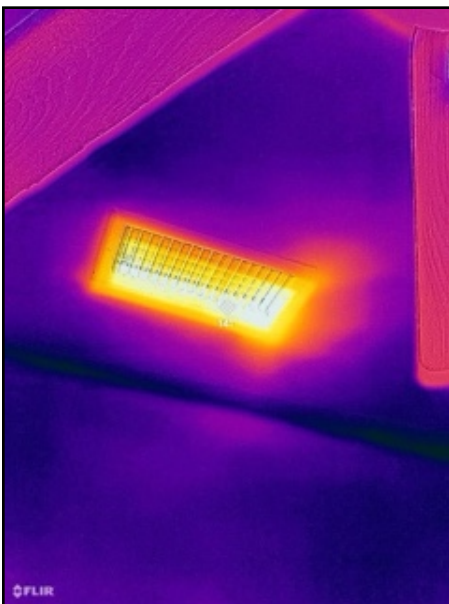
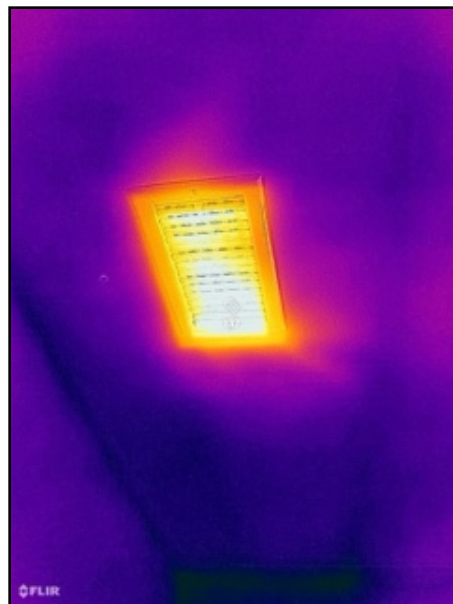
Comment 48:  
Heater outputs.

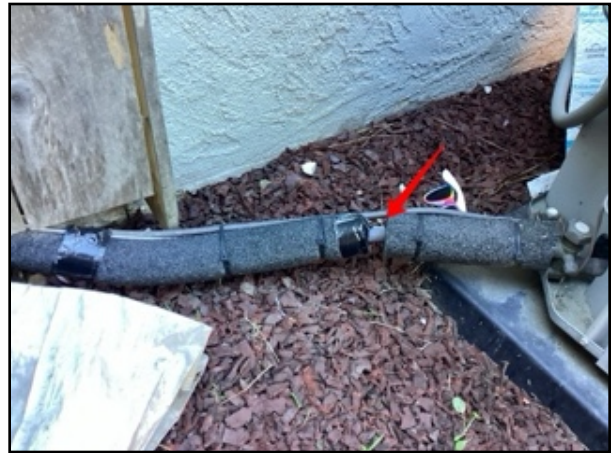
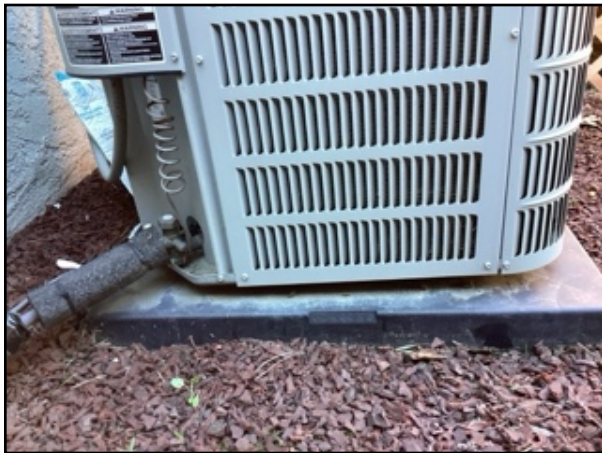
REPAIR OR REPLACE: AC refrigerator line insulation noted as partially missing and deteriorated, and condenser unit is not strapped down to the pad.

A licensed contractor should conduct an annual service and maintenance for all air conditioners over 10 years old and heat pumps over 5 years old.

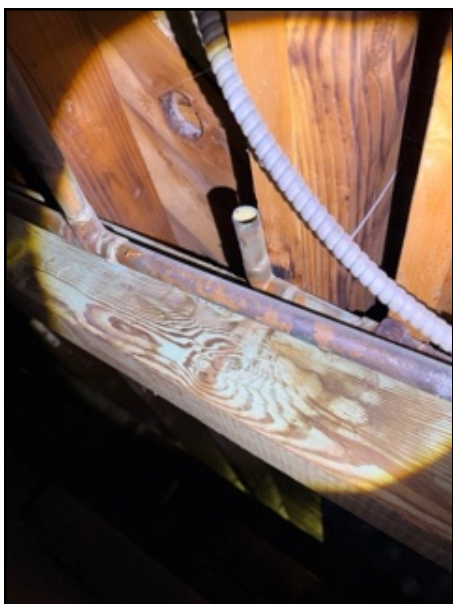
Figure 59-1

Comment 59:  
FURTHER EVALUATION REQUIRED: Inspector notes, old abandoned copper plumbing lines in crawlspace. Home appears to have been re-plumbed at some point.

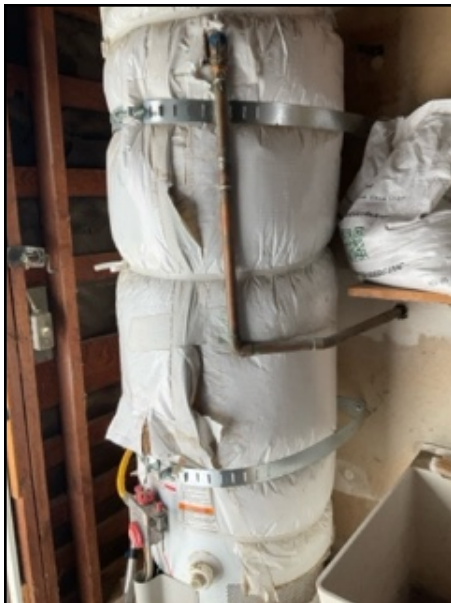
Figure 61-1

Water heater has an insulating blanket installed. Data plate was inaccessible and some basic information could not be obtained.

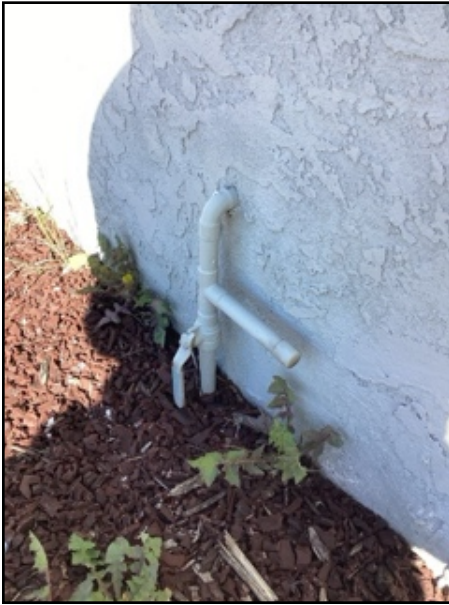
Figure 63-1

REPAIR OR REPLACE: Water pressure is 89psi. Most appliance manufacturers recommend pressure to be set between 50 and 80 psi.

FURTHER EVALUATION REQUIRED: Inspector notes there is currently no pressure reducing valve installed at time of inspection.

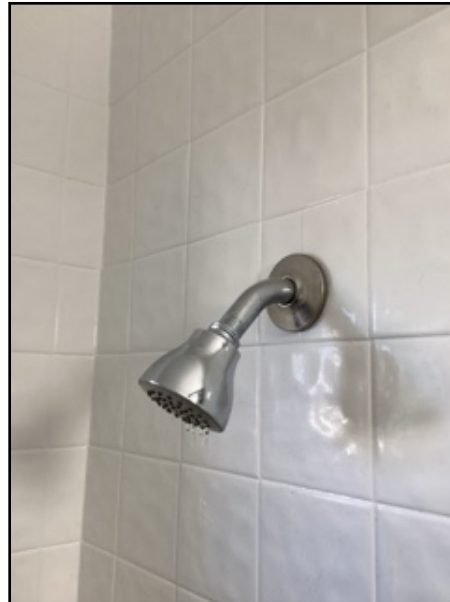
Figure 66-2

REPAIR OR REPLACE: Bath faucet and showerhead noted as loose and not sealed. Shower diverter allows water to leak by.

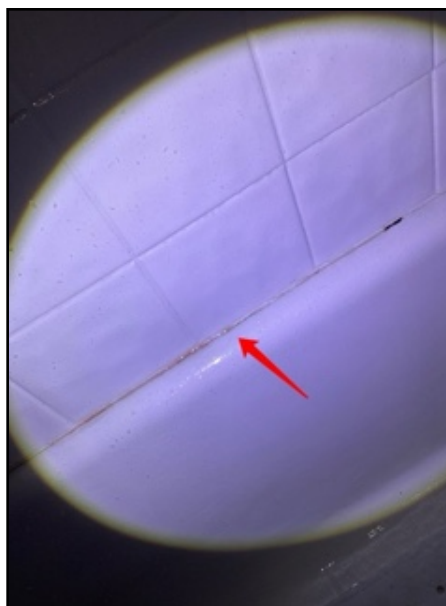
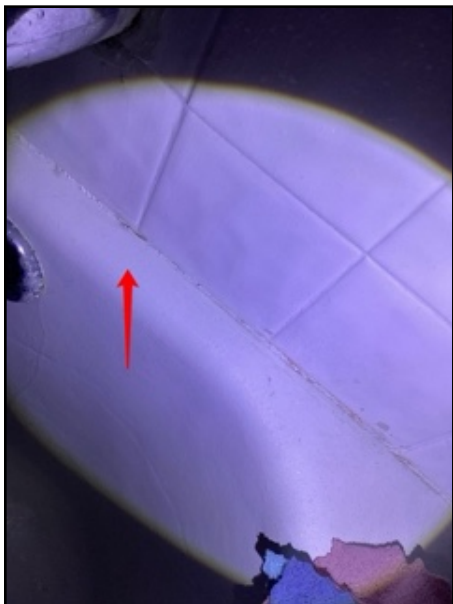
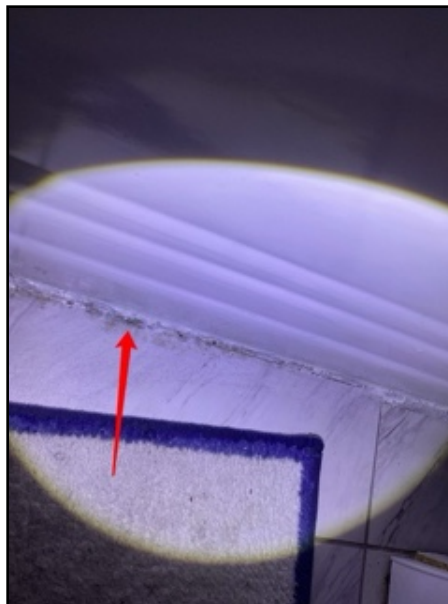
REPAIR OR REPLACE: Caulking noted as cracked deteriorated in various locations.

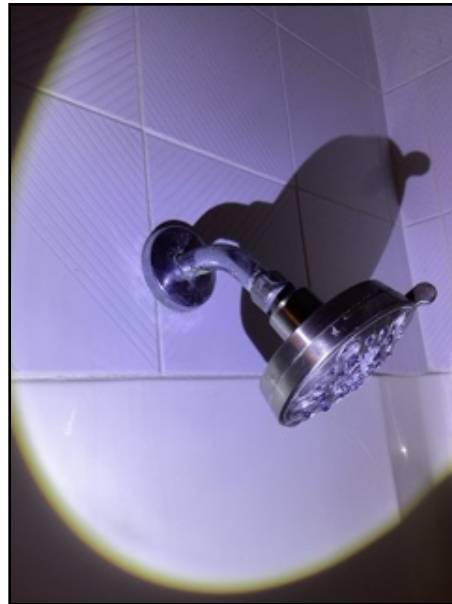
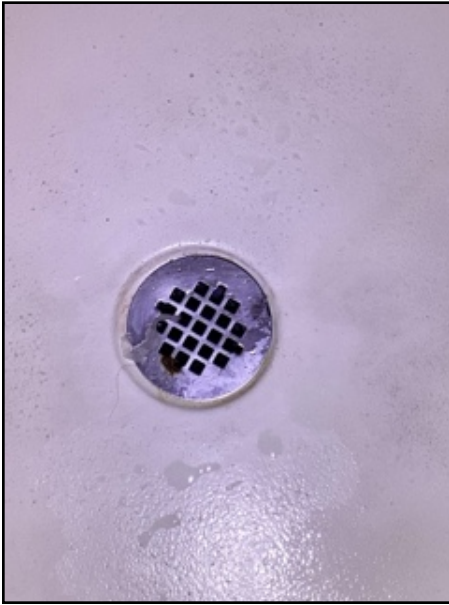
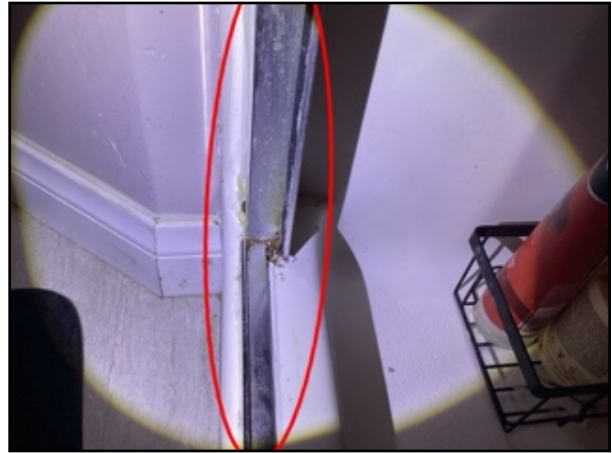
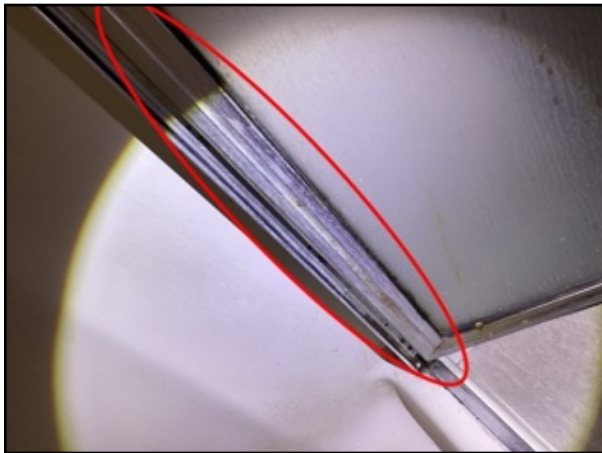
**REPAIR OR REPLACE:** Showerhead, shower controls, shower frame/door, and drain noted as stained/corroded. Shower controls noted as loose and not sealed at wall.

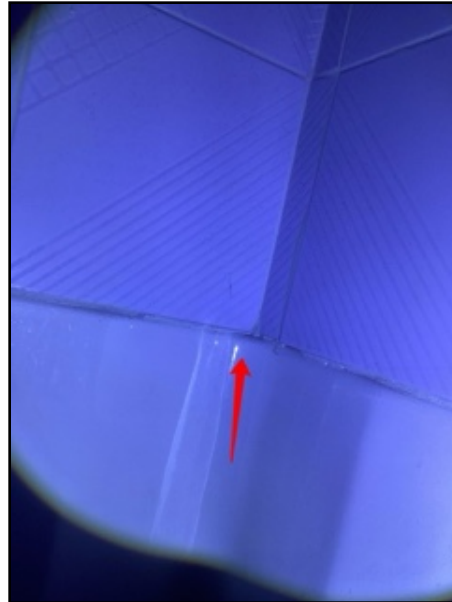
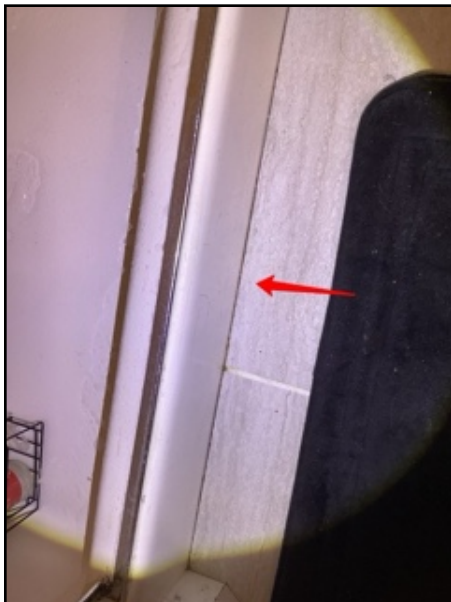
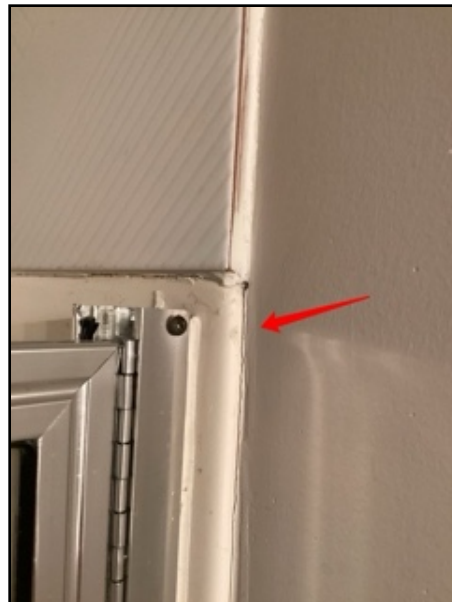
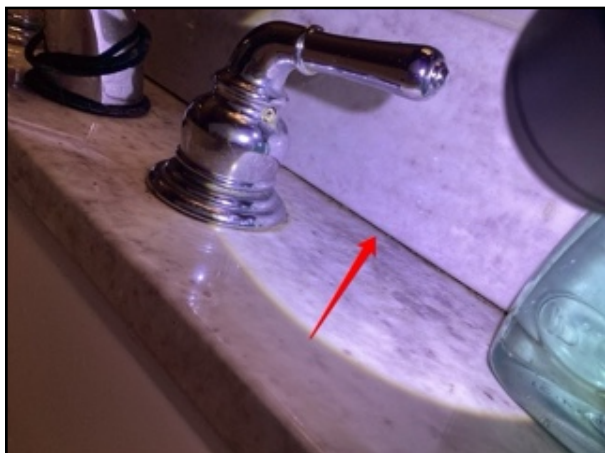
REPAIR OR REPLACE: Grout and caulking noted as cracked/deteriorated in various locations.

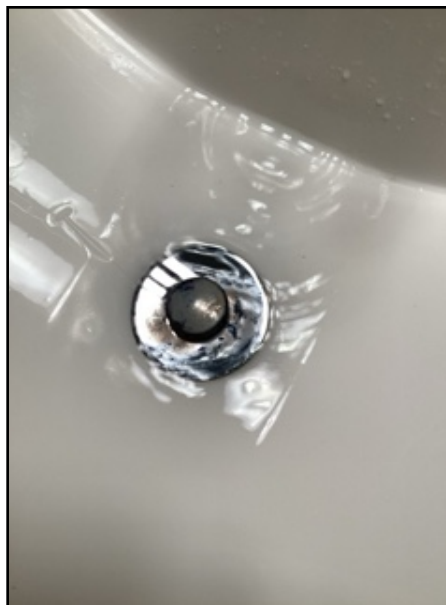
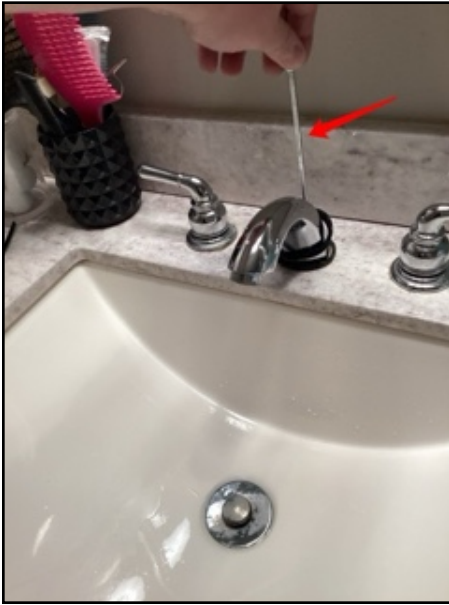
REPAIR OR REPLACE: Sink drains slowly, drain noted as stained/corroded, and broken stopper/control. Push button stopper noted as installed and is clogged.

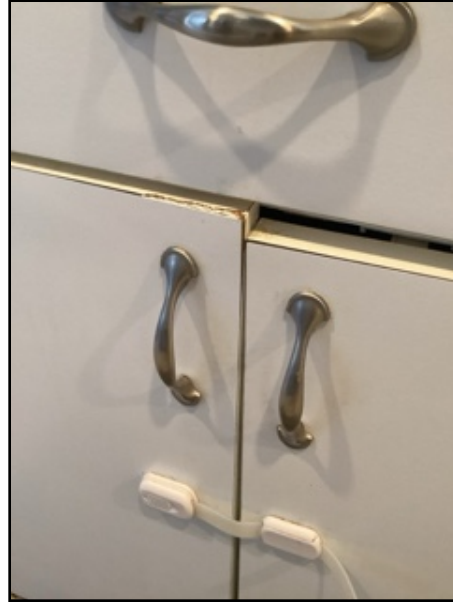
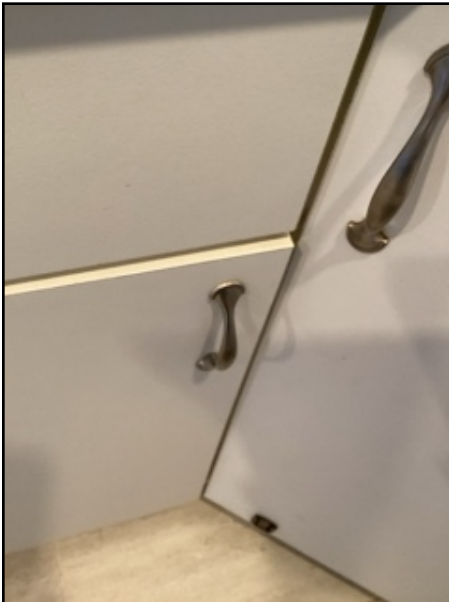
REPAIR OR REPLACE: Cabinets noted as misaligned, worn and unable to stay shut all the way in various locations.

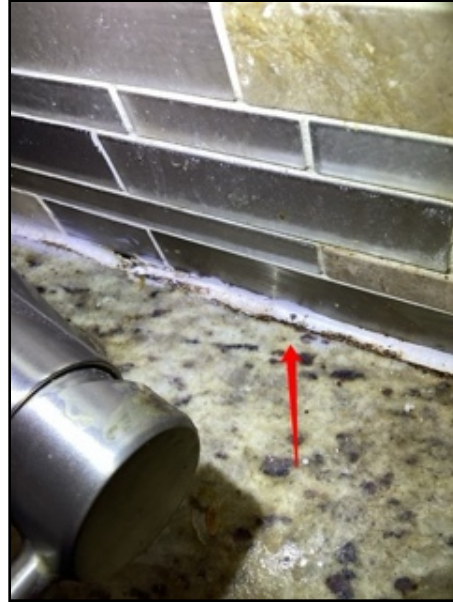
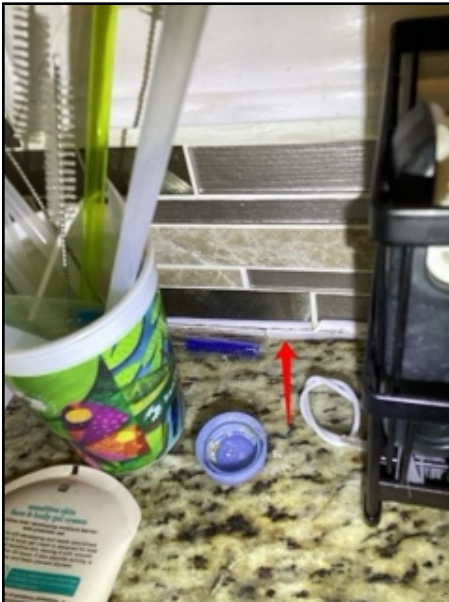
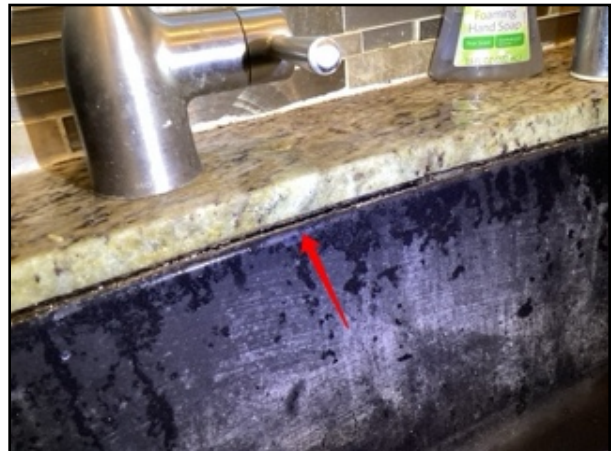
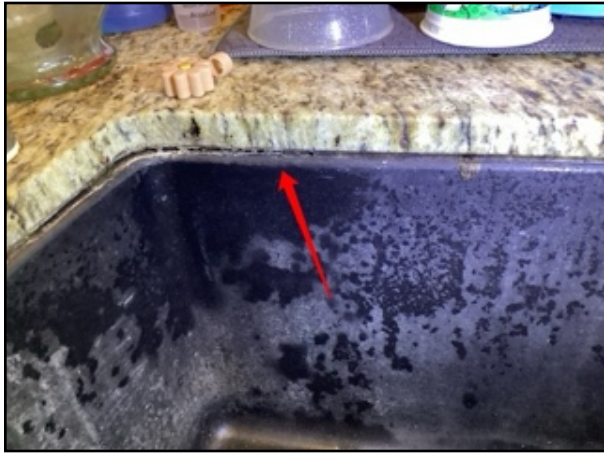
REPAIR OR REPLACE: Caulking and grout noted as cracked/deteriorated in various places around sink and backsplash.

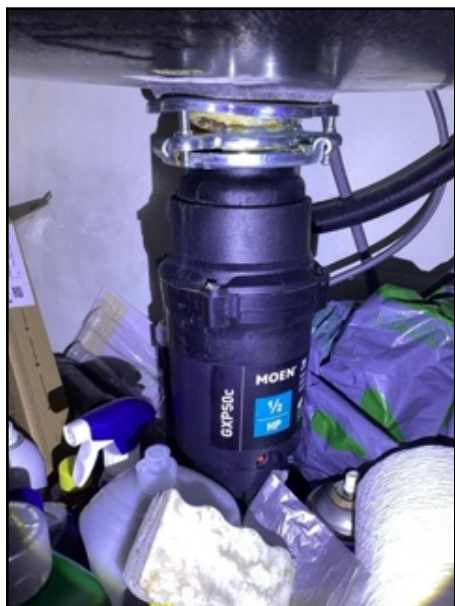
Figure 82-1

Comment 82:  
Disposal working.

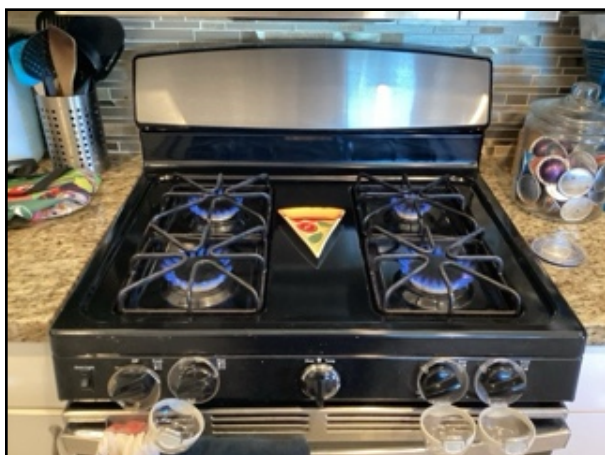
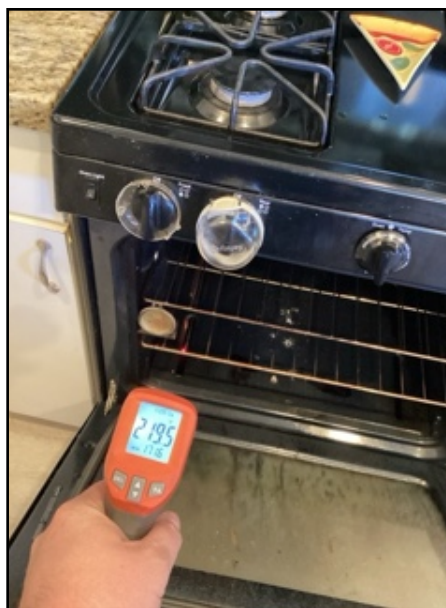
Comment 83:  
Range working.

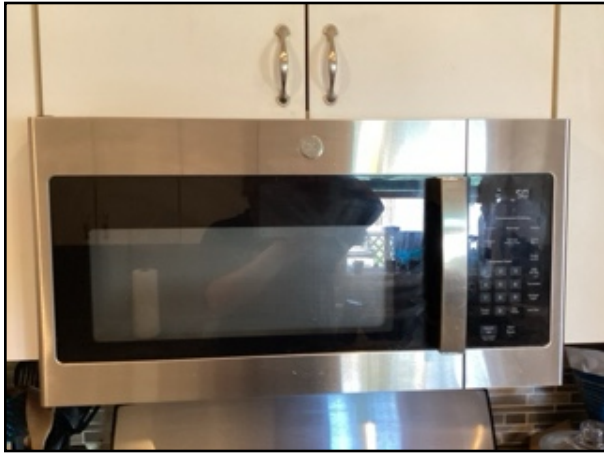
Figure 84-1

Comment 84:  
Microwave working.

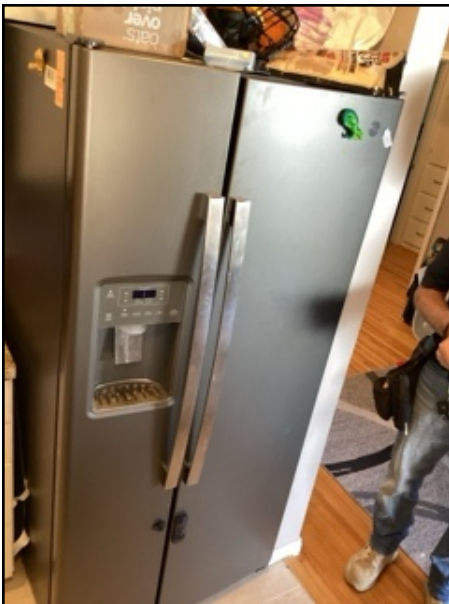
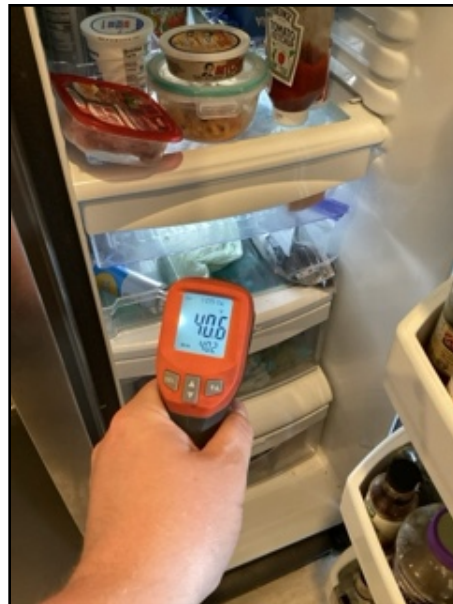
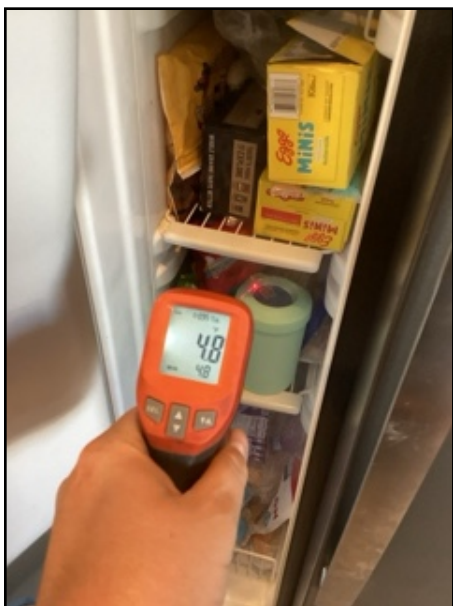
Comment 85:  
Refrigerator working.

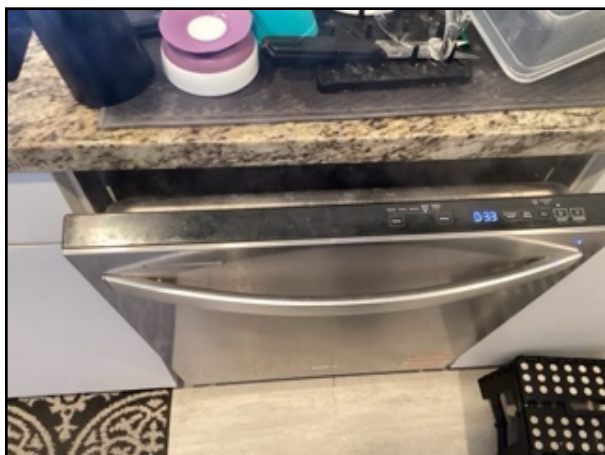
Figure 86-1

Comment 86:  
Dishwasher working.

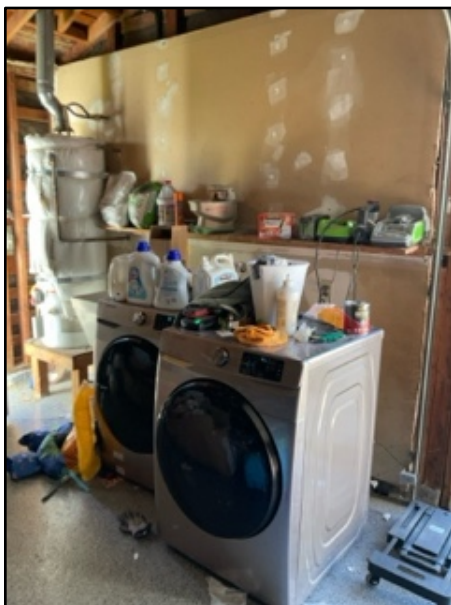
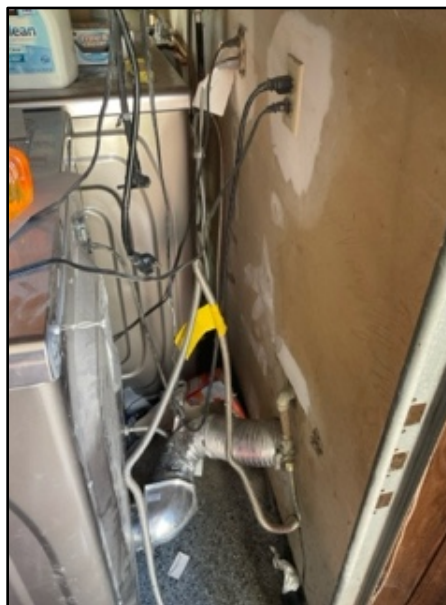
Comment 87:  
Laundry noted in garage.

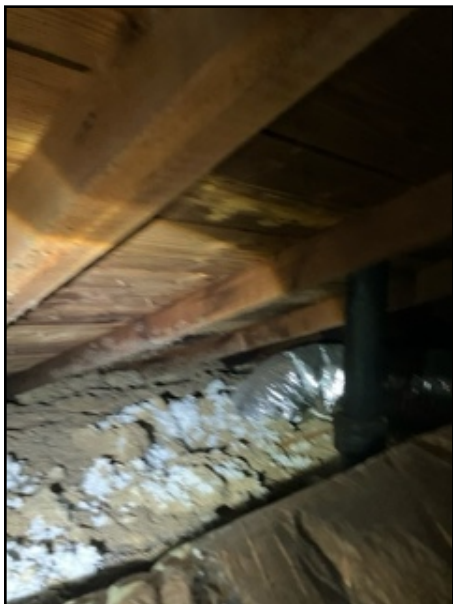
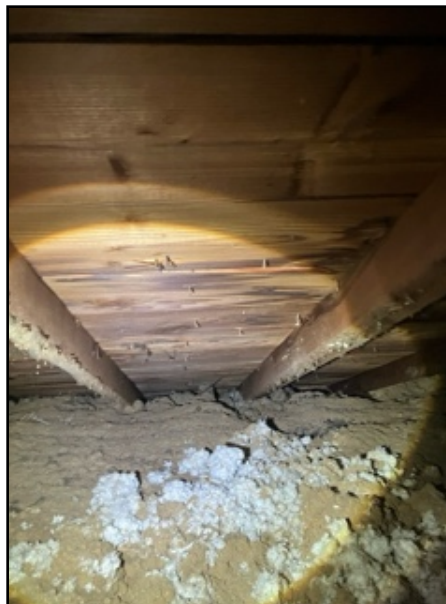
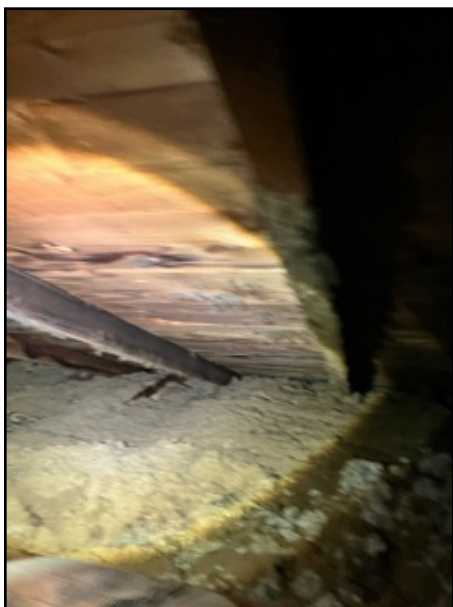
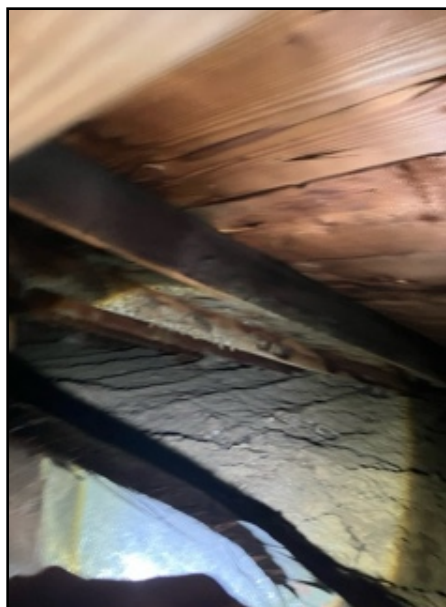
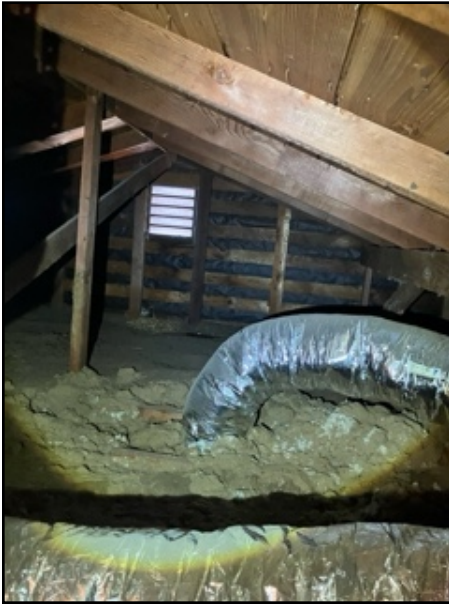
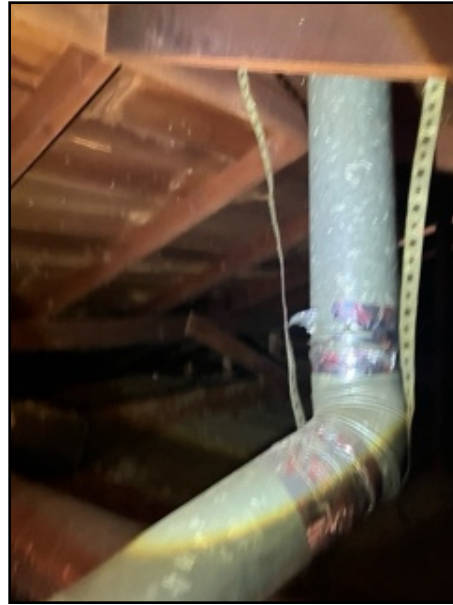
Attic inspection pictures. Some areas of the attic were not inspected due to limited access.

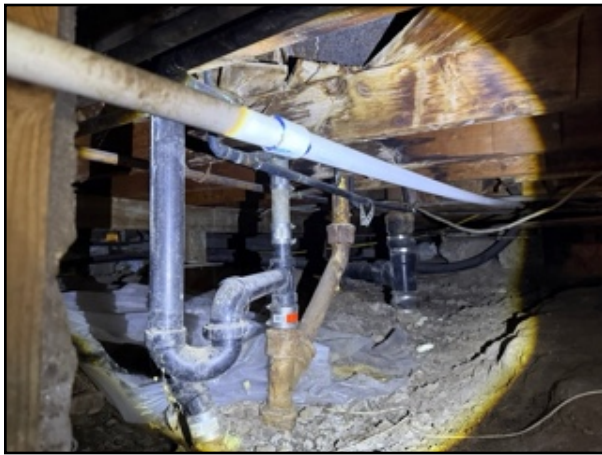
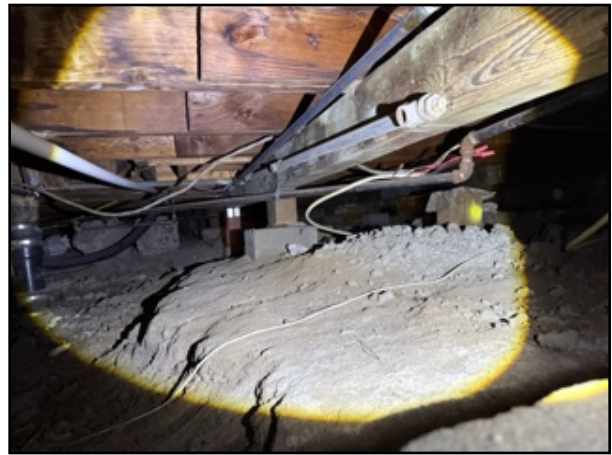
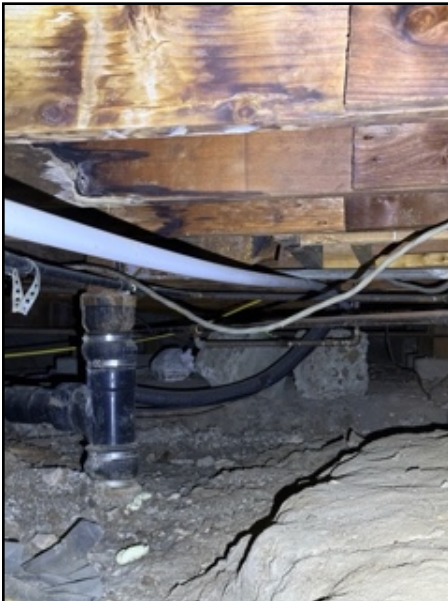
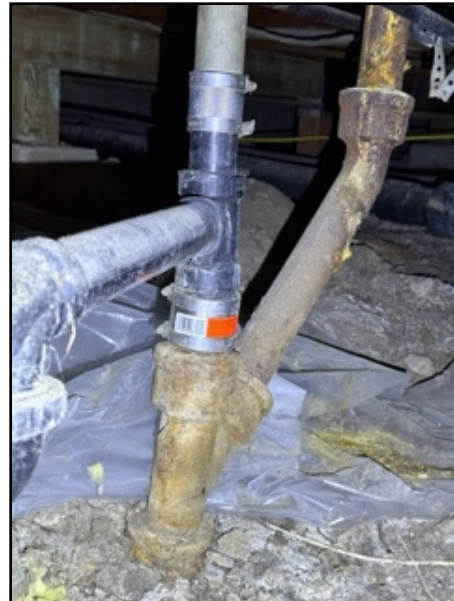
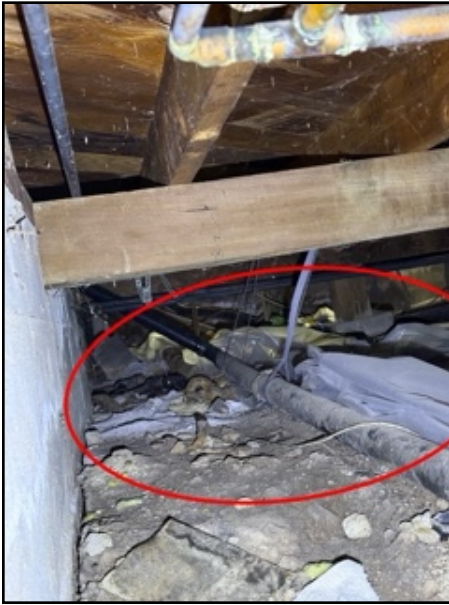
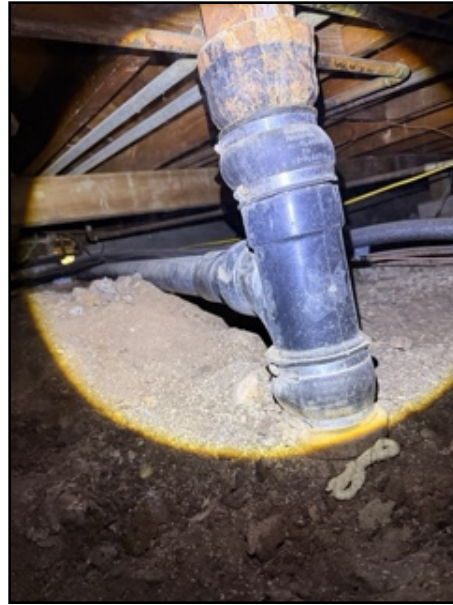
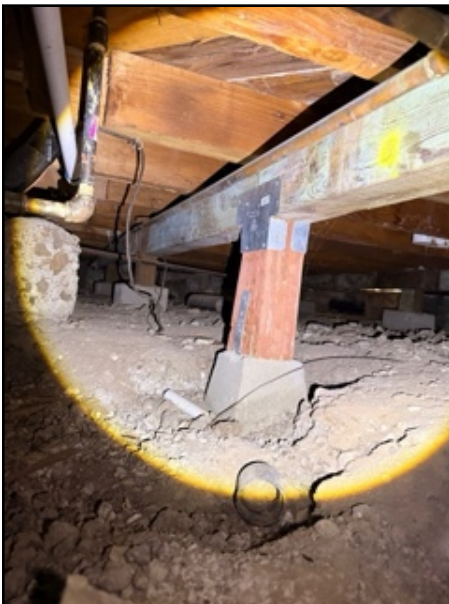
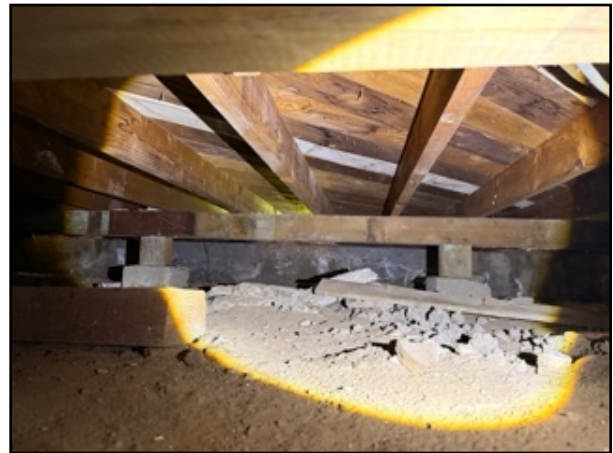
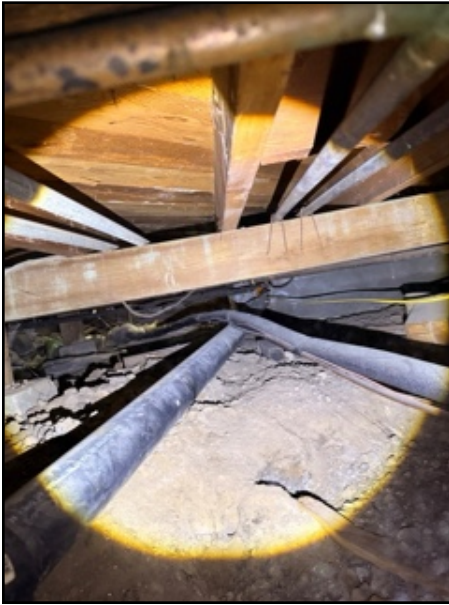
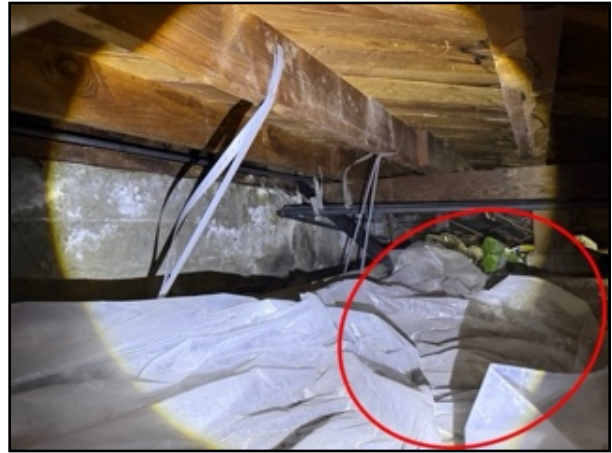
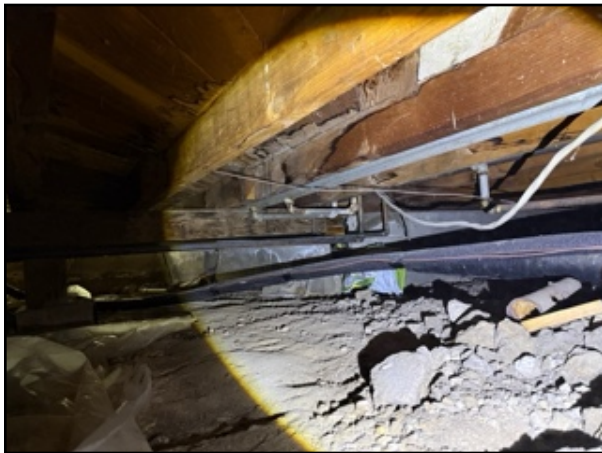
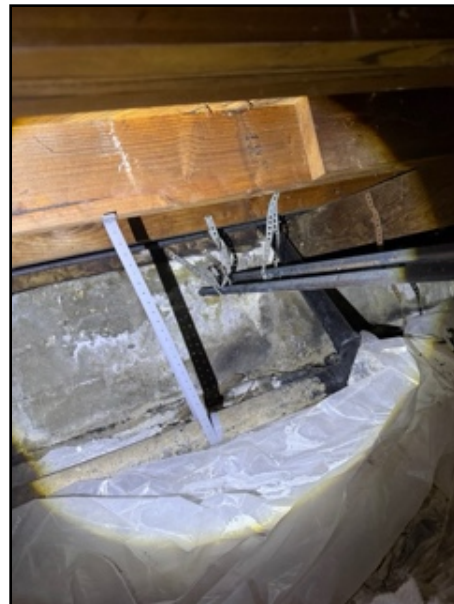
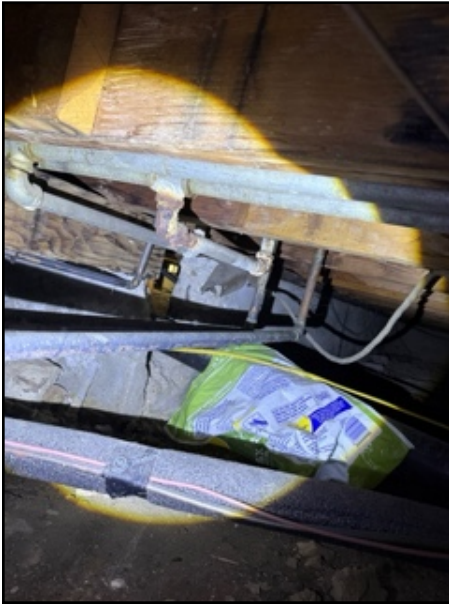
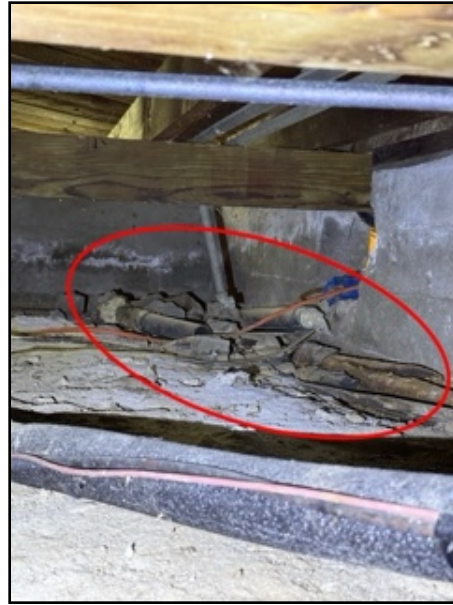
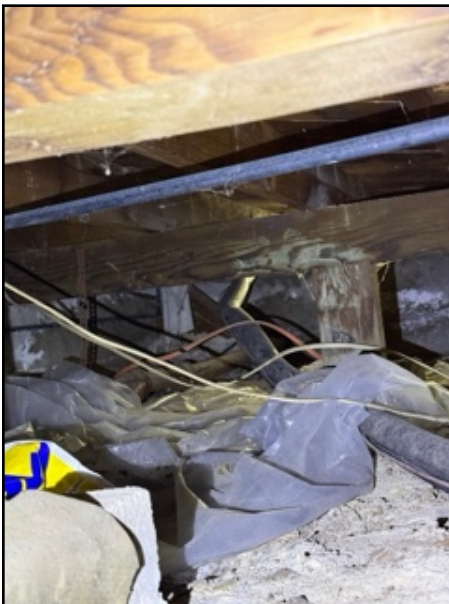
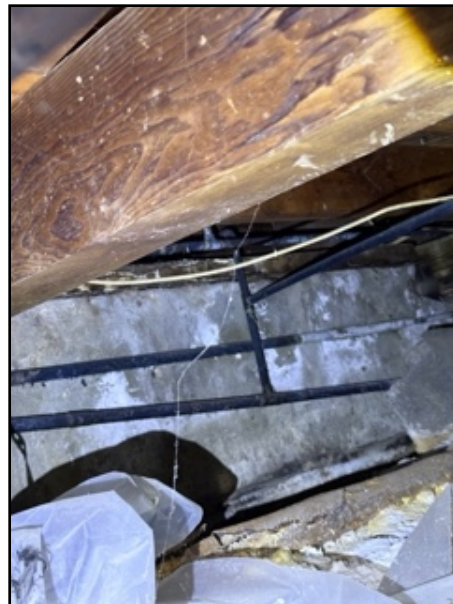
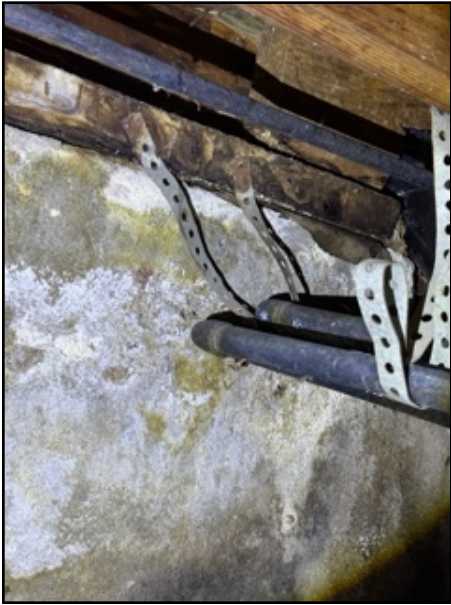
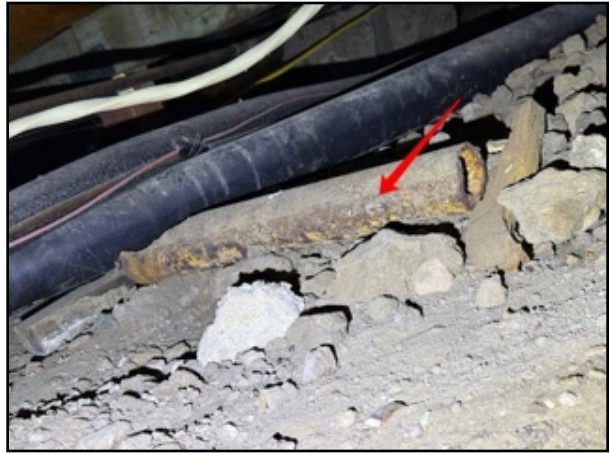
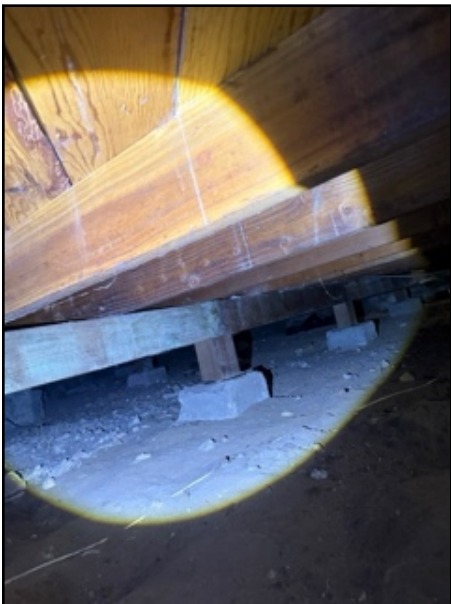
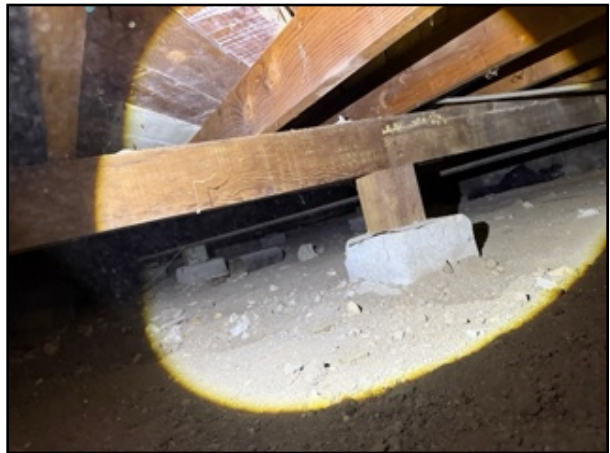
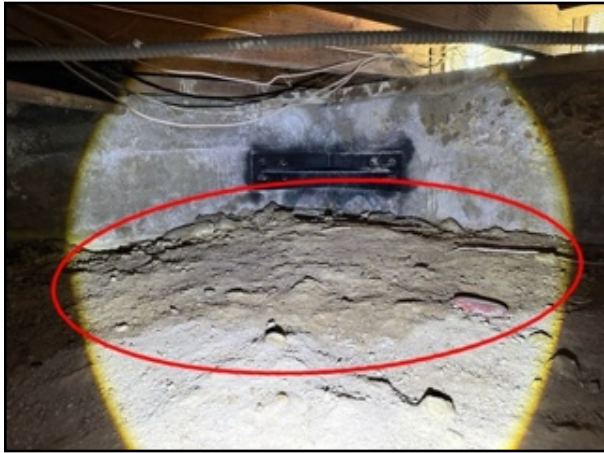
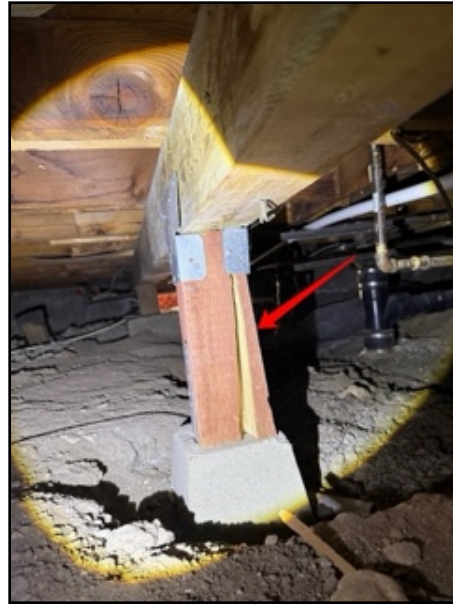
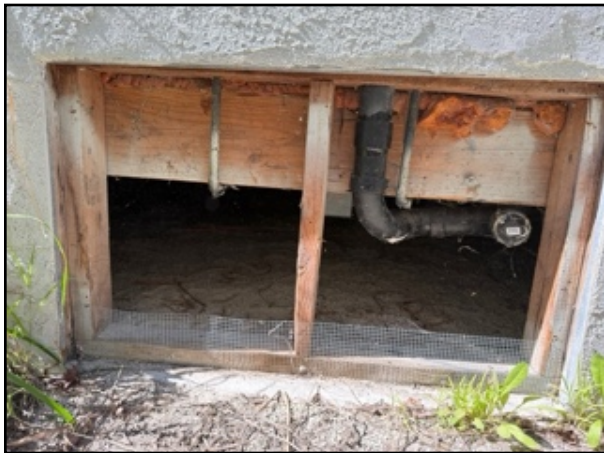
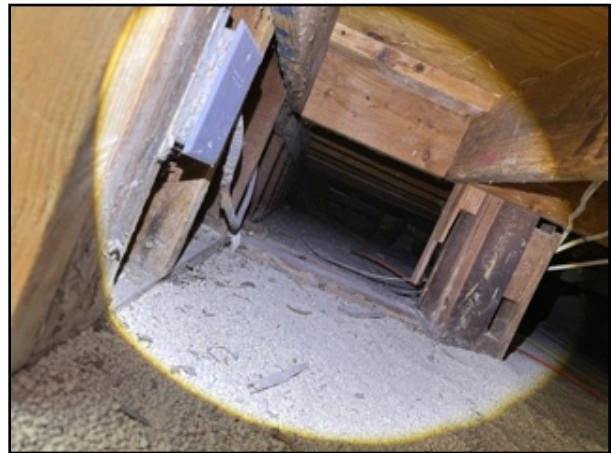
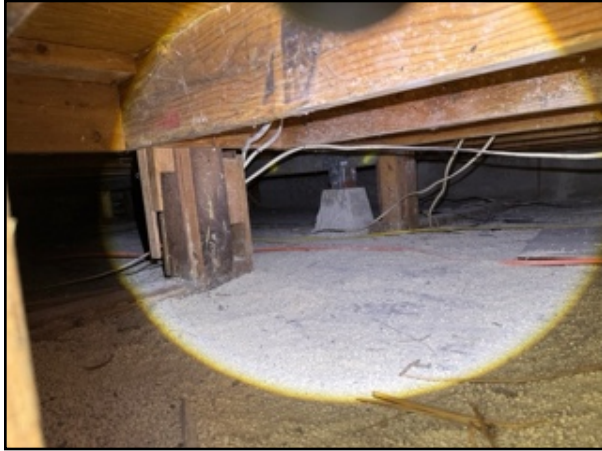
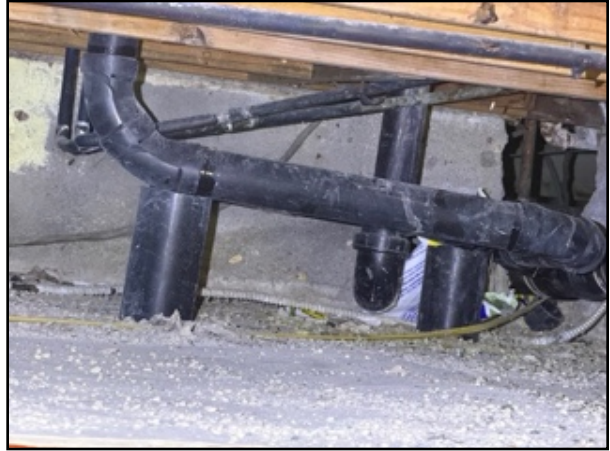
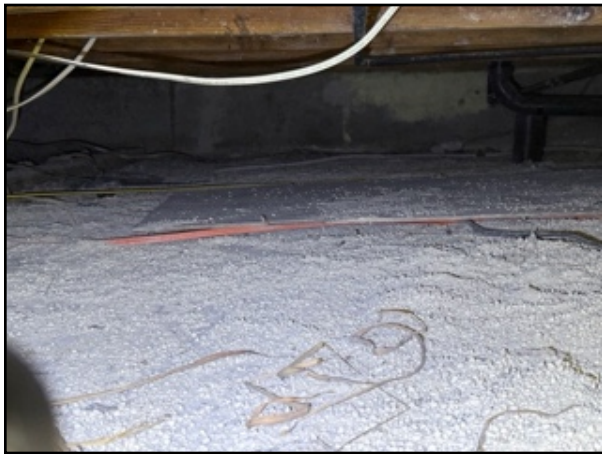
REPAIR OR REPLACE: Trash, debris and old abandoned plumbing lines noted in crawlspace. Wood support post noted as split. Various places noted as damp at time of inspection. No active plumbing leak noted at time of inspection.

Some areas of the crawl space were not inspected due to limited access.

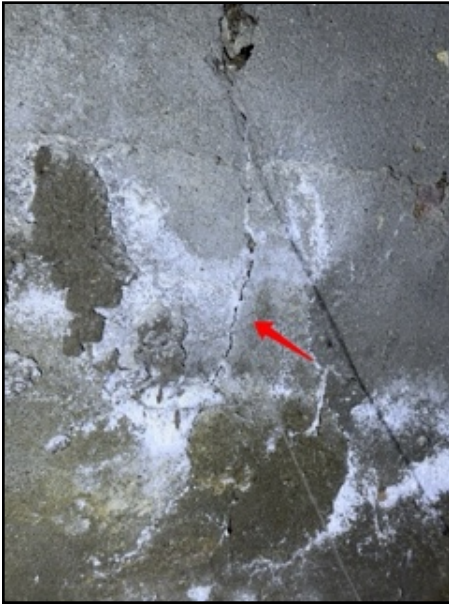
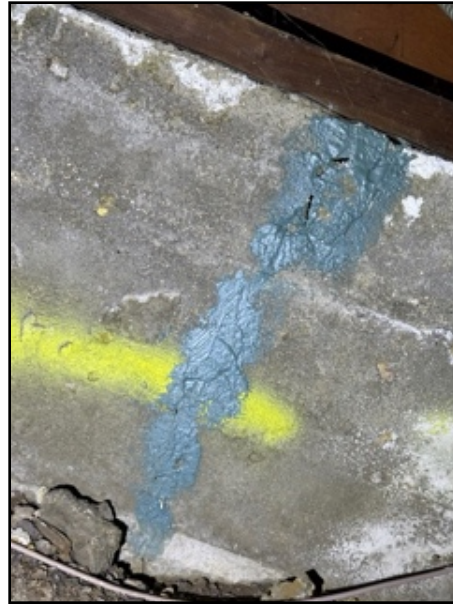
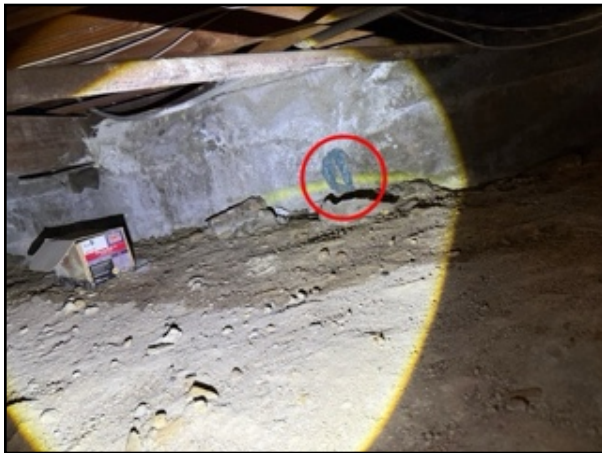
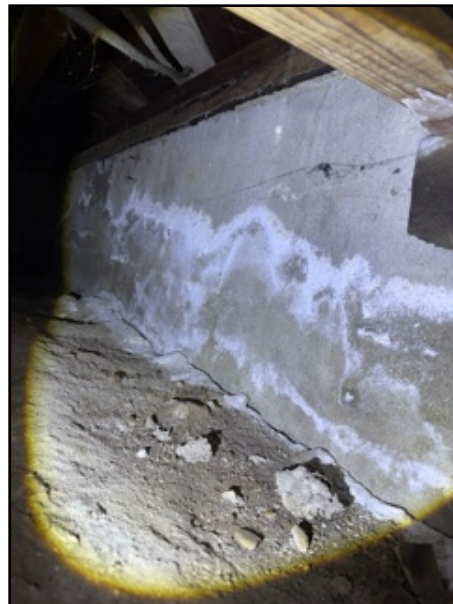
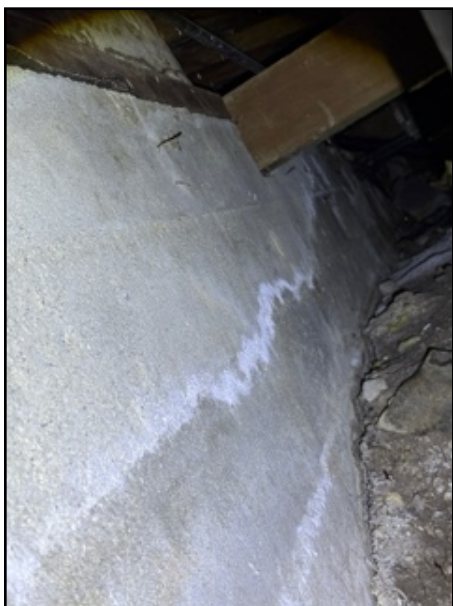
**FURTHER EVALUATION REQUIRED:** Previous repairs, efflorescence and minor cracking noted at exposed portions of foundation.

Generally, cracks less than 1/4 inch in size and with no deviation are no cause for concern. Questions about structural integrity should be evaluated by a more qualified professional (such as a licensed engineer).
