## USA Home Inspectors

## Home Inspection Report

**782 W Renette Ave**

Inspected On: Wed, Feb 25 2026 at 9:00AM

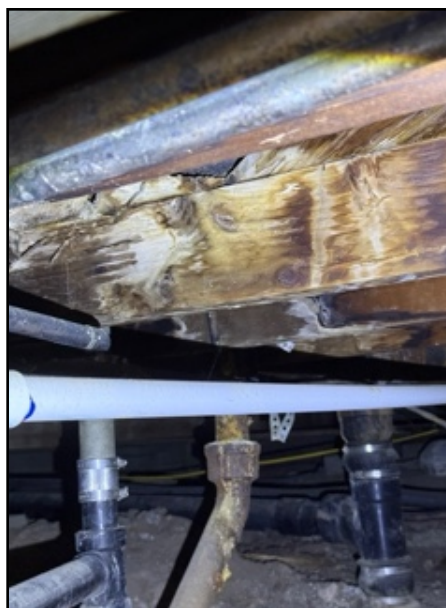
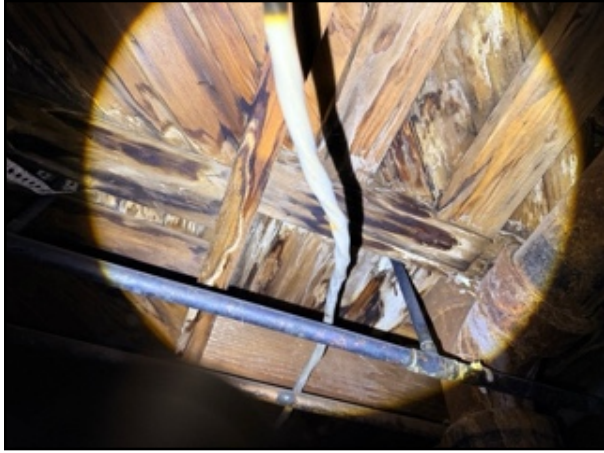
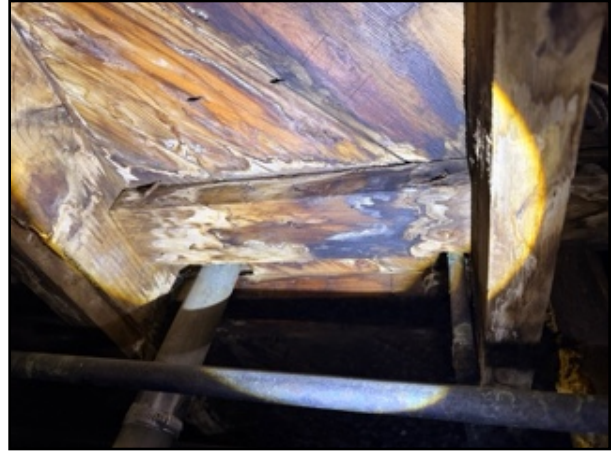
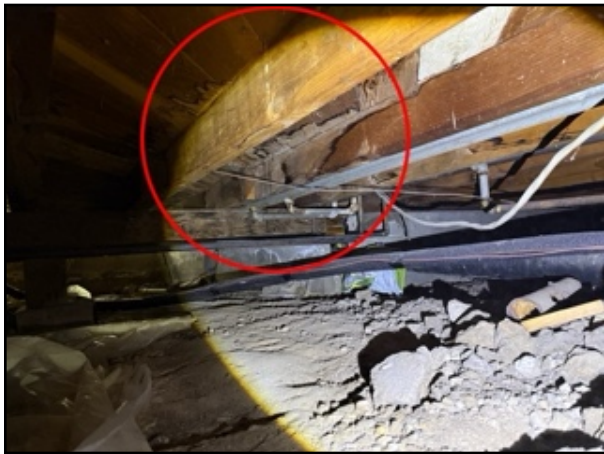
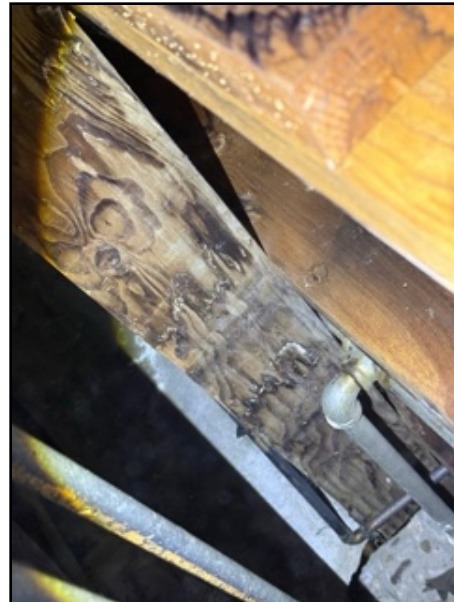
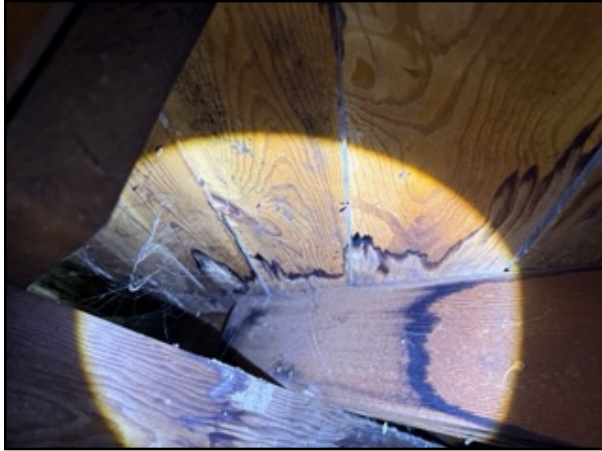
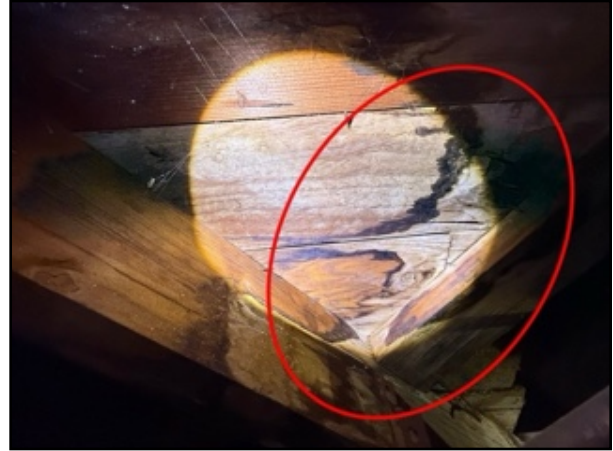
**FURTHER EVALUATION REQUIRED:** Evidence of previous water stains and wood destroying organisms/dry rot noted in various places through subfloor and floor framing.

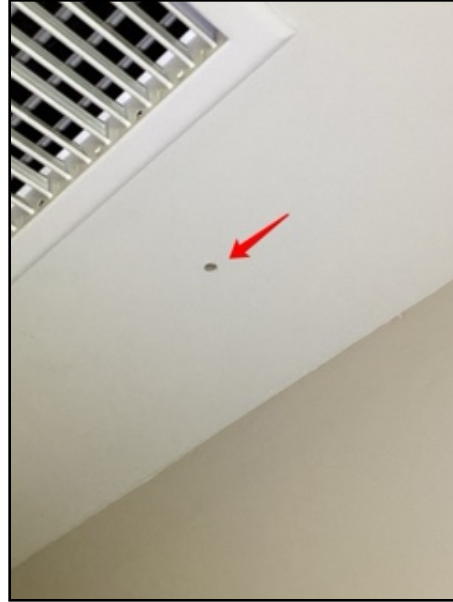
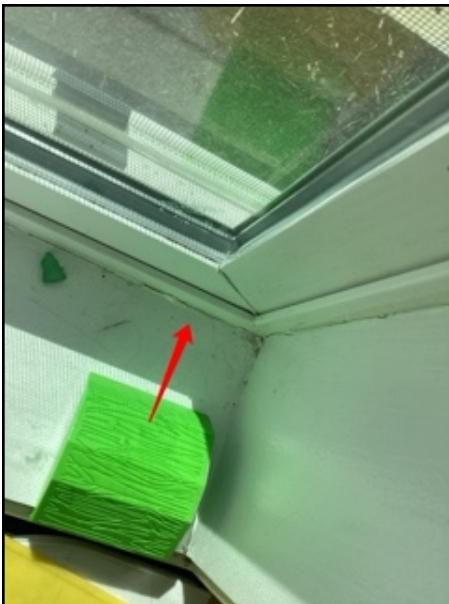
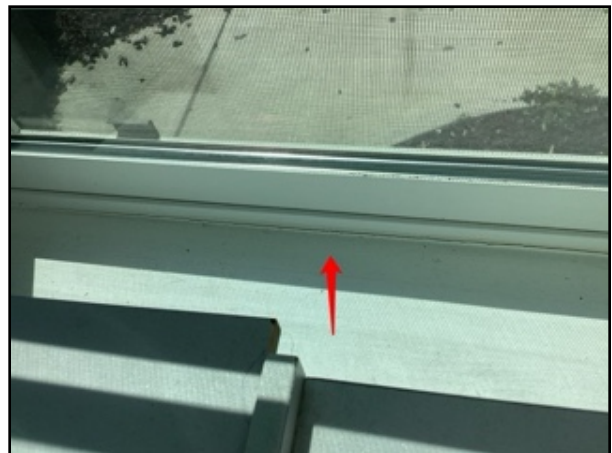
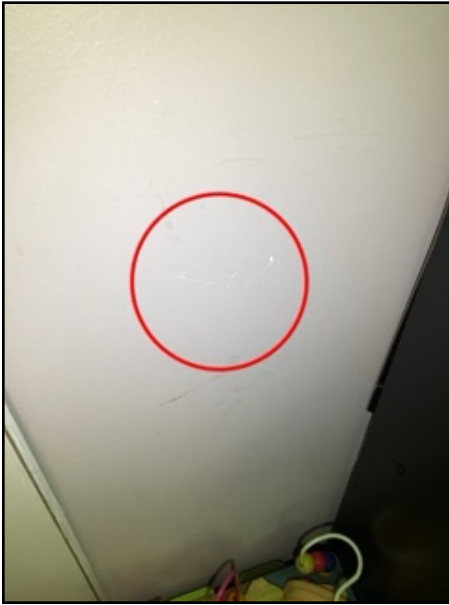
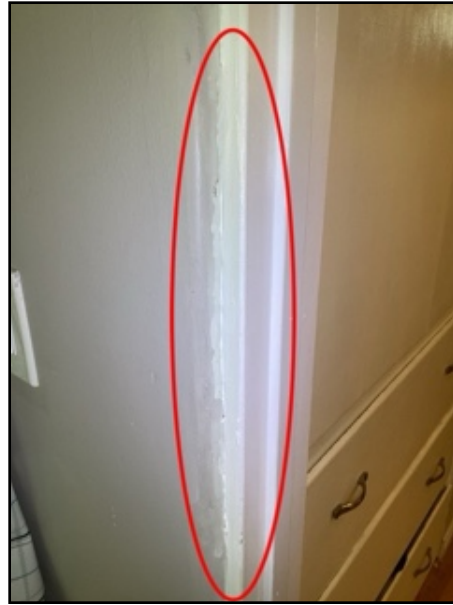
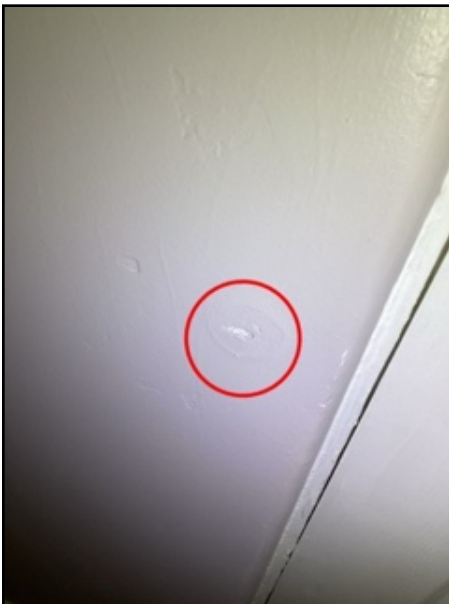
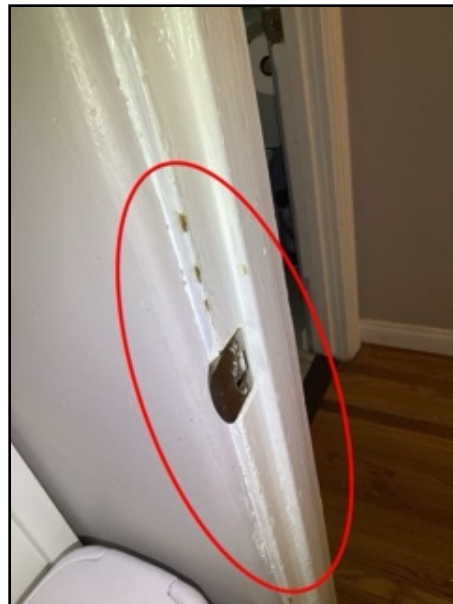
Minor paint, drywall damage, burned out bulbs, broken/missing covers and other minor cosmetic defects noted at various locations throughout the home.

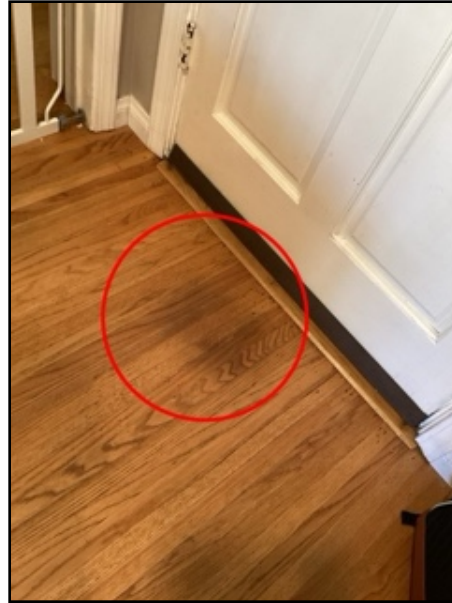
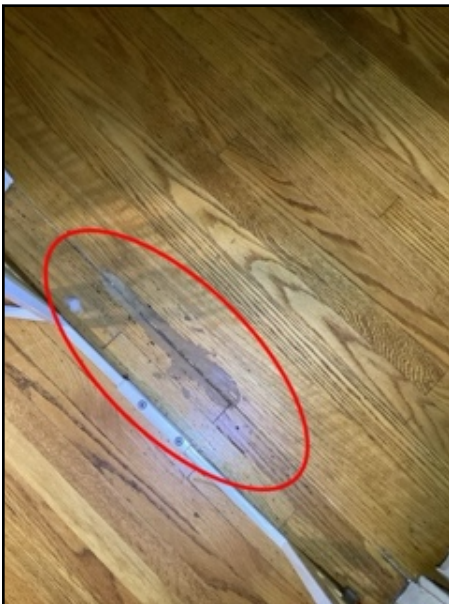
REPAIR OR REPLACE: Wood flooring noted as worn in various places throughout.
