Inspection Report

Address: 165 N 5th St Shandon, CA 93461

06/01/2026

Inspector: Taylor Vreeken, CCI

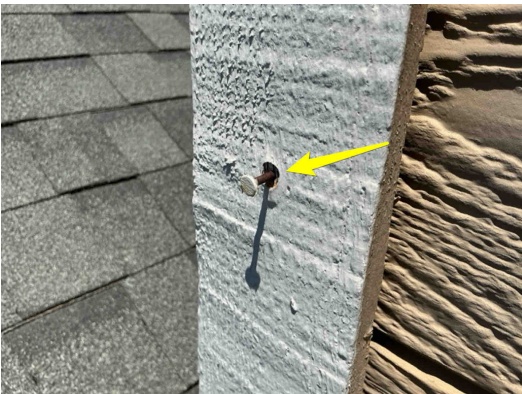
E&C MR 39: Multiple loose, unsealed, and/or damaged fasteners noted throughout the exterior. Further evaluation in corrections/ maintenance recommended.

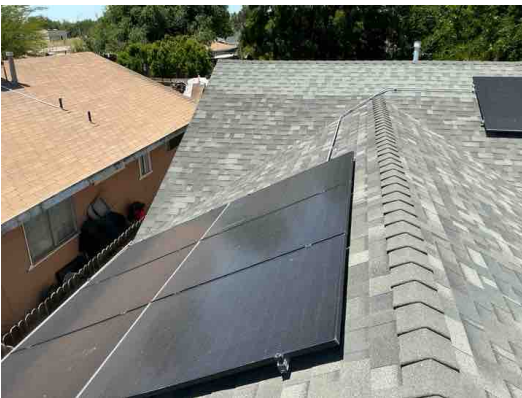
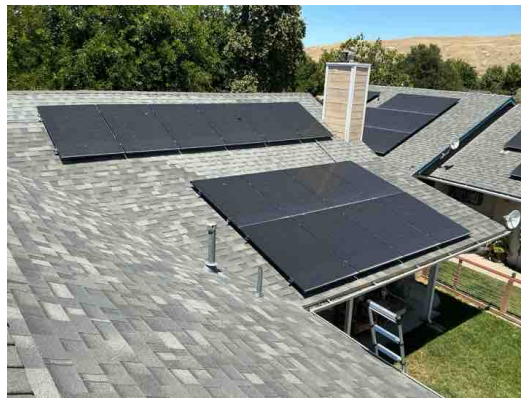
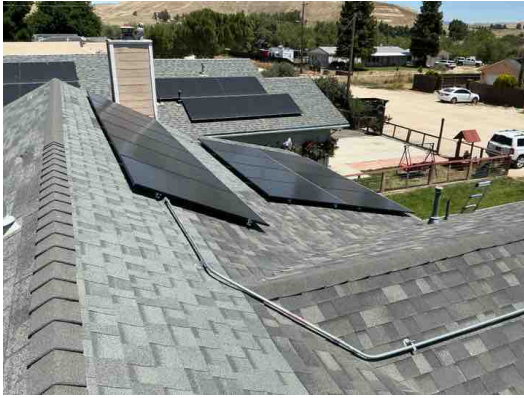
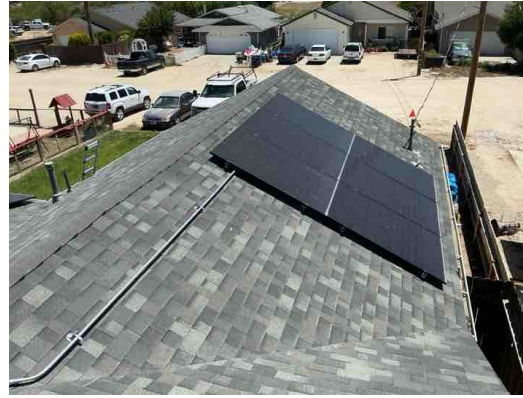
53: Gable- EAST SIDE

There is Approx. 1-3 +/- years of visible wear at areas of the roof.

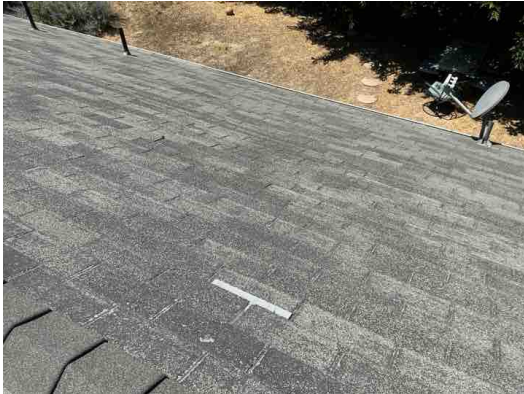
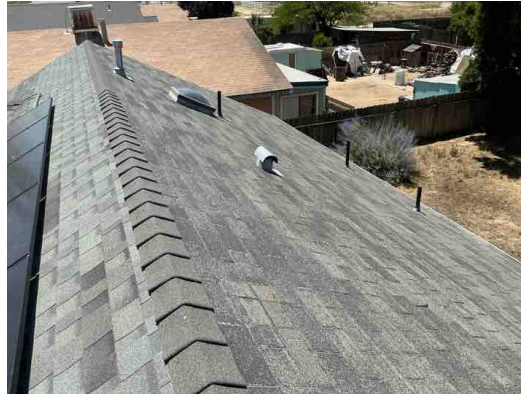
59: Gable -WEST SIDE

There is Approx. 33 +/- years of visible wear at areas of the roof.

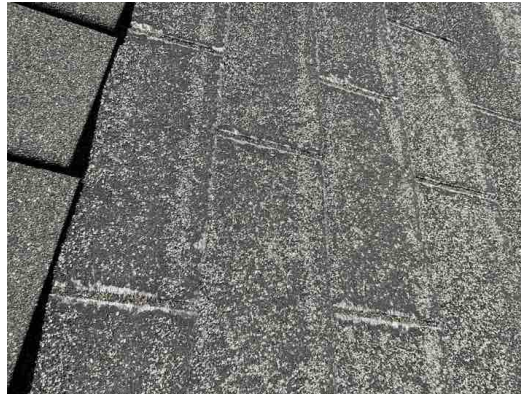
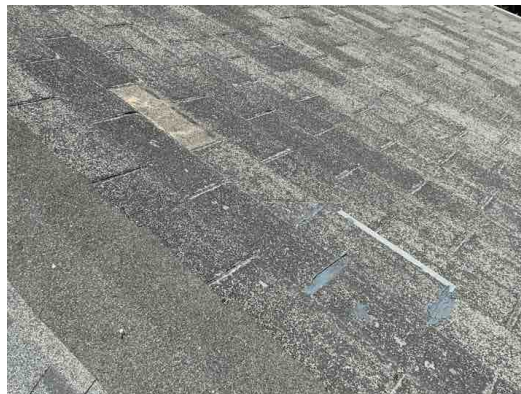
E&C DS 63: **ROOF CONDITION:** The WEST SIDE Roof is at the end of its life expectancy. Recommend contacting a licensed roofing contractor for a price / proposal for replacement.

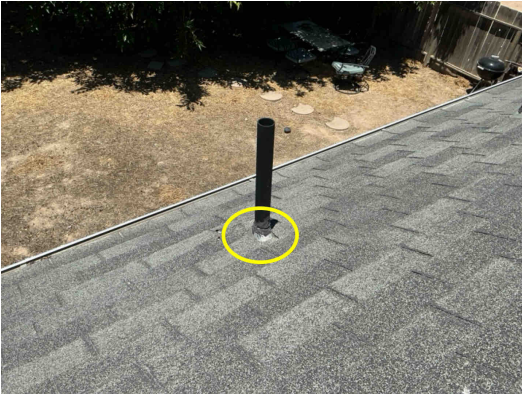
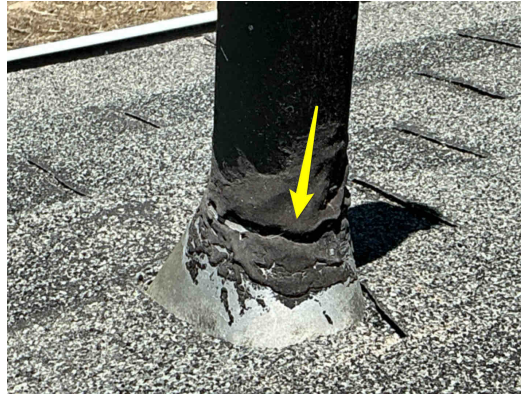
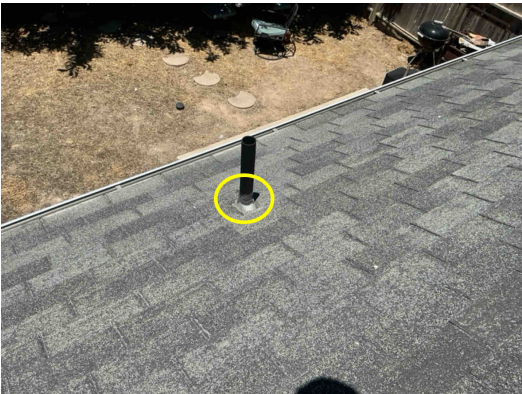
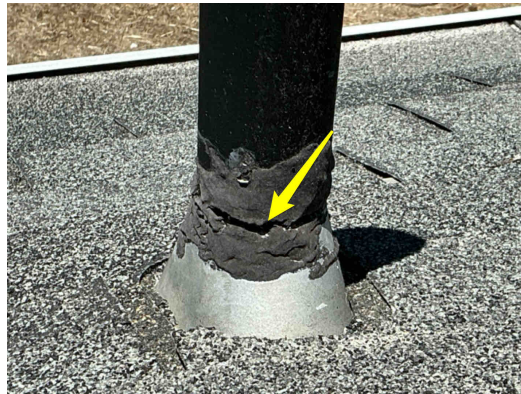
E&C MR 64: ROOF FLASHING CONDITION: Some roof flashing were found to be needing maintenance, servicing and/or repair. Contact a qualified roofing professional to review all roof flashings and provide maintenance and/or repairs as needed.

MR 65: Deteriorated sealant at some roof flashings, around the roof penetrations. Maintenance recommended to help prevent water intrusion into areas of the attic. Have roofer evaluate the roof flashings and correct as needed.

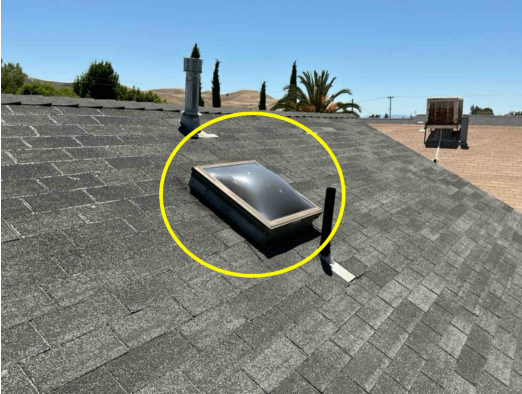
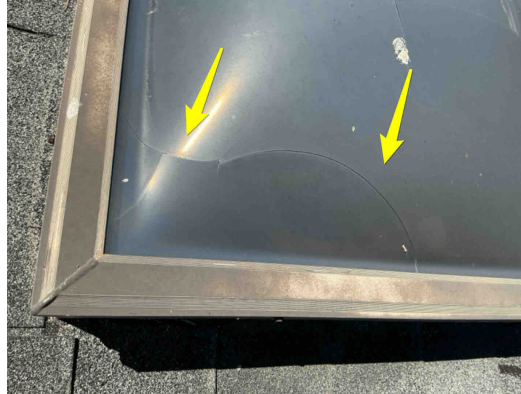
E&C 66: Some of the plastic roof skylights are cracked and damaged. Replacement is recommended. Contact a qualified roofer to evaluate and replace damaged skylights.

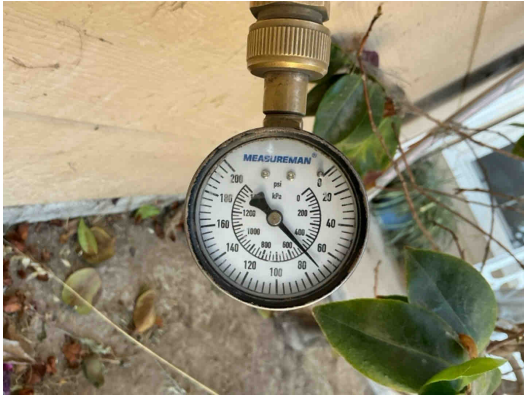
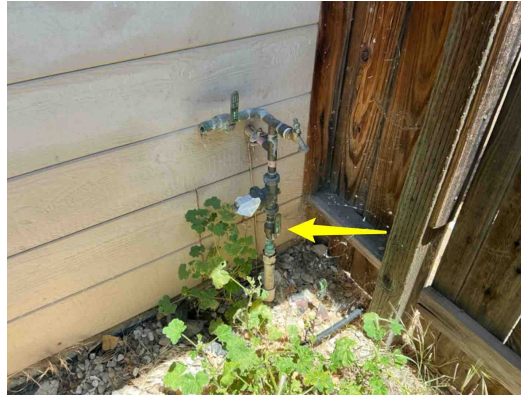
Water Pressure - *Is At Approx. 72 +/- PSI. Optimal water pressure is between 40 and 80 PSI.*

1. *Pressure Regulator Installed:* **YES**
2. *An Automatic Leak Detection Device installed on the main water supply:* **NO.**

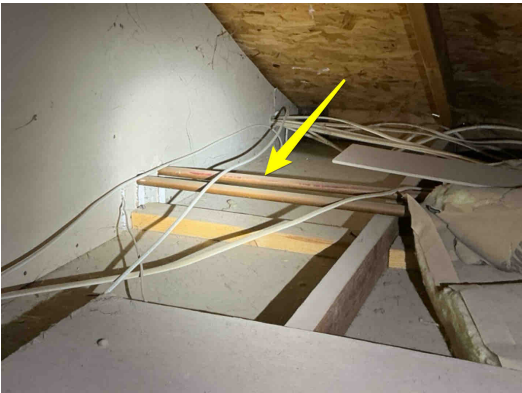
E&C 87: Some exposed plumbing pipes above the insulation, subject to freezing are not insulated in areas in the attic as required by standards. Upgrades and/or repairs recommended to help prevent freezing or breaking of pipes.

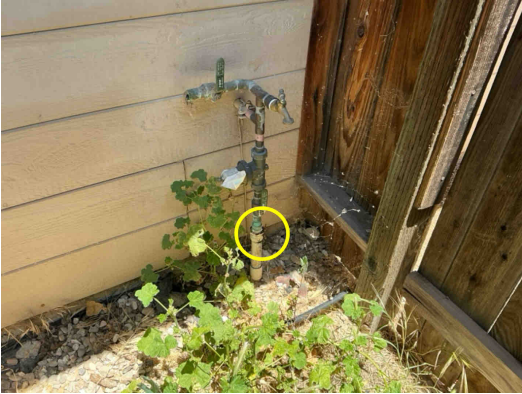
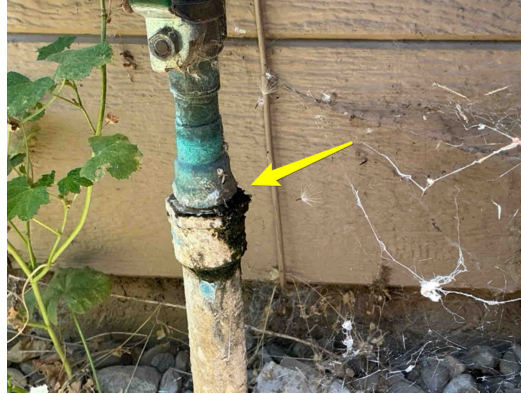
E&C 88: A small active water leak found at the SOUTH EXTERIOR OFF THE WATER MAIN SHUT OFF.
Corrections recommended.

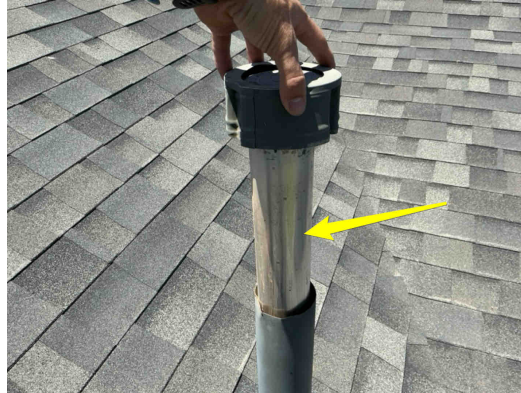
E&C 103: The water heater "B" vent double-wall type pipe found to have a damaged and disconnected interior sleeve. Contact a qualified plumbing professional to replace the damaged section of water heater and pipe for safety.

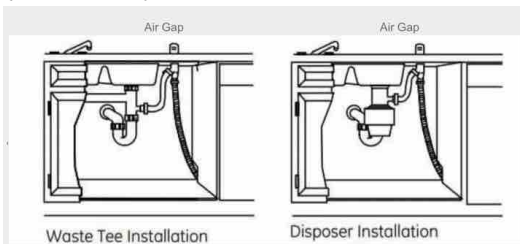
SU 115: Improper installation of the dishwasher drain hose. Missing the Air Gap Device at the dishwasher drain per minimum codes and standards (California does not allow for high-loop methods or direct waste connections). {CPC 801.2}

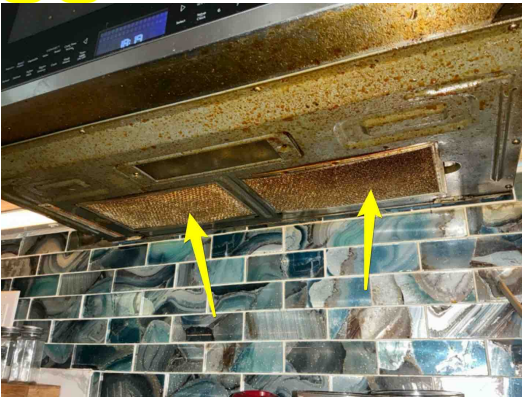
MR SU 122: Kitchen cook top exhaust hood and filter are dirty.

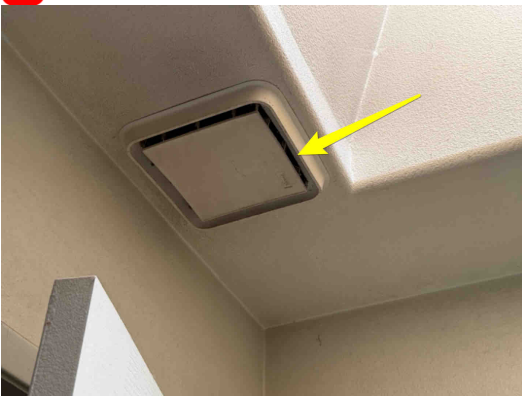
E&C 143: The bathroom exhaust fan did not operate: HALLWAY BATHROOM

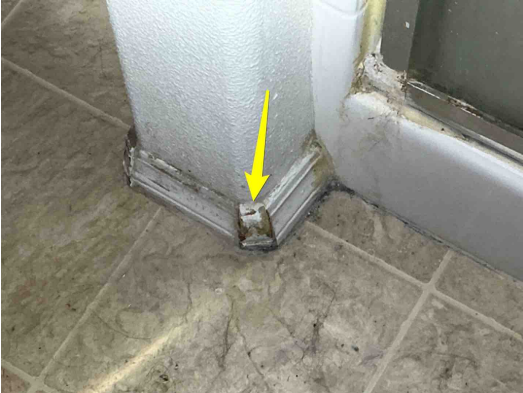
FI **146:** Moisture stains & damage to walls, baseboards and/or floor outside shower: PRIMARY BEDROOM BATHROOM

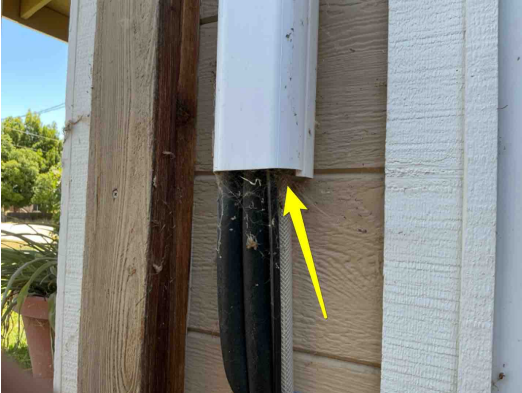
E&C 181: Recommend sealing the hole or opening through the exterior wall where the Air Conditioner's refrigeration pipes enter the building. This will help prevent rodent, bug and /or water intrusion through this area as need per standards.

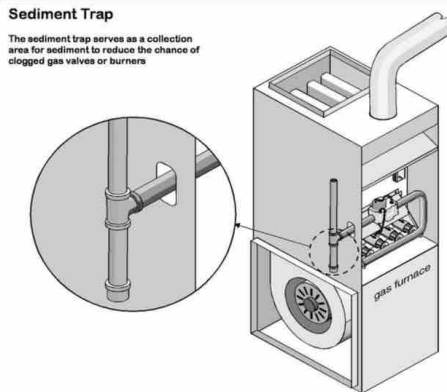
UPG 187: Missing the required installation of the sediment trap at the furnace gas piping at flex connection. Correction should be performed by a certified or licensed HVAC professional familiar with minimum requirements.

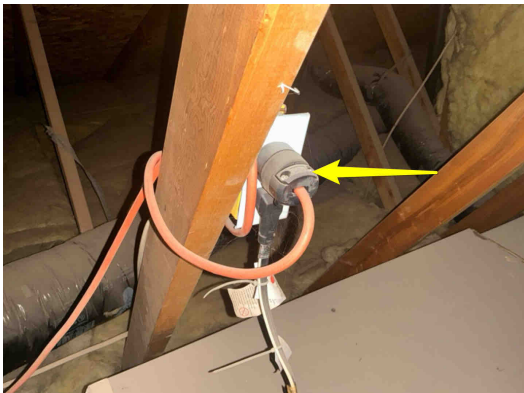
SC 200: Improper and unsafe "plug-in" style wiring - use of a cord and plug wiring as permanent wiring. Contact a qualified electrical contractor for upgrades/repairs: ATTIC FAN

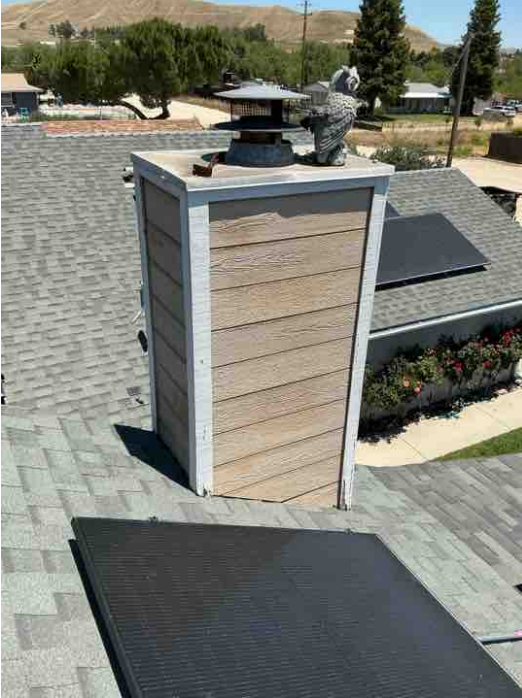
226: The LIVING ROOM fireplace chimney.

E&C 227: The spark screen found rusted, deteriorated and/or damaged atop the LIVING ROOM fireplace chimney. Recommend replacement for fire safety. Contact a qualified professional.

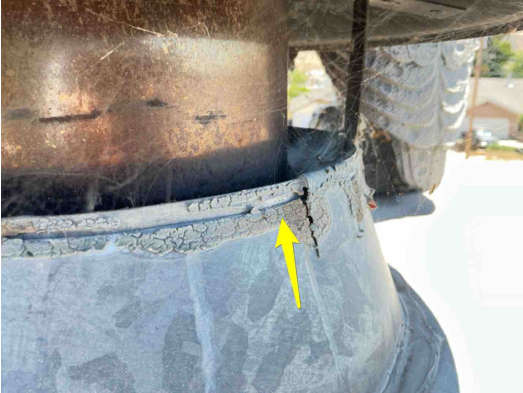
MR 228: Deteriorated sealant found around the storm collar at the LIVING ROOM fireplace chimney roof termination. Maintenance recommended to help prevent water intrusion into the wood framed fireplace chimney chase.

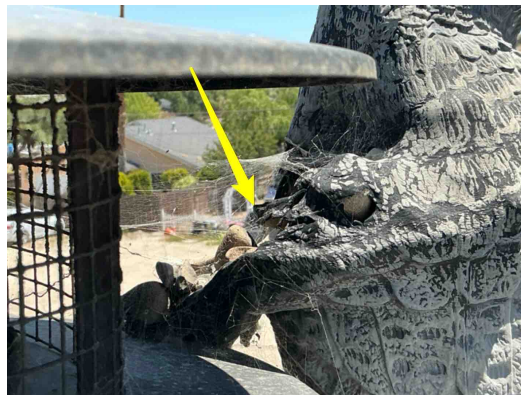
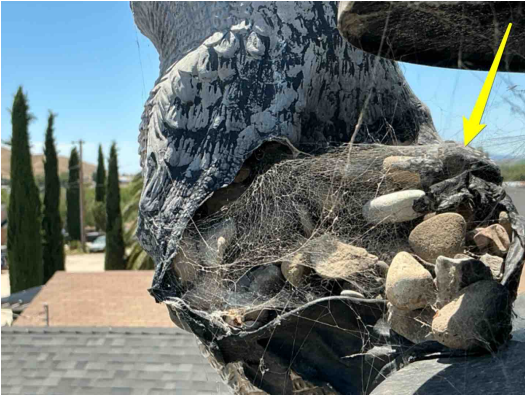
E&C SC 230: Improper installation of a plastic owl on the fireplace chimney chase near the cap as a bird deterrent device. The plastic owl is melted with evidence of a small past fire. Removal warranted for safety.
