# INSPECTION REPORT

**PROPERTY ADDRESS:**  
642 Lincolnville Avenue, Searsmont, ME 04973

| <b>Date:</b> 8/27/2026 | <b>Time:</b> 01:30 PM | <b>Report ID:</b> 2026082701 |

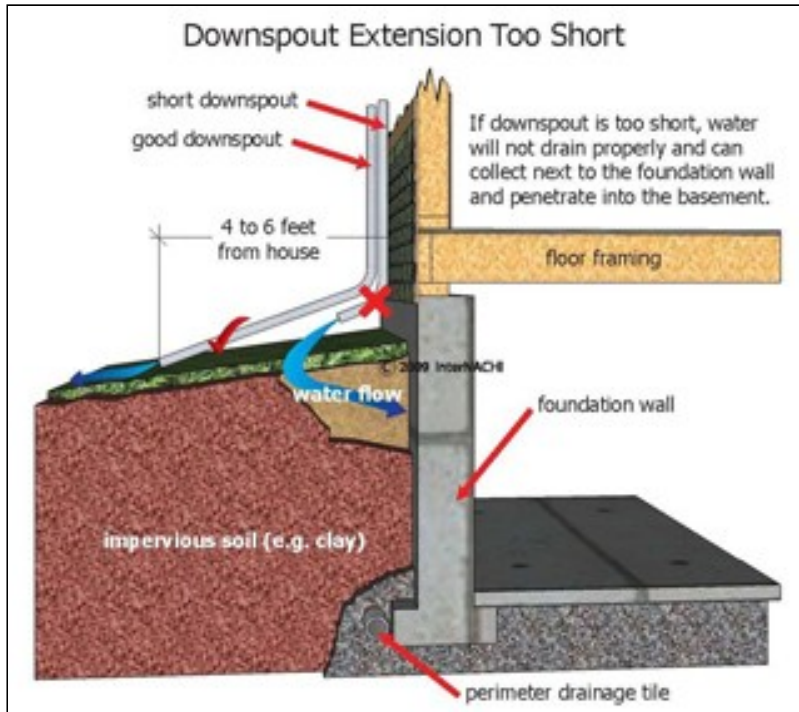
2.4 Item 9 (Picture) Illustration

(5) Downspouts were observed to be missing from one or more of the gutters. Downspouts are a critical part of the roof drainage system as they direct the water away from the structure. Inadequate downspouts can result in excessive moisture at the foundation of the structure that can cause structural deterioration. Repairs should be effected.
