HOME INSPECTION REPORT

771 W. 91st Street, Los Angeles

670819

February 7, 2026

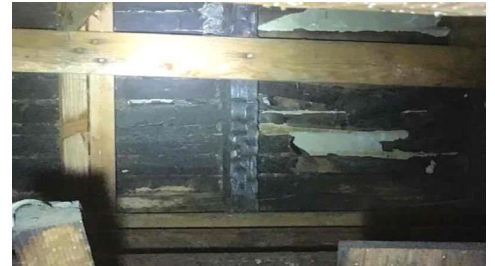
Photo 69

- ! 2. There are conditions indicating a past building fire in the attic. The owner or the local building department may have further information on the cause and extent of the fire, any repairs performed, and the status of permits involved in such work. If further information is desired the appropriate tradesperson should be contacted. (See Photo 69) (See Photo 68)

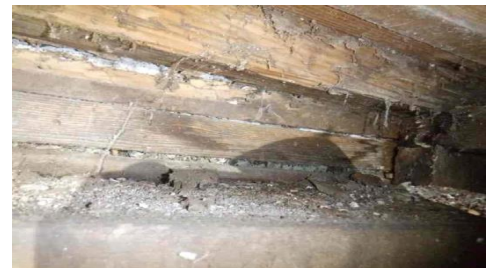
Photo 73

- ! 3. The wood members at the front right side of the crawlspace show evidence of damage. We recommend the services of a licensed structural pest control operator for investigation of this condition. (See Photo 73)

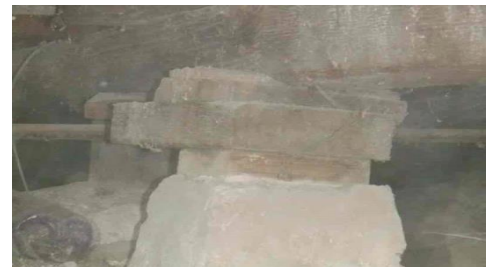
Photo 76

- ! 4. One or more piers and post at the crawlspace are marginally connected and/or shimmed. We recommend repair or replacement, in accordance with present standards. It is recommended that a qualified licensed contractor be consulted for further advice on structural improvements. (See Photo 76) (See Photo 75)

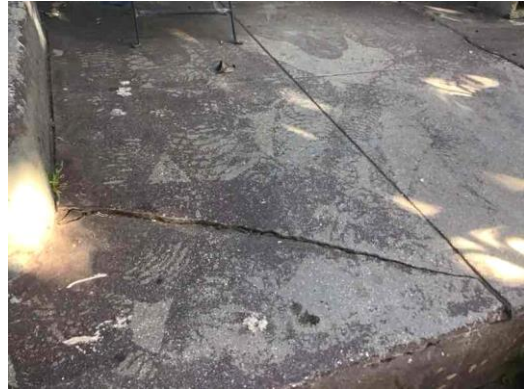
Photo 02

- 13. The cracked, heaved, or uneven walkway sections at the exterior pose a potential trip hazard. We recommend corrective action to improve safety and reduce the risk of injury. A qualified contractor should assess the affected areas and perform necessary repairs to ensure a level walking surface. (See Photo 11) (See Photo 2)

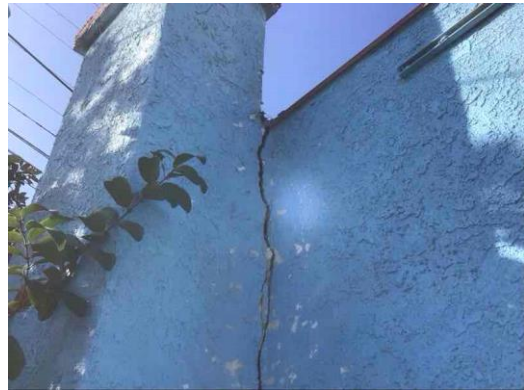
Photo 12

8. There is a large crack at the chimney. This condition may indicate movement of the chimney. It is impossible to determine the rate of movement during a one time visit to the property. We recommend the advice of a licensed masonry contractor. (See Photo 12)

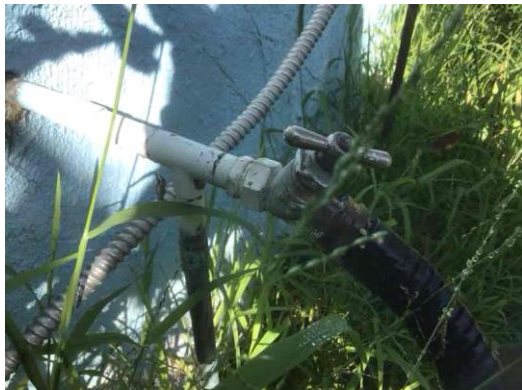
Photo 13

41. The exterior hose bib at the right side is leaking. We recommend all leaks be repaired. (See Photo 13)

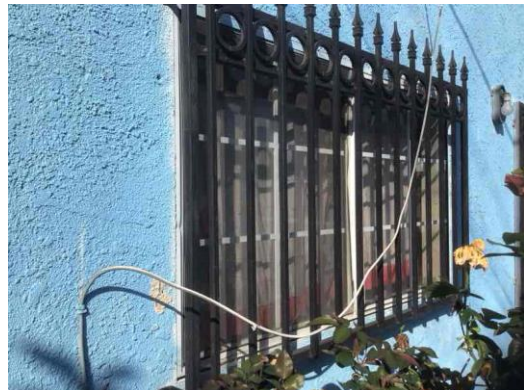
Photo 14

- 12. There are metal bars on one or more of the windows which do not all open from the inside. This is a significant safety hazard. We recommend that all window bars be removed or modified so they can be opened from the interior in case of an emergency. (See Photo 14)

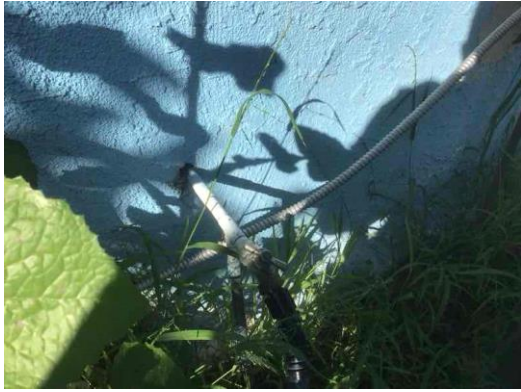
Photo 15

32. Loose, sagging or unsecured conduit at the right side and crawlspace should be properly re-secured or strapped. (See Photo 15) (See Photo 79)

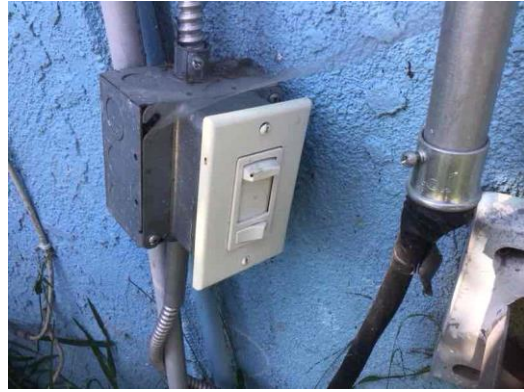
Photo 16

33. An exterior switch at the right side is missing a water proof cover plate. We recommend an exterior approved cover be installed. (See Photo 16)

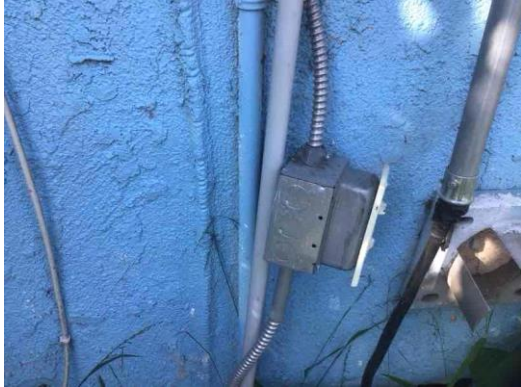
Photo 17

34. One or more electrical outlets or junction boxes at the right side were noted to be loose or unsecured. We recommend all loose or unsecured junction boxes be repaired. (See Photo 17)

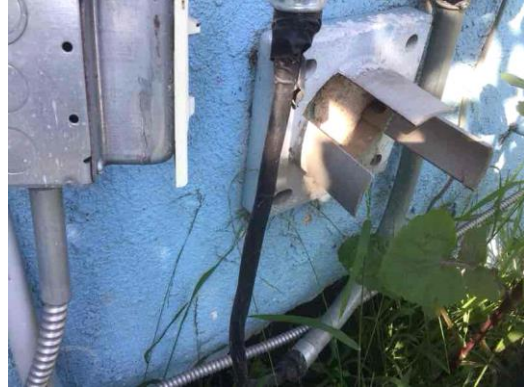
Photo 18

31. We found exposed wiring at the right side and rear. Even if insulated, we recommend all wiring be encased in conduit or otherwise protected in accordance with present standards. (See Photo 18)

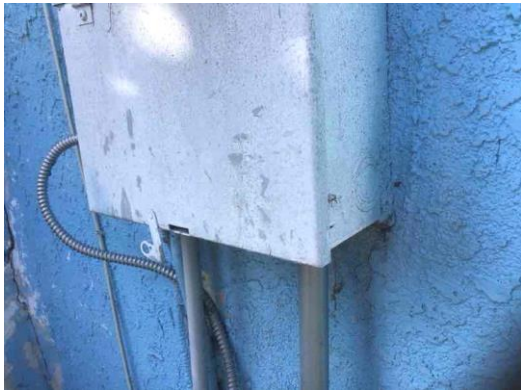
Photo 19

35. The main electric panel weatherproof cover plate latch is loose, damaged or missing. We recommend it be repaired or replaced. (See Photo 19)

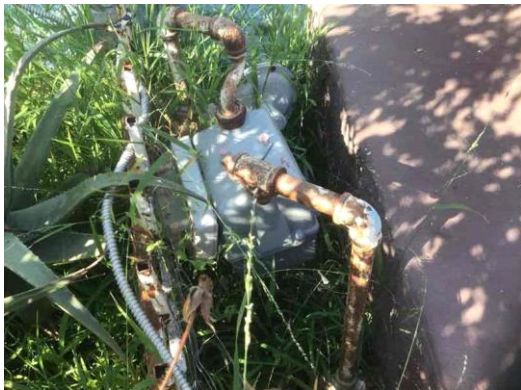
Photo 21

43. There is evidence of corrosion and rust on the exterior of the exposed and accessible metal gas supply piping at the main meter. This section of piping should be protected and/or replaced as necessary. (See Photo 21)

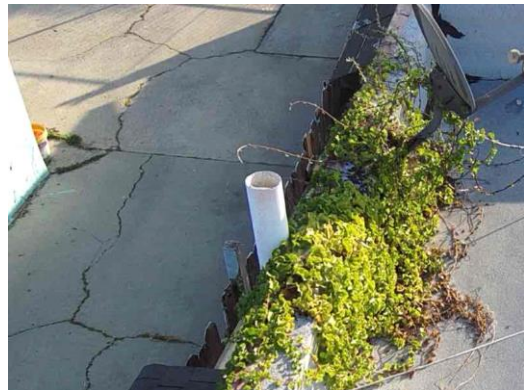
Photo 22

- 9. All missing roof plumbing or appliance vent caps should be replaced. (See Photo 22)

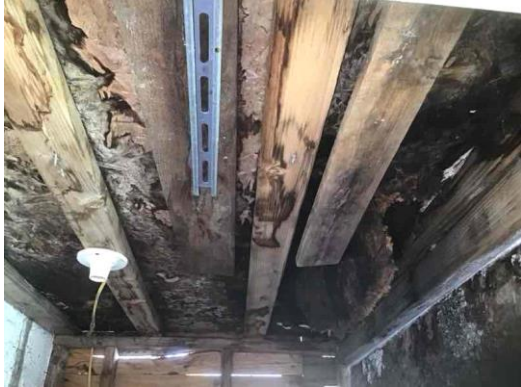
Photo 25

- 11. Evidence of water damage was noted at the rear patio cover. Consult a licensed structural pest control company regarding necessary repairs. (See Photo 25)

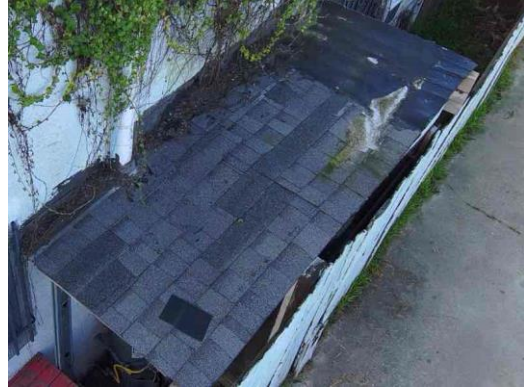
Photo 26

22. The patio cover roofing is damaged or in need of repairs. Damaged or missing roofing material should be repaired or replaced as necessary. (See Photo 26)

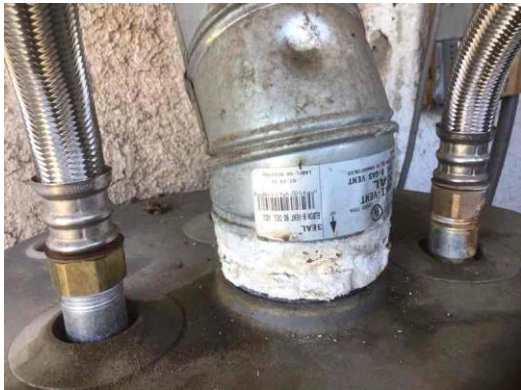
Photo 27

40. For enhanced safety, it is recommended that the loose or damaged connections of the water heater venting system be improved. A minimum of 3 screws at each section of the duct is recommended. (See Illustration 8M) (See Photo 27)

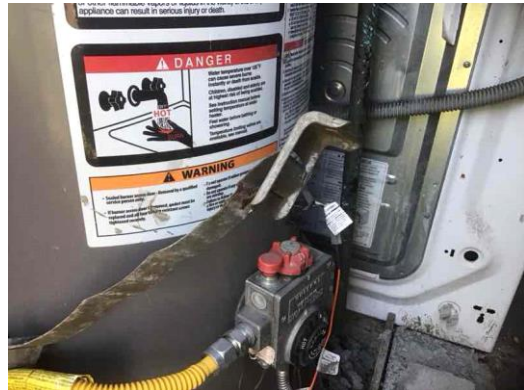
Photo 28

37. The water heater seismic straps are loose or disconnected, this will allow movement of the tank in an earthquake. We recommend tightening the straps and/or adding bracing between the tank and wall to improve safety. (See Photo 28)

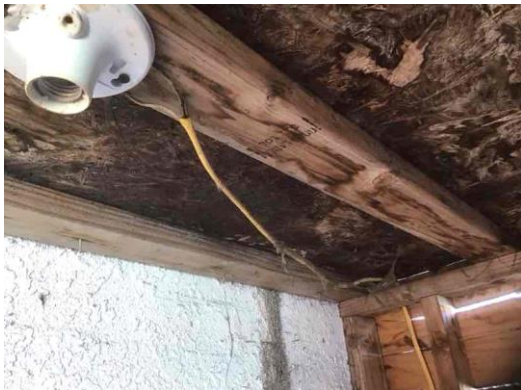
Photo 29

25. The installation of the distribution wiring at the rear is non-standard. It is suspected that installation was performed by someone other than a licensed electrician. We recommend the services of a licensed electrician. (See Photo 29)

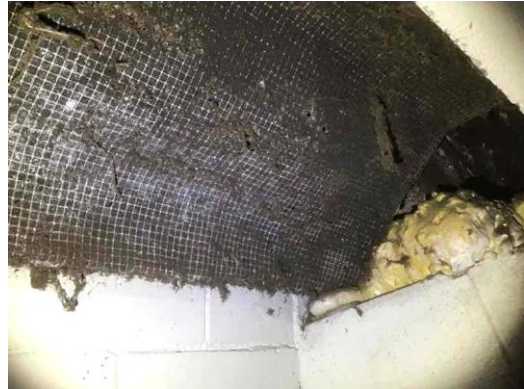
Photo 42

- ! 3. There does not appear to be a damper in the fireplace. We recommend the installation of a damper. (See Photo 42)
4. The trim at various areas shows evidence of cosmetic damage. Repairs are considered optional. (See Photo 46)

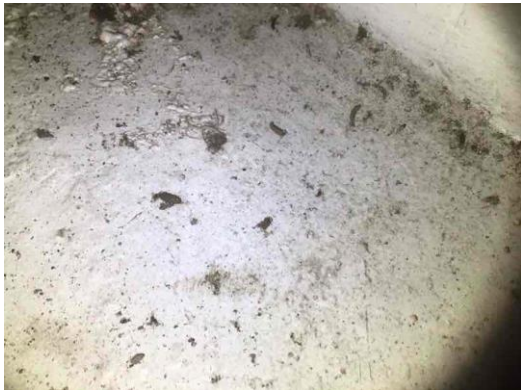
Photo 43

- ! 6. Evidence of vermin activity was observed within the structure. It is likely this evidence will extend into inaccessible areas. The owner is advised to contact the appropriate trade for further evaluation and remedial measures if necessary. (See Photo 43)

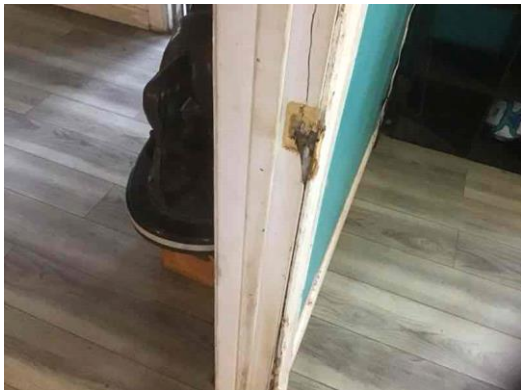
Photo 45

- ! 7. The door frame (jambs and/or trim) is cracked, split or damaged at the front left bedroom. We recommend all damaged door framing be repaired or replaced. (See Photo 45)

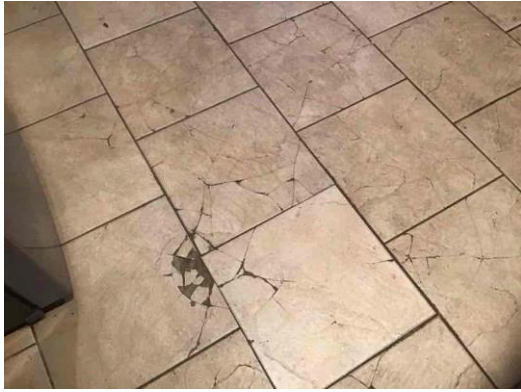
Photo 47

- ! 27. Cracked floor tile in the kitchen and hall bathroom should be replaced. Water leaking through non-sealed areas can cause damage. Damage caused by water seepage cannot be determined by this visual inspection. (See Photo 47)

- 46. The basin countertop or cabinet in the hall bathroom is loose or disconnected. It should be properly secured and caulked. (See Photo 57)
- ! 47. Cracked floor tile in the kitchen and hall bathroom should be replaced. Water leaking through non-sealed areas can cause damage. Damage caused by water seepage cannot be determined by this visual inspection. (See Photo 47)

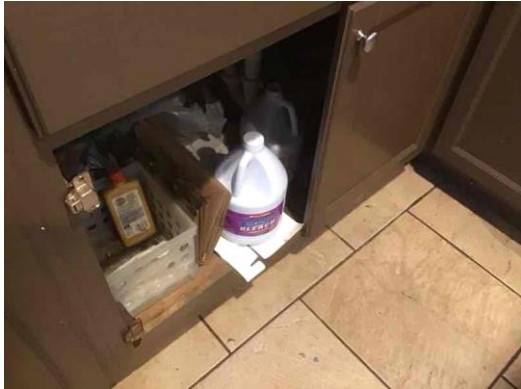
Photo 49

28. One or more of the kitchen cabinet door and/or drawers are missing. We recommend any missing doors or drawers be replaced. (See Photo 49)
 29. The kitchen countertop shows evidence of wear.

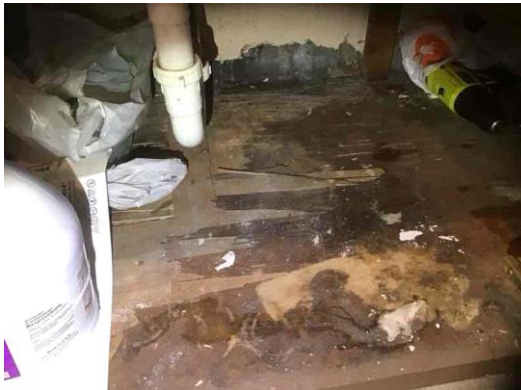
Photo 51

- ! 26. The base and/or side of the kitchen cabinet sink shelf is water damaged. We recommend the services of a licensed structural pest control operator for investigation of this condition. (See Photo 51)

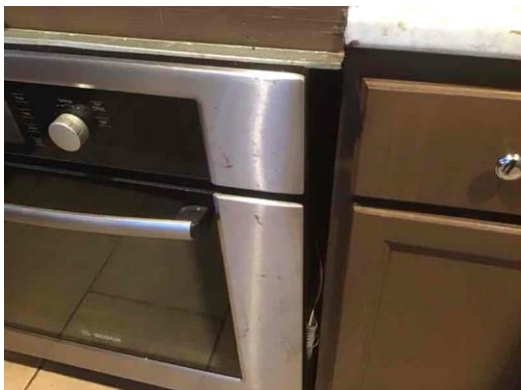
Photo 53

2. The oven is not properly secured to the cabinet. We recommend it be attached according to the manufacture's installation instructions. (See Photo 53)

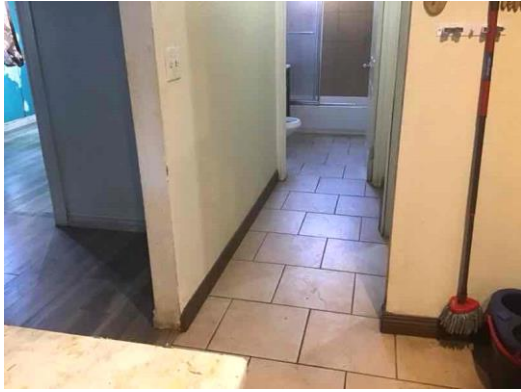
Photo 55

- ! 5. California law requires that all homes have a State Fire Marshall approved Carbon Monoxide Detector be installed outside of the sleeping areas in the hallway and on each level of the home including basements. At the time of this inspection a Carbon Monoxide Detector could not be located. We recommend consulting with the owner to see if a Carbon Monoxide Detector exists and if not they should be installed in all required locations. (See Photo 55)

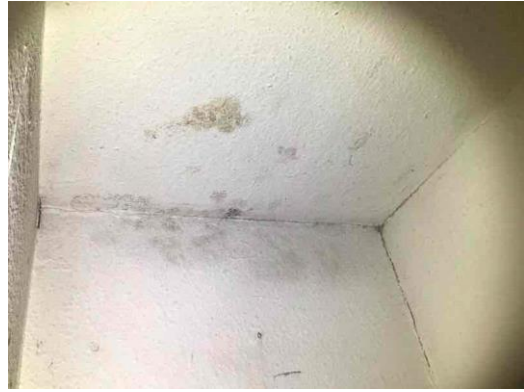
Photo 56

- ! 40. The ceiling at the rear left bedroom closet and hall bathroom shows evidence of water stains and/or damage. We recommend the services of a licensed structural pest control company for investigation of this area. (See Photo 56) (See Photo 67)
- ! 41. The wall at the hall bathroom shows evidence of water damage. We recommend the services of a licensed structural pest control company for investigation. (See Photo 60)
- ! 42. The faucet handles at the hall bathroom are damaged or missing. We recommend the handles be repaired or replaced for full use of the faucet. (See Photo 64)
- ! 43. The wall at the hall bathroom is damaged. We recommend it be repaired. (See Photo 65)
- ! 44. The tub in the hall bathroom shows evidence of wear and/or chipping. It may be desirable to refinish or repair it for cosmetic considerations and/or prolong the life of the tub. (See Photo 63)

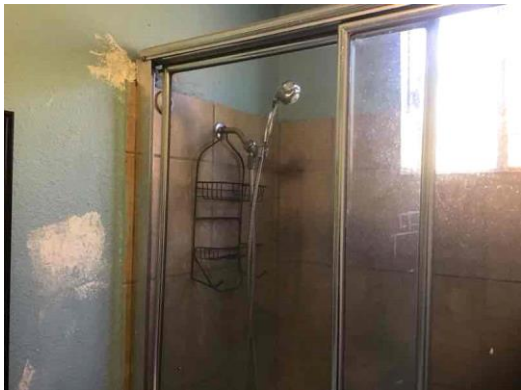
Photo 61

- ! 48. The tub/shower door in the hall bathroom is not installed or adjusted properly. We recommend it be properly reinstalled and/or adjusted to function properly. (See Photo 61)

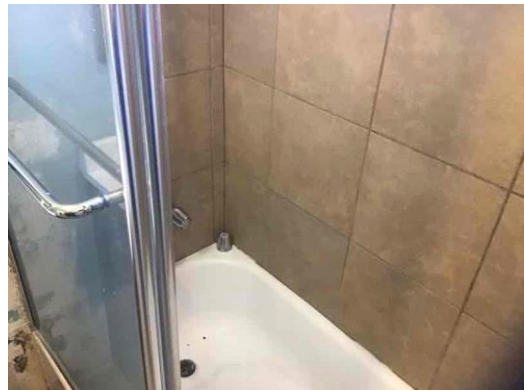
Photo 62

- ! 45. Cracked, deteriorated and/or missing grout and caulk in the hall bathroom shower should be replaced. Water leaking through non-sealed areas can cause damage. Damage caused by water seepage cannot be determined by this visual observation. A flexible caulking material is recommended rather than rigid cementitious grout. (See Photo 62)

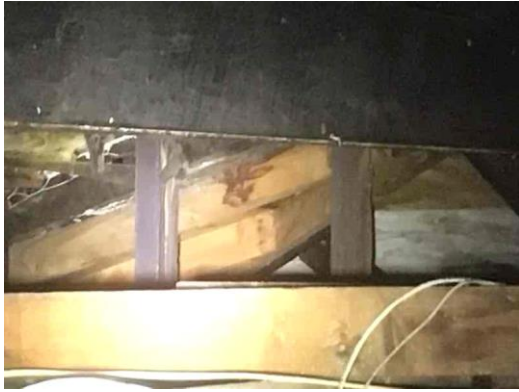
Photo 71

6. The plastic piping installed in the crawlspace has inadequate support. We recommend the pipe be supported as per industry standards. (See Photo 77)
- ! 7. Water stains were evident in the attic. This could indicate leakage through the roof covering. We recommend the services of a licensed roofing contractor to further evaluate this condition. (See Photo 71)

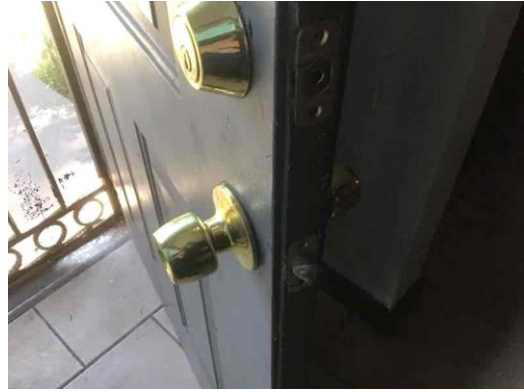
Photo 72

20. Loose and/or damaged hardware was noted at the rear right side door. We recommend that hinges, knobs, latches and strike plates be adjusted or replaced to restore full operation. (See Photo 72)

- ! 11. Loose and/or damaged hardware was noted at the rear right side door. We recommend that hinges, knobs, latches and strike plates be adjusted or replaced to restore full operation. (See Photo 72)

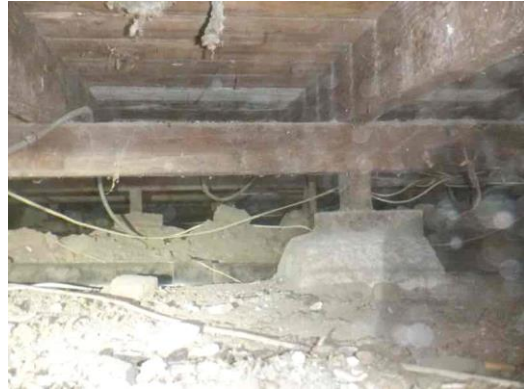
Photo 74

Due to the lack of clearance between the ground and ducting, plumbing, and/or floor joist/girders, the rear section of the crawl space was not inspected. With access and an opportunity for a complete inspection, conditions in need of attention may be discovered. We recommend further inspection when a minimum of 16 inches between the ground and any obstructions is provided. (See Photo 74)

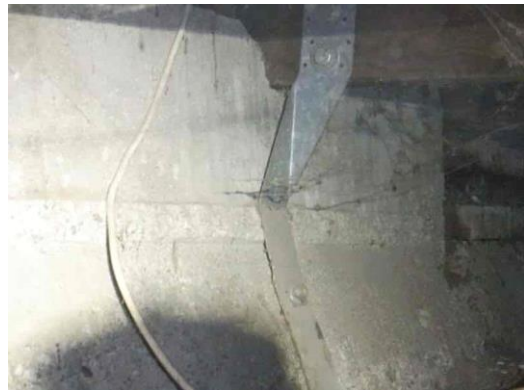
Photo 78

The sill appeared to be adequately secured (anchor bolts or straps) to the foundation, unless noted otherwise. Evidence of past repairs and/or modifications have been made to the foundation. The owner may have information about the repairs or remodeling work, and any permits that were required, obtained and completed. (See Photo 78)

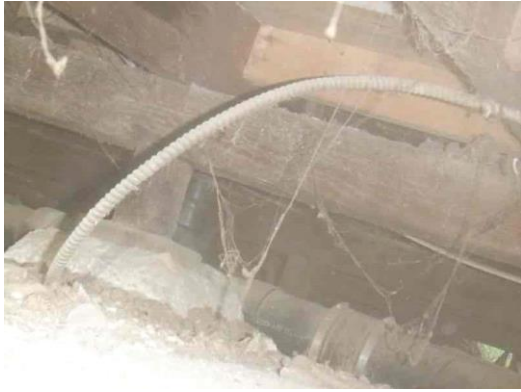
Photo 79

- ! 4. Loose, sagging or unsecured conduit at the right side and crawlspace should be properly re-secured or strapped. (See Photo 15) (See Photo 79)
- ! 5. An exterior switch at the right side is missing a water proof cover plate. We recommend an exterior approved cover be installed. (See Photo 16)
