REAL ESTATE INSPECTION REPORT

LARocca
INSPECTIONS

3540 N Knoll Dr, Los Angeles, CA 90068

DATE OF INSPECTION: Friday, September 12, 2025

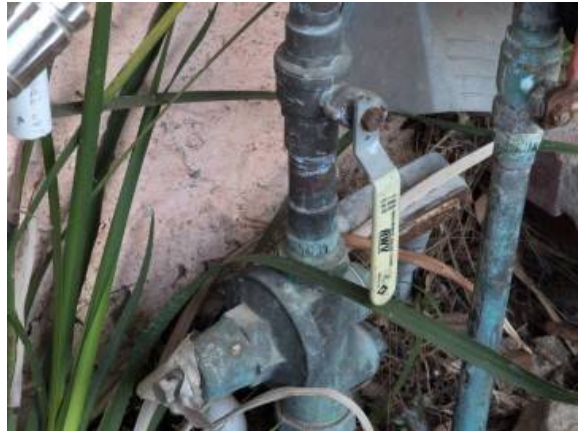
SHUT OFF VALVE CONDITION

During a general visual inspection valves are not operated or tested for correct operation, due to the potential of failure. Their operating condition is not determined. If more information is desired it is recommended to consult with a qualified plumber.

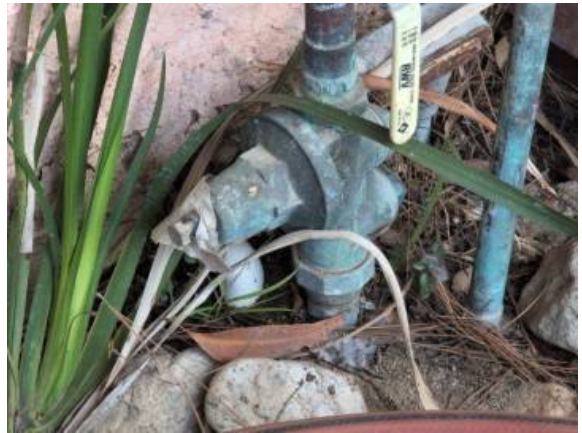
PRESSURE REGULATOR CONDITION

This device is sealed and its function and condition are not evaluated. Further evaluation by a qualified plumber would be needed to determine its operating condition.

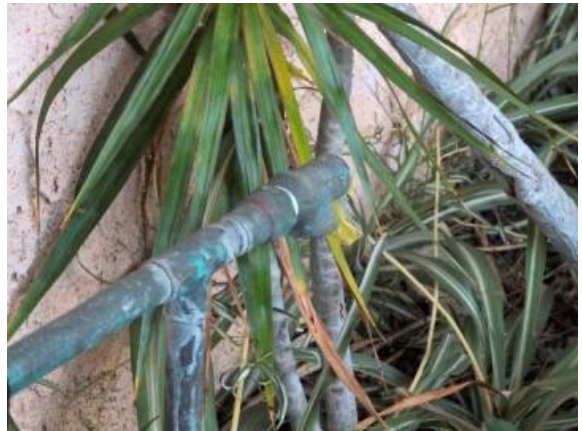
PRESSURE RELIEF VALVE CONDITION

PRESENT. A safety pressure relief valve is required to reduce the risk of pipes bursting and potential flooding of the building. This valve is not tested or operated as part of a general visual inspection. Ideally, this valve would be tested by a qualified plumber.

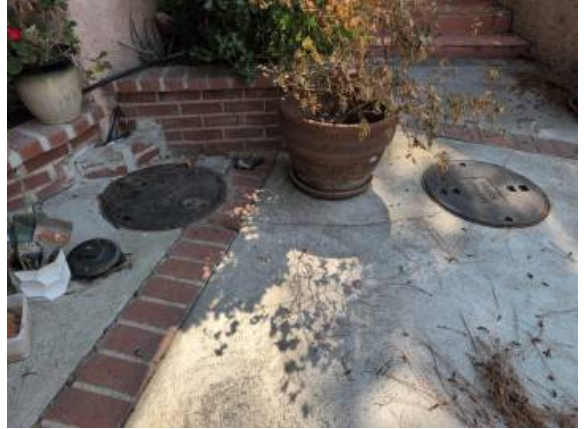
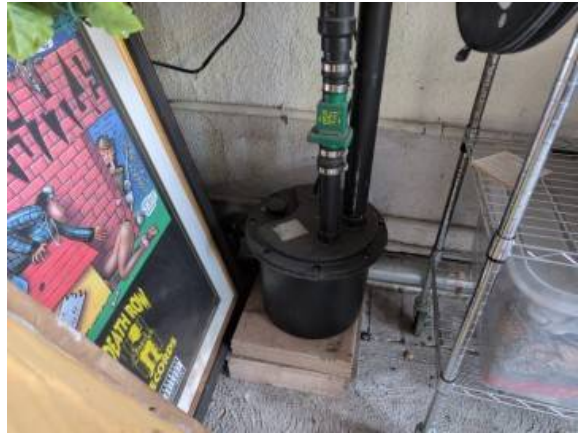
ADDITIONAL WASTE LINE INFORMATION

The property may be on a septic system. This type of system is beyond the scope of this inspection. It is advised to have a specialist in this field examine and certify the system.

EVALUATION/REPAIR. Repairs and/or further evaluation are needed to the waste line system at this time.

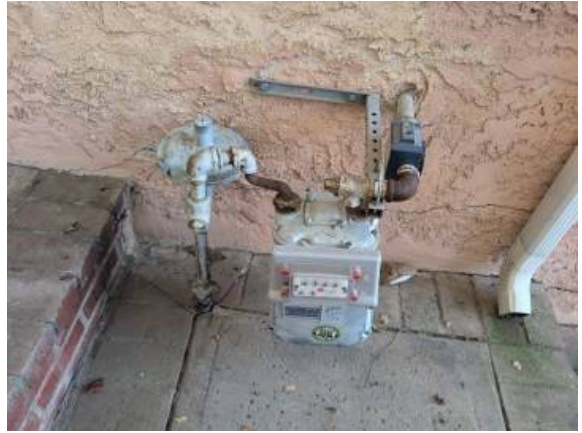
The gas meter is located on the left side of the building.

During a general visual inspection the main gas valve is not operated or tested for correct operation, due to the potential of failure. Additionally, the adequacy of the meter for this property is not evaluated as part of a general visual inspection. If there is a concern consult with your gas provider for more information.

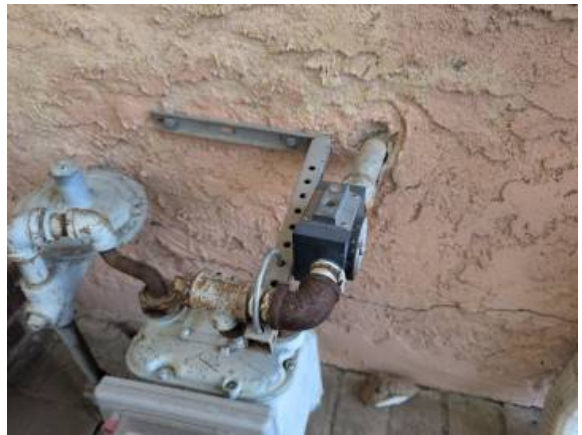
SEISMIC GAS SHUT OFF VALVE

PRESENT: There is a seismic safety shut off valve present. This valve is not tested or operated and is not verified for correct installation. It is only noted as being in place. For information, as desired or required, it is advised to consult a qualified plumbing contractor or the gas company for more information.

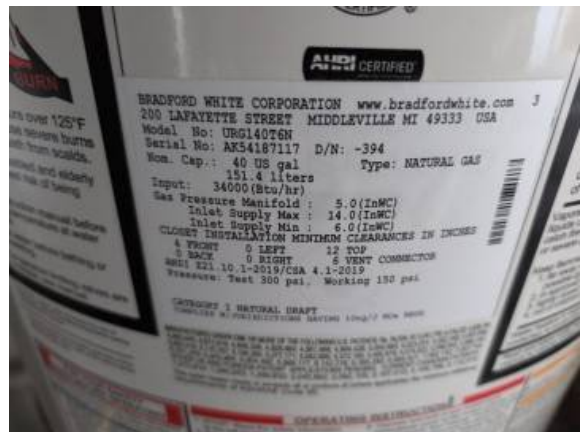
AGE

It is indicated that the water heater has been installed within the last year. Water heaters have an average life span of 8 - 12 years.

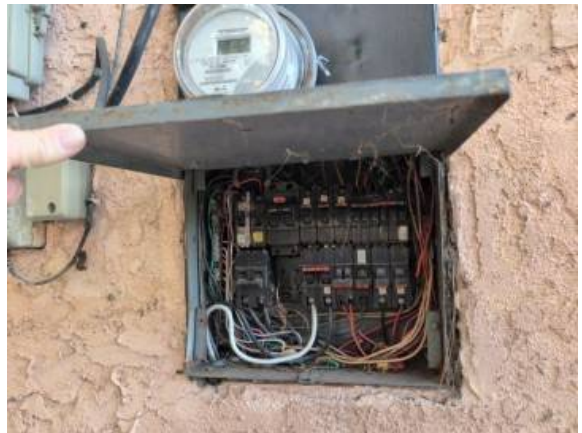
MAIN PANEL LOCATION

The main electrical panel is located on the left exterior side of the building, near the front.

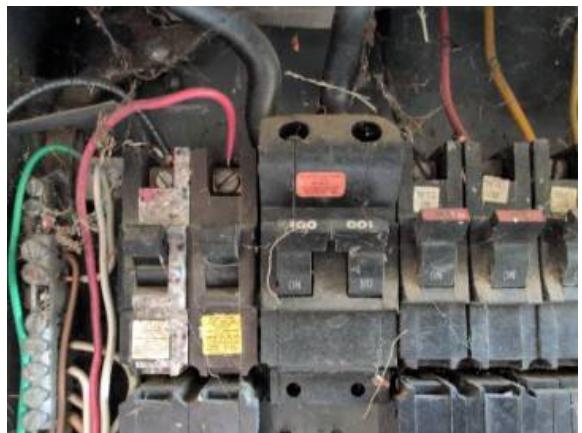
MAIN PANEL AMPERAGE

Service Amperage - 100 Amps.

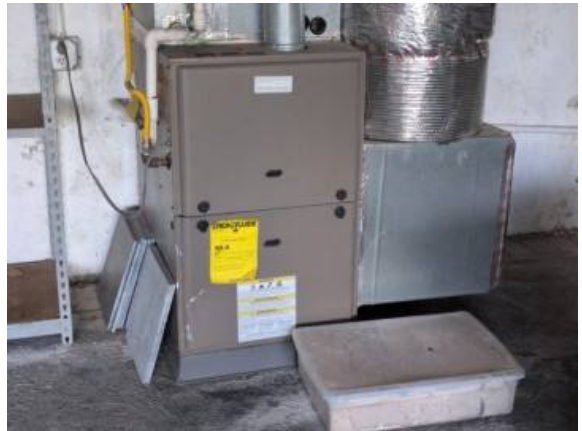
FURNACE LOCATION: The unit is located in the garage.

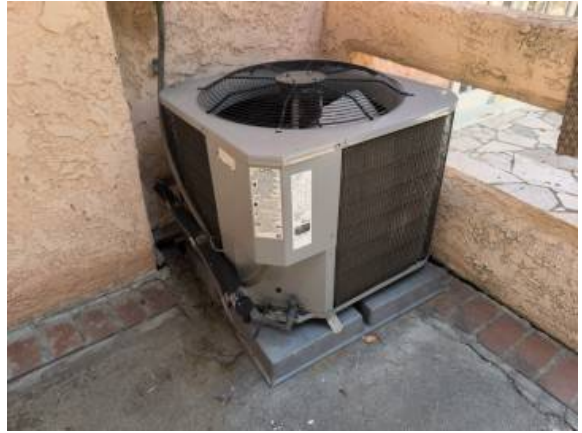
LOCATION: The air conditioning condenser is located in the rear yard.

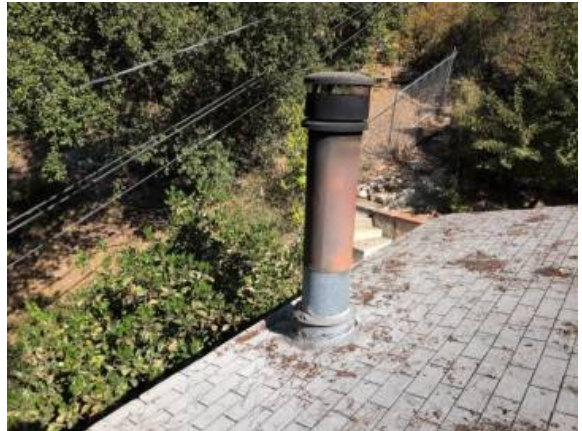
LIVING ROOM.

The chimney is a metal flue pipe.

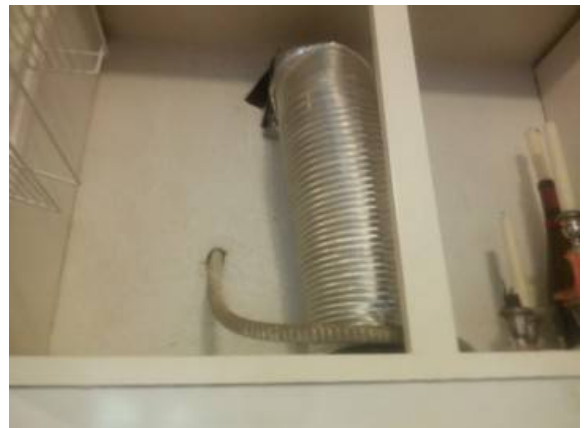
NOT ACCEPTABLE. The range hood exhaust duct is made of aluminum corrugated material, this is not recommended as it can trap grease. It should be smooth wall steel ducting.

NEEDS ATTENTION. The unit is older.
