Address of Property: 465 Hillcrest Drive, Lakeport CA 95453  
Inspection Date: 10/30/2025  
Report #: 27617  
Title Co. & Escrow #:

# WOOD DESTROYING PESTS AND ORGANISMS INSPECTION REPORT

| General Description:<br>Two Story, Single Family Dwelling, Wood & Brick Exterior, Attached Decks.<br>Furnished/Occupied | | Inspection Tag Posted:<br>Subarea | |

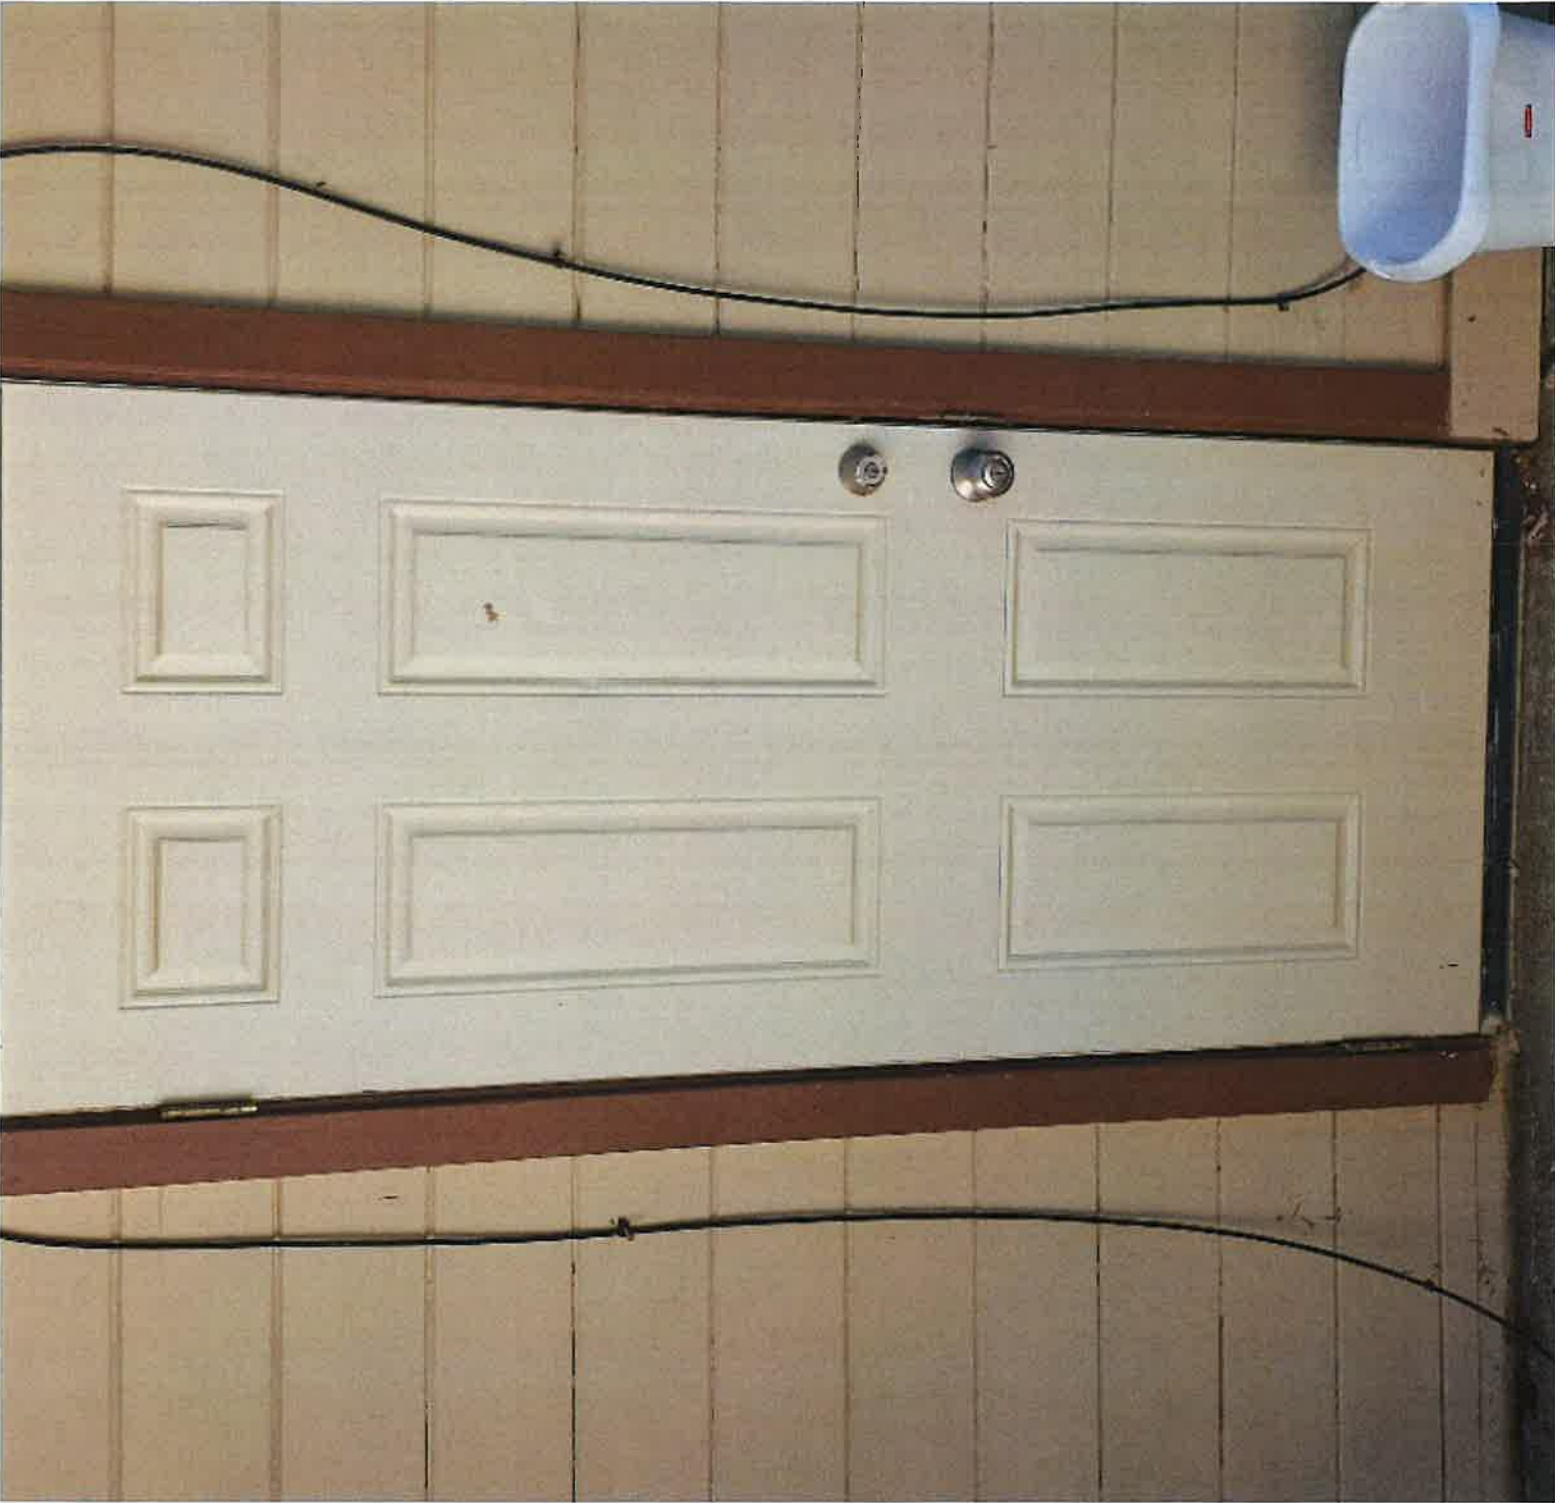
ITEM 1A **FINDING:** Fungus damage was found at the downstairs exterior door.

**RECOMMENDATION:** Install a new pre hung white steel or fiberglass door of similar design.

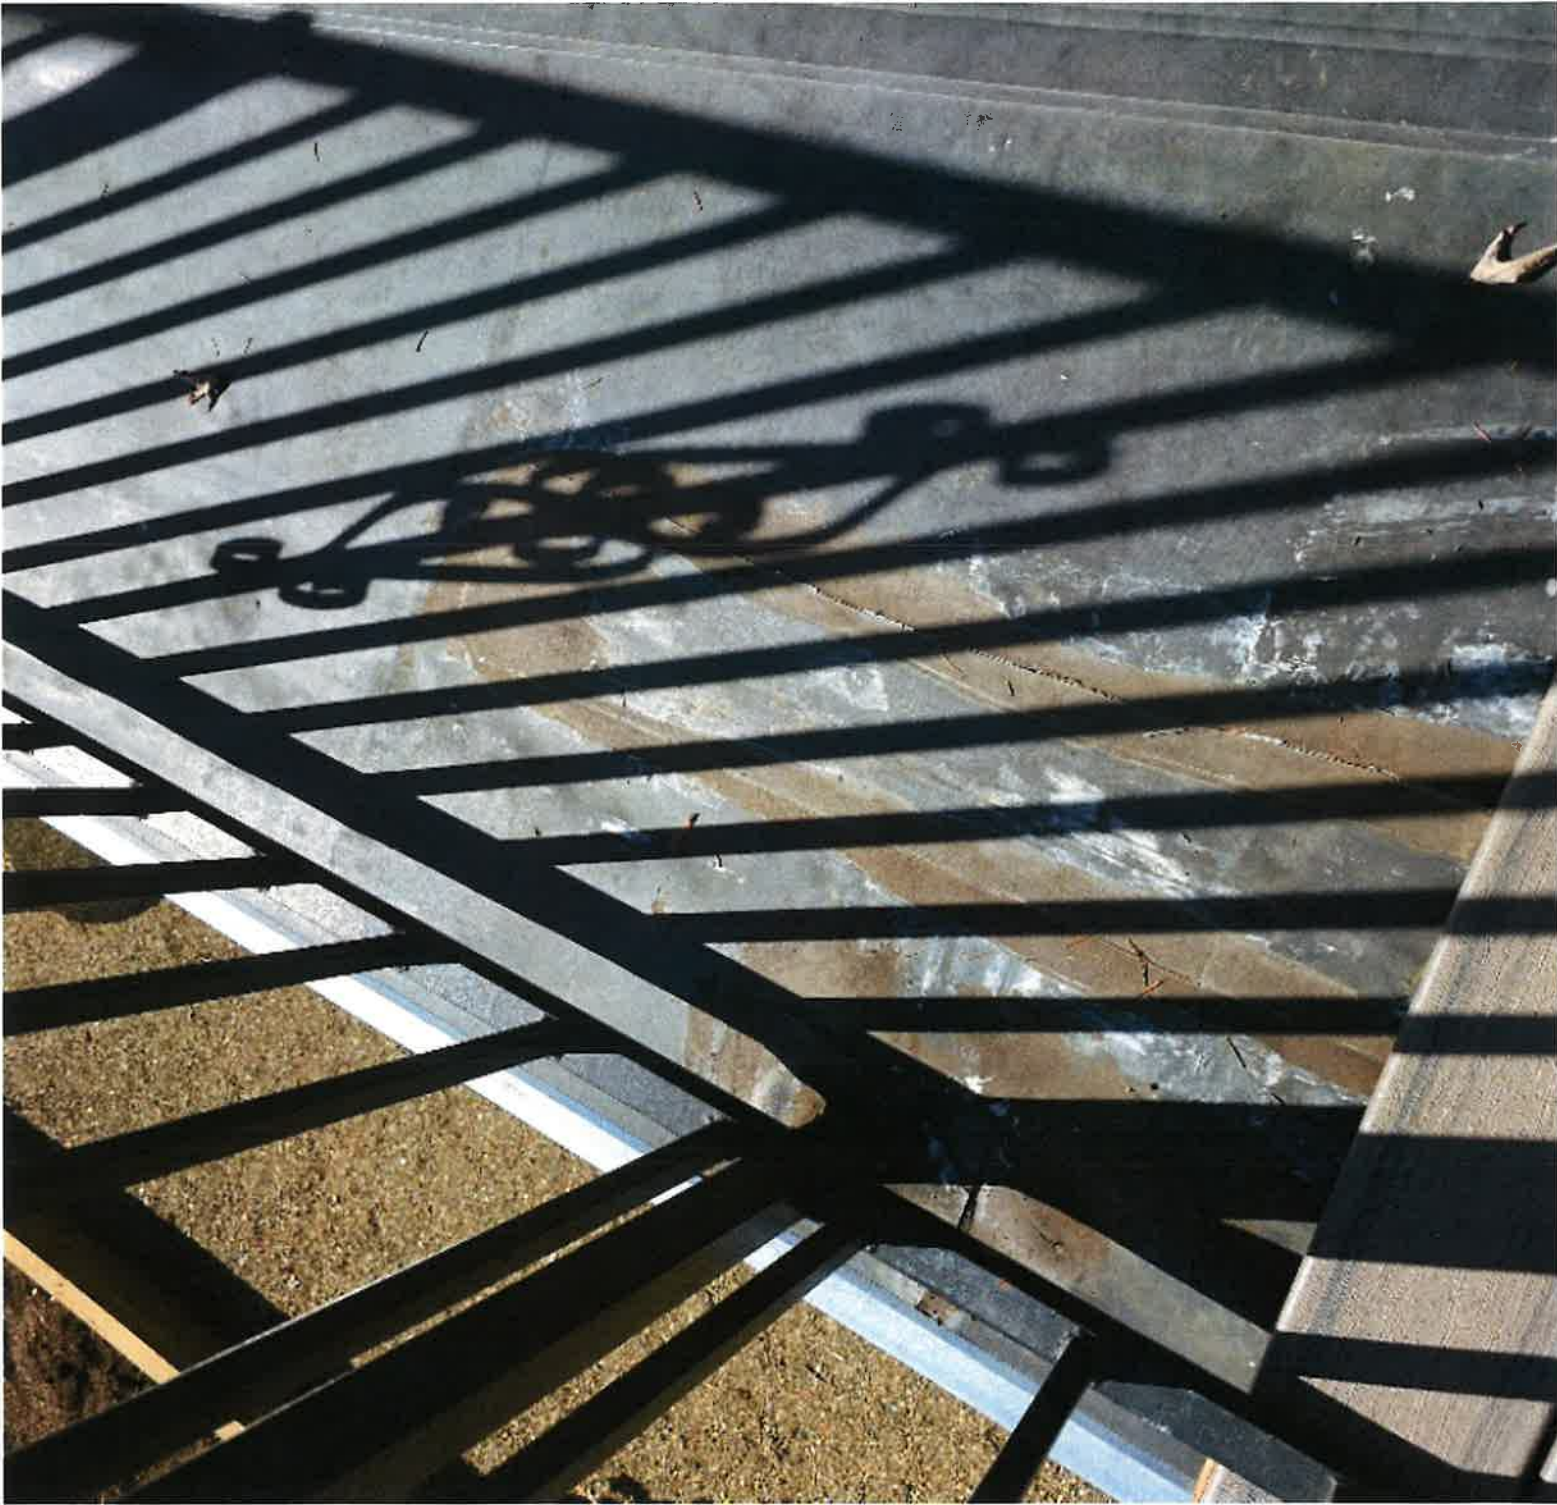
ITEM 2A **FINDINGS:** The upper deck cover was found to be peeling up creating voids. Creating a moisture condition.

**RECOMMENDATION:** Other trades to make repairs as needed.

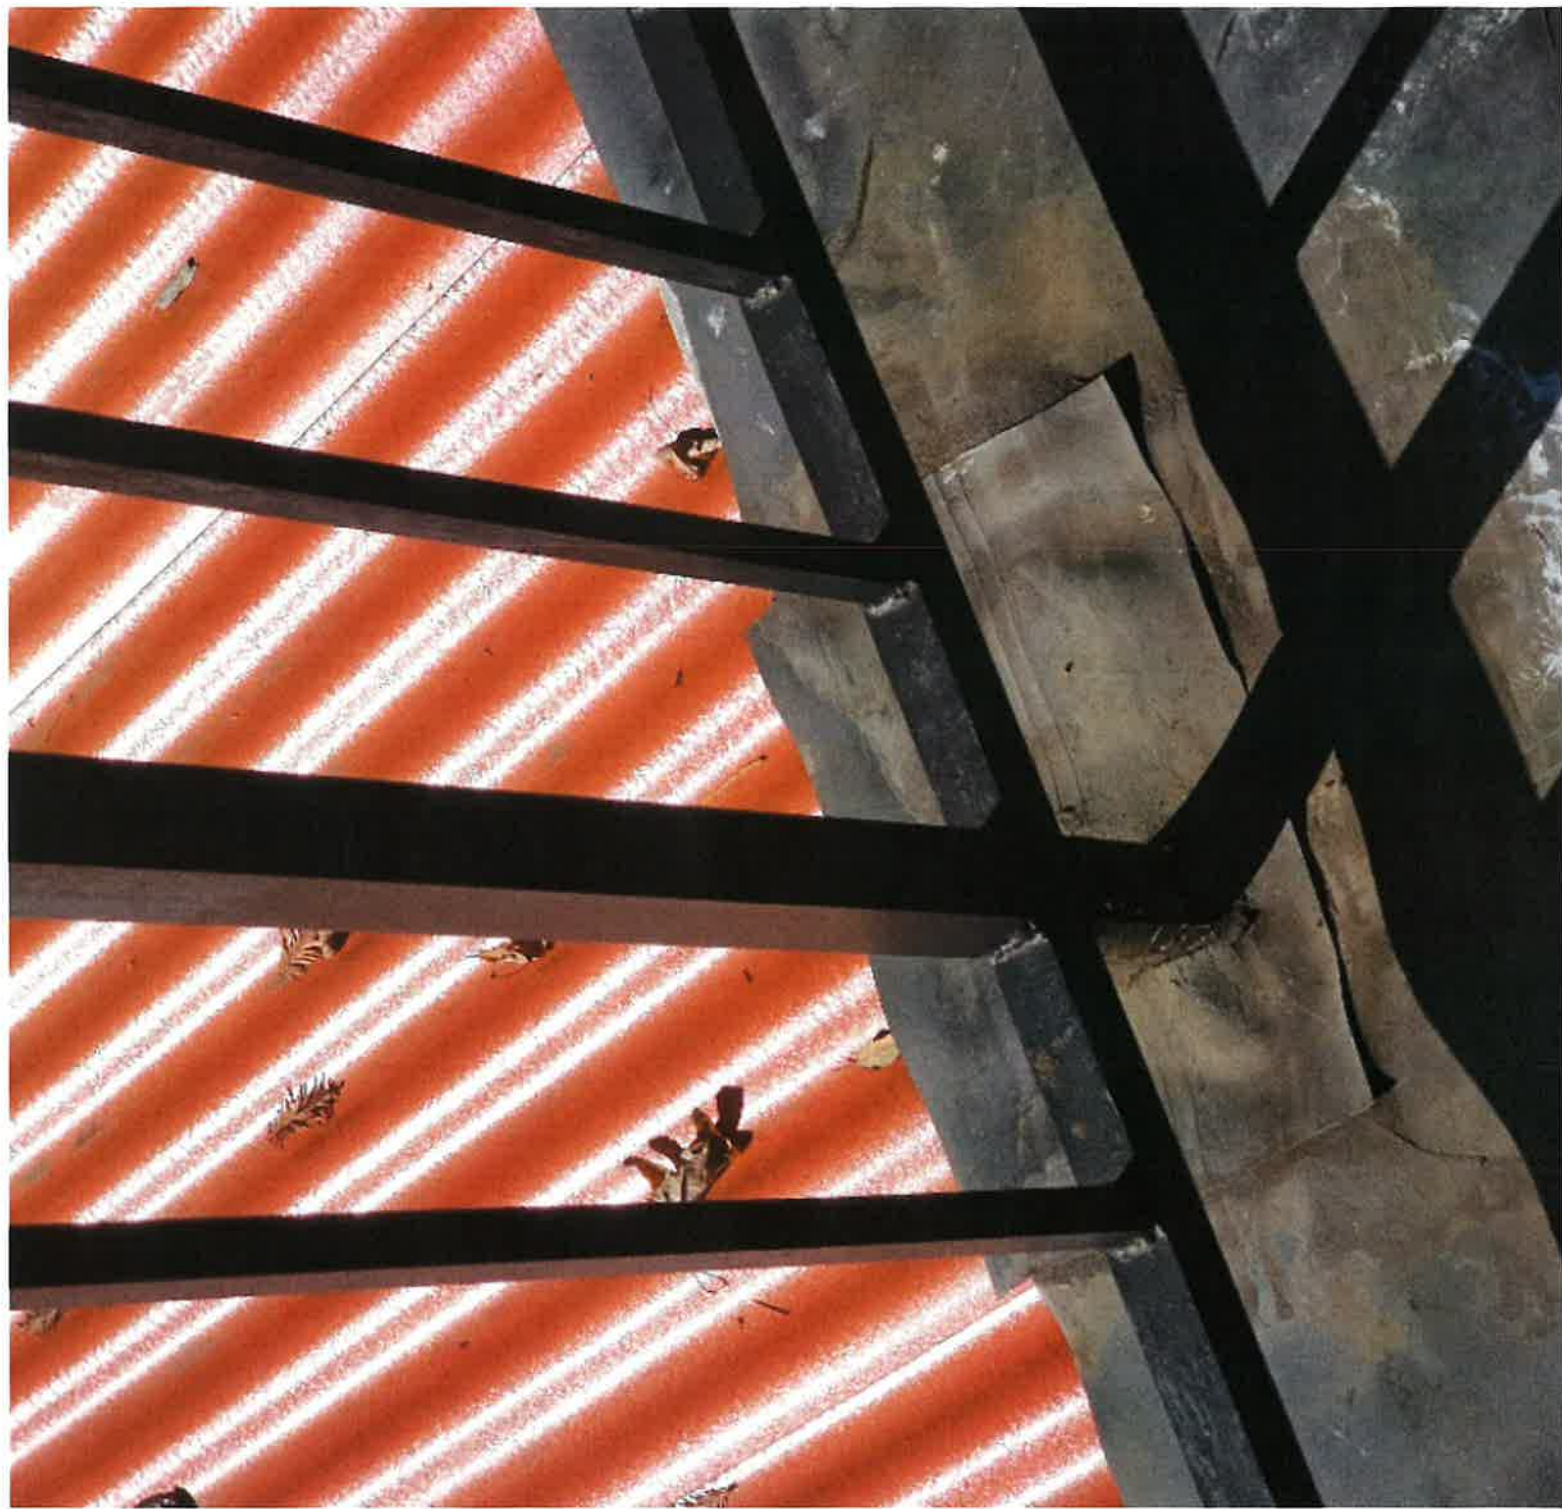
ITEM 2B **FINDING:** Earth to wood contact was noted at the subarea support posts. Untreated wood members in contact with soil may lead to and/or conceal infestations or fungus infections and damage.

**RECOMMENDATION:** Grade the soil away from the support posts to correct the earth to wood contact.

**NOTE:** UPON REMOVAL OF THE EARTH TO WOOD CONTACT, IF DAMAGE IS FOUND, A SUPPLEMENTAL REPORT SHALL BE ISSUED.
