Johnson / Clarion Inspection

Client(s): **Colin & Susan Johnson**

Property address: **14405 Clarion Way
Magalia, Ca. 95954**

Inspection date: **Friday, October 3, 2025**

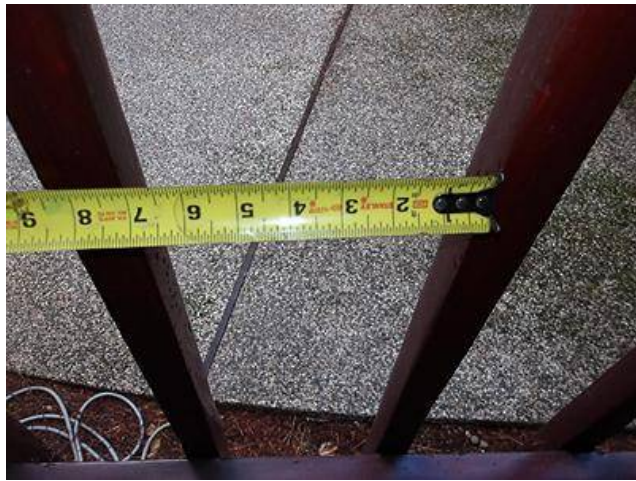
Photo 2-2 Front porch guardrail

Guardrails in some areas with drop-offs higher than 30 inches were substandard with gaps over 4". This is a safety hazard. Standard building practices require that they:

A qualified contractor should evaluate and repair, replace or install guardrails as necessary, and as per standard building practices.

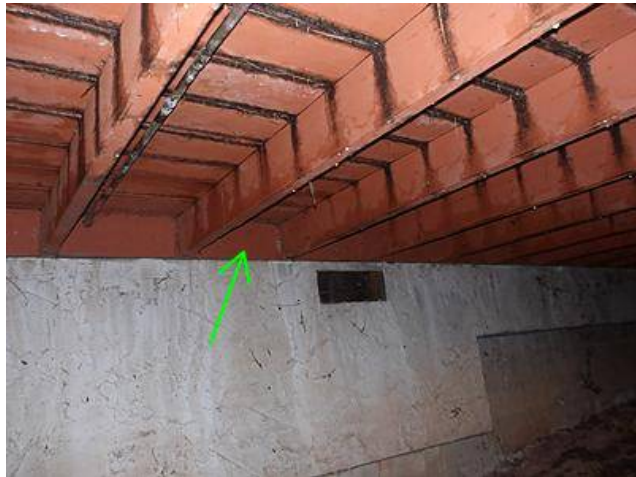
Photo 3-2 West deck ledger board

One or more deck ledger boards were nailed to the building rather than being attached by adequate fasteners. This poses a significant safety hazard since the ledger board(s) may separate from the building, causing the deck(s) to collapse. A qualified contractor should install lag screws or bolts as per standard building practices to securely attach the ledger board(s) to the building. For more information on installing deck ledger boards visit: http://www.hometime.com/Howto/projects/decks/deck_4.htm

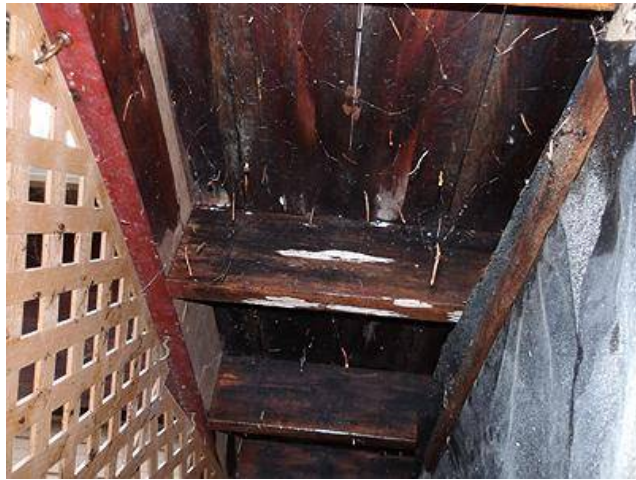
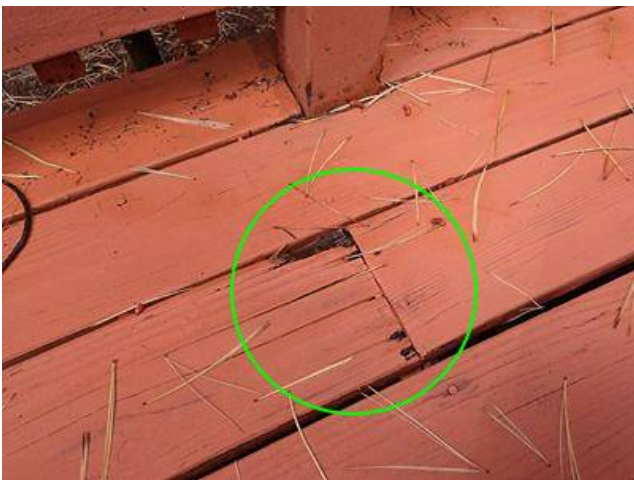
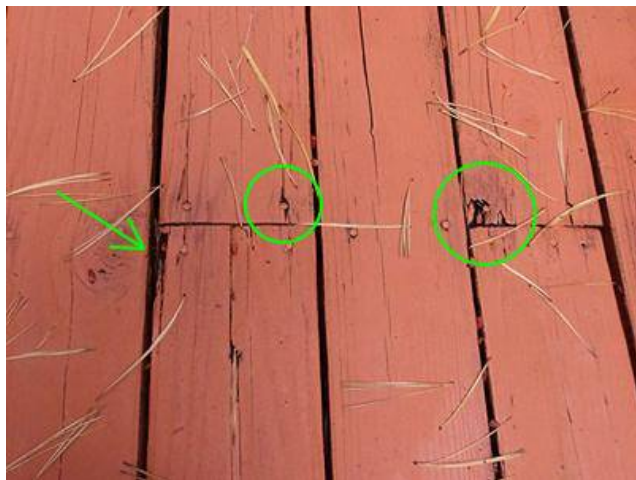
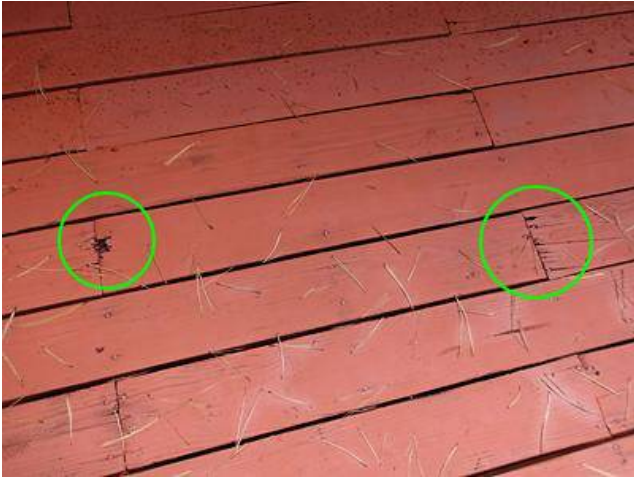
Rot or water damage was found at one or more decks, porches or balconies in decking boards and/or joists. A qualified person should evaluate and repair as necessary. All rotten wood should be replaced.

Photo 5-2 Front porch joist

Photo 5-3 West deck

Photo 5-4 West deck

Photo 5-5 West deck

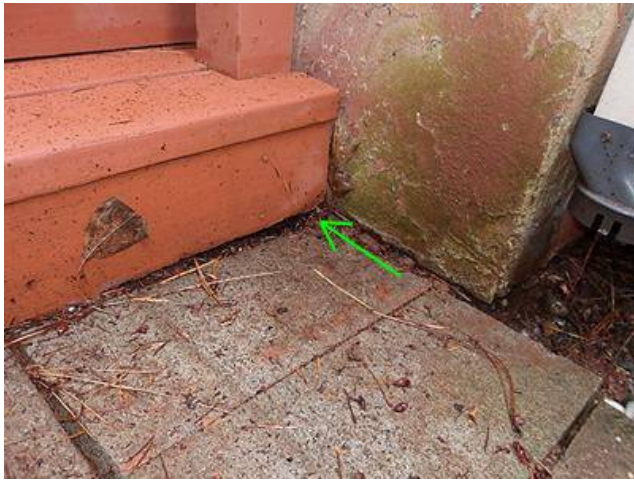
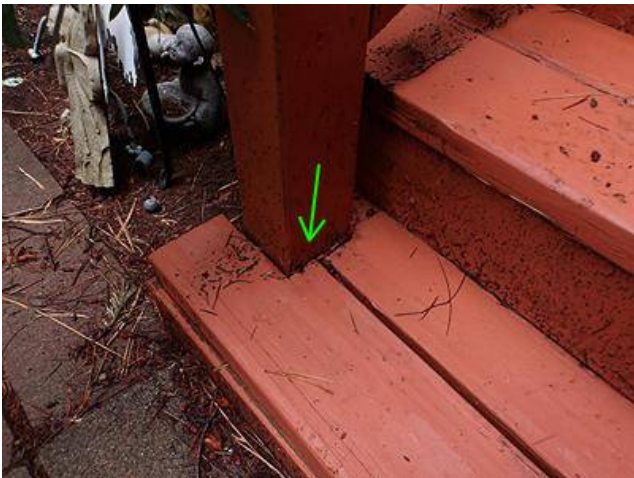
Rot or water damage was found at one or more sets of exterior stairs in treads and/or support posts. A qualified person should evaluate and repair as necessary. All rotten wood should be replaced.

Photo 6-2 West deck stairs

Photo 6-3 West deck stairs

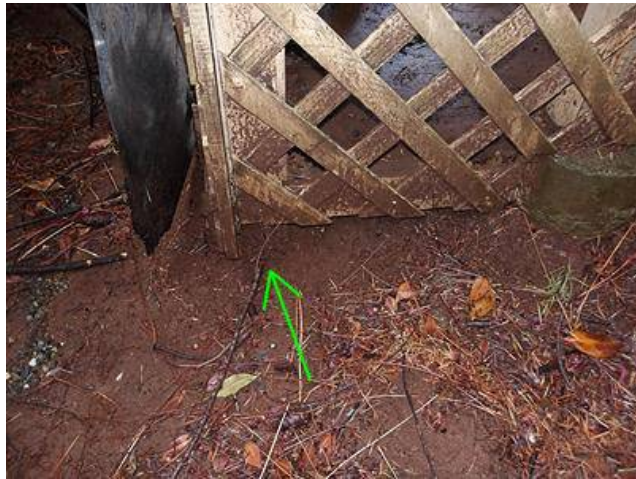
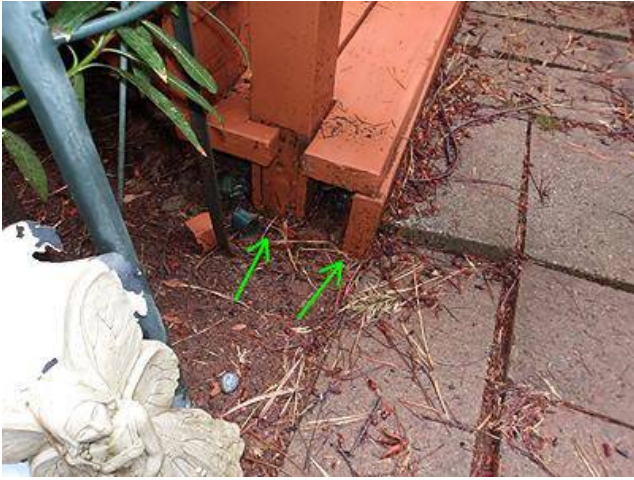
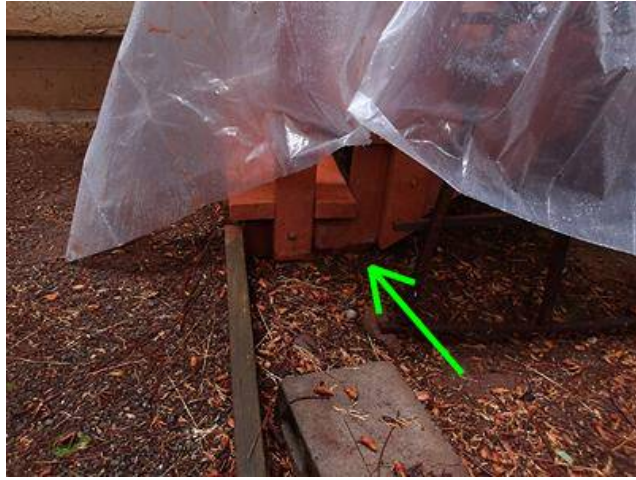
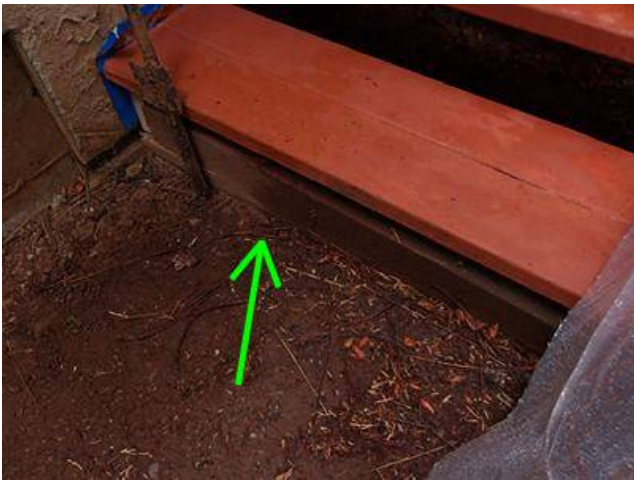
Soil was in contact with or too close to wooden support posts and/or stairs. This is a conducive condition for wood destroying insects and organisms. Standard building practices require the following clearances to soil below:

Photo 8-2 NW corner carport

Photo 8-3 West deck stairs

Photo 8-4 South stairs

Photo 8-5 South stairs

Efforts should be made, such as grading and/or removing soil, to maintain these clearances. If this is not practical, then installing borate based Impel rods may help to prevent infestation and damage. For more information, visit:

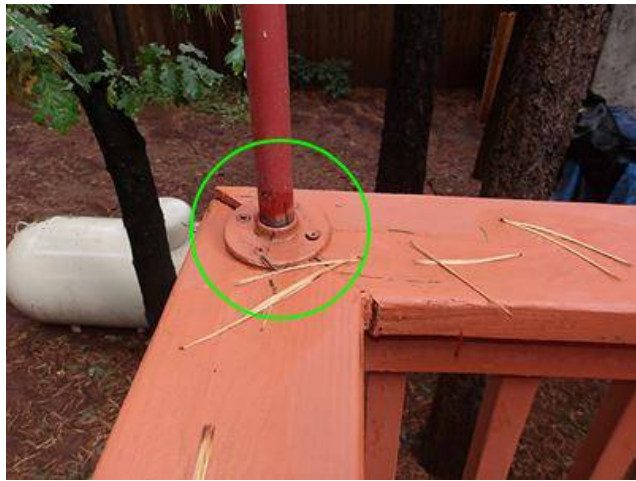
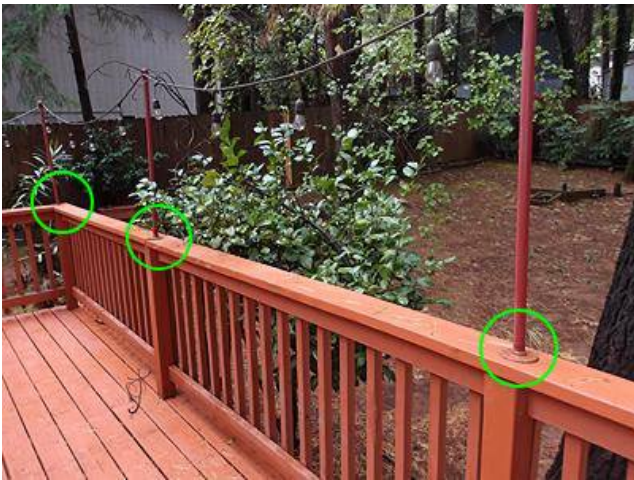
One or more decks, porches and/or balconies were damaged. A qualified person should evaluate and repair or replace as necessary.

Photo 10-2 West deck

Photo 10-3 West deck

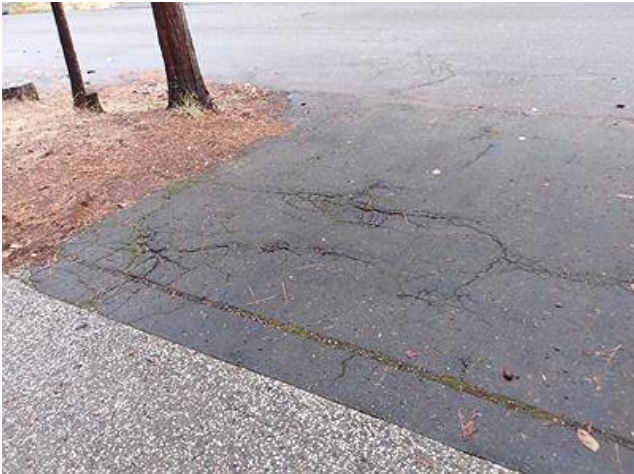
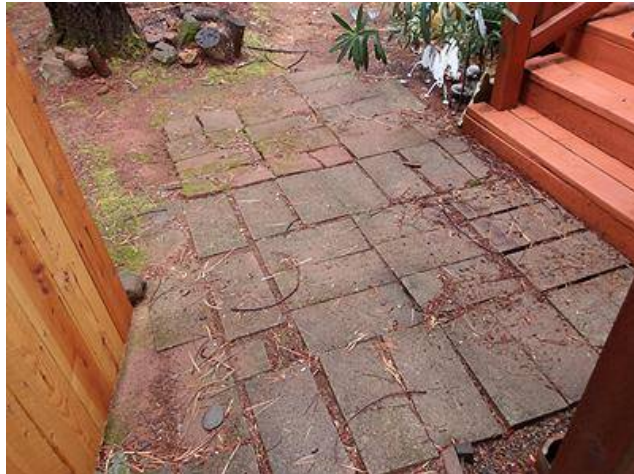
13) **i** Minor cracks, settlement, heaving and/or deterioration were found in one or more sidewalk or driveway sections. However they don't appear to be a structural concern and no trip hazards were found. No immediate action is recommended, but the client may wish to have repairs made or have cracked sections replaced for aesthetic reasons.

Photo 13-1 Driveway

Photo 13-2 SW corner

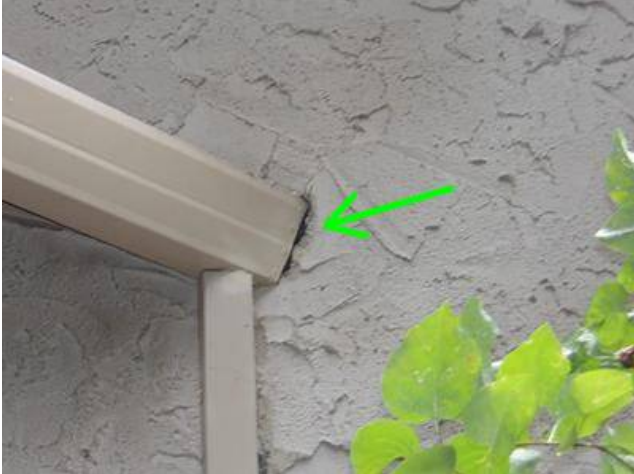
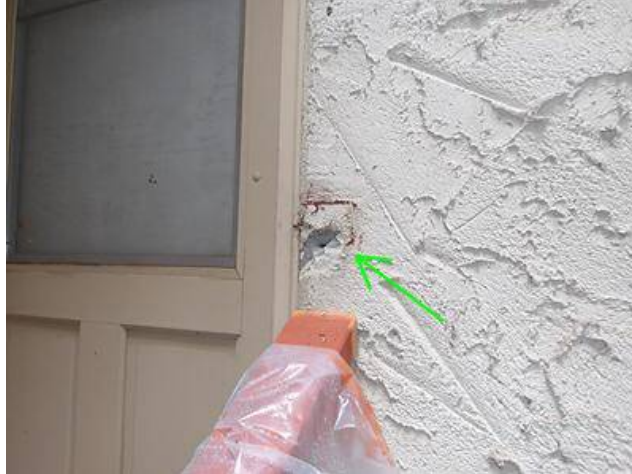
Some sections of siding and/or trim were damaged and/or substandard. A qualified person should evaluate and repair, replace or install as necessary.

Photo 14-1 South side

Photo 14-2 South side

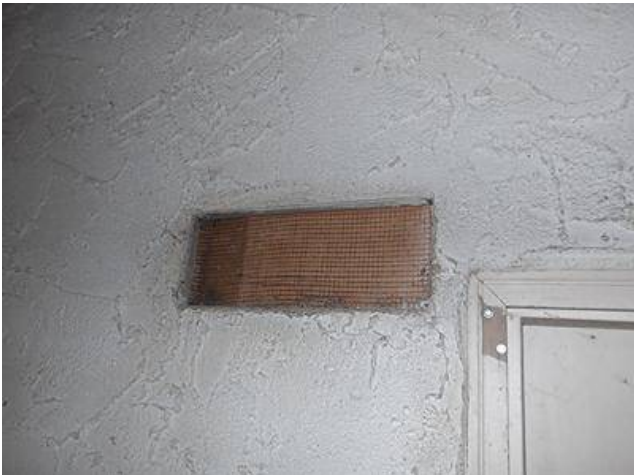
Photo 15-1 North side

Some crawl space vents were blocked by removable panels. This restricts ventilation in the crawl space and may result in increased levels of moisture inside. Materials or items blocking vents should be removed as necessary.

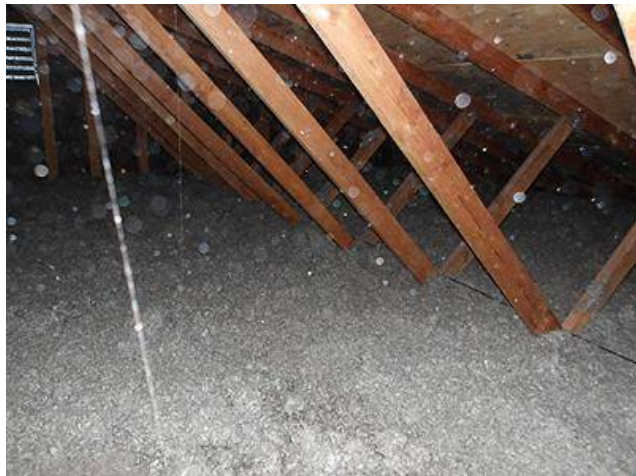
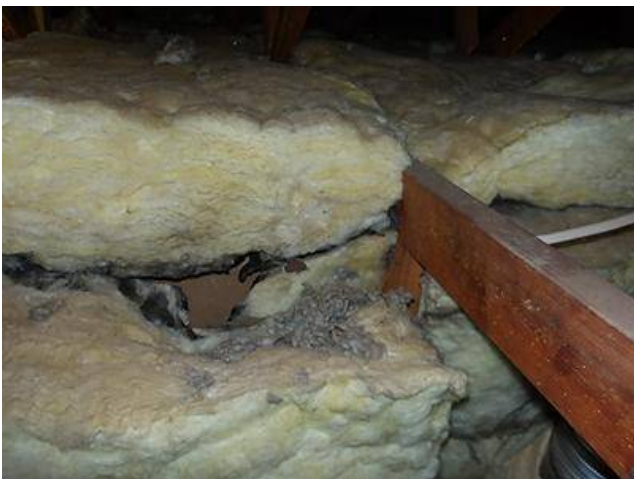
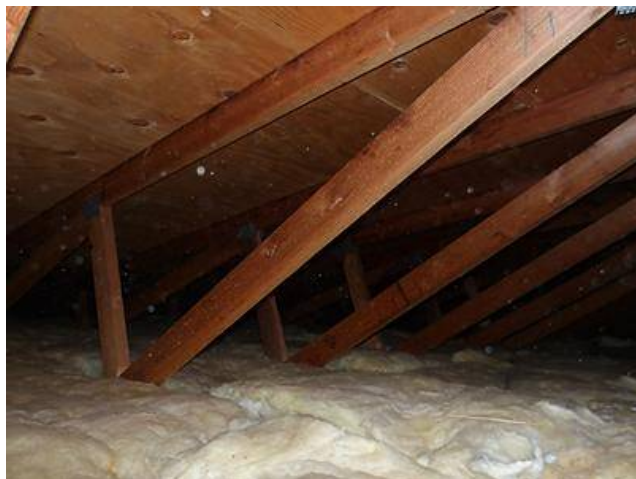
Photo 21-2 Attic insulation

Photo 21-3 Attic insulation above sloped ceiling

Photo 21-4 Attic insulation above sloped ceiling

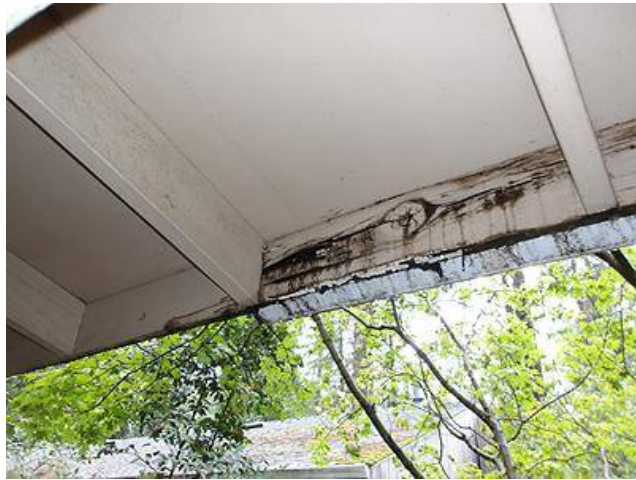
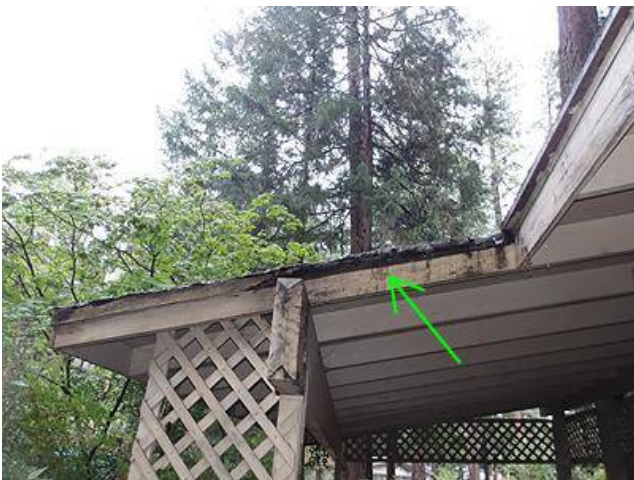
Photo 31-2 Carport fascia

Photo 31-3 Carport

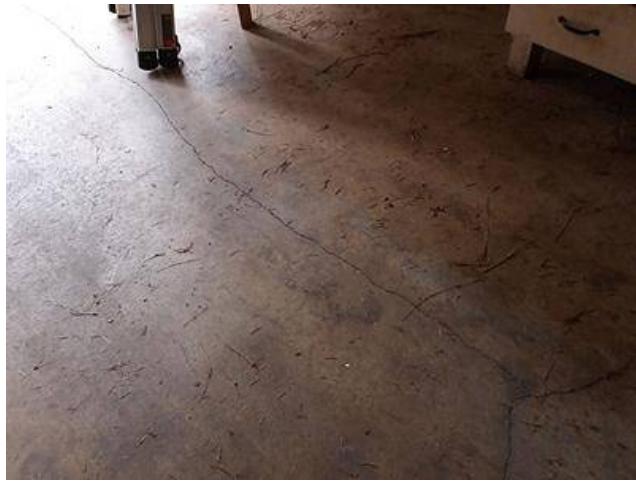
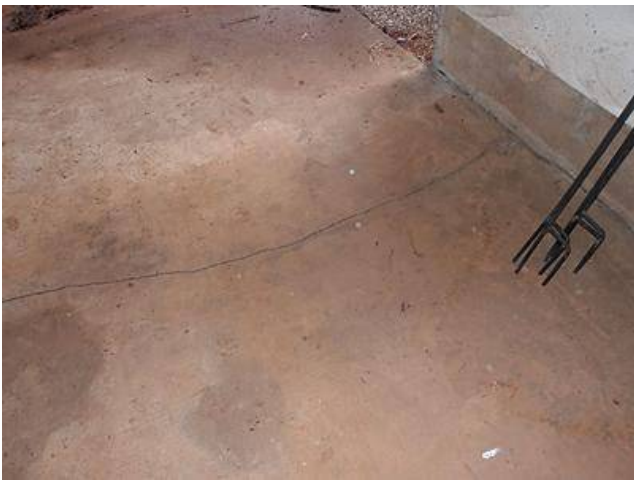
Photo 33-2 Garage

Photo 33-3 Carport

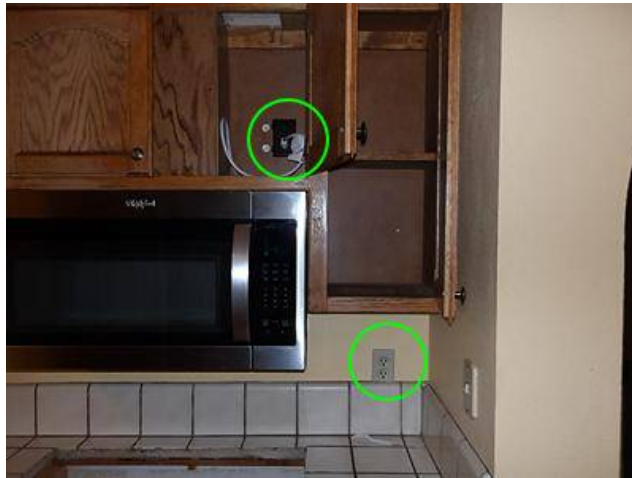
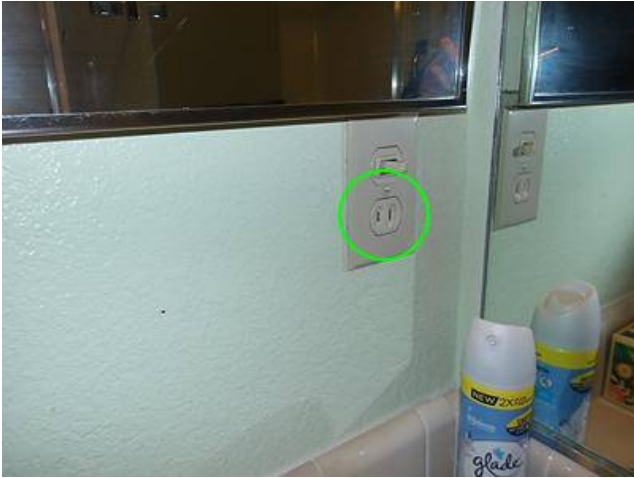
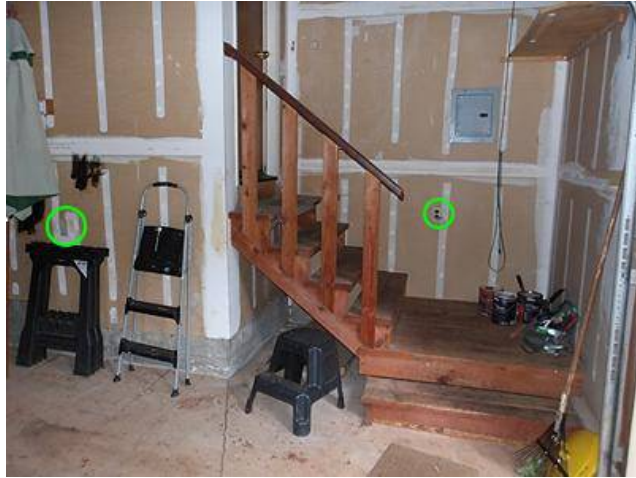
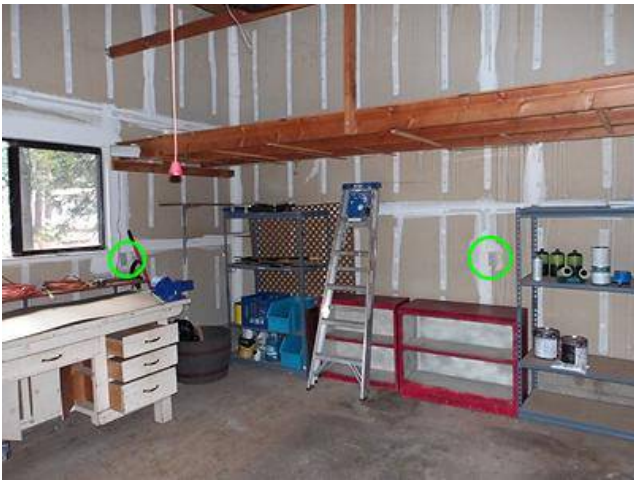
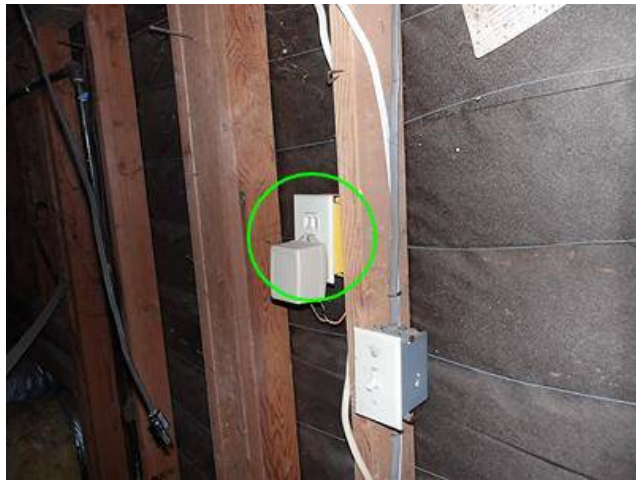
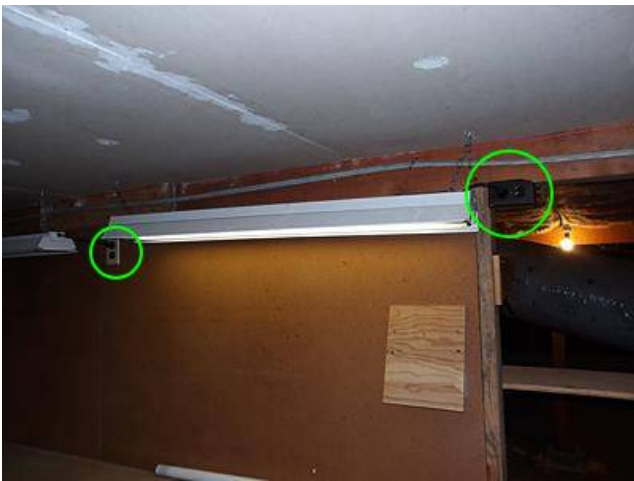
Photo 34-2 Kitchen

Photo 34-3 Master bathroom

Photo 34-4 Garage

Photo 34-5 Garage

Photo 34-6 Crawl space

Photo 34-7 Crawl space

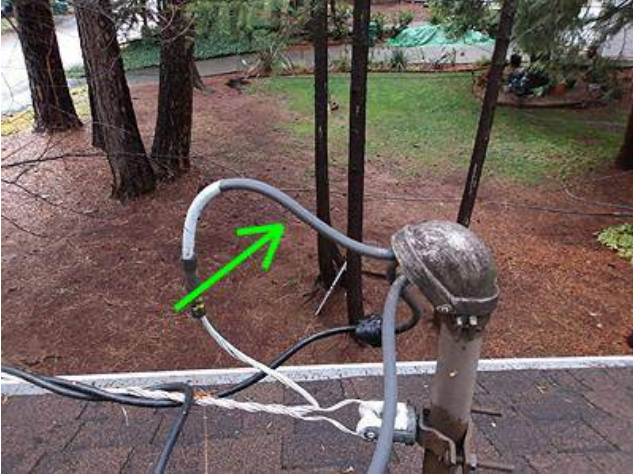
Photo 37-1 Electric service mast

The drip loop in the service entrance wires was substandard. A qualified electrician should evaluate and repair as necessary.

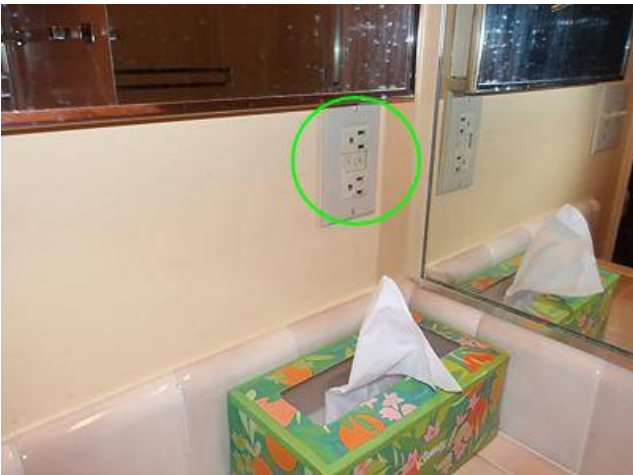
Photo 39-1 Hall bathroom

One or more ground fault circuit interrupter (GFCI) electric receptacles wouldn't trip and/or wouldn't trip with test instrument at the following "wet" locations: bathroom(s). This is a safety hazard due to the risk of shock. A qualified electrician should evaluate and repair as necessary.

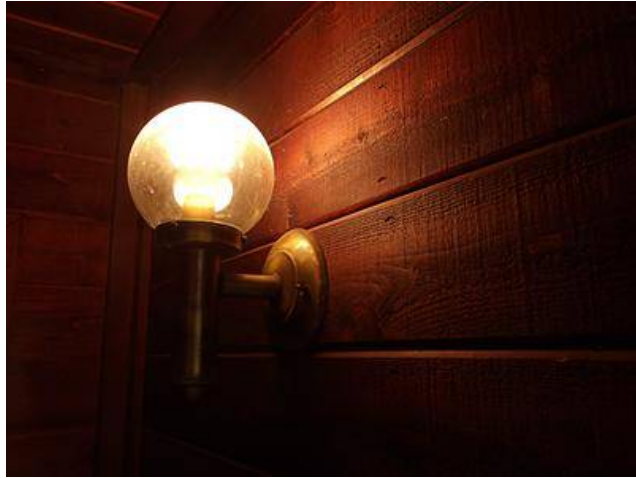
Photo 42-2 Front entry

42) 🚨 One or more wall-mounted exterior light fixtures had wiring that's subject to water intrusion due to caulk not being installed around the light fixture's back plate. Caulk should be applied around the perimeter of back plates where missing. A gap should be left at the bottom for condensation to drain out.

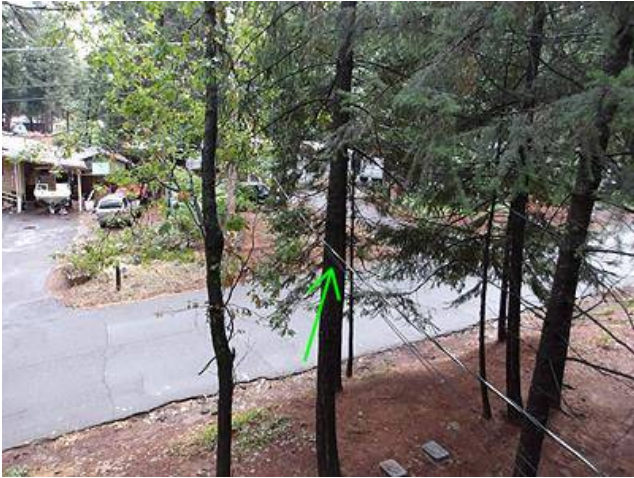
Photo 44-1 SE corner

44) 🏠🔍 The service drop wires were in contact with trees or vegetation. The utility company should prune or remove trees as necessary to prevent straining or abrading the service drop wires.

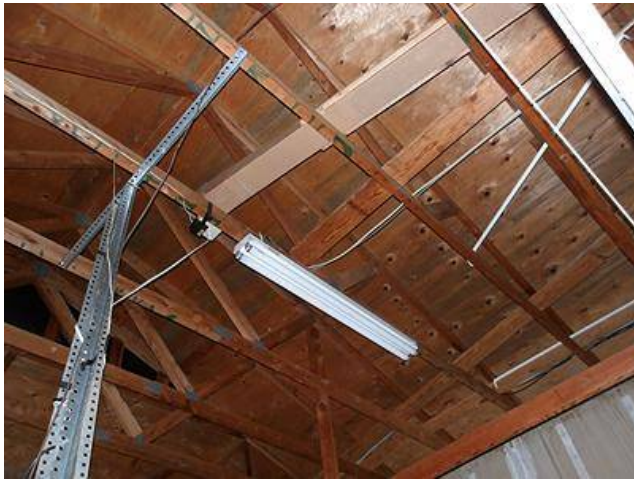
Photo 45-2 Garage

Some light fixtures were inoperable. Recommend further evaluation by replacing bulb(s) and/or consulting with the property owner. Repairs or replacement of the light fixture(s) by a qualified electrician may be necessary.

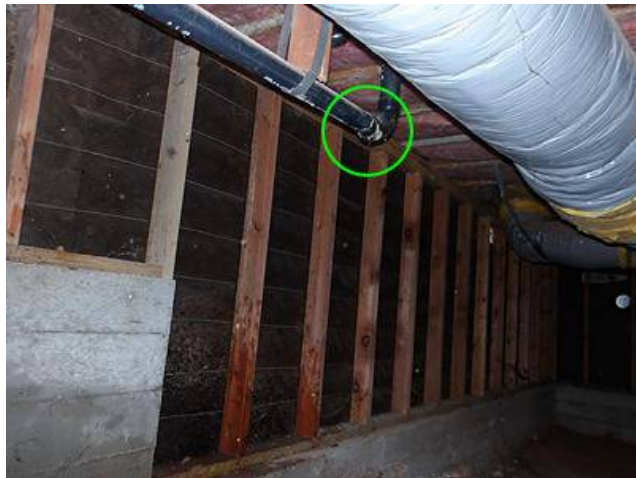
Photo 48-2 Master bathtub drain line

Leaks were found in one or more waste fittings. A qualified plumber should evaluate and repair as necessary.

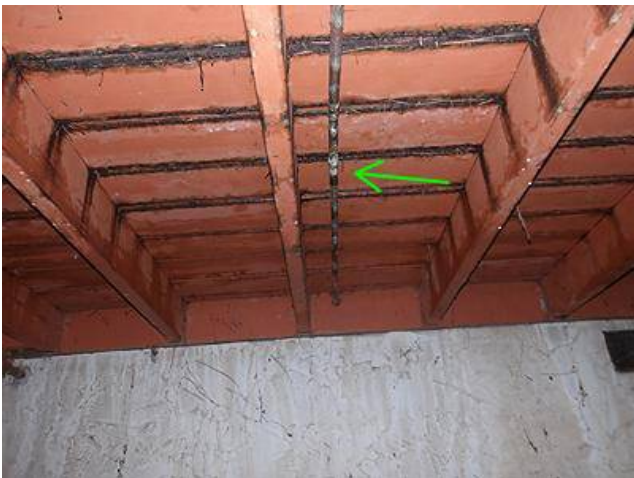
Photo 49-1 Water line below West deck

Water supply lines were routed outside and are subject to freezing. The client should ask the property owner if inside shut-off valves exist for these supply pipes. If unable to determine if shut-off valve(s) exist, or if none do, then a qualified plumber should evaluate and install interior shut-off valves as necessary to prevent pipes from freezing and bursting.

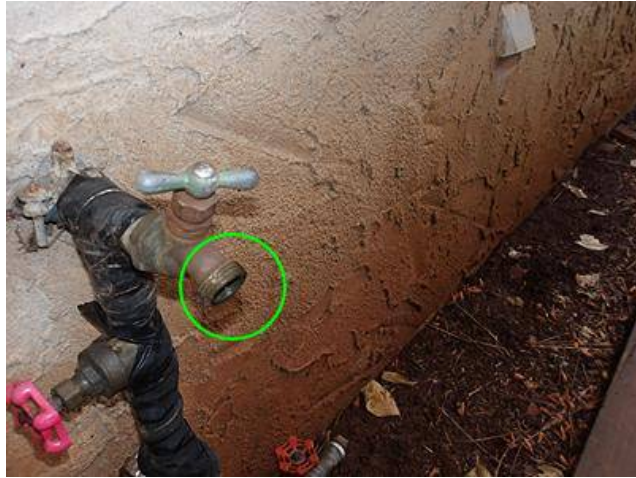
Photo 51-2 SW corner garage

One or more outside faucets were missing [backflow prevention devices](#). These devices reduce the likelihood of polluted or contaminated water entering the potable water supply. This condition can occur when an outside faucet is left in the "on" position with a hose connected and the sprayer head turned off. When pressure in the system fluctuates, water can be drawn back into the water supply pipes from the building. If a chemical sprayer is being used with the hose, those chemicals can enter the water supply pipes.

Recommend installing backflow prevention devices on all exterior hose bibs where missing. They are available at most home improvement stores and are easily installed. For more information, visit: http://edis.ifas.ufl.edu/BODY_AE079

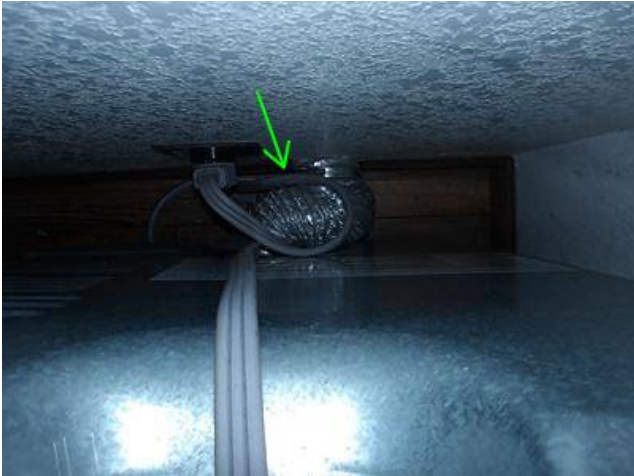
Photo 63-1 Behind dryer

63) 🚧🔧 The clothes dryer was equipped with a foil, accordion-type, flexible exhaust duct. The U.S. Consumer Product Safety Commission considers these types of ducts to be unsafe, and a fire hazard. These types of ducts can trap lint and are susceptible to kinks or crushing, which can greatly reduce the air flow. This duct should be replaced with a rigid or corrugated semi-rigid metal duct, and by a qualified contractor if necessary. Most clothes dryer manufacturers specify the use of a rigid or corrugated semi-rigid metal duct. For more information on dryer safety issues, visit: <http://www.cpsc.gov/CPSCPUB/PUBS/5022.html>

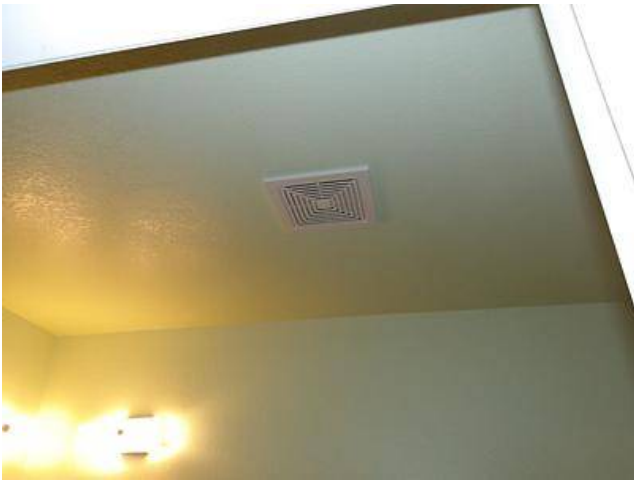
Photo 64-1 Master bathroom

64) 🚧🔧💧 The exhaust fan at location #B was inoperable. Moisture may accumulate as a result. A qualified person should evaluate and repair or replace as necessary.

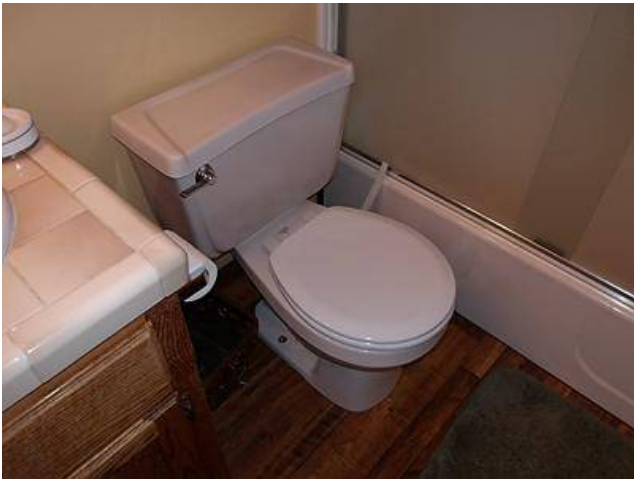
Photo 65-1 Hall bathroom

65) 🛠️🔍💧 The toilet at location #A was loose. A qualified contractor should remove the toilet(s) for further evaluation and repairs if necessary. A new wax ring should be installed and toilet(s) should be securely anchored to the floor to prevent movement and leaking.

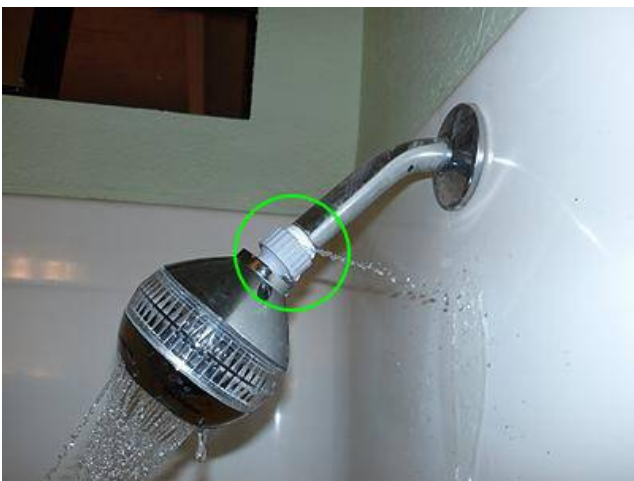
Photo 66-1 Master bathroom

66) 🛠️🔍💧 Leaking or dripping was found at the shower head fitting at location #B. A qualified plumber should evaluate and repair as necessary.

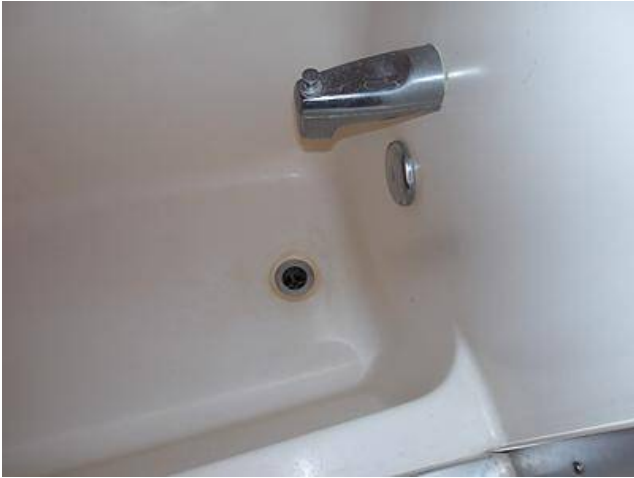
Photo 67-1 Hall bathroom

67) 🛠️ The bathtub drain stopper mechanism at location #A and B was missing. A qualified person should repair or replace as necessary.

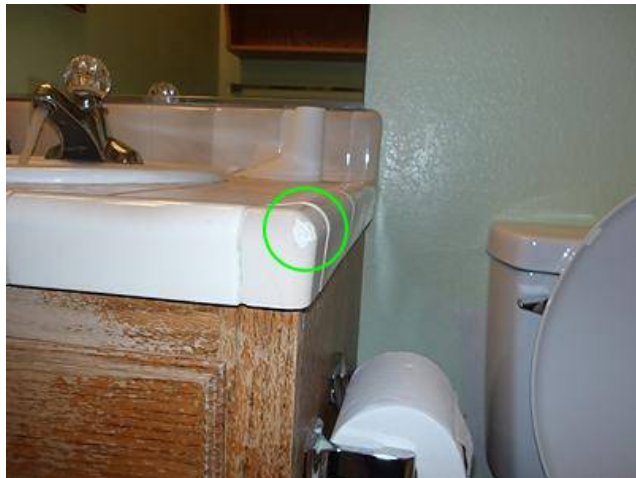
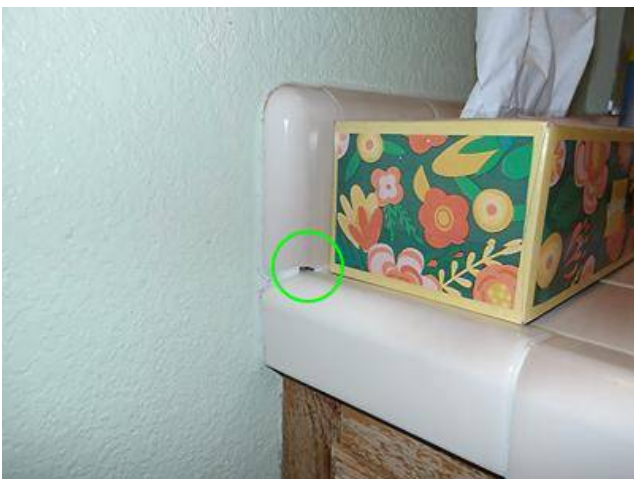
68) **i** Counters showed minor deterioration and/or damage at location #A and B.

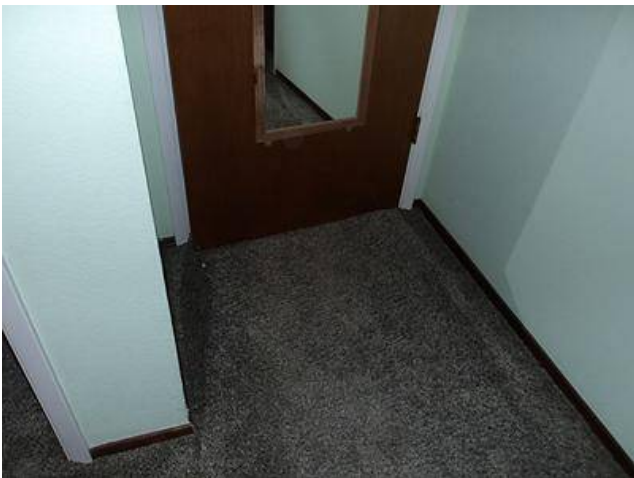
Photo 69-1 Master bedroom

All bedroom doors has no gap between it and the floor below, or has a gap substantially less than one inch. This structure has a forced air heating system with centrally located return air ducts. When bedroom doors are closed, the only effective path for return air out of the bedrooms is under the doors. A minimum gap of one inch below bedroom doors is recommended to allow an adequate air flow for return air. Recommend trimming the bottoms of bedroom doors as necessary so each door has a minimum one inch gap at its base.

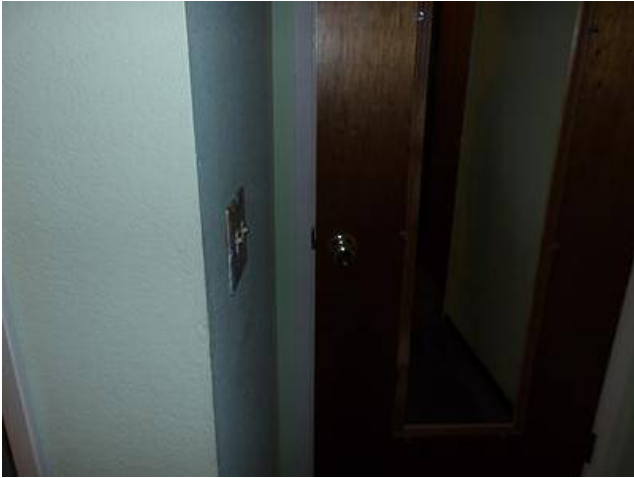
Photo 70-1 Master bedroom

Some interior doors were difficult to open or close and/or wouldn't latch. A qualified person should evaluate and repair as necessary.

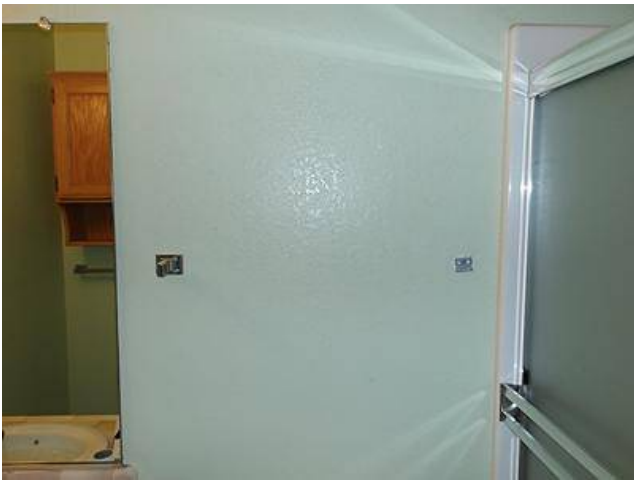
Photo 71-1 Master bathroom

71) 🛠️ Fixtures such as towel hangers were damaged. A qualified person should repair or replace as necessary.
