# Confidential Inspection Report

LOCATED AT:  
3631 Windspun  
Huntington Beach, California

INSPECTED ON:  
Wednesday, March 4, 2026

Inspector: Kevin Switter  
HomeSpec Home Inspections (818) 308 HOME

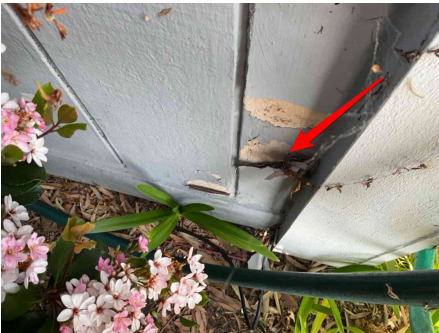
**s-60:** There was damage to the exterior finish noted in one or more areas (assumed from water spraying the structure). We recommend further evaluation and repair as necessary.

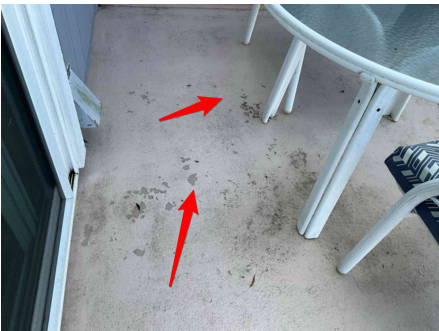
**s-99:** The finish coat shows some peeling and consideration should be given to further evaluation by a specialist to ensure a proper seal and recoating as deemed necessary.

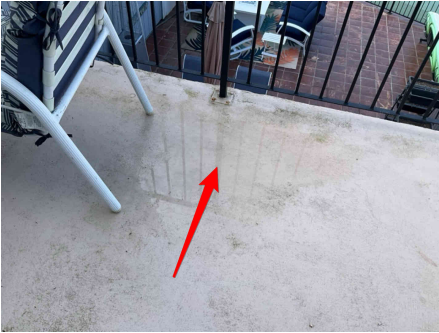
**s-101:** There was water staining and/or evidence of past ponding noted on the balcony. We recommend consulting owner regarding any past performance issues.

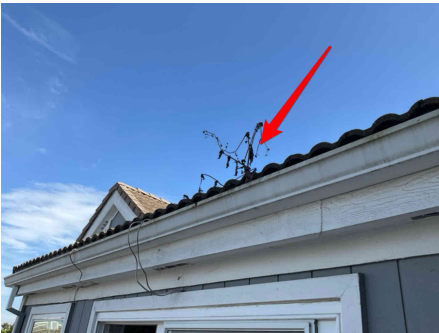
**s-130:** The gutters need to be cleaned and serviced to help ensure that they will drain properly.

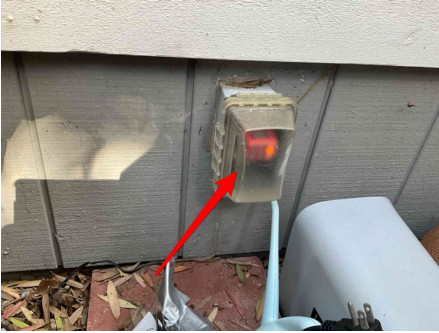
**s-252:** Complete ground fault circuit interrupter(GFCI) protection was not found/verified at the exterior as is the current standard. We recommend complete protection be ensured at all exterior receptacles.

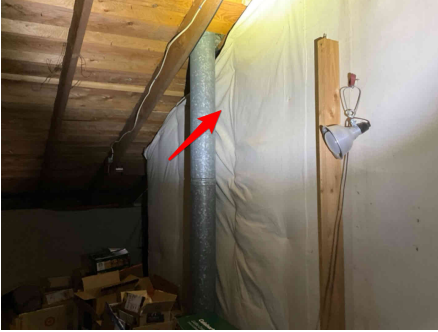
**s-271:** The vent pipe is in close to or in contact with some combustibile material in the attic. We recommend all contact be eliminated and proper clearances provided to help prevent the possibility of combustion.

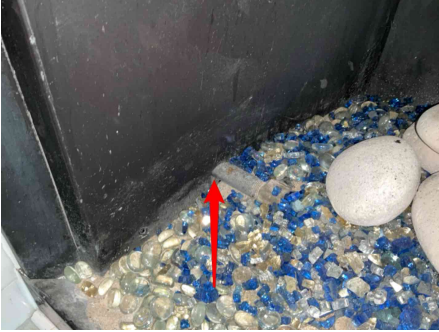
**s-312:** Voids were noted around the gas pipe in the firebox. While no adverse conditions appear to have resulted, this is a fire safety issue and we recommend filling the voids as preventative maintenance.

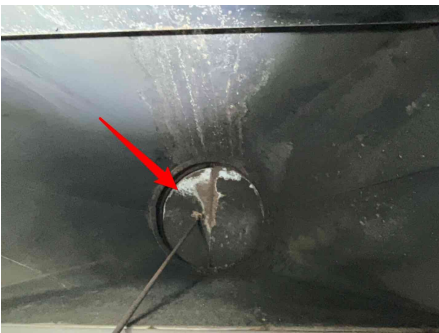
**s-317:** Because the fireplace is equipped with a gas supply and/or artificial logs, care should be taken to keep the damper open or combustible gas fumes could be trapped inside the building. The installation of a damper block is recommended. Most manufacturers currently recommend that the damper be blocked fully open for the safest possible operation.

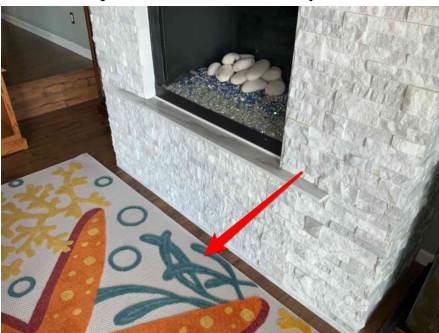
**s-322:** There is not a proper hearth installed as is the current standard and the adjacent flooring material appears to be combustible. Consideration should be given to the installation of a proper hearth as per current jurisdictional requirements.

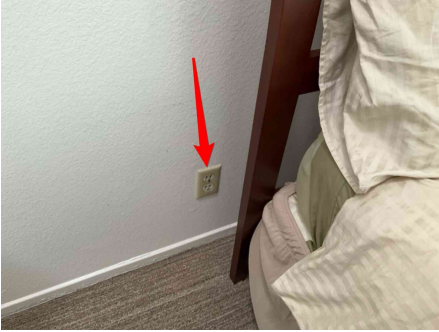
**s-436:** There was an obstacle or ground pin stuck in one or more of the receptacles, which prevented us from testing it. We recommend removal of any obstruction and verification of proper operation.

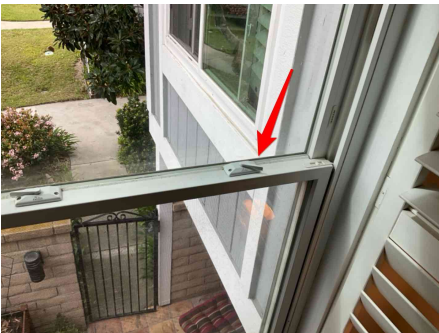
**s-441:** One or more window locks or latches need to be serviced to be fully/properly functional.

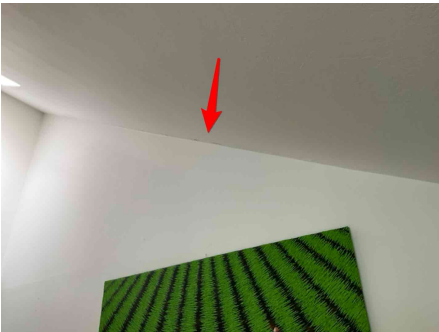
**s-446:** There were cracks, bubbling tape, or seams noted on ceiling. They appear to be cosmetic only at this point and probably a result of patching holes, remodeling or scraping and retexturing the ceilings. However, we recommend consulting the owner or a specialist to confirm this.

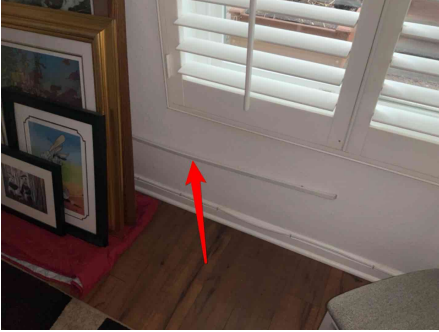
**s-456:** Improper wiring methods have been employed in this area(loose on wall wiring). We recommend all substandard wiring be abandoned or removed and properly installed using approved materials.

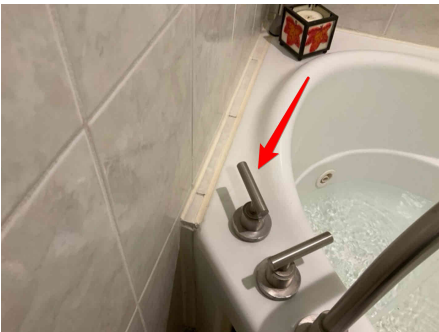
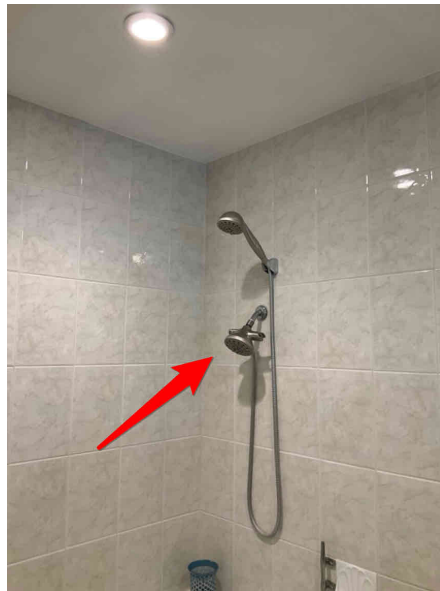
**s-477:** The shower diverter was not working properly and not allowing water to come out of the shower head(worked hard - inspector afraid to break it).

Not functional

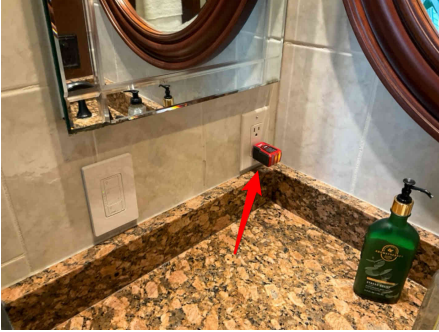
**s-478:** There is not complete GFCI protection installed in this area. We recommend complete protection be installed as per current standards.

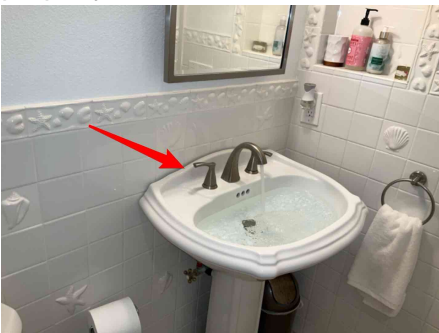
**s-516:** The pedestal sink is loose at its connection to the wall. We recommend securing and sealing it properly.

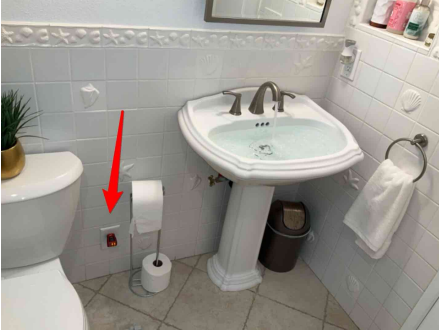
**s-520:** There is not complete GFCI protection installed in this area. We recommend complete protection be installed as per current standards.

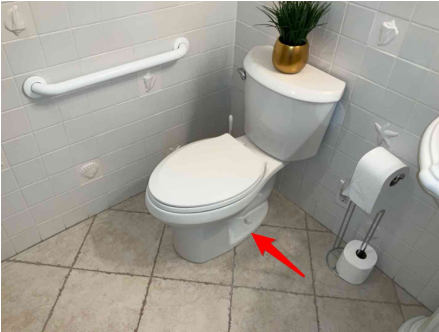
**s-523:** The toilet is loose or not sitting level at the floor. While no damage was evident, this condition should be addressed so that leakage does not develop and cause damage. We recommend that the toilet be removed, a new wax ring installed, then reattached to the floor.

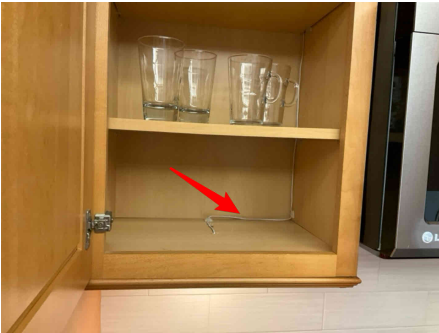
**s-583:** We noted exposed wiring in the cabinets. We recommend all exposed wiring be protected or terminated as necessary in compliance with current jurisdictional requirements.

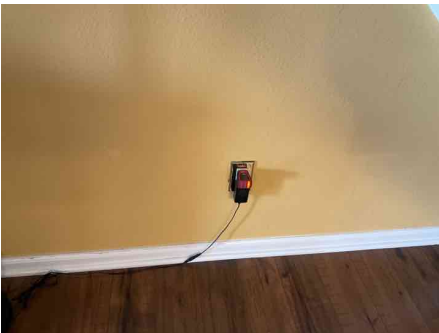
**s-636:** One of the receptacles in this area has an open or weak ground. We recommend its connections be checked and secured and verified as properly grounded for safety.

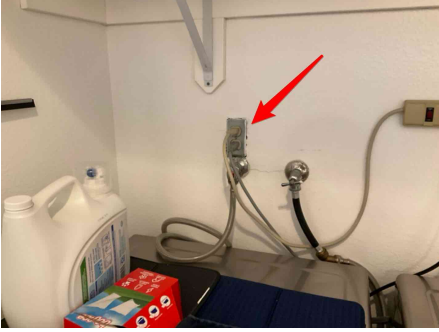
**s-653:** There is no GFCI protection installed for this area as is currently required. We recommend anti-shock protection be installed in accordance with current jurisdictional requirements.

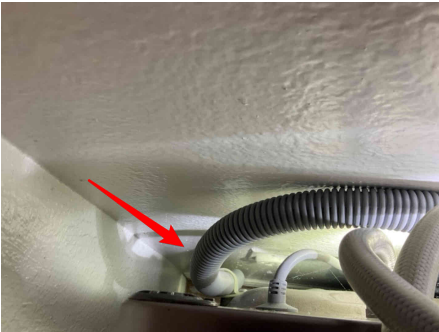
**s-660:** The drain for the washing machine was not visible due to the placement of the appliances. We recommend verification of a properly installed evacuation drain.

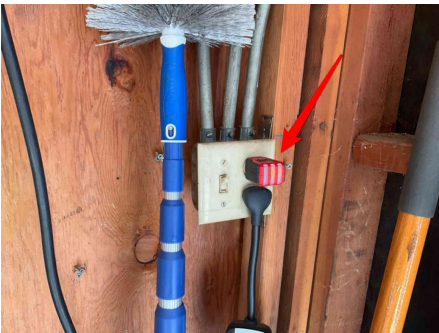
**s-683:** There is no visible/functional GFCI (ground fault circuit interrupter) protection for this area as is the current standard. For an increased margin of safety, we recommend complete protection be installed in compliance with current standards.

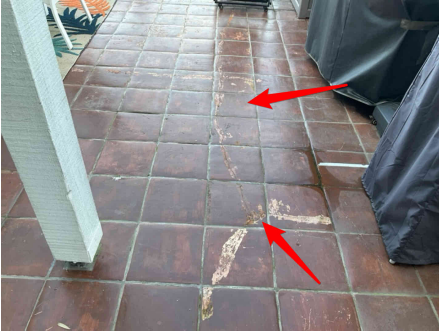
**FEVL 85:** There are cracks noted at a portion of the patio that appear to be atypical, bigger and/or more numerous than what would be considered "normal" or typical. While they appeared to be primarily of a aesthetic issue only, you may wish to get a second opinion or have a specialist comment on them.

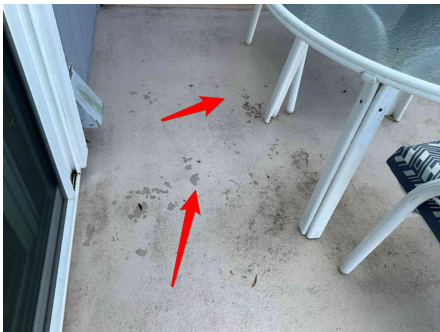
**99:** The finish coat shows some peeling and consideration should be given to further evaluation by a specialist to ensure a proper seal and recoating as deemed necessary.

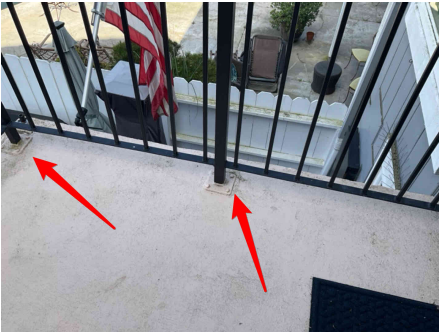
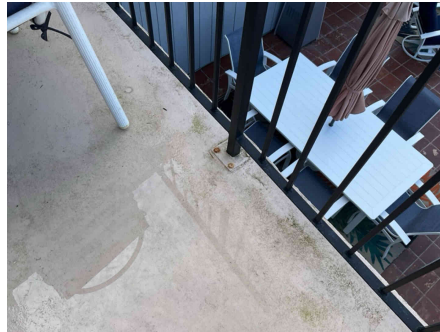
**FTRW** **WARN** **102:** One or more of the balcony railing posts do not appear to be flashed. We were unable to determine if the posts were properly sealed to prevent moisture intrusion. We recommend consulting with the owner regarding any past issues as well as with a waterproofing expert to ensure the integrity of the membrane.

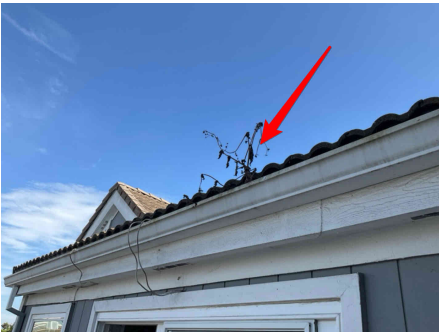
**130:** The gutters need to be cleaned and serviced to help ensure that they will drain properly.

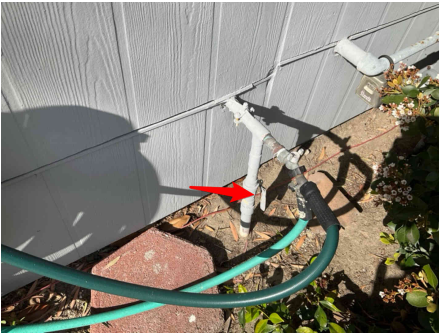
**139:** The main water shut-off valve appears to be located at the front of the residence.

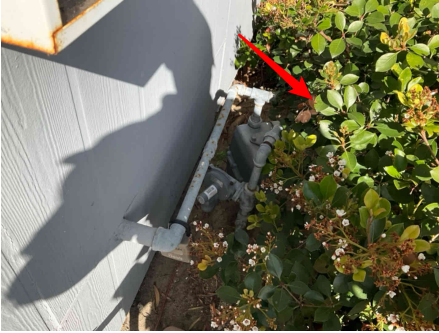
**FTRW 154:** There is vegetation in contact with the gas meter or piping/valve. We recommend cutting back the vegetation to avoid deterioration of the meter or components and potential subsequent leakage.

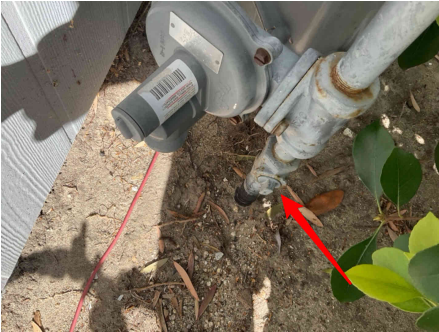
**155:** The gas main shut off is located at the front of the structure.

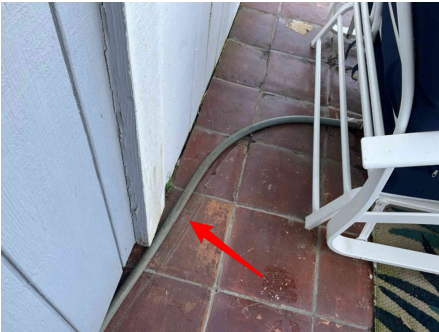
**FTRW WARN IMPT 162:** There was a flexible unsecured natural gas line running along the side of the structure. We recommend obtaining pertinent receipts for the installation of the line to ensure it, and the gas meter, are properly sized and the pipe is properly placed, protected and supported in accordance with jurisdictional requirements (for portable fire pit&. May be removed by seller

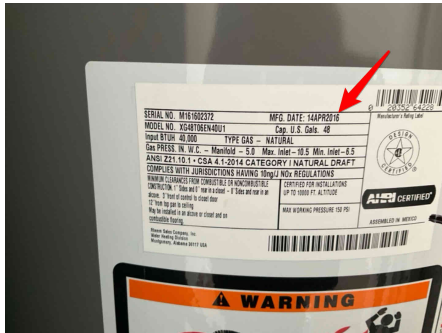
**167:** The water heater is approximately 10 years old.

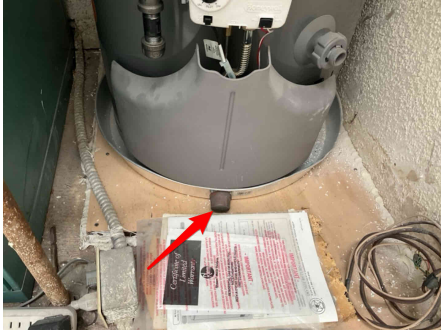
**FTRW** **WARN** **184:** The water heater is equipped with a drip pan, which is designed to minimize water damage from a leak, but does not have a visible drain pipe to a visible exterior location, as would be required by current building standards. It should be monitored regularly for signs of a leak and/or extended to the exterior in compliance with current jurisdictional requirements.

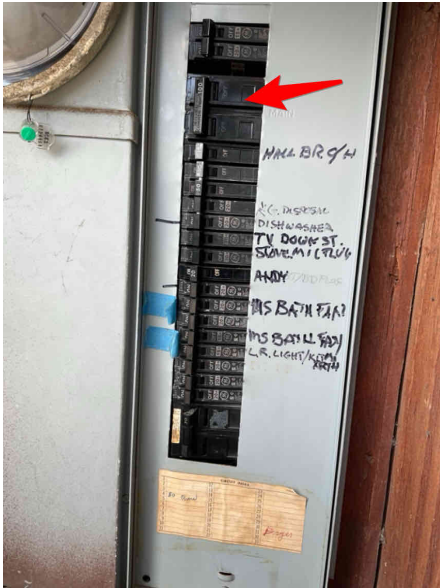
**217:** The capacity of the service(shut off) appears to be 100 amps.

**218:** The main panel and/or shut off is located at the front of the structure.

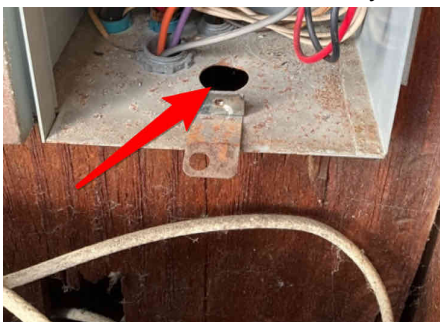
**FEVL** **WARN** **223:** There were knockouts/twist outs missing from the panel. We recommend installing a blank cover over the hole for safety reasons.

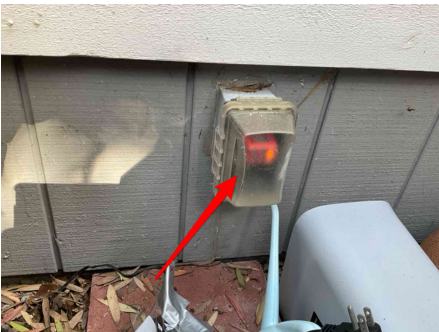
**252:** Complete ground fault circuit interrupter(GFCI) protection was not found/verified at the exterior as is the current standard. We recommend complete protection be ensured at all exterior receptacles.

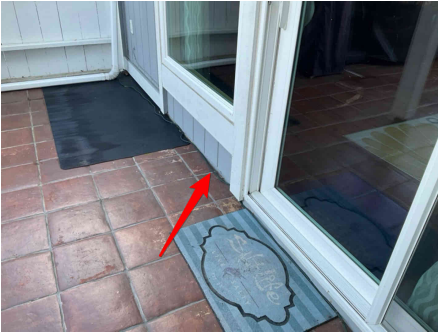
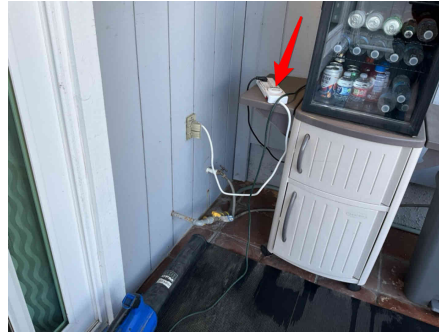
**WARN 254:** We found extension cord and/or multi-plug adapter wiring installed/in use. This type of wiring is easy to overload and can be easily damaged. Removal of all substandard wiring and replacement with proper circuitry is recommended.

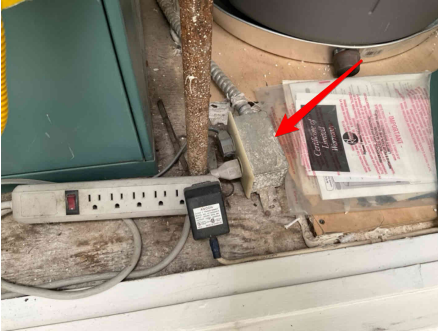
**FTRW** **WARN** **IMPT** **277:** The receptacle in this area was placed such that it would be susceptible to damage (on furnace deck).

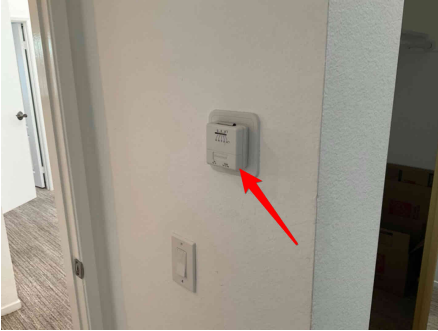
**286:** There are 2 thermostats. We recommend consulting owner/expert regarding their function.

Not functional

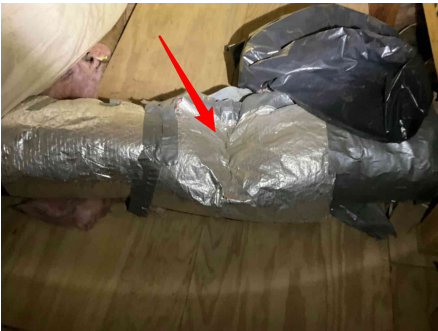
**289:** One or more sections of the ducting have been deformed. This condition could affect the air flow and we recommend consulting owner/expert regarding past/future performance .

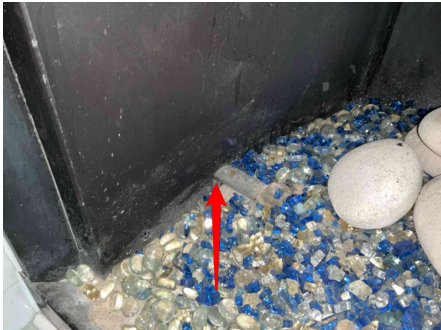
**312:** Voids were noted around the gas pipe in the firebox. While no adverse conditions appear to have resulted, this is a fire safety issue and we recommend filling the voids as preventative maintenance.

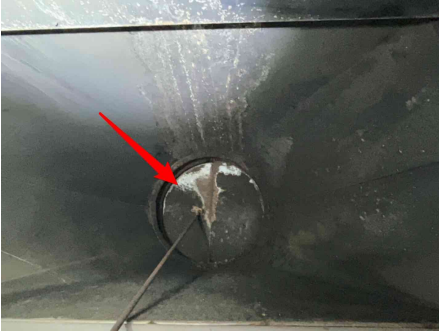
**317:** Because the fireplace is equipped with a gas supply and/or artificial logs, care should be taken to keep the damper open or combustible gas fumes could be trapped inside the building. The installation of a damper block is recommended. Most manufacturers currently recommend that the damper be blocked fully open for the safest possible operation.

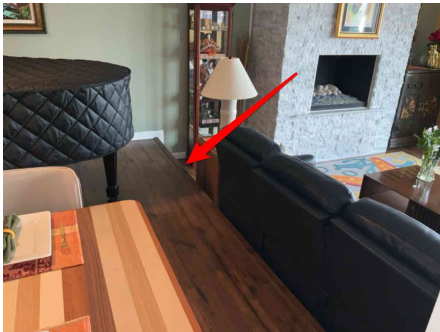
**SFTY** **WARN** **397:** The railings are missing at the entry stairs or raised platform. We recommend they be replaced or install new ones for safety.

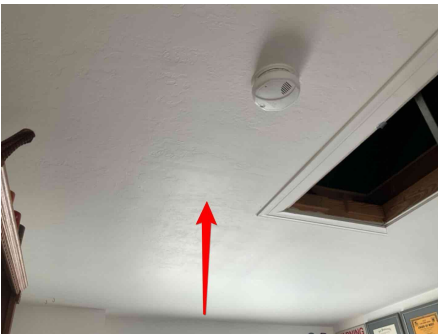
**FTRW 428:** There was patching noted on the ceiling. We recommend consulting seller/occupant regarding reason for the patching as well as obtaining any pertinent receipts.

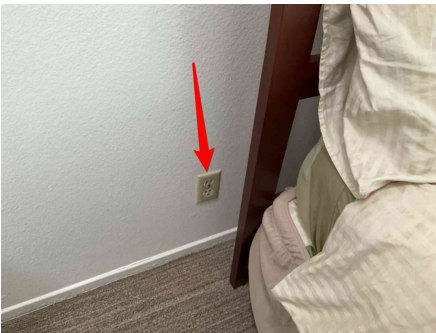
**436:** There was an obstacle or ground pin stuck in one or more of the receptacles, which prevented us from testing it. We recommend removal of any obstruction and verification of proper operation.

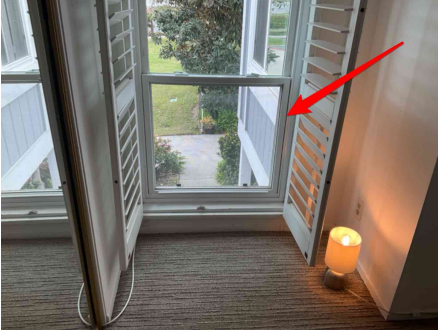
**FTRW SFTY 439:** Due to the location/orientation of the house, weather conditions, film, being dirty or other factors which we will discuss, it was difficult to determine with certainty that there are no failed thermal pane windows in this area. Cleaning of the windows or different weather conditions may reveal issues. We recommend the windows be properly cleaned and then evaluated by a window specialist.

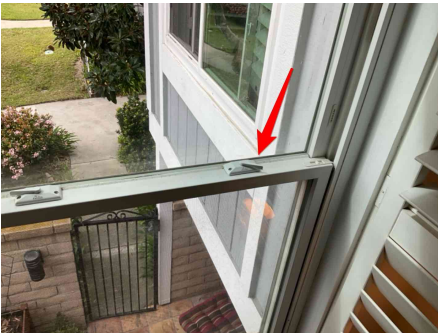
**FTRW 440:** One or more windows will need service to work properly, such as lubricating, trimming, or adjusting the hardware.

**441:** One or more window locks or latches need to be serviced to be fully/properly functional.

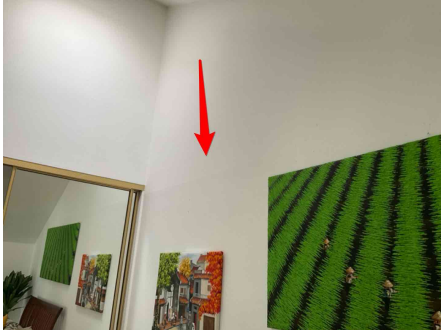
**FTRW 444:** There are cracks on one or more of the walls. While this is a common condition with this type of construction, in this geographic area and may not necessarily indicate a structural deficiency, it does indicate movement and we recommend confirming this with the appropriate specialist as well as consulting owner regarding possible past issues.

Seam crack/patch

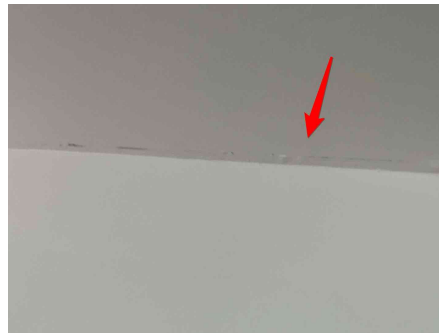
**446:** There were cracks, bubbling tape, or seams noted on ceiling. They appear to be cosmetic only at this point and probably a result of patching holes, remodeling or scraping and retexturing the ceilings. However, we recommend consulting the owner or a specialist to confirm this.

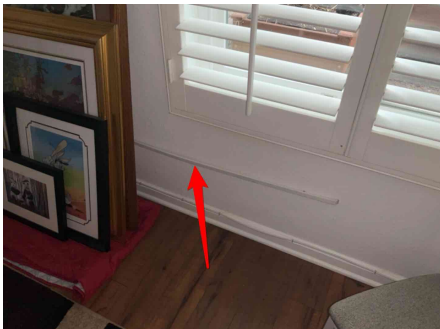
**456:** Improper wiring methods have been employed in this area(loose on wall wiring). We recommend all substandard wiring be abandoned or removed and properly installed using approved materials.

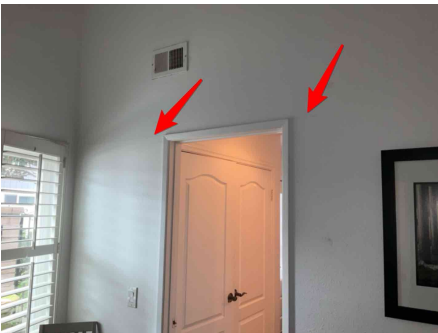
**462:** There were cracks, bubbling tape, or seams noted on walls. They appear to be cosmetic only and probably a result of movement or installation issues. However, we recommend consulting the owner or a specialist to confirm this.

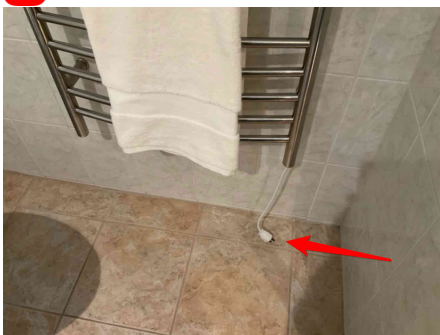
**FTRW** **470:** The towel warmer was not functional time of inspection.

Unplugged - no receptacle

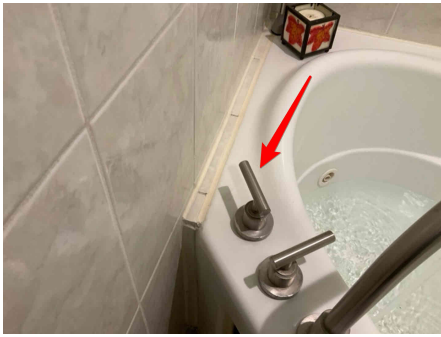
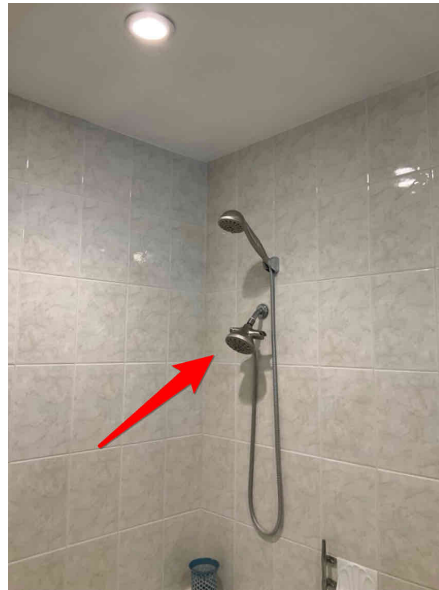
**477:** The shower diverter was not working properly and not allowing water to come out of the shower head(worked hard - inspector afraid to break it).

Not functional

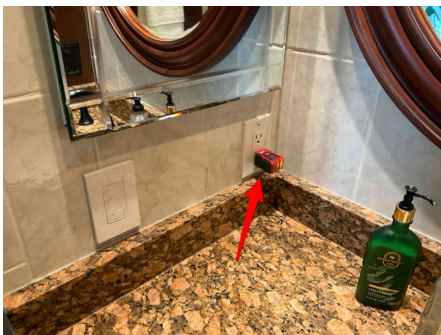
**478:** There is not complete GFCI protection installed in this area. We recommend complete protection be installed as per current standards.

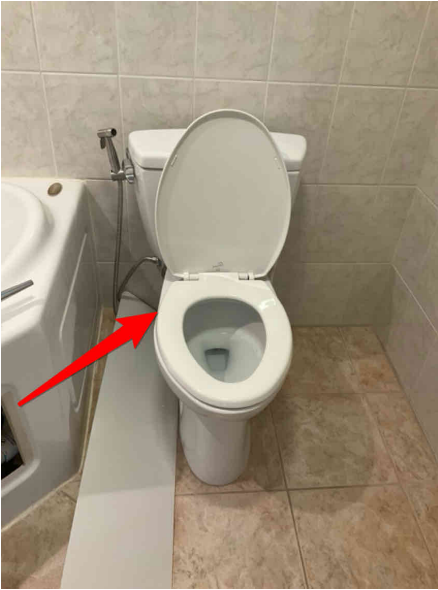
**482:** The toilet was not operational at the time of our inspection(shut off at valve). We recommend the reason be determined and the toilet be repaired or replaced as needed.

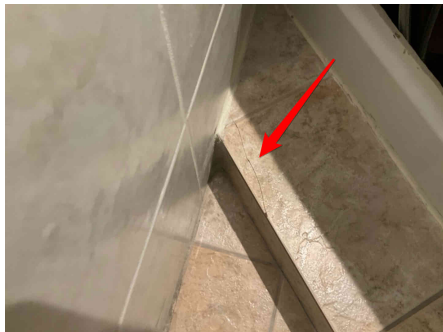
**FTRW** **491:** There are cracks and/or chips in the tiles and/or grout, which you should view for yourself. They are likely to have been caused by movement or an insubstantial mortar base, but you may wish to seek the opinion of a specialist.

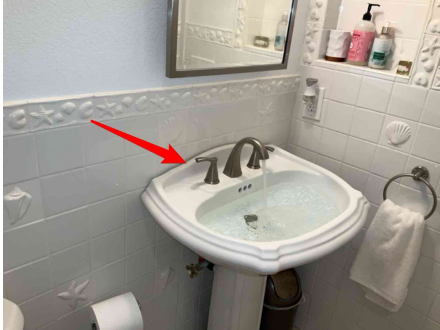
**516:** The pedestal sink is loose at its connection to the wall. We recommend securing and sealing it properly.

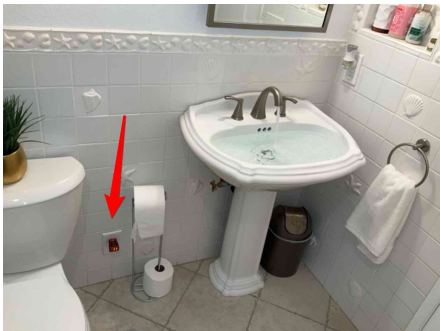
**520:** There is not complete GFCI protection installed in this area. We recommend complete protection be installed as per current standards.

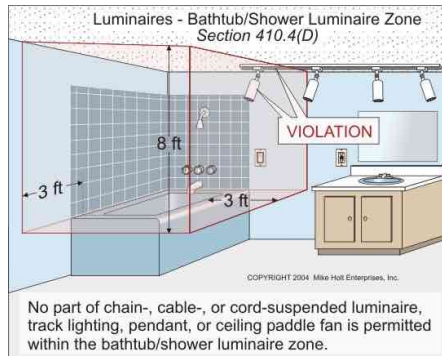
**WARN 522:** One or more lights in this area fall into the wet or moist environment zone. The fixtures within this area are currently required to be rated for wet or moist environments. We recommend consulting a qualified, licensed electrician for ramifications of this condition and suggested remedies.

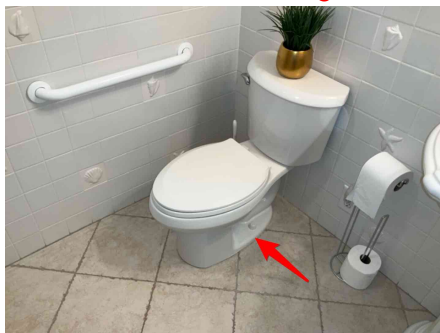
**523:** The toilet is loose or not sitting level at the floor. While no damage was evident, this condition should be addressed so that leakage does not develop and cause damage. We recommend that the toilet be removed, a new wax ring installed, then reattached to the floor.

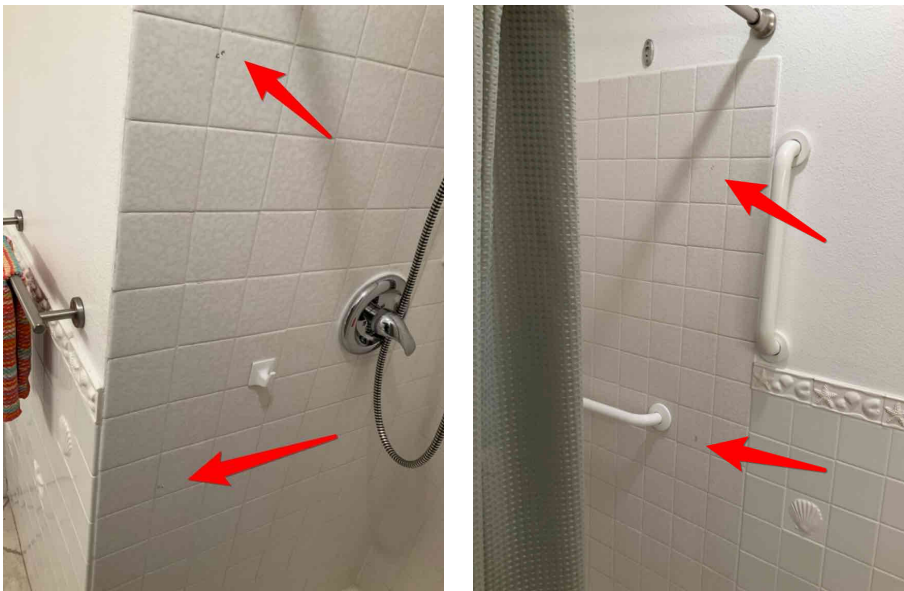
**FTRW 534:** There were voids noted in the shower walls that may allow water intrusion into the wall cavity. We recommend they be sealed and regularly monitored.

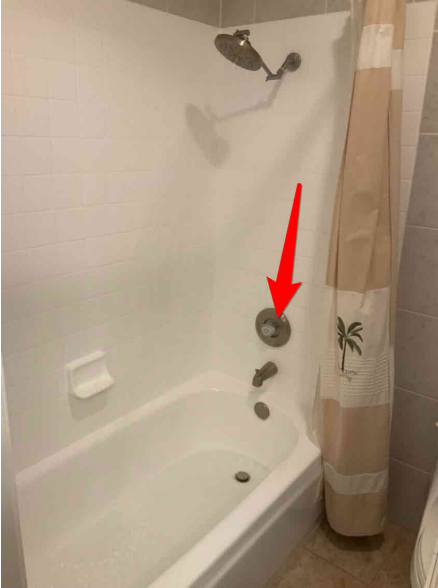
**FTRW 551:** The mixing valve does not appear to be operating properly (there is not a positive stop on the hot or cold side). We recommend repair or replacement as deemed necessary.

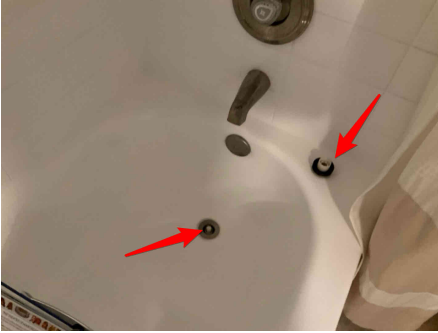
**FEVL 558:** The drain stop is missing or is not functioning properly/easily. We recommend repair or replacement as needed.

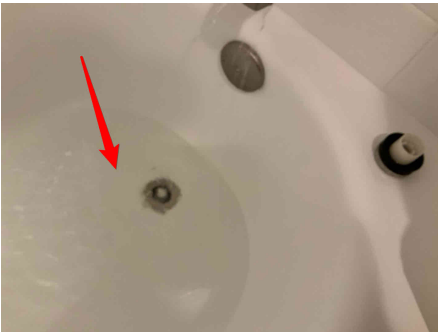
**FEVL 559:** The tub drains slowly and should be serviced to ensure that the blockage does not involve the main sewer pipe.

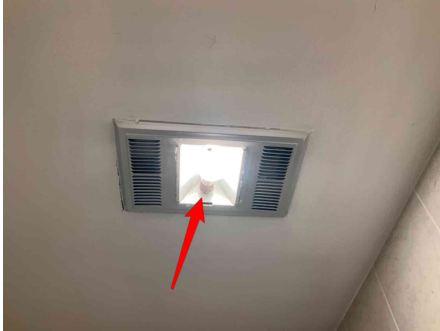
**FEVL 567:** A grill or light cover was loose or missing at the exhaust fan. We recommend securing/replacement as deemed necessary.

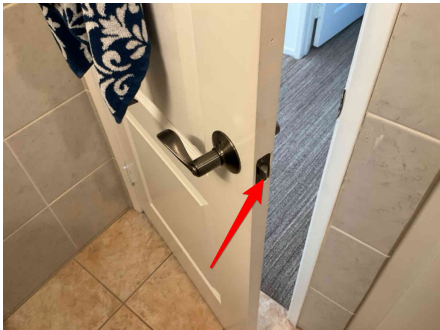
**DFMT 570:** One or more of the door striker plates need to be adjusted for the striker pin to engage and the door(s) to latch as intended.

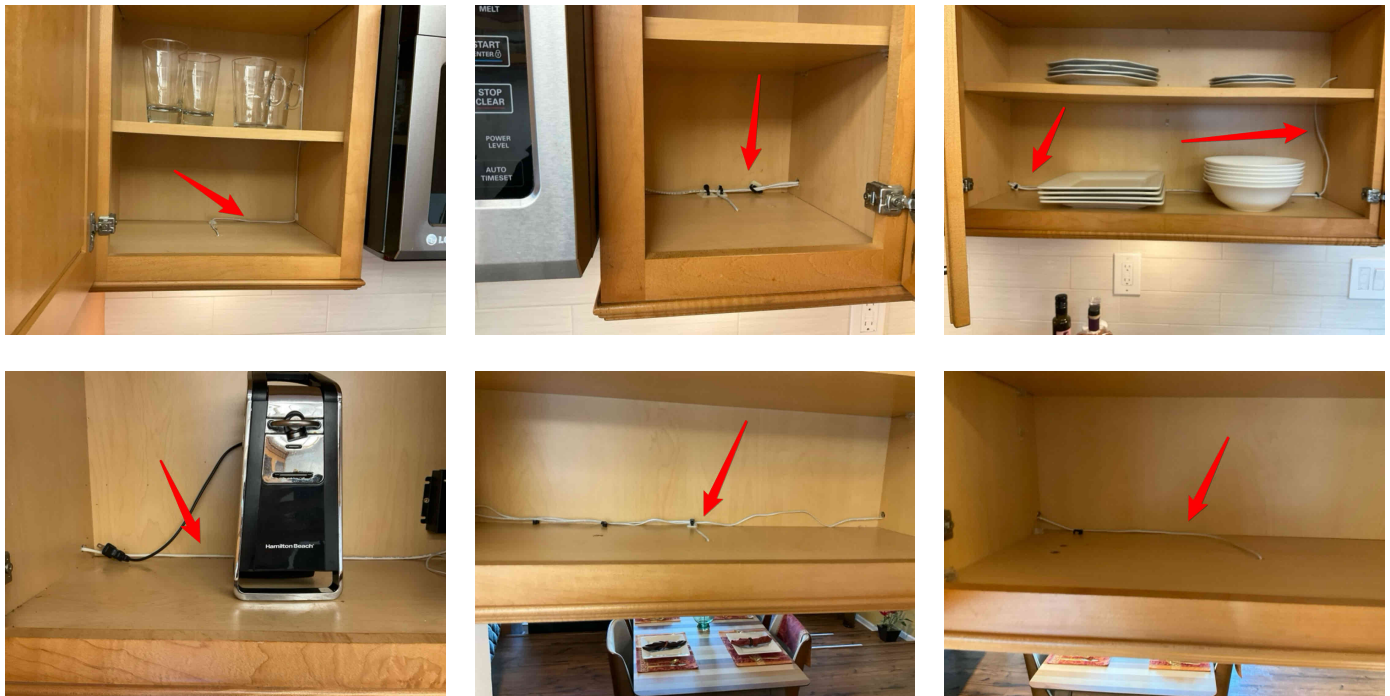
**583:** We noted exposed wiring in the cabinets. We recommend all exposed wiring be protected or terminated as necessary in compliance with current jurisdictional requirements.

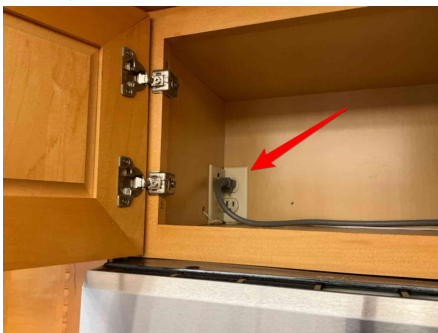
**FTRW** **WARN** **591:** There are not proper clearances to a combustible material at one or more receptacles in this area (cabinet above microwave). We recommend proper clearances be provided.

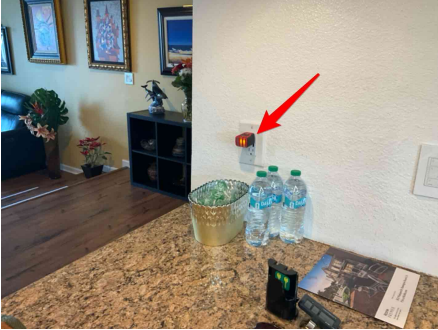
**592:** There is not complete Ground Fault Circuit Interrupt (GFCI) protection at all receptacles serving the countertops, which is required by current building standards. We recommend upgrading to current standards for a higher level of safety.

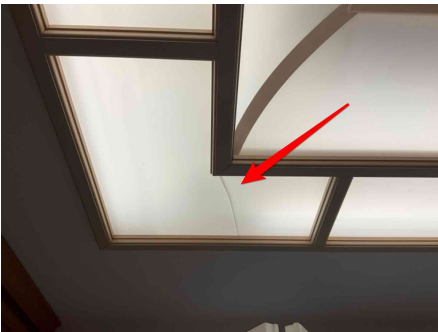
**DFMT 595:** One or more of the light panels were missing, cracked or broken at the time of our inspection. We recommend replacement as necessary.

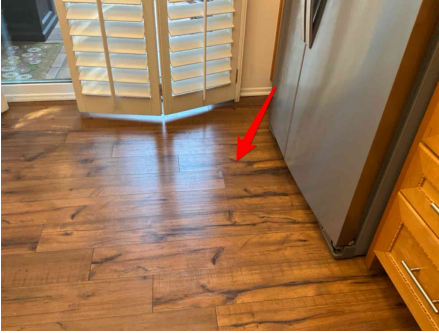
**FEVL 600:** The flooring shows some cupping, which typically indicates the presence of water at some point. We recommend consulting owner regarding any past water issues as well as further evaluation by the appropriate professional to ensure issues have been remedied.

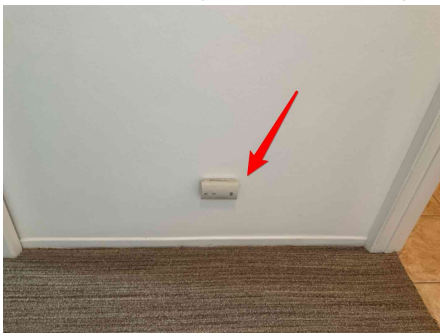
**FEVL 621:** While there are one or more carbon monoxide detectors installed, the placement does not appear to be in the proper/optimal place/position. We recommend consulting the manufacturer's recommended placement and placing as required for optimum response and safety.

**UPGR IMPT 622:** This inspector recommends the installation of a newer style combination smoke detector/carbon monoxide detector with a 10 year battery life in this area. These detectors are both effective and long-lasting.

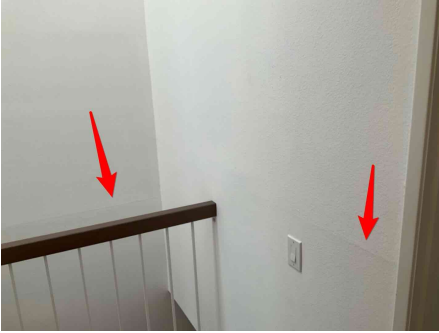
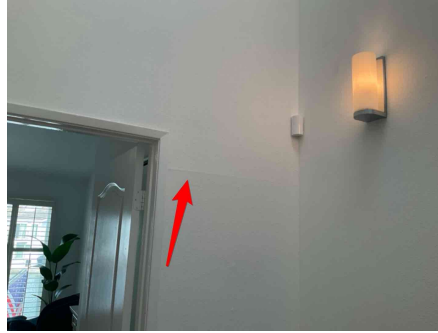
**FEVL 626:** There were cracks, bubbling tape, or seams noted on walls. They appear to be cosmetic only and probably a result of movement or installation issues. However, we recommend consulting the owner or a specialist to confirm this.

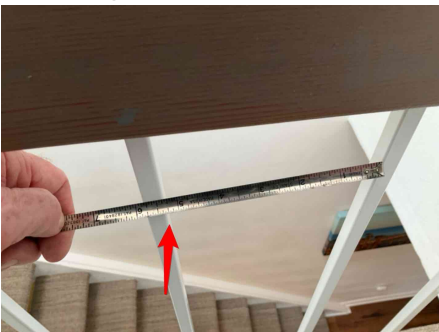
**WARN 629:** Some of the railings are considered "open and climbable" by current standards which means that the balusters are greater than 4 inches apart or there are other openings that are greater than 4 inches apart that could facilitate easy climbing by a child.

More than 4" current standard

**IMPT 630:** If small children occupy or visit this residence, suitable precautions should be taken to safeguard them.

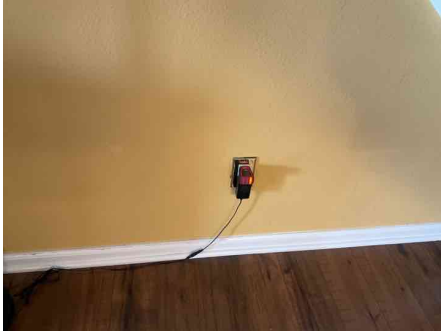
**636:** One of the receptacles in this area has an open or weak ground. We recommend its connections be checked and secured and verified as properly grounded for safety.

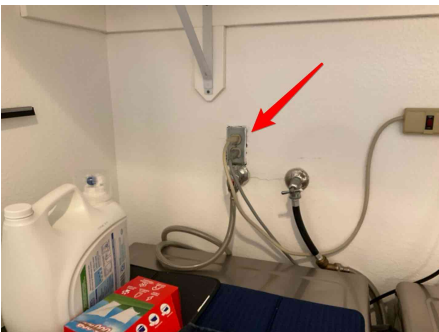
**653:** There is no GFCI protection installed for this area as is currently required. We recommend anti-shock protection be installed in accordance with current jurisdictional requirements.

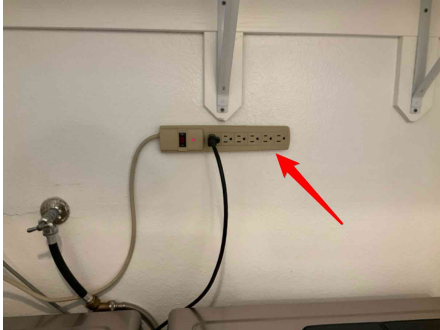
**654:** There are extension cord or multi-plug adapters installed. We recommend removal as they are easy to overload.

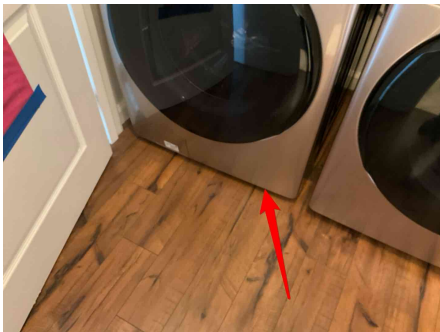
**UPGR** **658:** As a preventative measure, we recommend that a drained catch pan be installed under the washing machine to help prevent leakage onto the flooring and the subsequent damage to surrounding areas in the event of a leak or overflow

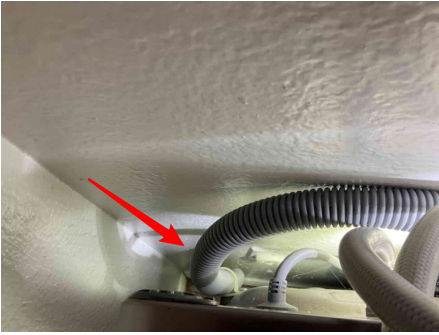
**659:** The output and standpipe trap for the washing machine was not seen/verified. We recommend verification or installation of a proper standpipe trap.

**660:** The drain for the washing machine was not visible due to the placement of the appliances. We recommend verification of a properly installed evacuation drain.

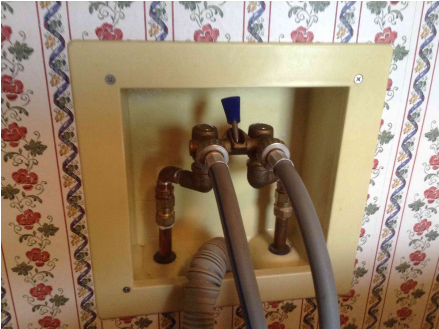
**UPGR** **663:** Here is an example of an easy water shut off setup for the washing machine to help prevent water leaks and subsequent damage.

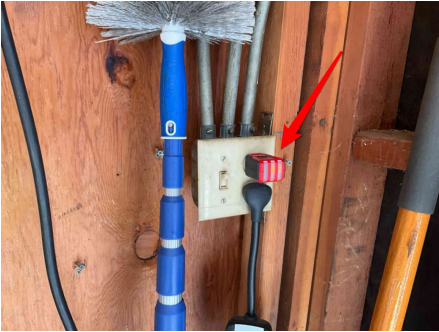
**683:** There is no visible/functional GFCI (ground fault circuit interrupter) protection for this area as is the current standard. For an increased margin of safety, we recommend complete protection be installed in compliance with current standards.

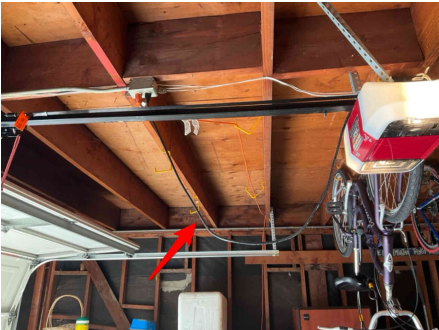
**FTRW** **WARN** **684:** We found extension cords and/or multi-plug adapters in use. This type of wiring is easy to overload and can be easily damaged. Removal of all extension cords/multi-plugs and replacement with proper circuitry is recommended.

**FTRW** **WARN** **IMPT** **685:** There was loose wiring and/or conduit noted. We recommend all wiring and conduit be secured in accordance with current jurisdictional requirements to ensure safety.

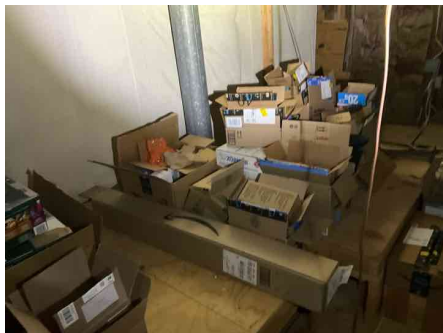
**FEVL 698:** Portions of the attic are being used for storage which precluded a thorough inspection of the area. The framing was not engineered for such use and storage should be limited to lightweight items.

**699:** There were some personal belongings noted in the attic which precluded a thorough inspection of the area.

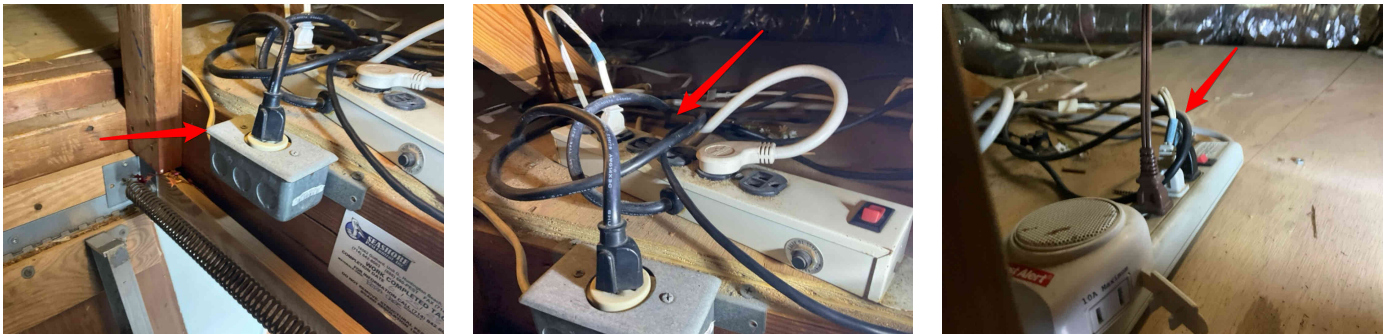
**712:** There is loose wiring near the access and a receptacle protruding in the opening. We recommend that all loose wiring be secured to the framing and/or protected from damage in accordance with present standards.

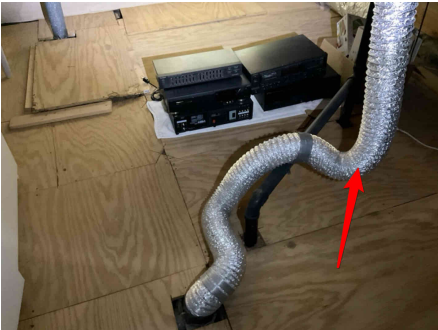
**FTRW 721:** One or more of the bathroom exhaust vent configurations do not appear to be optimal to ensure the best possible performance of the unit(not best material, routed optimally or completely to the exterior). We recommend redress as deemed necessary if the performance of the fan(s) is deemed inappropriate.

**722:** There were exhaust fan ducts installed that are not typically recommended for this purpose and are easily damaged. We recommend replacing them with proper ducting material and running them optimally for best performance.
