Key Findings Report

Property Address: 1807 Newport Hills Dr E
Newport Beach CA 92660

Date of inspection: 1/23/2026 **Inspector:** Reid Anderson

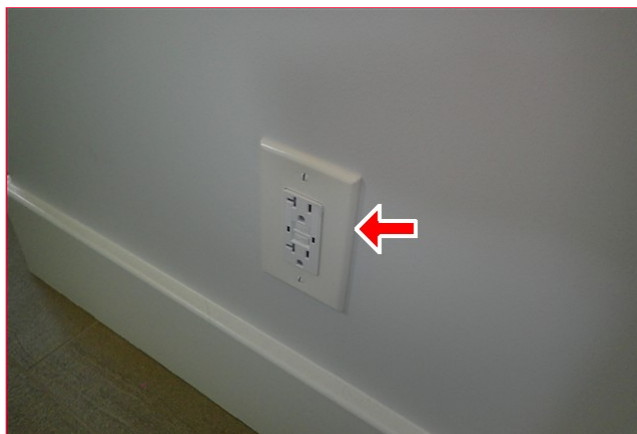
Item 1 - Item 2(Picture)

1. When tested, the GFCI tripped or was already tripped at some Bathroom receptacles near floor . However, despite attempts to do so, the device would not reset. This usually indicates that either the GFCI is defective or is on the same circuit as another GFCI that is tripped.- The seller may know the location of another GFCI on this circuit. If not, a qualified electrician should make repairs as needed. The seller/occupant should take immediate steps to connect any appliance to a functional power source, particularly freezers or refrigerators.

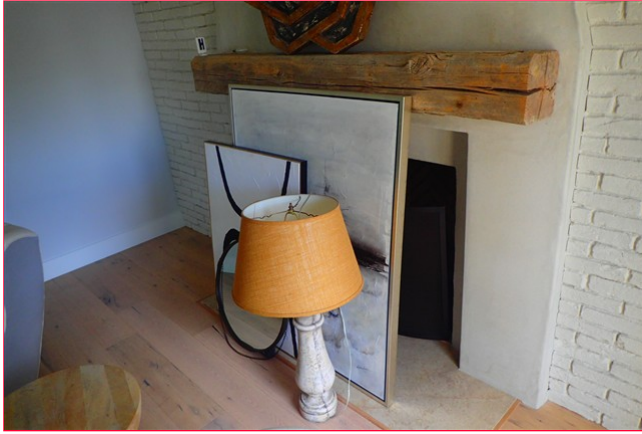
Item 3 - Item 1(Picture)

3. (2) The gas log fireplace is not equipped with a damper clamp that stops the damper from fully closing. - A proper metal C clamp or damper clamp should be installed to ensure toxic gases go up the chimney, instead of escaping to the interior.

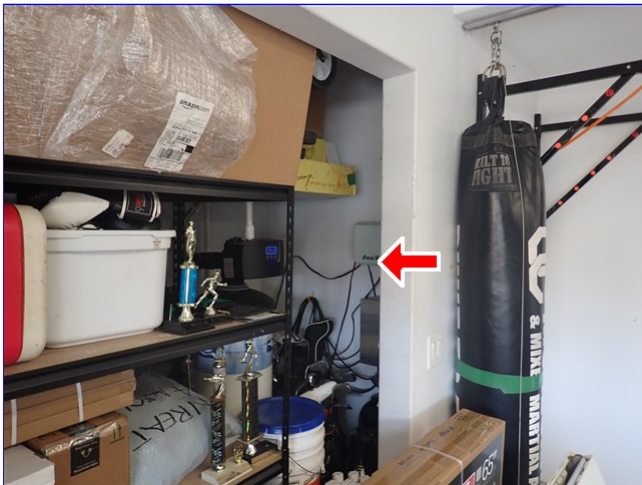
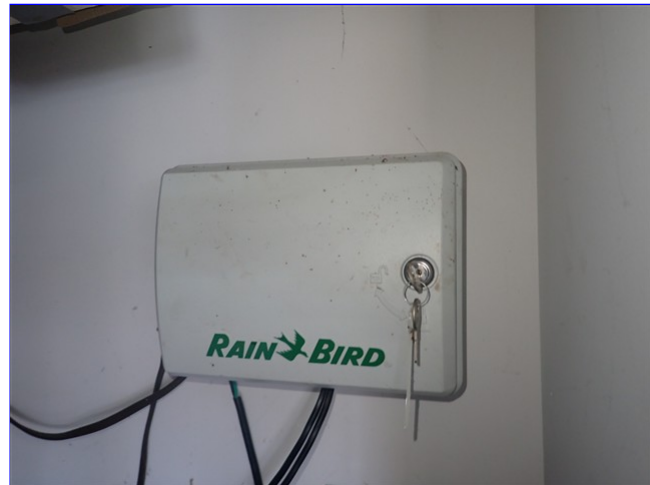
18. Testing of irrigation (yard sprinklers) systems is beyond the scope of this inspection.
- We suggest that you have the seller, or a qualified sprinkler specialist, demonstrate the irrigation system and any related timer controls.

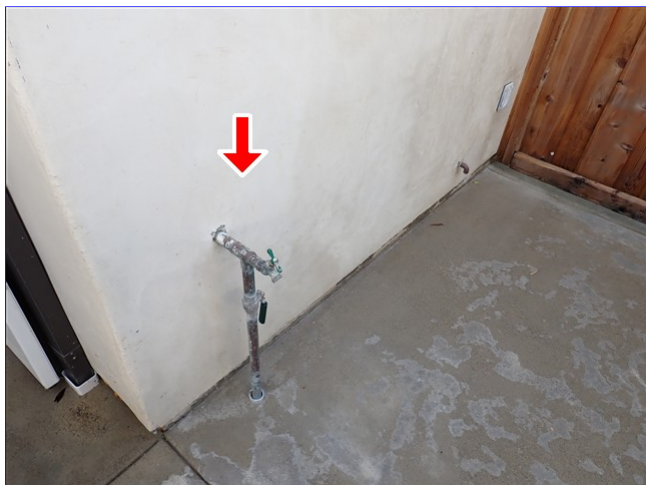
Item 20 - Item 1(Picture)

20. We could not verify the location of the main water supply shut-off valve. - We recommend that you ask the seller where the shut-off valve is located.

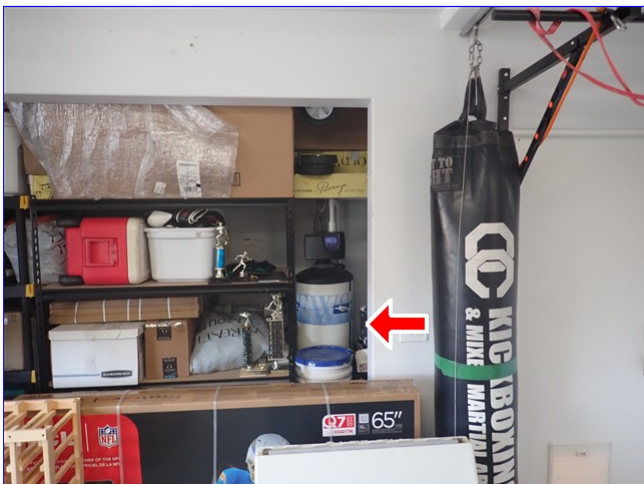
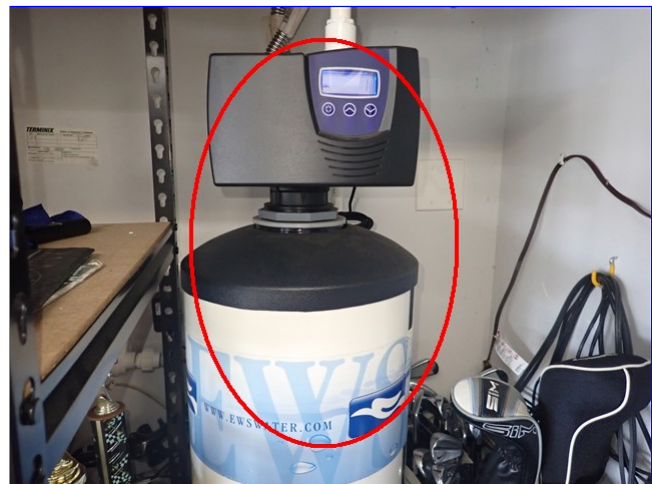
- 28. Water softening/conditioning equipment has been added to the water supply system for this house. Evaluation of this equipment is outside the scope of this inspection.
 - We recommend asking the seller for information about this equipment. Sometimes this equipment is leased from, and serviced by, a service provider.

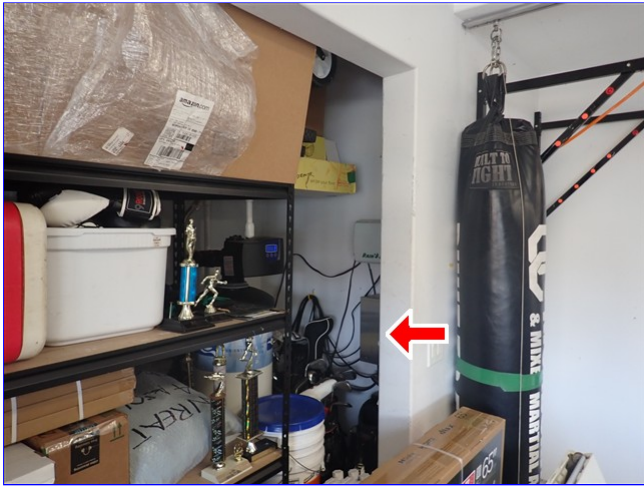
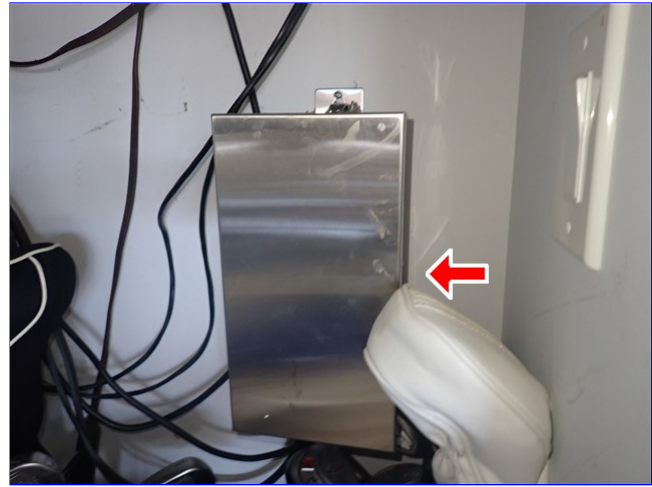
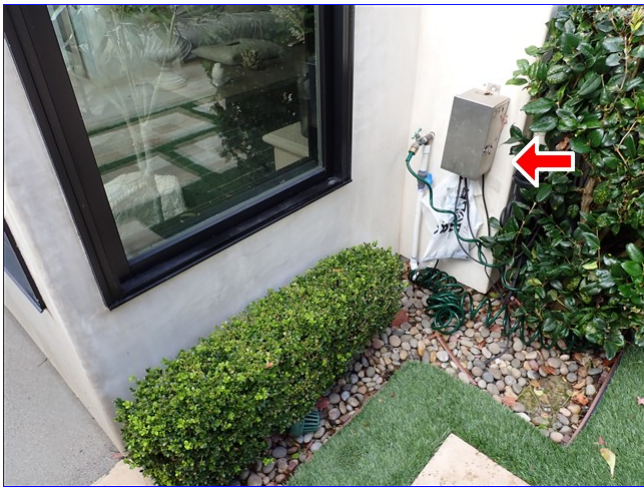
- 29. This property has low voltage landscape lighting and/or fixtures controlled by timers or photo cells. An evaluation of these types of lighting is beyond the scope of this inspection.
 - The function of these fixtures should be verified at or before the final walkthrough.

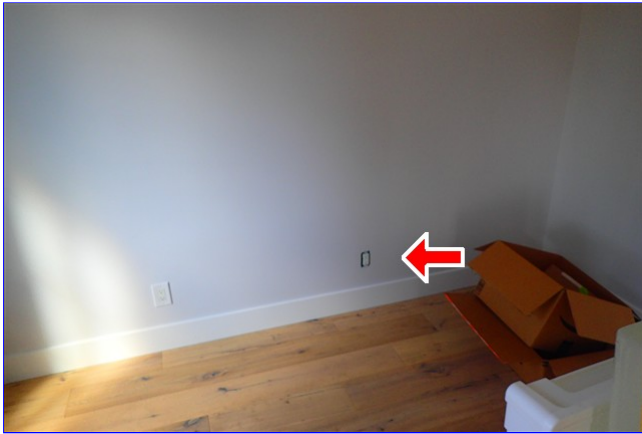
Item 30 - Item 3(Picture)

- 30. (1) One or more cover plates for receptacles and/or switches are missing and/or damaged in the building. This can be a shock hazard. All missing or damaged cover plates should be replaced with new cover plates.

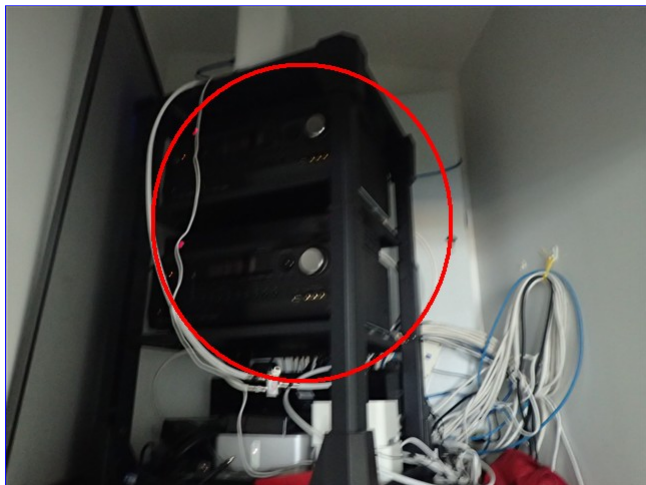
Item 38 - Item 1(Picture)

- 38. (3) Speakers and/or audio controls were noted but not inspected and are beyond the scope of this inspection. - We recommend having the seller demonstrate the system and/or review by a qualified specialist.

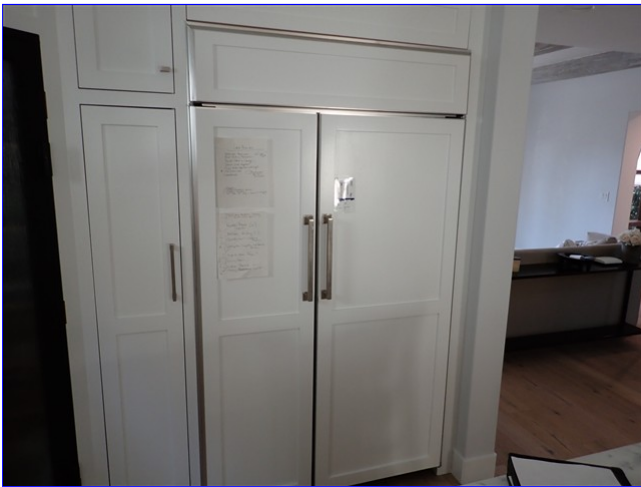
Item 42 - Item 1(Picture)

42. Tip: Inspection and evaluation of the refrigerator is beyond the scope of this inspection. Periodic cleaning of the refrigerator coils is recommended to keep the unit operating at peak efficiency. Referral to the owner's manual is recommended for information on access and cleaning of the coils.

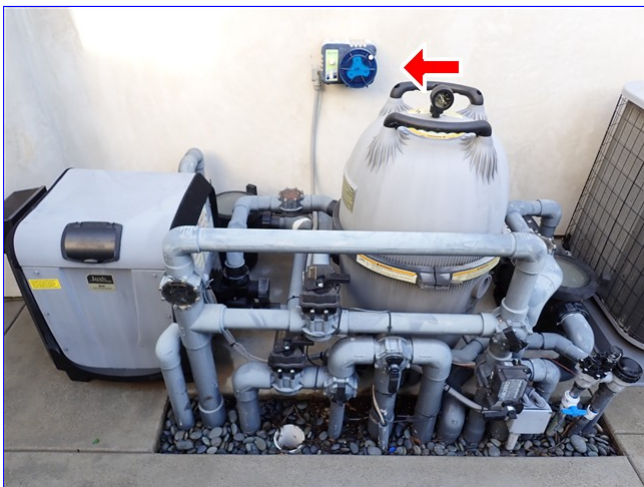
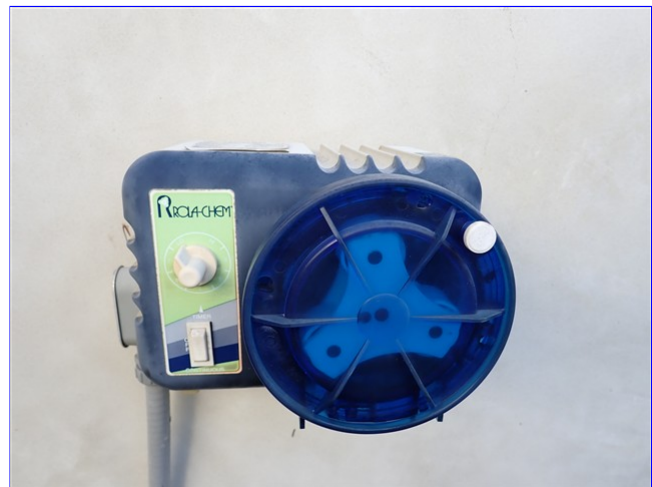
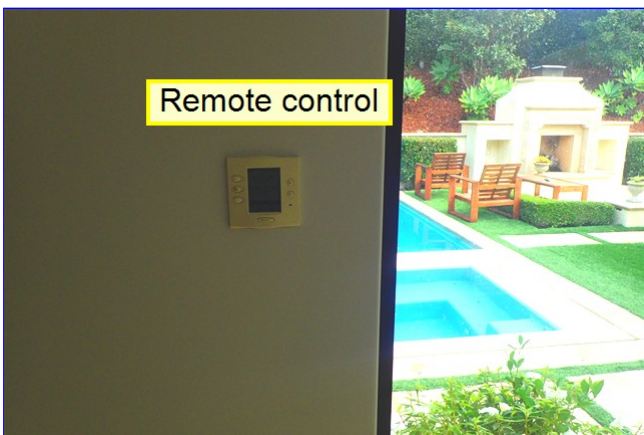
- 44. The operation and testing of the special features that are associated with some pool installations (i.e. automatic water treatment systems and remote controls etc.) are beyond the scope of this inspection. -We recommend that you have the owner or a pool technician demonstrate the special equipment and/or features before closing escrow.
