### *Inspection Report*

Address: 710 Los Osos Valley Rd Los Osos, California

2/16/23

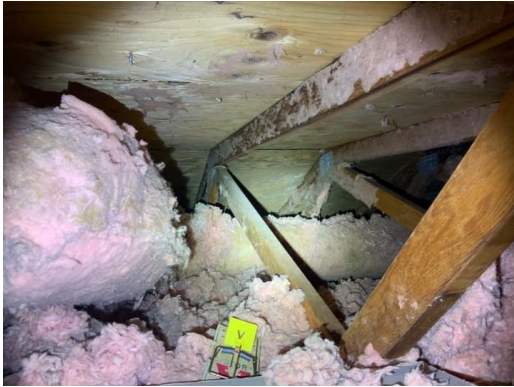
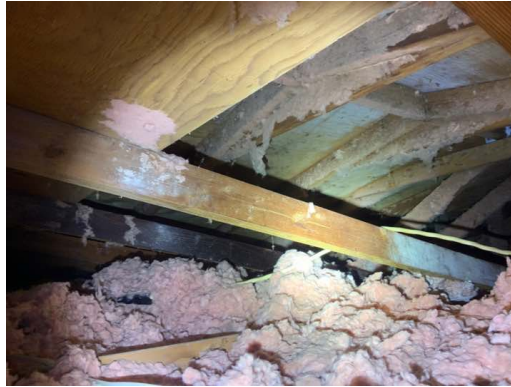
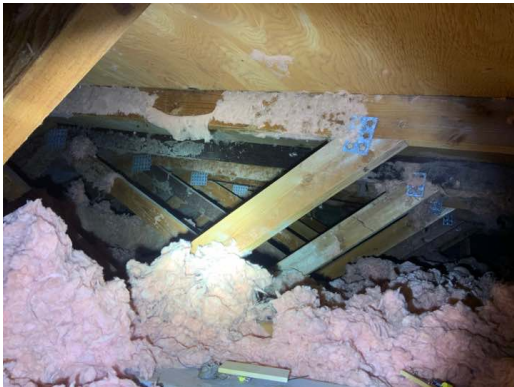
46: ATTIC ACCESS LOCATION: Primary Bedroom Closet

47: ATTIC CONDITION: No noted framing defects found in the accessible and visible areas of the attic.

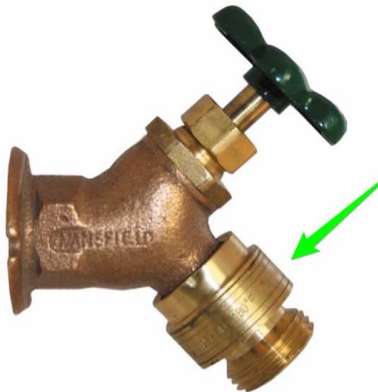
**SU 57:** Anti-siphon valves recommended on exterior hose faucets where not installed.

Example of an anti-siphon valve on a hose faucet

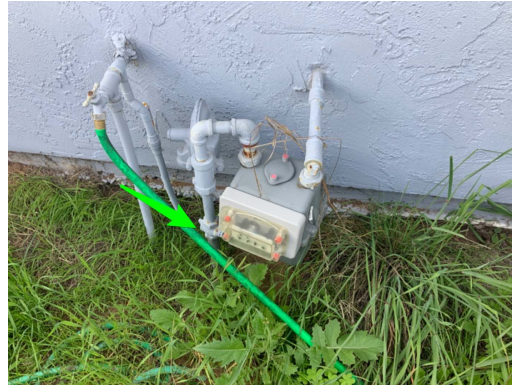
Main gas shut off valve

**62:** Gas shut-off appears serviceable.

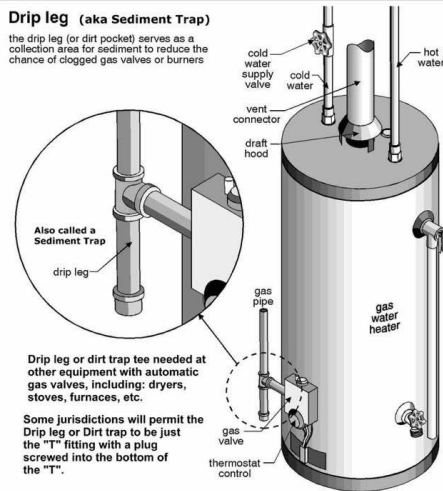
**FIGURE 1212.8**  
**METHOD OF INSTALLING A**  
**TEE FITTING SEDIMENT TRAP**  
[NFPA 54: FIGURE 9.6.7]

**E&C 70:** Recommend the installation of the missing sediment trap / drip leg at the WATER HEATER gas piping at flex connection by a certified or licensed plumbing professional familiar with minimum requirements.
