# Home Inspection Report

Prepared for: Walter Gularte

715 Shannon Hill dr.  
Paso Robles, CA 93446

Inspected by:  
Tom Myers  
Myers Home Inspection LLC  
805-470-9191

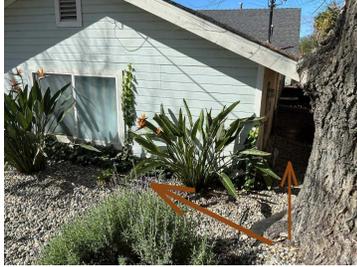
Grading: (continued)

Grading: Negative slope, Moderate slope - **MAINTENANCE:**, Landscape grading should be sloped away from Garage, house and foundation. Recommend a licensed landscaper to correct grading issues. Hidden moisture damage may be present., Driveway Grading has negative slope and water is pooling and running against the foundation. Water can cause foundation settling and erosion problems.. drainage needed at garage.

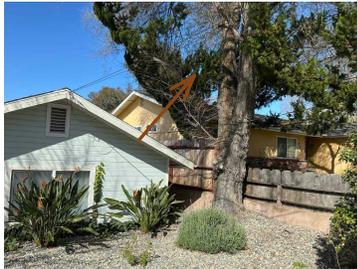
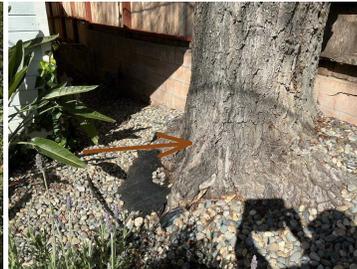
10. Maintenance required Vegetation: Trees and shrubs - MAINTENANCE: Planting should be maintained away from exterior of structure. , Tree limbs over hang the roof and should be cut back

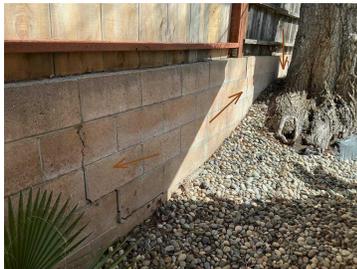
11. Maintenance required Retaining Walls: Concrete - MAINTENANCE: Tree damage

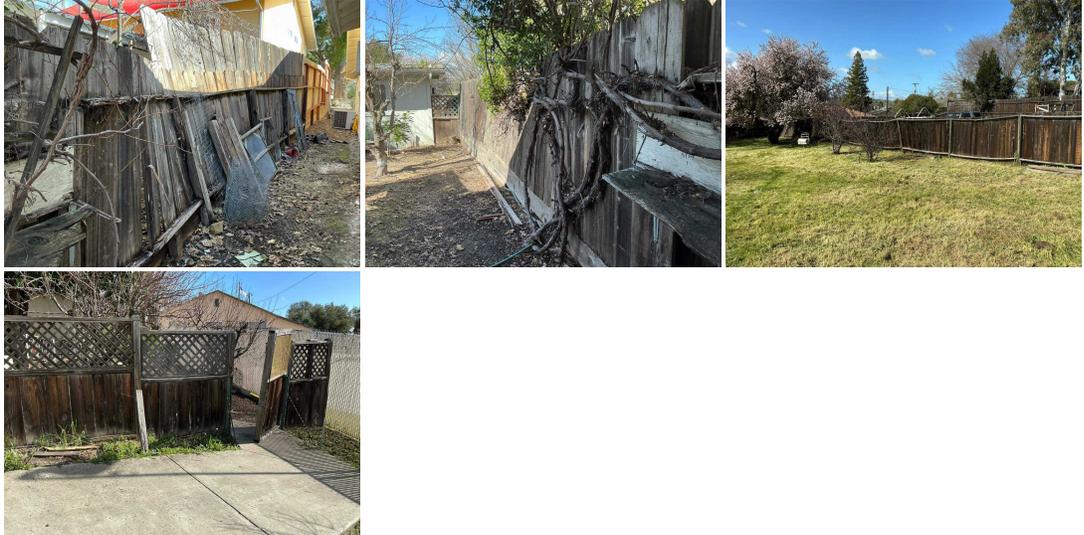
Fences: (continued)

13. Maintenance required Fences: Wood, Chain link - MAINTENANCE: , Damaged, Wood rot or pest damage. Falling over into neighbor. A qualified contractor is recommended to evaluate and estimate repairs

Repair of fences needed

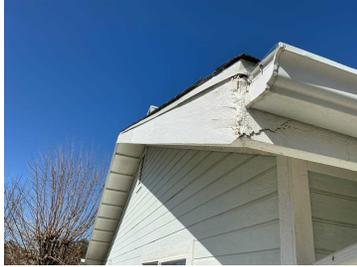
Fascia: (continued)

, Areas of Moisture, Wood rot or pest damage noticed., A qualified contractor is recommended to evaluate and estimate repairs, Also, Refer to pest report for further information.

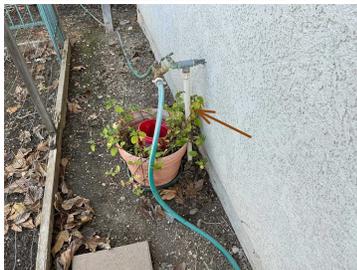
Hose Bibs: Rotary - **MAINTENANCE:**, Install of anti siphon device recommend at all exterior hose bibs to prevent reverse water contamination.. leaking spigots. Loose pipes need secured. , Exterior PVC pipe are not UV protected and need wrapped and supported to prevent damage., Note: Valves are not operated as part of this inspection, any reference to any valve inspected is visual only unless otherwise noted., A licensed plumber is recommended to evaluate and estimate repairs

Recommend further evaluation by a licensed, qualified plumber to repair leaking spigots, faucets and water line connections in house and exterior. See individual room notes. Adjust water pressure to between 60-80psi. Secure water lines and pipes as needed.

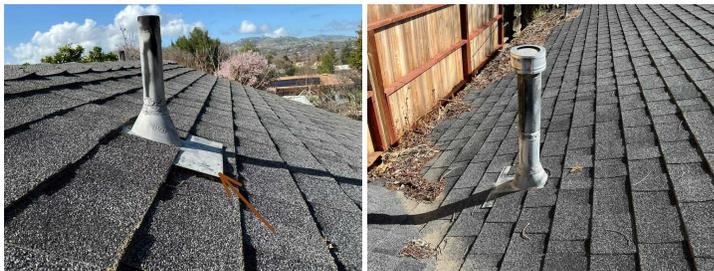
9. Maintenance required Plumbing Vents: ABS, Galvanized - MAINTENANCE:

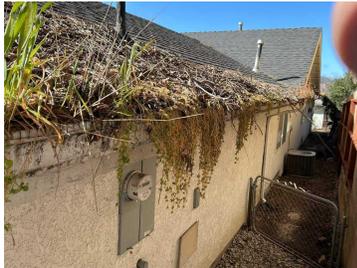
11. Maintenance required Gutters: Aluminum - MAINTENANCE:

, Need cleaning

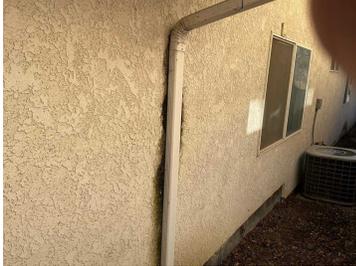
12. Maintenance required Downspouts: Aluminum - MAINTENANCE:  
, Leaking

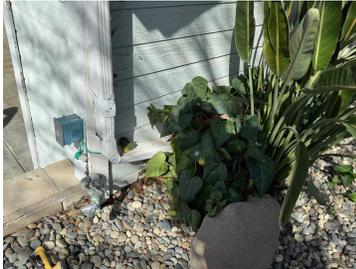
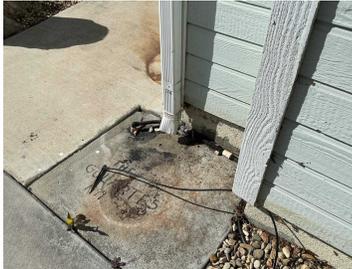
13. Maintenance required Leader/Extension: Missing, In ground drainage - MAINTENANCE:  
, Leaders do not extend 6 feet beyond the foundation perimeter and should be corrected to move water away from foundation

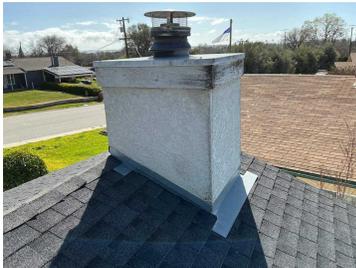
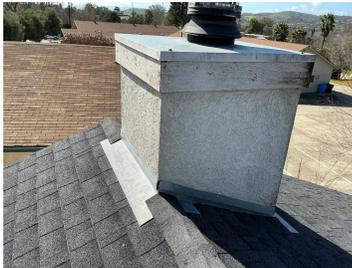
Front of house Chimney

14. Maintenance required Chimney: Framed - MAINTENANCE:  
, Recommend a contractor evaluate, check for hidden damage, eliminate source of moisture and properly repair all deteriorated components.

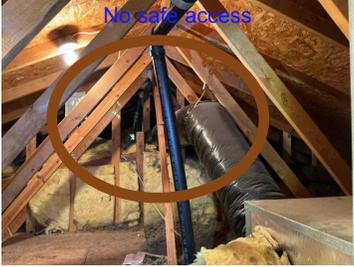
Method of Inspection: (continued)

- 2. Maintenance required Unable to Inspect: 50% - **MAINTENANCE:**  
, Cathedral or vaulted ceiling are not able to be inspected as they have no access., No access or entry at primary bathroom
- 3. Acceptable Roof Framing: 2x4 Truss
- 4. Acceptable Sheathing: Strand board
- 5. Acceptable Ventilation: Gable and soffit vents
- 6. Acceptable Insulation: Blown in
- 7. Acceptable Insulation Depth: 6
- 8. Not Present Vapor Barrier:
- 9. Not Present Attic Fan:
- 10. Not Present House Fan:
- 11. Acceptable Wiring/Lighting: 110 VAC lighting circuit
- 12. Acceptable Moisture Penetration: Not noticed
- 13. Acceptable Bathroom Fan Venting: Electric fan

There was no attic access above primary bathroom or bedroom. Recommend contractor addition in closet or exterior. Check for hidden water damage needed.

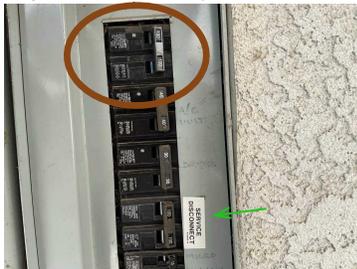
13. Maintenance required Breakers: Copper - **MAINTENANCE:**

There are two 100amp breakers, one main so the other shouldn't be there., Evaluation and repairs from a qualified electrician is needed

Recommend further evaluation by a licensed, qualified electrician to assess dual 100amp breakers in main panel and repair as needed. Repair or replace any non GFCI outlets and exterior weather covers as needed.

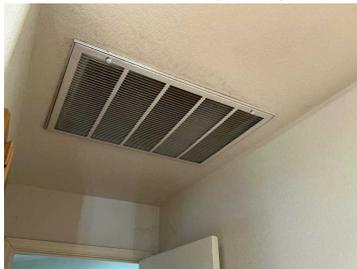
- 2. Manufacturer: Tempstar
- 3. Model Number: GNJ075M16A1 Serial Number: L953922351
- 4. Type: Forced air Capacity: 75 btuhr
- 5. Area Served: Whole building Approximate Age: 1996
- 6. Fuel Type: Natural gas
- 7. Acceptable Heat Exchanger: 3 Burner
- 8. Unable to Inspect: 20%
- 9. Maintenance required Blower Fan/Filter: Direct drive with disposable filter - **MAINTENANCE:**  
Filter is extremely dirty

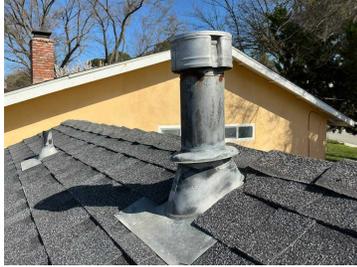
Flue Pipe: (continued)

- 10. Acceptable Distribution: Insulflex duct
- 11. Acceptable Circulator: Gravity
- 12. Acceptable Draft Control: Manual
- 13. Maintenance required Flue Pipe: Double wall - **MAINTENANCE:**  
, Rust holes in piping-replace rusted sections at roof

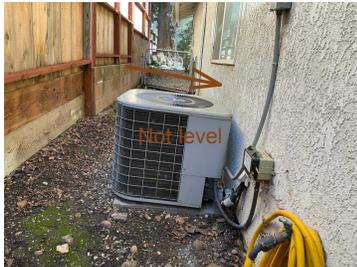
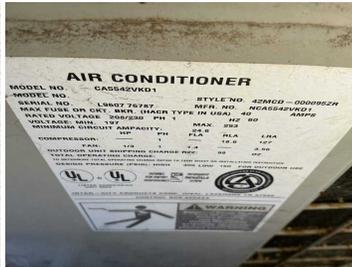
- 1. Acceptable A/C System Operation: Appears serviceable
- 2. Acceptable Condensate Removal: PVC
- 3. Maintenance required Exterior Unit: Pad mounted - **MAINTENANCE:**  
, Not properly supported, sitting out of level. Exterior box has excessive rust. Recommend service.

Recommend further evaluation by a licensed, qualified HVAC contractor to service and repair AC exterior unit and Heater in attic as needed. Advise to life expectancy.

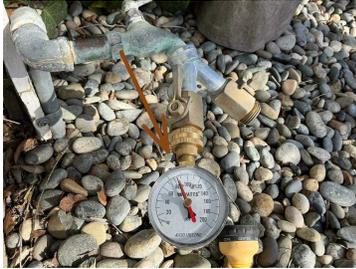
1. Maintenance required Service Line: Copper - **MAINTENANCE:**  
, Pressure should be between 60 - 80 PSI max (82psi) , Recommend adjusting pressure regulator.

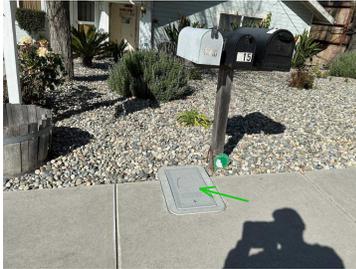
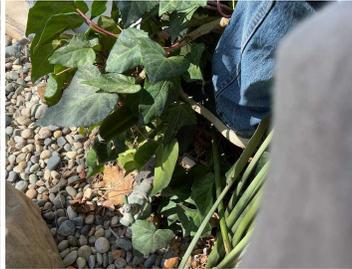
2. Maintenance required Main Water Shutoff: Garage - **MAINTENANCE:**  
Remove vines for access

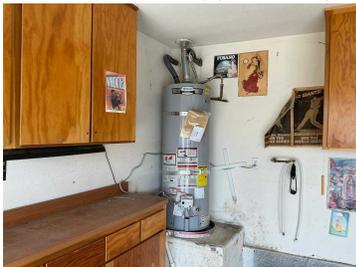
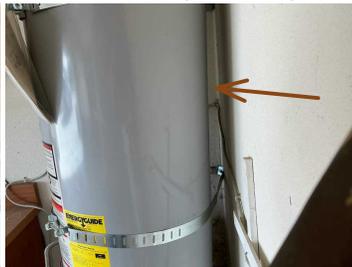
8. Maintenance required Water Heater Operation: Adequate - **MAINTENANCE:**  
, Earthquake support straps and or blocking missing or not properly installed

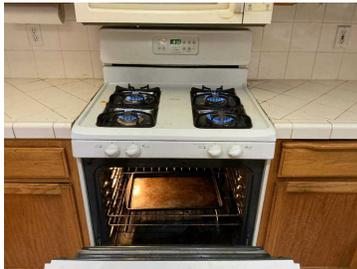
- 1. Maintenance required Cooking Appliances: No tag - **MAINTENANCE:**  
, Recommend anti tip device be added to stove for child safety , recommend cleaning and service

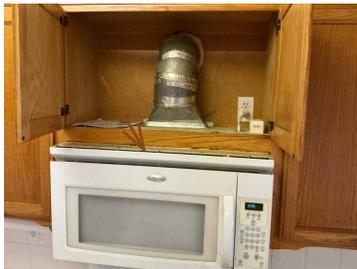
- 2. Maintenance required Ventilator: In microwave above, Through roof venting - **MAINTENANCE:**  
, Not properly vented, leaking at microwave. Recommend repair

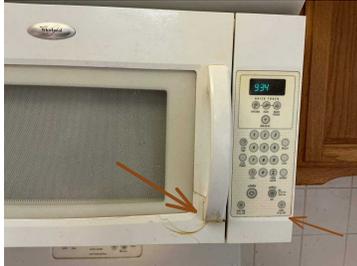
8. Maintenance required Microwave: Whirlpool - MAINTENANCE:  
, Leakage detected at the door seal, loose panel may need replacing

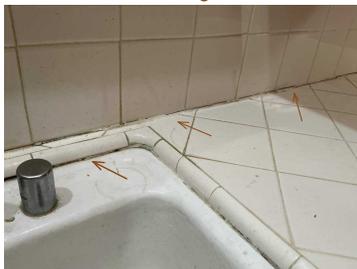
12. Maintenance required Counter Tops: Tile - MAINTENANCE:  
, Needs caulking

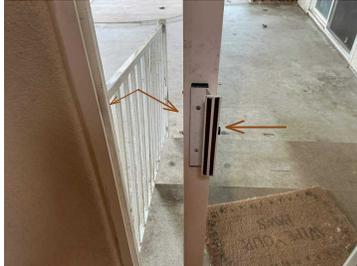
18. Maintenance required Doors: Slider - MAINTENANCE:  
, Lockset(s) not latching-requires adjustment

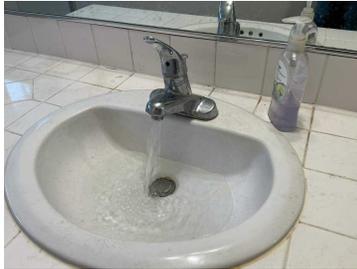
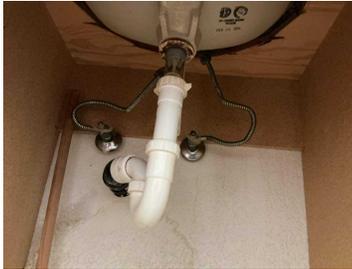
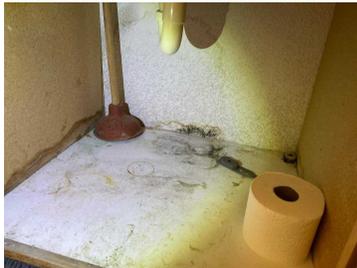
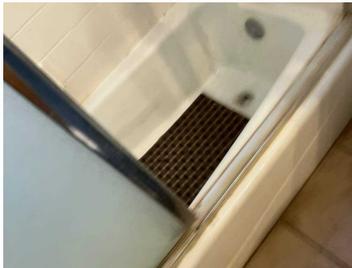
10. Maintenance required Faucets/Traps: Metal with PVC trap - **MAINTENANCE:**  
**, Leaking supply line, Shower diverter not functioning properly, all water is not flowing to showerhead, Build up found in aerator of fixtures possibly caused by deteriorated water., Missing or faulty drain stopper, Recommend a plumber evaluate, check for hidden damage, eliminate source of moisture and properly repair all deteriorated components.**

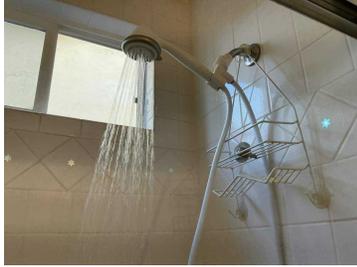
11. Maintenance required Tub/Surround: Porcelain tub and ceramic tile surround - **MAINTENANCE:**  
, Loose grout, Recommend caulking to prevent water intrusion

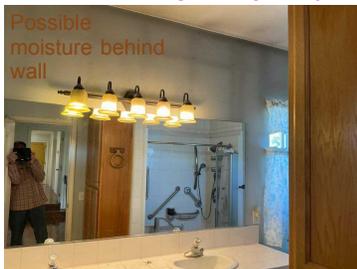
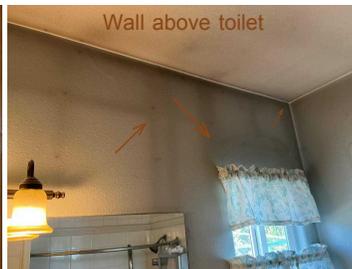
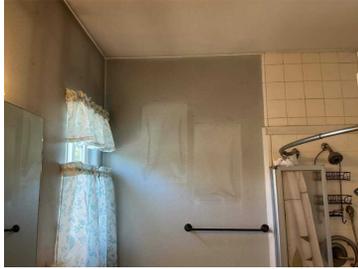
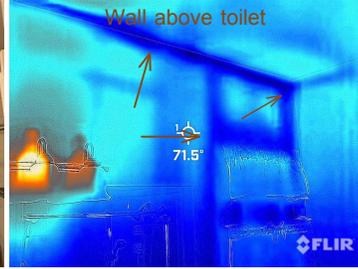
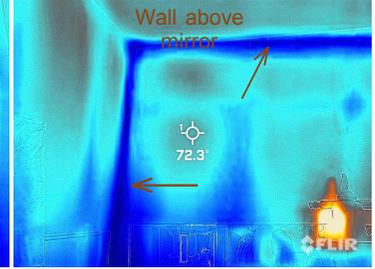
19. Marginal Walls: Paint - **MARGINAL:**  
, Evidence of past or present water leakage, Moisture or current water present on drywall from exterior . Recommend a contractor investigate and repair as needed. Possible mold, recommend a specialist review and mitigate if needed. This is a visual inspection only and Hidden damage may be present.

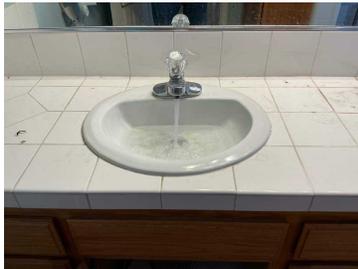
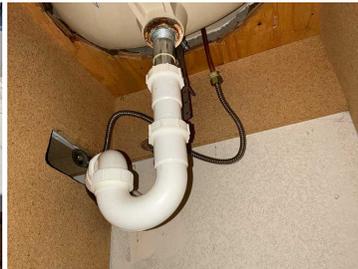
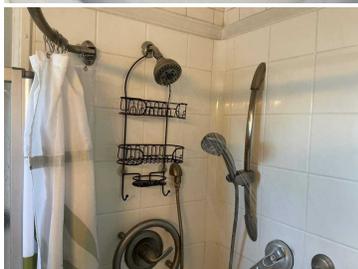
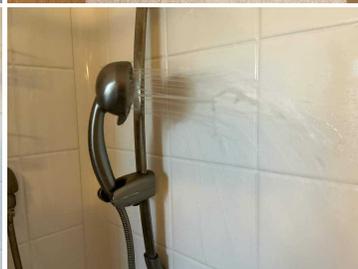
Floor: Tile  
 Doors: Hollow wood  
 Windows: Vinyl slider  
 Electrical: 110 VAC GFCI  
 Counter/Cabinet: Tile and wood  
 Sink/Basin: Molded dual bowl  
 Faucets/Traps: Metal with PVC trap - **MAINTENANCE:**

, Build up found in aerator of fixtures possibly caused by deteriorated water., Missing or faulty drain stopper

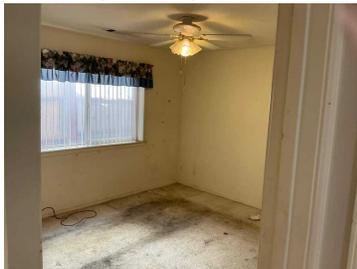
- 1. Acceptable Closet: Large
- 2. Acceptable Ceiling: Paint
- 3. Acceptable Walls: Paint
- 4. Maintenance required Floor: Carpet - **MAINTENANCE:**

, Damaged carpet

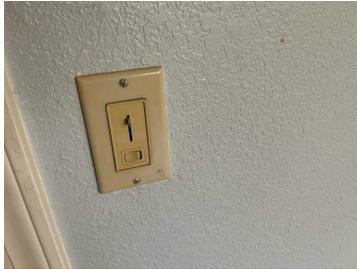
17. Maintenance required Electrical: 110 VAC - **MAINTENANCE:**  
**Missing outlet/switch cover plates**

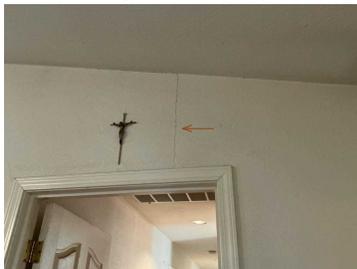
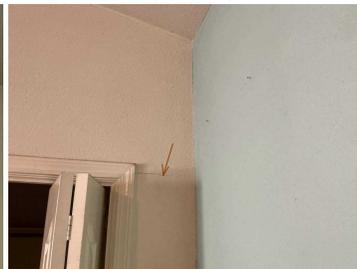
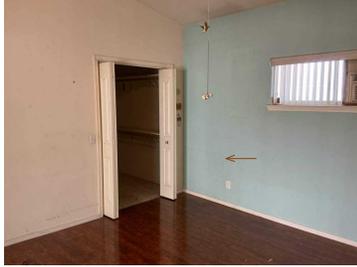
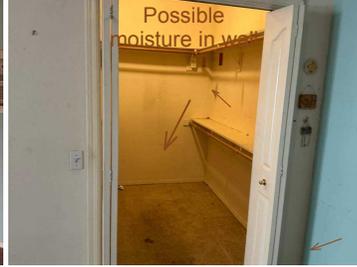
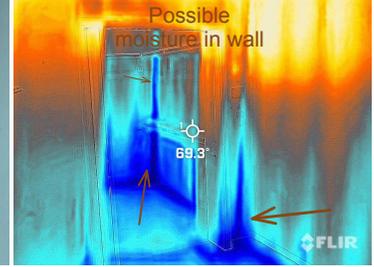
23. Maintenance required Walls: Paint - **MAINTENANCE:** cracks present.

, Evidence of past or present water behind drywall near and in closet., A qualified contractor is recommended to evaluate and estimate repairs and check for water damage. This is a visual inspection only and Hidden damage may be present.

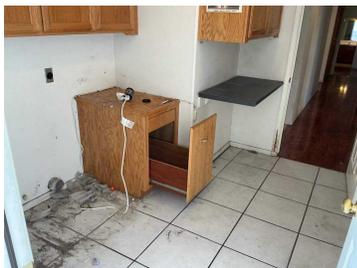
- 1. Acceptable
  - 2. Acceptable
  - 3. Acceptable
- Closet: Cabinets - **Water stains noted**  
Ceiling: Paint  
Walls: Paint

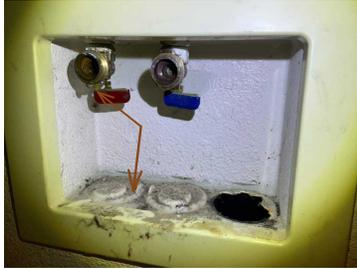
Washer Hose Bib: Ball valves - **MAINTENANCE:**

, Faucet leaking, A licensed plumber is recommended to evaluate and estimate repairs

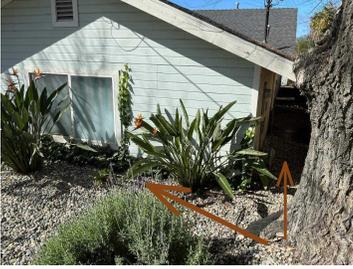
#### 2. Grading: Negative slope, Moderate slope - MAINTENANCE:, Landscape grading should be sloped away from Garage, house and foundation. Recommend a licensed landscaper to correct grading issues. Hidden moisture damage may be present., Driveway Grading has negative slope and water is pooling and running against the foundation. Water can cause foundation settling and erosion problems.. drainage needed at garage.

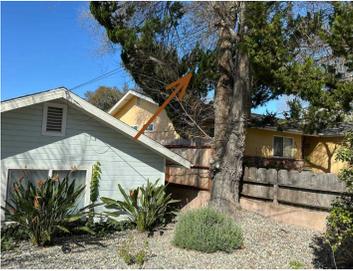
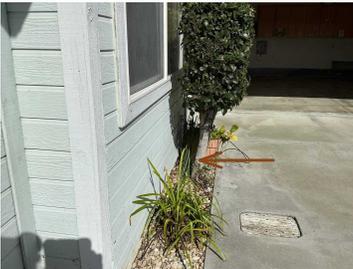
3. Vegetation: Trees and shrubs - **MAINTENANCE:**, Planting should be maintained away from exterior of structure. , Tree limbs over hang the roof and should be cut back

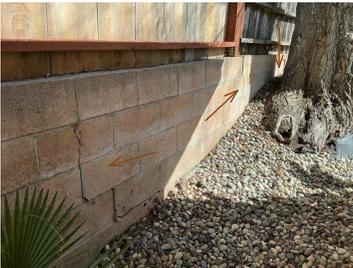
4. Retaining Walls: Concrete - **MAINTENANCE:**  
Tree damage

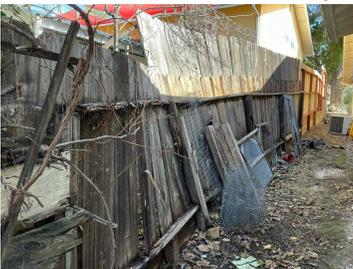
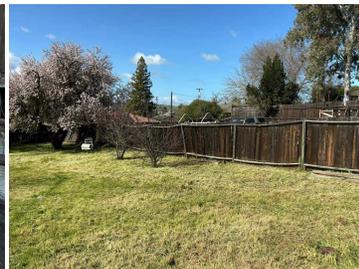
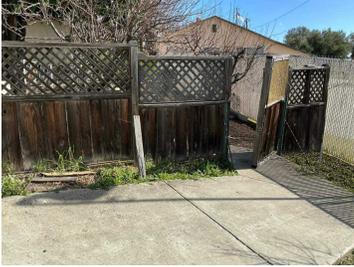
5. Fences: Wood, Chain link - **MAINTENANCE:**  
, Damaged, Wood rot or pest damage. Falling over into neighbor. A qualified contractor is recommended to evaluate and estimate repairs

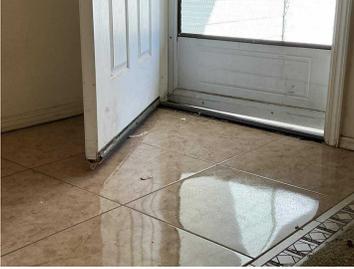
10. Entry Doors: Wood with glass - **MAINTENANCE:**

, Recommend sealing to prevent water or pest entrance. , Loose or missing threshold

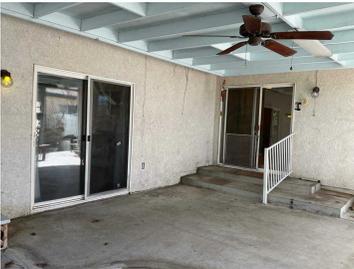
11. Patio Door: Vinyl sliding - **MAINTENANCE:**

Damaged lock in kitchen

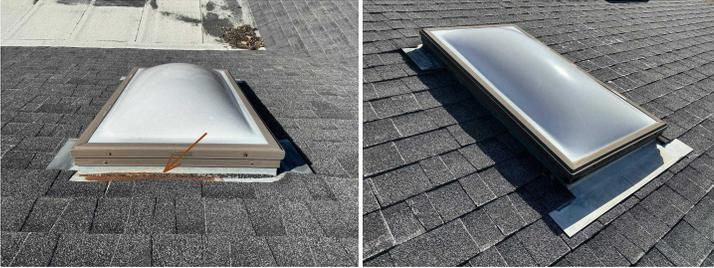
16. Skylights: Plastic - **MAINTENANCE:**

, Skylights are visually inspected only and not water tested., Hidden damage may be present. Recommend a contractor investigate as necessary to determine the full extent of damage and make proper repairs.

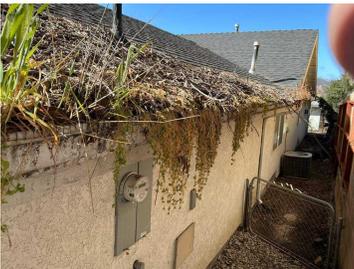
18. Gutters: Aluminum - **MAINTENANCE:**

, Need cleaning

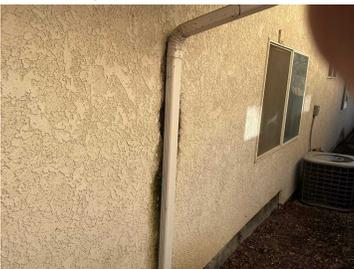
19. Downspouts: Aluminum - **MAINTENANCE:**

, Leaking

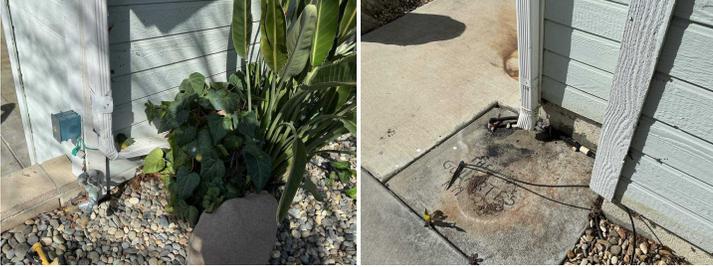
20. Leader/Extension: Missing, In ground drainage - **MAINTENANCE:**  
, Leaders do not extend 6 feet beyond the foundation perimeter and should be corrected to move water away from foundation

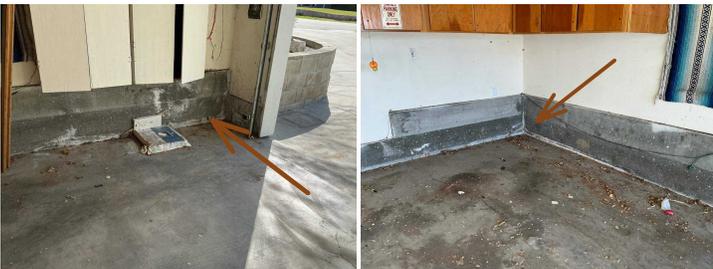
24. Attached Garage Floor/Foundation: Poured concrete - **MAINTENANCE:**  
, Efflorescence is a white powdery substance of minerals left behind from moisture intrusion.

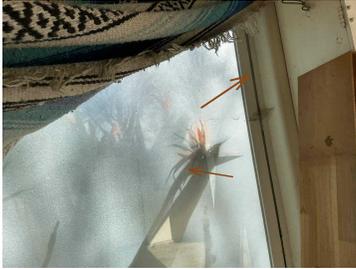
25. Attached Garage Windows: Vinyl slider - **MAINTENANCE:**

, The window will not open, Current or previous water damage present. Recommend windows be review and repaired by a qualified glazer or contractor. Hidden damage may be present.

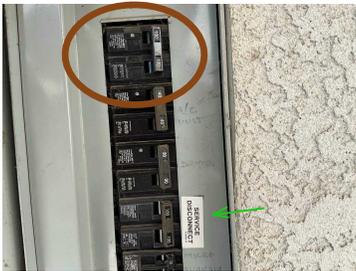
26. Garage Electric Panel Breakers: Copper - **MAINTENANCE:**

There are two 100amp breakers, one main so the other shouldn't be there., Evaluation and repairs from a qualified electrician is needed

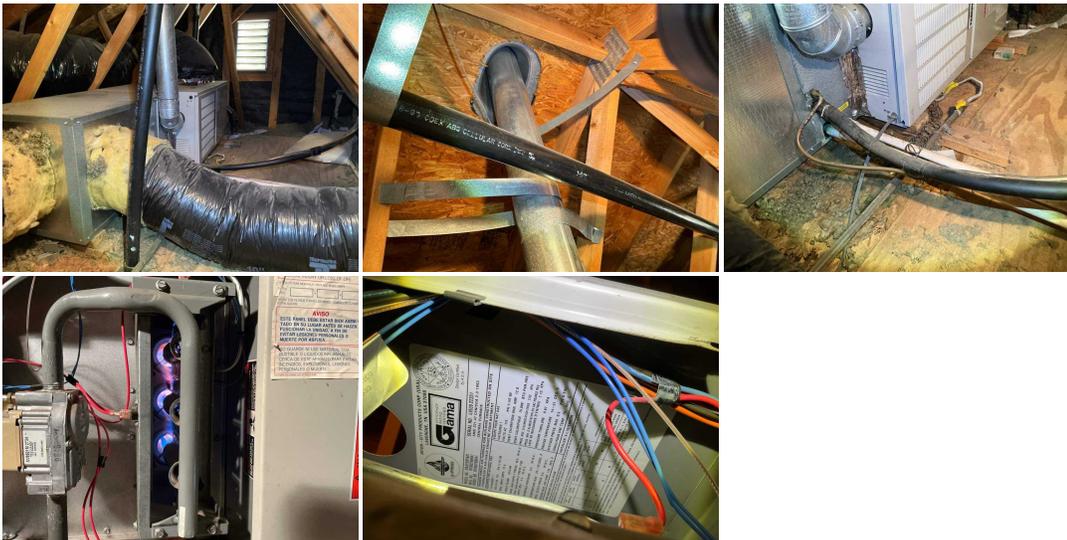
27. Main House Heating System Heating System Operation: Appears functional - **MAINTENANCE:**

Service recommended

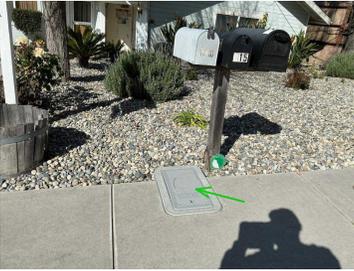
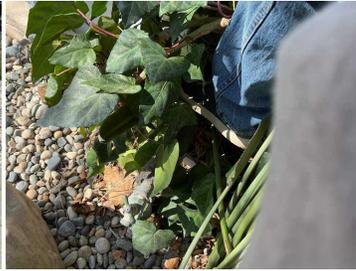
34. Main Water Shutoff: Garage - **MAINTENANCE:**  
Remove vines for access

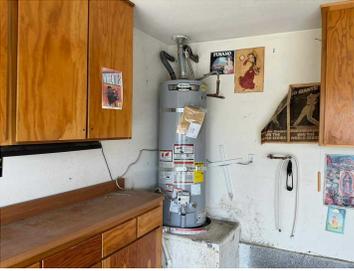
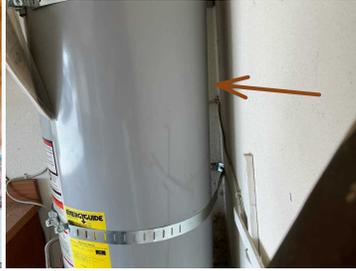
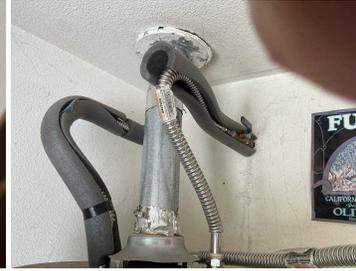
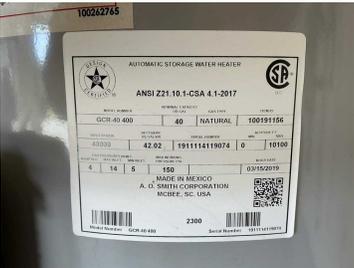
35. Garage Water Heater Water Heater Operation: Adequate - **MAINTENANCE:**  
, Earthquake support straps and or blocking missing or not properly installed

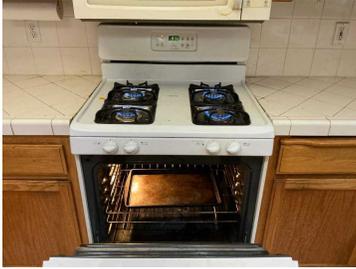
36. Kitchen with dining Kitchen Cooking Appliances: No tag - **MAINTENANCE:**  
, Recommend anti tip device be added to stove for child safety , recommend cleaning and service

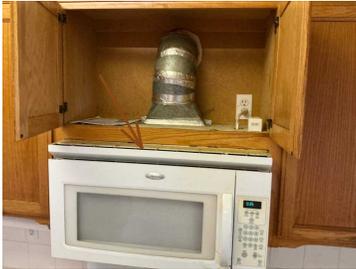
37. Kitchen with dining Kitchen Ventilator: In microwave above, Through roof venting - **MAINTENANCE:**  
, Not properly vented, leaking at microwave. Recommend repair

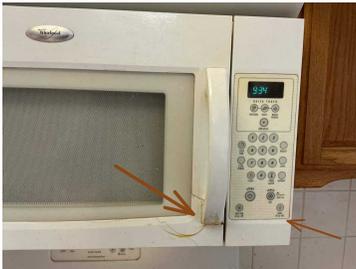
38. Kitchen with dining Kitchen Dishwasher: Whirlpool - **MAINTENANCE:**  
, Ran with loud noise during inspection
39. Kitchen with dining Kitchen Microwave: Whirlpool - **MAINTENANCE:**  
, Leakage detected at the door seal, loose panel may need replacing

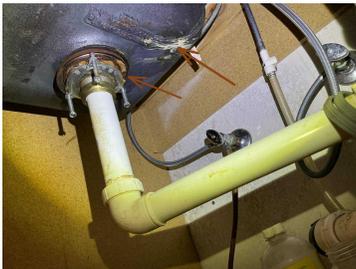
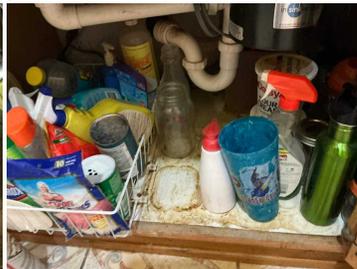
40. Kitchen with dining Kitchen Sink: Porcelain Coated - **MAINTENANCE:**  
, Pitting stem, Leaking, recommend plumber repair  
Stains under sink. No standing water at time of inspection

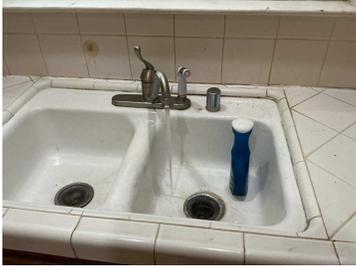
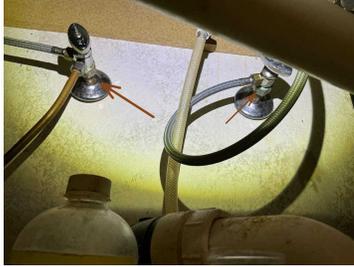
41. Kitchen with dining Kitchen Electrical: 110 VAC GFCI - **MAINTENANCE:**  
, Ceiling fan inoperative
42. Kitchen with dining Kitchen Plumbing/Fixtures: Metal and PVC - **MAINTENANCE:**  
, The supply piping under the sink is corroded. It may be desirable to replace it before leaks develop., Recommend a plumber evaluation and repairs.

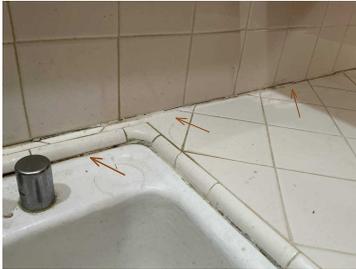
43. Kitchen with dining Kitchen Counter Tops: Tile - **MAINTENANCE:**  
, Needs caulking

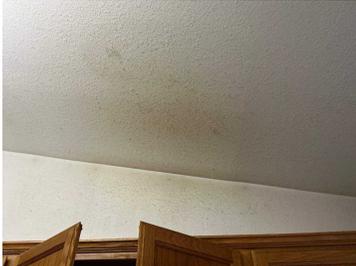
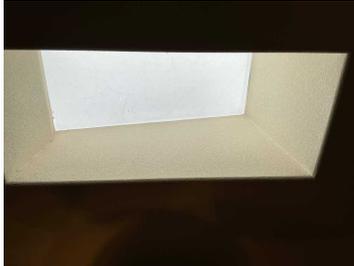
44. Kitchen with dining Kitchen Ceiling: Paint - **MAINTENANCE:**  
Exhaust stains present from oven vent

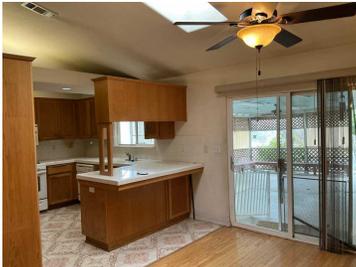
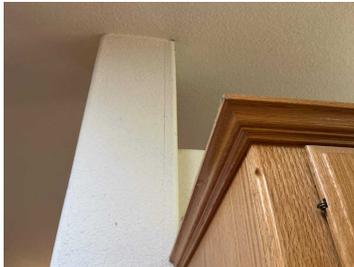
45. Kitchen with dining Kitchen Walls: Paint - **MAINTENANCE:** clearing needed  
Normal Cracks present

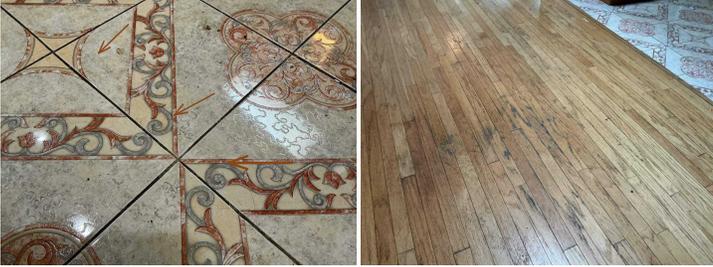
46. Kitchen with dining Kitchen Floor: Tile, Wood - **MAINTENANCE:**  
Tile cracks present , Water damage

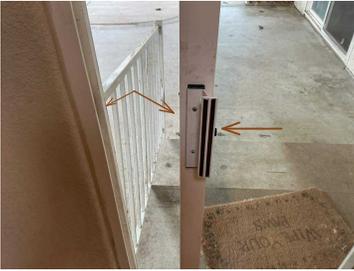
47. Kitchen with dining Kitchen Doors: Slider - **MAINTENANCE:**  
, Lockset(s) not latching-requires adjustment

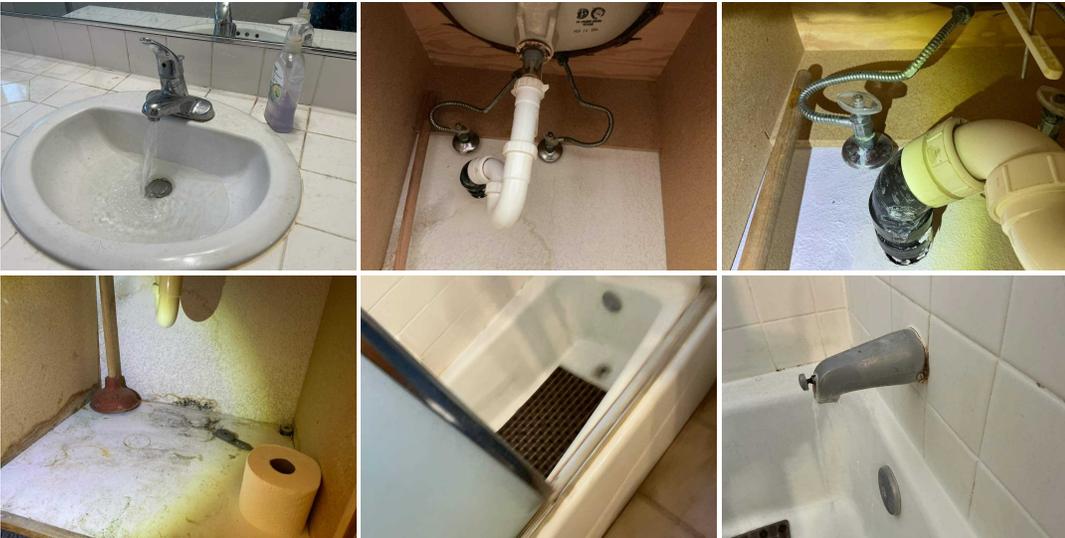
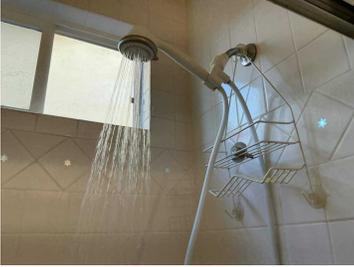
48. Guest Bathroom Counter/Cabinet: Tile and wood - **MAINTENANCE:**  
, Needs caulking
49. Guest Bathroom Sink/Basin: Molded single bowl - **MAINTENANCE:**  
Rust present in the sink bowl
50. Guest Bathroom Faucets/Traps: Metal with PVC trap - **MAINTENANCE:**  
, Leaking supply line, Shower diverter not functioning properly, all water is not flowing to showerhead, Build up found in aerator of fixtures possibly caused by deteriorated water., Missing or faulty drain stopper, Recommend a plumber evaluate, check for hidden damage, eliminate source of moisture and properly repair all deteriorated components.

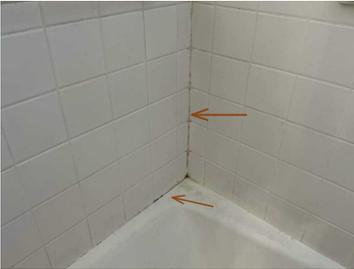
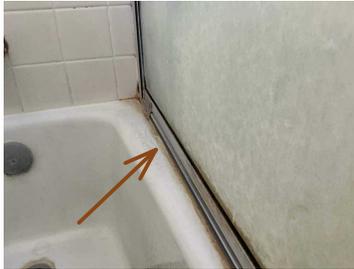
51. Guest Bathroom Tub/Surround: Porcelain tub and ceramic tile surround - **MAINTENANCE:**  
, Loose grout, Recommend caulking to prevent water intrusion

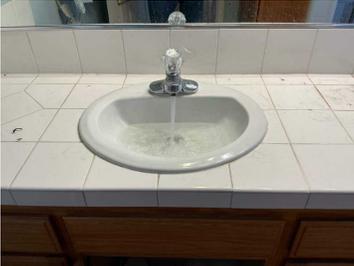
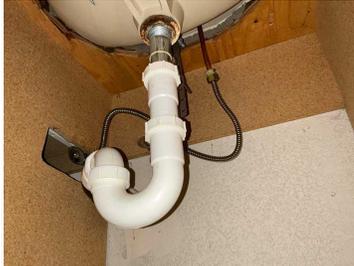
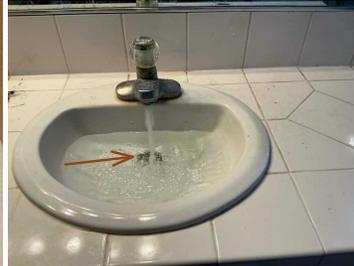
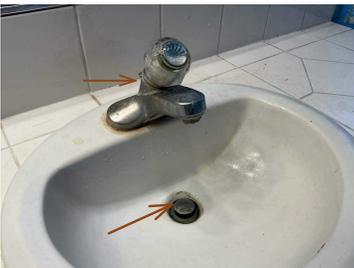
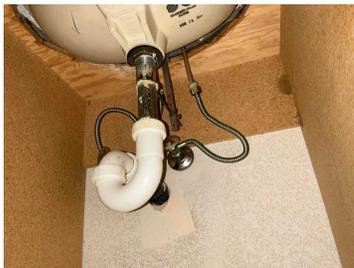
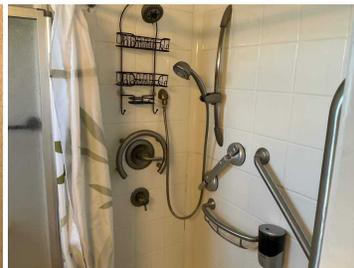
52. Primary Bedroom Bathroom Faucets/Traps: Metal with PVC trap - **MAINTENANCE:**  
, Build up found in aerator of fixtures possibly caused by deteriorated water., Missing or faulty drain stopper

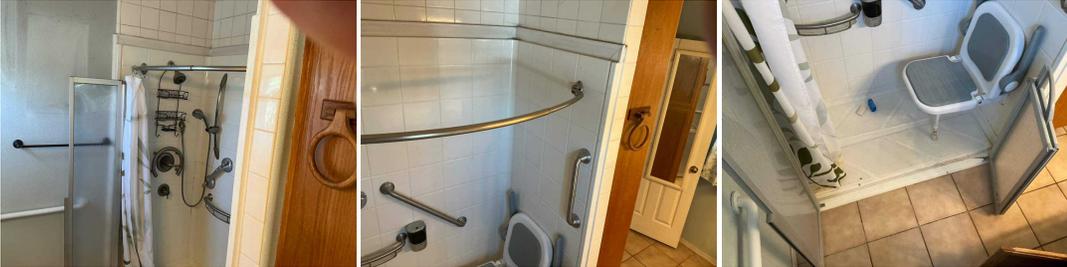
53. Primary Bedroom Bathroom Shower/Surround: Fiberglass pan and fiberglass surround - **MAINTENANCE:**  
, Recommend chalking to prevent water intrusion, custom install may need further review, ask owner for warranty information

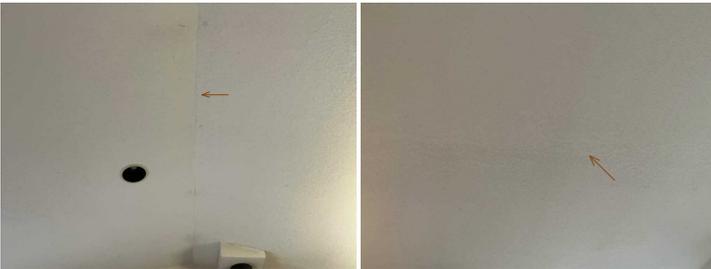
55. Living Room Living Space Ceiling: Paint - **MARGINAL:**  
, Cracks present

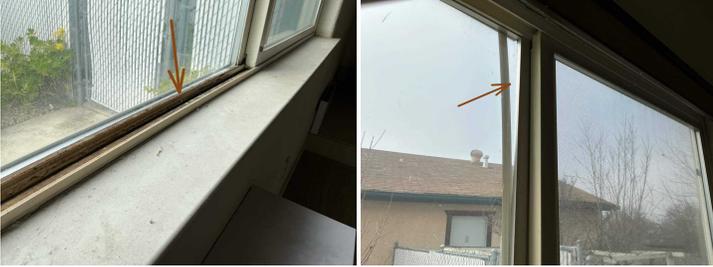
59. Living Room Living Space Windows: Vinyl slider - **MAINTENANCE:**

, Hard operation, Replace weather stripping, Current or previous water damage present. Recommend windows be review and repaired by a qualified glazer or contractor. Hidden damage may be present.

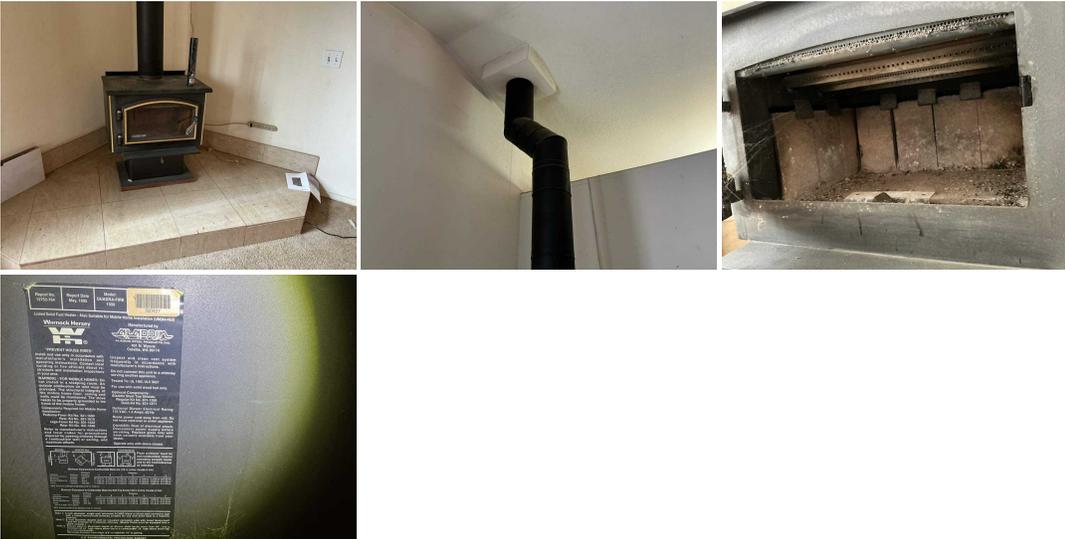
61. Living Room Fireplace Freestanding Stove: Wood burning - **Maintenance, Recommend cleaning and inspection prior to use and Annually.**

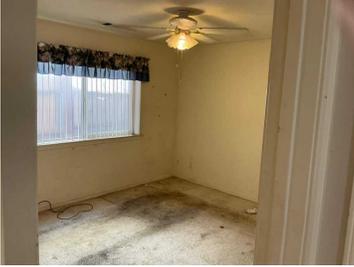
, Damaged carpet

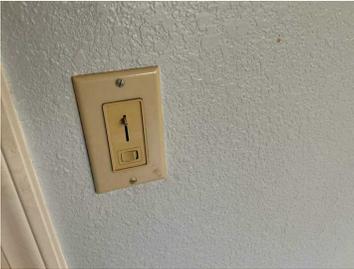
64. Bed 2 middle Bedroom Electrical: 110 VAC - **MAINTENANCE:**  
Missing outlet/switch cover plates

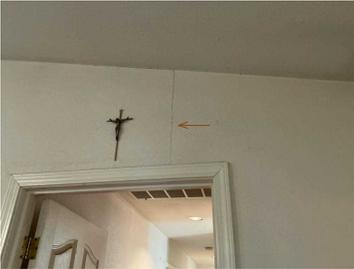
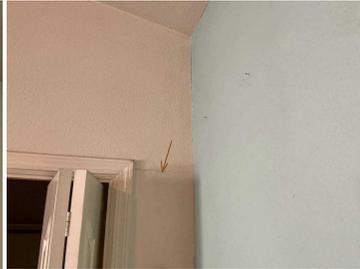
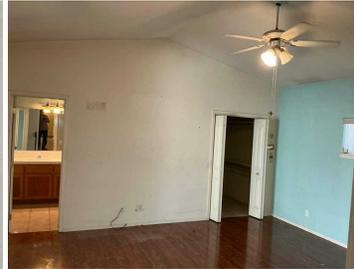
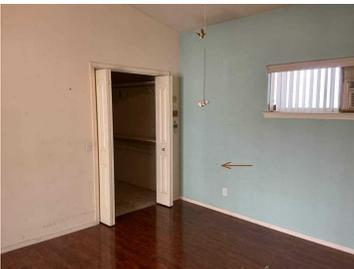
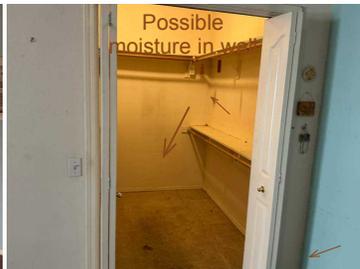
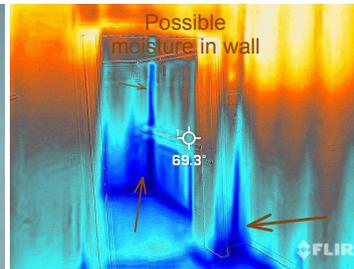
65. Bed 3 primary Bedroom Walls: Paint - **MAINTENANCE:** cracks present.  
, Evidence of past or present water behind drywall near and in closet., A qualified contractor is recommended to evaluate and estimate repairs and check for water damage. This is a visual inspection only and Hidden damage may be present.

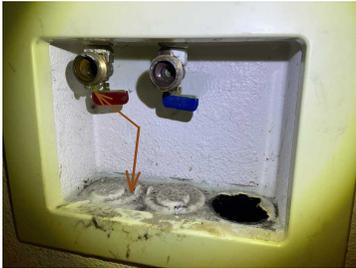
67. Garage Laundry Room/Area Washer Hose Bib: Ball valves - **MAINTENANCE:**  
, Faucet leaking, A licensed plumber is recommended to evaluate and estimate repairs

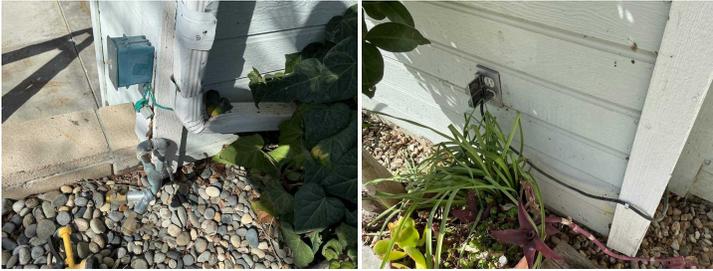
1. Exterior Electric Outlets: 110 VAC - **MARGINAL:**  
, Exposed wiring present, Loose or missing moisture cover, Non-GFCI outlet, Improper wiring for exterior application, Review by an electrician suggested.

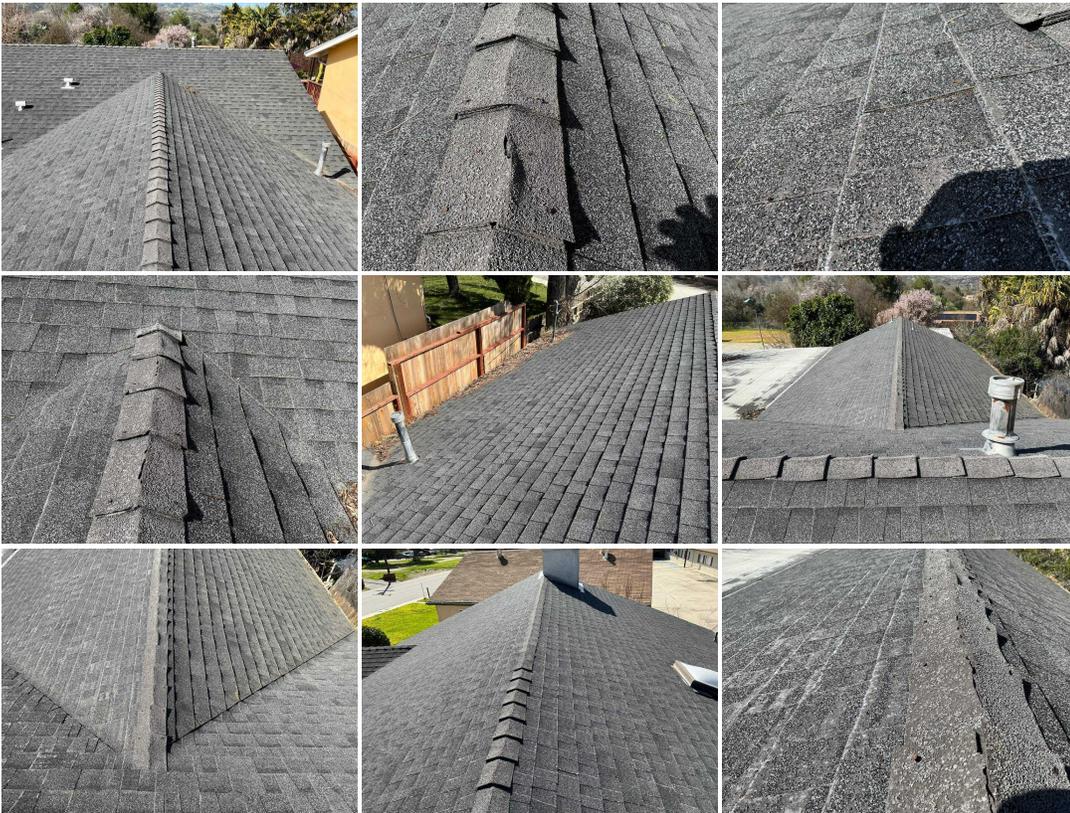
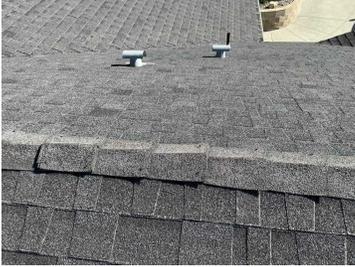
2. Main House Roof Surface Material: Composition Shingle - **MARGINAL:**  
, Loose or damaged shingles, Shingles nailed improperly or nails loose. This can lead to water intrusion. , Signs of cracking, Roof near end of useful life, Algae growth noted and should be cleaned to prevent deterioration. , A qualified roofing contractor is recommended to evaluate and estimate repairs

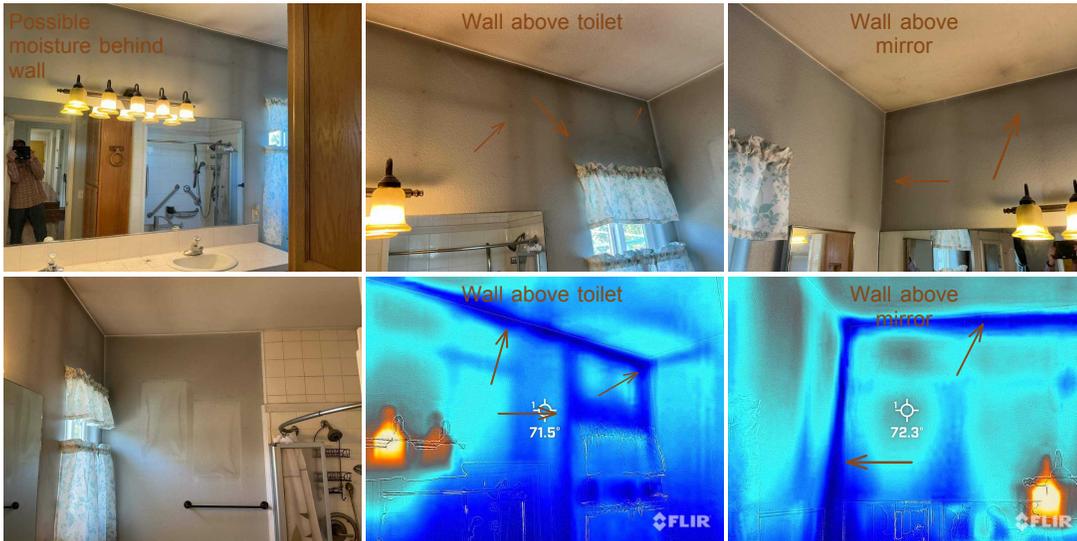
3. Primary Bedroom Bathroom Ceiling: Paint - **MARGINAL:**  
, Evidence of past or present water at ceiling near exterior. Recommend a qualified siding contractor investigate and seal all penetrations as needed. Water can intrude through exterior cracks and hidden damage or mold may be present.
4. Primary Bedroom Bathroom Walls: Paint - **MARGINAL:**  
, Evidence of past or present water leakage, Moisture or current water present on drywall from exterior . Recommend a contractor investigate and repair as needed. Possible mold, recommend a specialist review and mitigate if needed. This is a visual inspection only and Hidden damage may be present.
