# PROPERTY INSPECTION REPORT

**FOUR POINT**  
HOME INSPECTION INC.

**1545 Park St**  
**Inspection Prepared For: Jim Gates**  
**Agent: -**

**Date of Inspection: 10/24/2023**  
**Year Built: 1900 Size: 1290**  
**Weather: Mild/Dry**

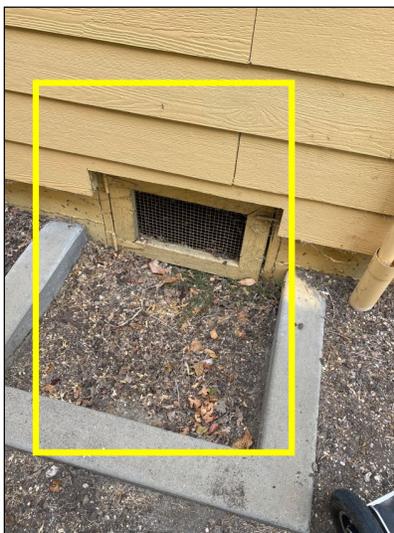
This crawlspace was accessed through a foundation hatch at the South side of the home.

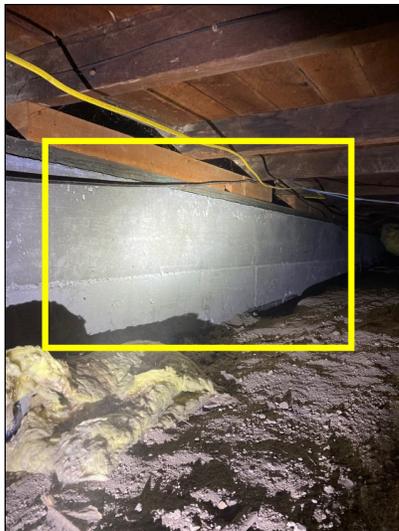
At the time of the inspection, the Inspector observed no deficiencies in the condition of the visible portions of the poured concrete foundation walls.

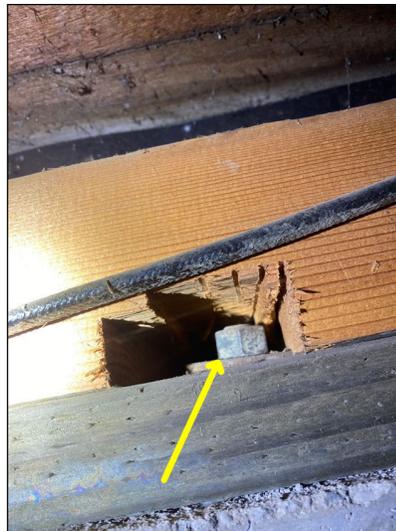
Anchor bolts designed to attach the home structure to the foundation were installed and appear to be serviceable.

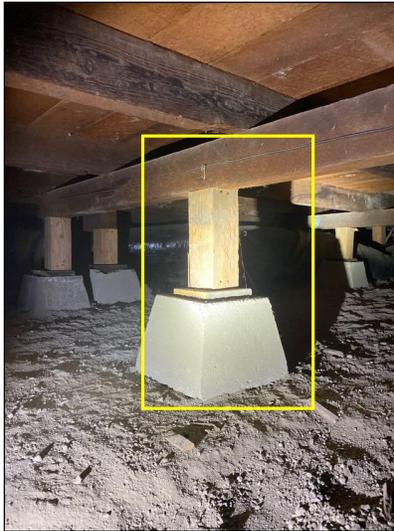
Where floor joists overlapped, they were supported by Wood beam girders, that were supported by wood posts that rested on concrete pavers.

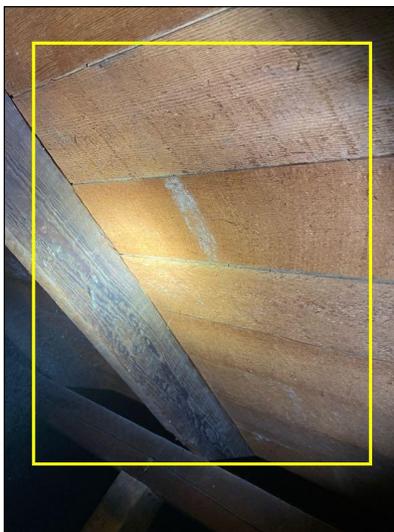
The floor structure consisted of 1x6 wood board subfloor installed over conventional joists resting on the concrete foundation.

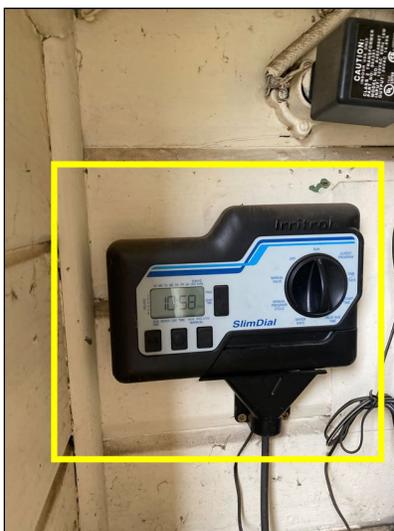
The sprinkler system operates with a control panel located on the exterior of the home. (inside water heater closet)

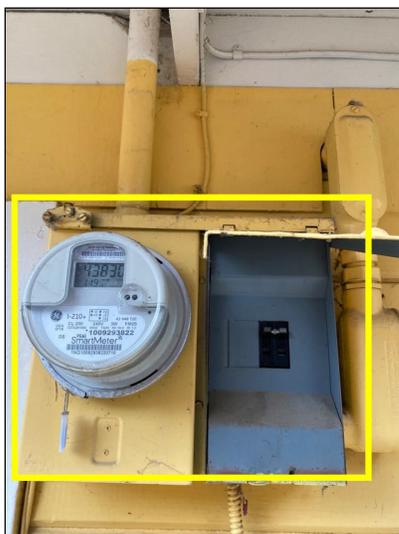
Main electrical service panel to the home.

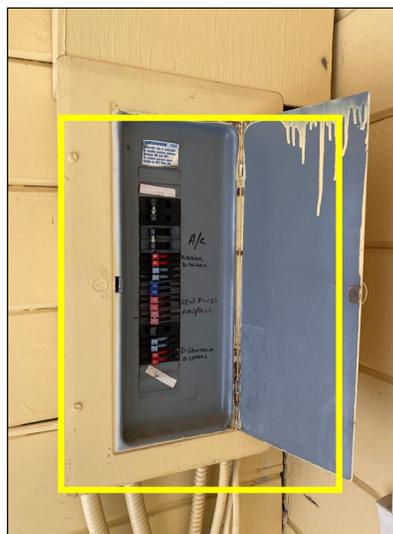
The service sub panel brand was Sylvania. Sylvania service panels are reputed to have a high rate of circuit breaker failure which can result in a fire or shock/electrocution. The Inspector recommends that before the expiration of your Inspection Objection Deadline, you consult with a qualified electrical contractor concerning the necessity for replacing this service panel. Information about defective Sylvania service panels is widely available on the internet.

Subpanel on exterior of the west side of home

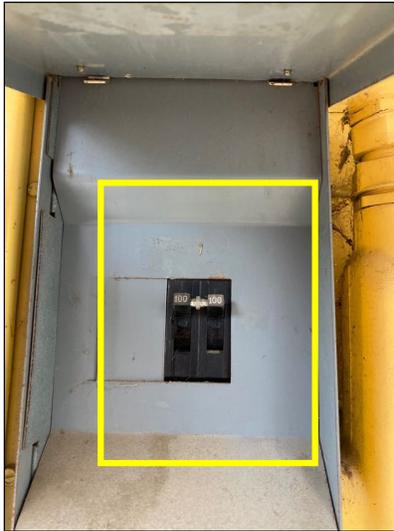
Main electrical shut off to the home

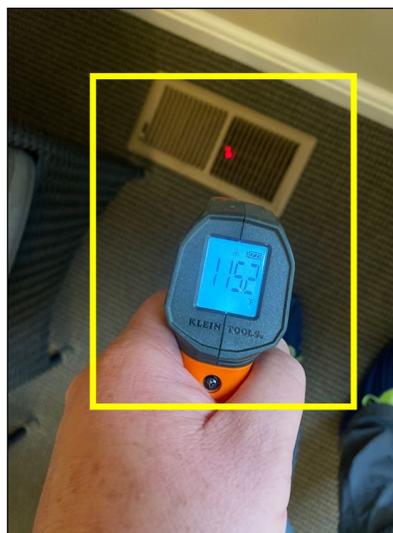
The supply air temperature at the registers should be 100 °F - 110 °F + to be considered running efficiently.

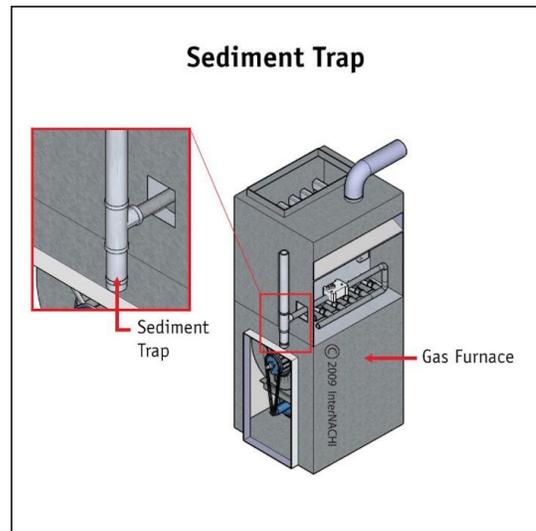
**Improvement:** The gas supply pipe contained no sediment trap.

The purpose of a sediment trap is to prevent sediment or debris particulates from entering and clogging the heaters gas valve.

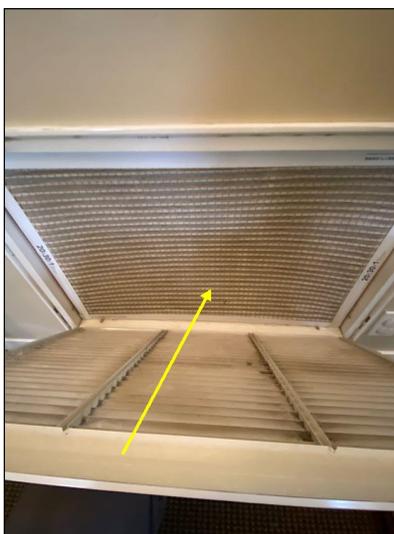
Filter (20x30 size).

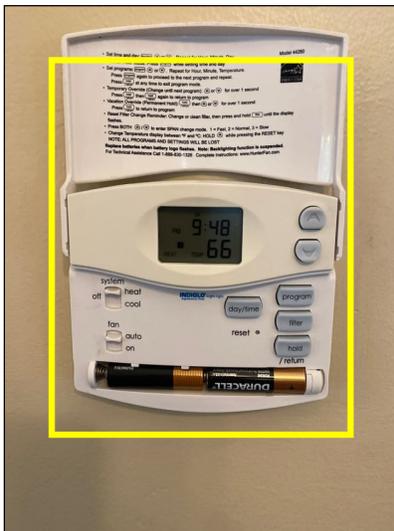
Digital - programmable type.

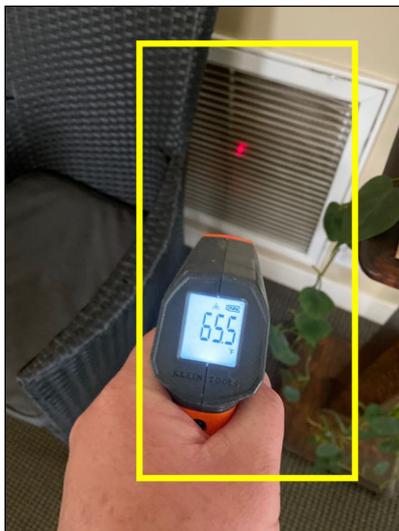
The differences in air temperature measured at supply and return registers fell within the acceptable range of between 14 and 22 degrees F.

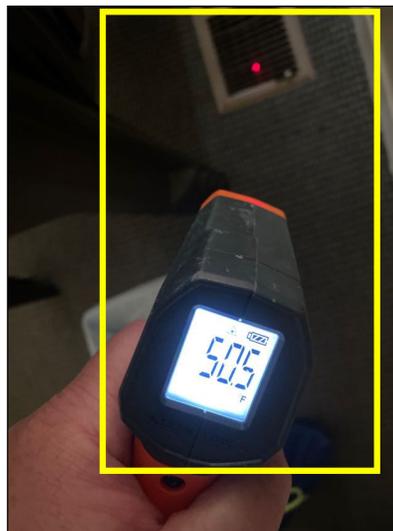
The differences in air temperature measured at supply and return registers fell within the acceptable range of between 14 and 22 degrees F.

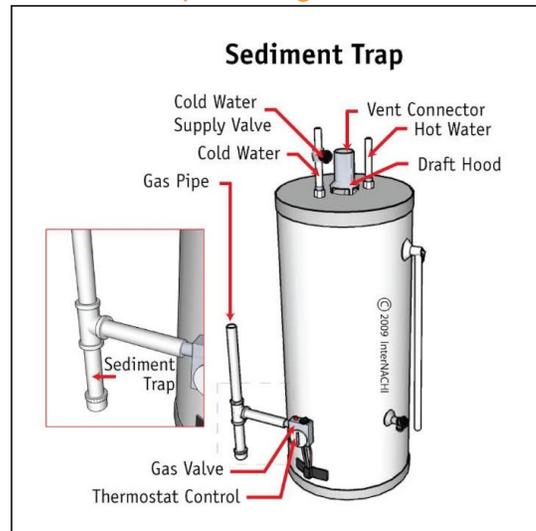
**Improvement:** The gas supply pipe contained no sediment trap.

The purpose of a sediment trap is to prevent sediment or debris particulates from entering and clogging the water heaters gas valve
