SEARCHLIGHT
HOME INSPECTIONS

Confidential Inspection Report

LOCATED AT:
16483 Hwy. 67 Ramona, Ca.
Ramona, CA 92065

INSPECTED ON:
Sunday, December 7, 2025

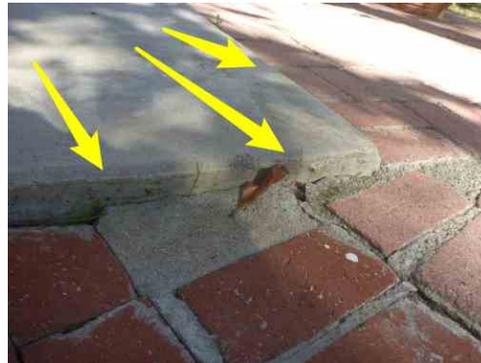
SC s-50: There are cracks and heaving or settling of the patio(s). These conditions pose a trip hazard. We recommend correcting any trip hazard conditions. The brick to concrete transitions have offsets that are a trip hazard and need repair. The patio to balcony transitions are uplifted with damage and need evaluation and repair by a specialist and to improve site drainage to minimize soil movement and settling issues.

Patio Concrete Cracked & Offsets at Transition to Bricks is a Trip Hazard

Patio Offsets at Transition From Bricks to Concrete = Trip Hazards

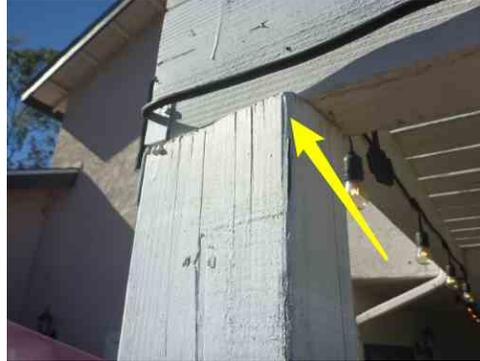
CR s-51: The patio cover is not structurally sound with loose post connections at the top and the base of the posts are in contact with the soils and need evaluation & repair by a general contractor. The posts are loose and have improper metal brackets installed that are not secure at the connection points and need repair by a general contractor along with any costs for your budgeting purposes prior to close of contingencies. Unpainted wood sections at the patio cover also need sanding, sealing, and repainting to protect the wood from further deterioration.

Loose Patio Cover Posts Not Secured Properly at Top

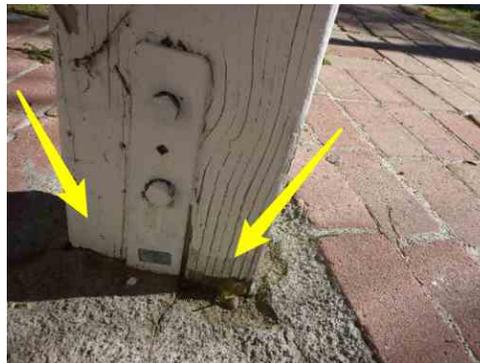
Patio Cover Support Posts Not Elevated Above Grade w/ Metal Brackets in Places Subject to Wood Rot

Patio Cover Posts in Contact w/ Soils Conducive to Wood Rot Damage Not Elevated

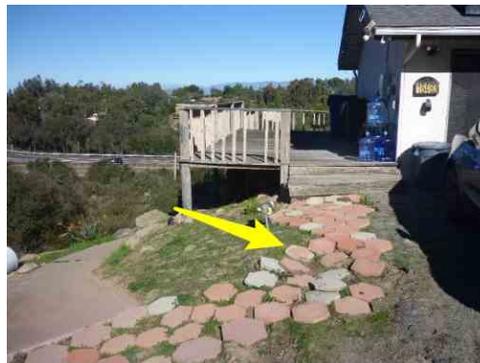
SC s-52: Uneven sections in the walkway surface(s). This condition is a trip hazard.

Uneven Brick Walkways Need Repair to Prevent Any Trip Hazards

Loose Uneven Concrete Pavers Are a Trip Hazard & Need Repair

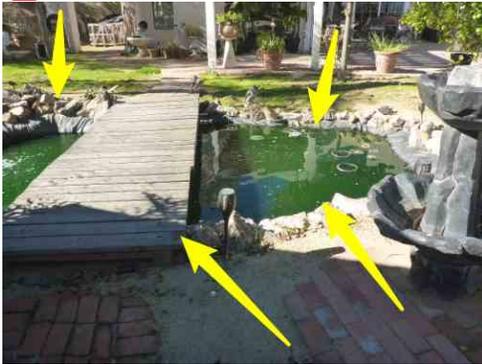
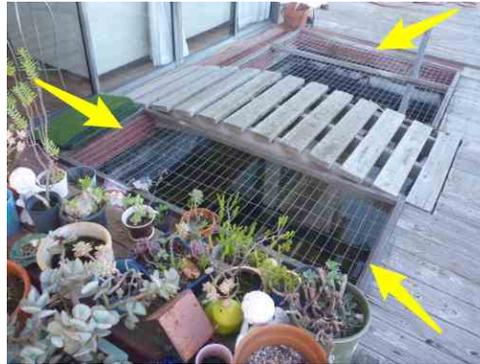
SC 53: There are no guardrails at the ponds or bridges over them and are not child safe.

No Guardrails at Ponds Not Child Safe

No Guardrails at Abandoned Pond Not Child Safe

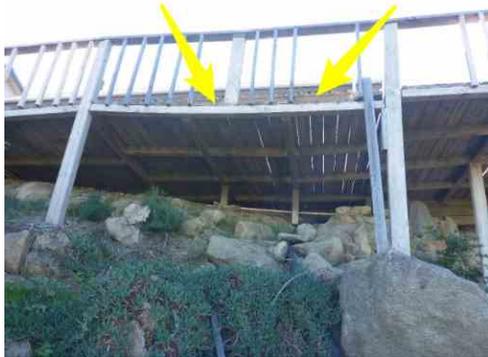
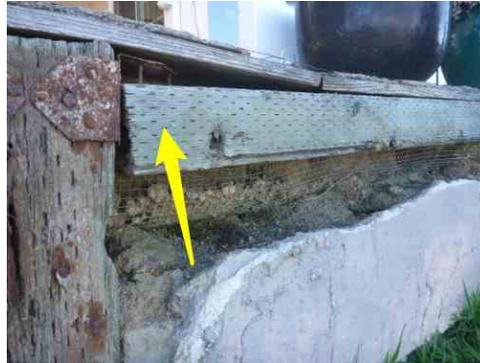
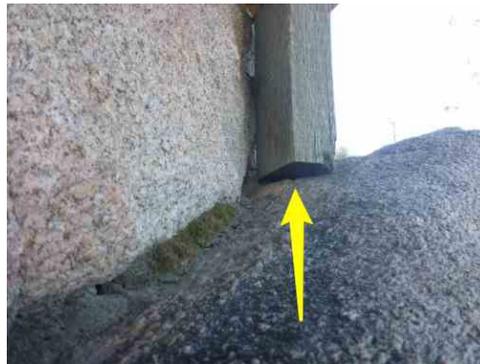
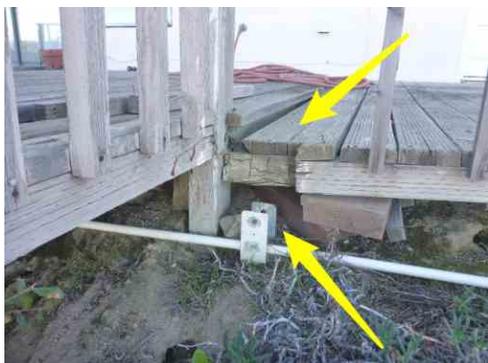
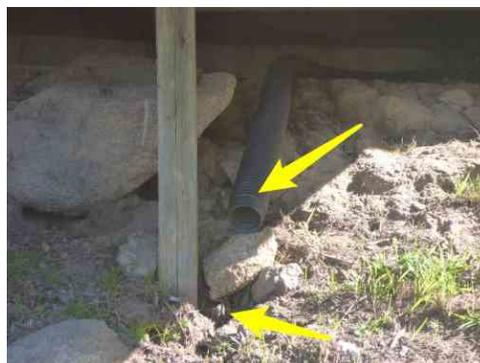
SC 57: The balcony deck is not structurally sound and needs further evaluation by a deck specialist for costs of replacement as it is not safe for access in its current condition. The deck framing is not secure or safe as posts are set on rocks, framing is sagging, guardrails are missing balusters with wide openings and posts are not secured and lack metal brackets for secure connections. Wood deck planks are loose with raised nails and are a trip hazard. Have further evaluation by a balcony deck specialist for costs of repair/replacement prior to close of contingencies.

Balcony Deck Not Structurally Sound. Over Spanned, Sagging, Not Secure/Safe

Balcony Deck Not Safe Not Secure Needs Replacement

Balcony Deck Posts Set on Rocks Not Secured (Not Safe)

Balcony Deck Needs Replacing Not Secure Sags Etc.

Drain Lines Discharging at Balcony Deck Support Posts. Deck Not Safe

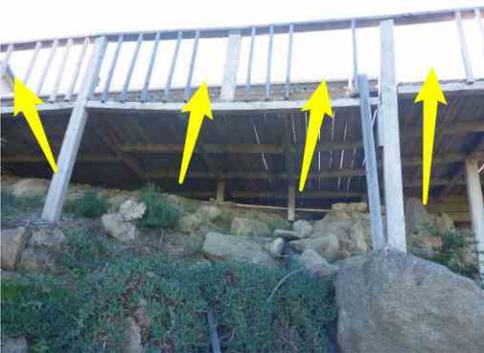
SC 59: The balcony guardrails installed have wide spaces. We recommend additional measures be taken for child safety.

Balcony Rail w/ Wide Open Spaces Missing Balusters Not Safe

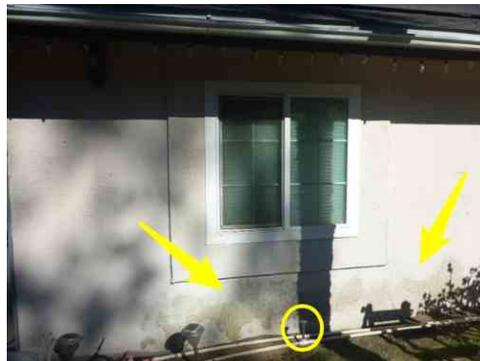
Stucco w/ Sprinkler Stains & Past Patching Repairs. Check Sprinklers Aren't Spraying Stucco

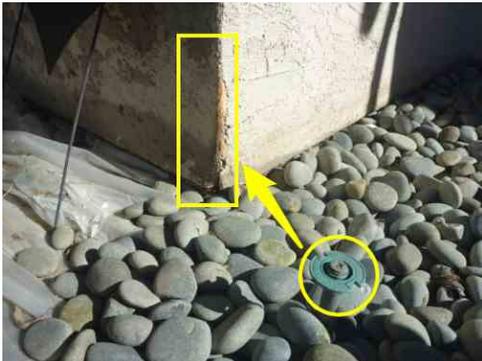
CR 64: The stucco has moisture stains. Some of the sprinkler heads are spraying on the exterior walls of the building. This conditions is conducive to moisture intrusion, damage and deterioration. Redirect sprinklers away as necessary and patch where needed.

Sprinkler Damage on Stucco Needs Patching Repair

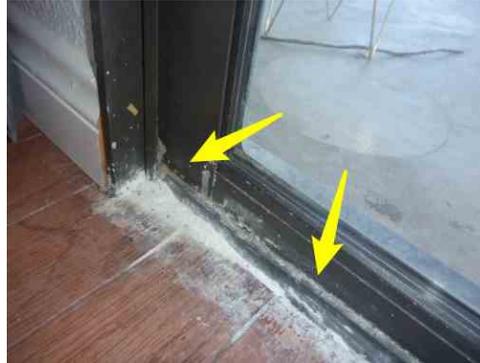
Corroded Metal Sliding Glass Door Frames & Tracks Need Evaluation/Repair To Open Easily

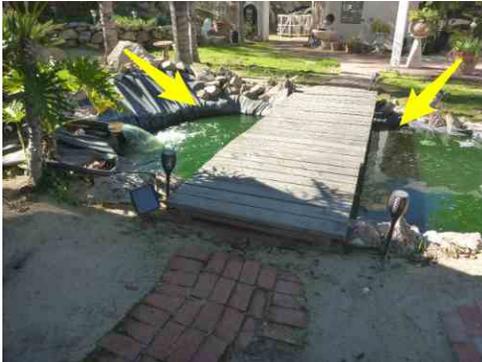
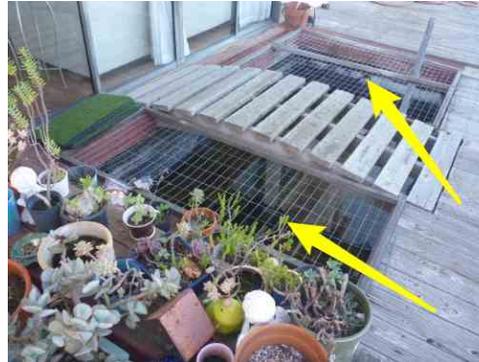
SC 76: These pond system(s) & bridges are outside the scope of the inspection and are not inspected. We recommend consulting with an appropriate professional in the appropriate trade. Any comments made are as a courtesy only. Ponds over 24" deep require the same access restrictions as a pool to keep restricted access to children. Fencing, door alarms, self closing gates to restrict child access to the pond areas are required just like a pool for any ponds over 24 inches deep. Add restrictions for child access to prevent an injury as this is a home owners responsibility.

The abandoned rear deck pond is a trip hazard and is covered with light metal rolled fencing material that will not support the weight of a child or person and needs repair as this is part of a walkway outside the sliding glass door. This needs repair to prevent a trip and fall hazard.

Ponds & Bridges Over 24" Deep Require Restricted Access to Children & Are Not Inspected

Abandoned Pond at Rear Deck Not Safe w/ Loose Fencing Over the Hole. Trip Hazard

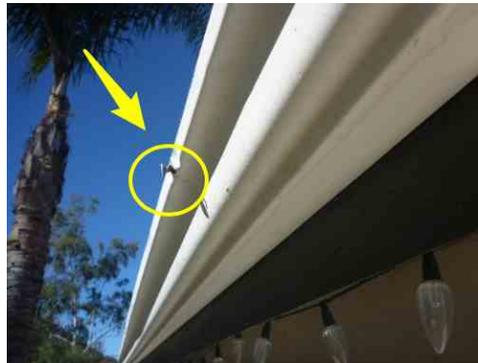
CR s-83: The rain gutters are loose from the building and need to be secured.

Loose Nails That Support the Rain Gutters
Need to be Secured & Sloped Properly

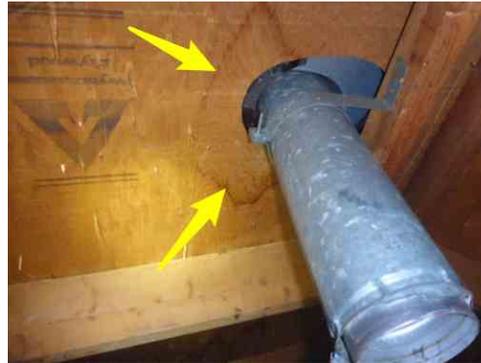
Check Old Furnace Vent Pipe Penetration Seal at the Roof Top & Seal Any Voids

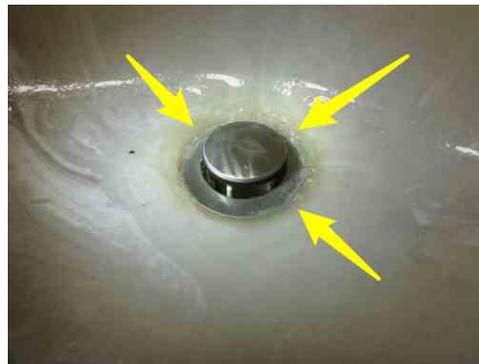
Primary Bathroom Sink Drain Caulked at Basin Needs Resealing Repair

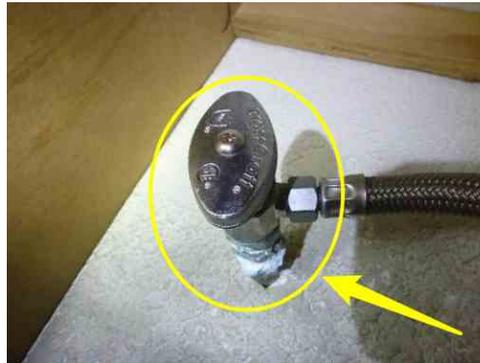
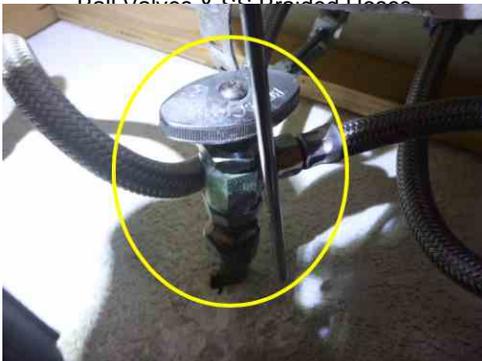
Old Style Corroded Gate Valves at Sinks &
Toilets

Bathroom Gate Valves Are Recommended to
Be Updated w/ Angle Stop Ball Valves

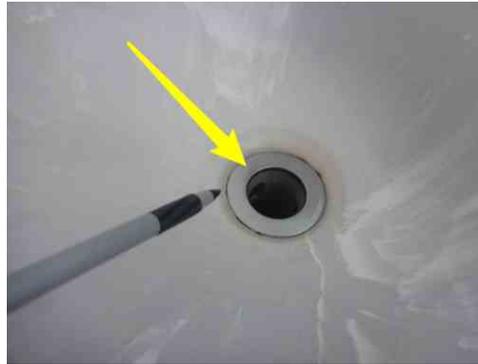
Replace Missing Sink Stopper Parts as Needed

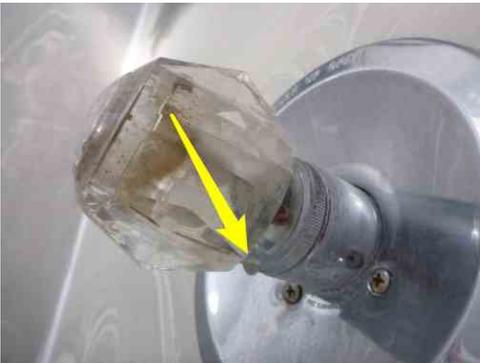
CR 120: The upstairs hall bathroom tub/shower faucet handle drips when the faucet is operated and needs service by a plumber. This condition is conducive to moisture intrusion and deterioration.

Upstairs Hall Bath Tub/Shower Valve Handle Leaks When On & Needs Service

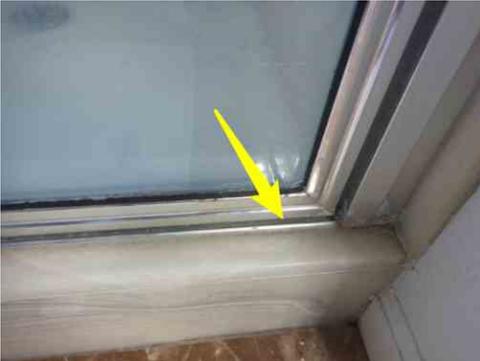
CR 125: The primary bathroom shower door drags at the base and needs hardware service to close easily.

The Upstairs Primary Shower Glass Door
Drags at the Base & Needs Hardware Service

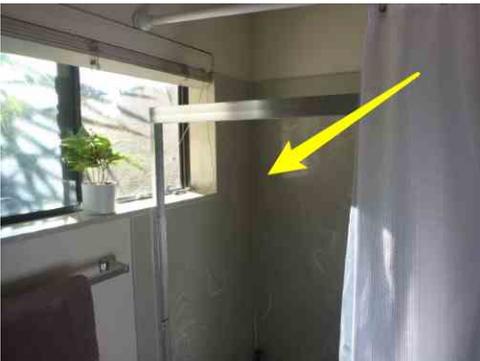
FE 126: The upstairs hall bath shower glass doors are missing and have been replaced with a shower curtain.

Upstairs Hall Bath Shower Glass Doors
Removed & Replaced w/ a Curtain

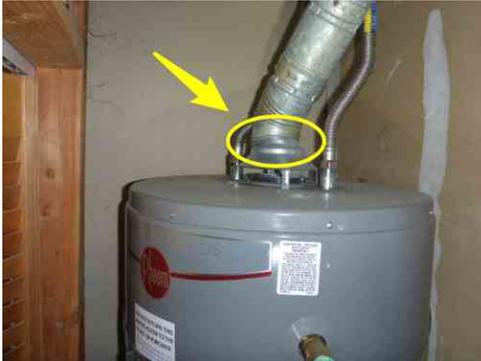
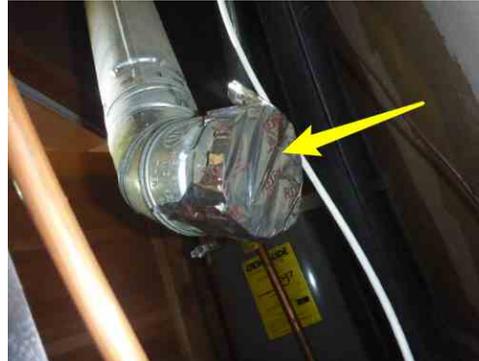
SC 135: The water heater flue vent pipe is not properly secured at connections above the water heater at the collar and needs to be secured as per manufactures specs. There is a second vent pipe that is connected via a T and is taped off and should be properly capped off as noted in the report photos.

Water Heater Vent Pipe is Loose Not Fastened at Collar Vent Pipe Connection

Vent Pipe Tied Into Vent for Water Heater Taped Off & Needs to be Capped Off Properly

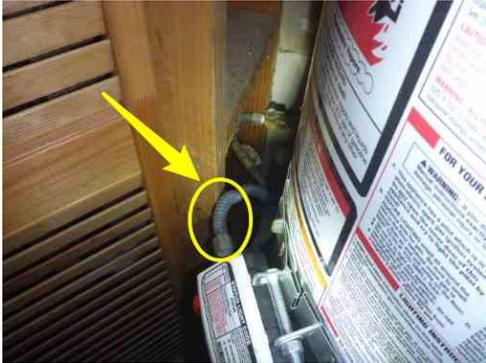
SC 141: There is no sediment trap/drip leg in the gas line as required by the water heater manufacturer and should be installed as per specifications. This can void a home warranty if not installed as per manufactures specs and needs service.

No Sediment Trap on Gas Line to Water Heater As Per Manufactures Specs

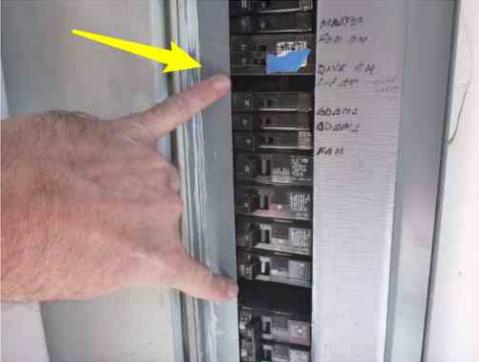
Garage Sub Panel w/ Missing Knockout Inserts & Open Voids & Partial Labels

SC 166: There are at least 5 missing twist-outs/unused breaker slots in the garage sub panel. This condition is a safety hazard and needs plastic inserts installed to prevent any shock hazards.

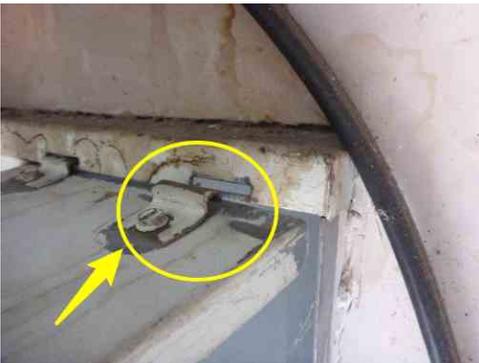
CR 164: The cover hinges are bent/loose at the top of the garage sub panel and need repair to keep the front cover secure at the top as noted for the top right hinge and needs service repair.

Loose Hinge at Front Panel Cover For Garage Sub Panel Needs Securing

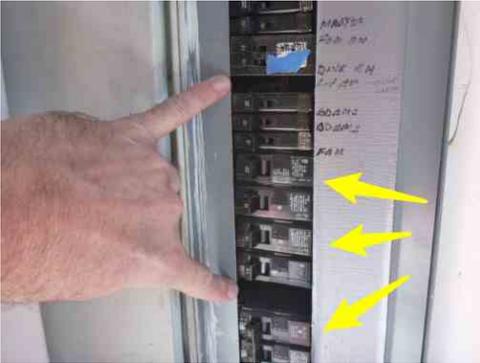
CR 165: A number of breakers are not properly labeled at the garage sub panel. We recommend they be accurately labeled to allow individual circuits to be shut off for maintenance or emergency needs.

Partial Labels At Some Panel Only. Relabel All Circuit Breakers

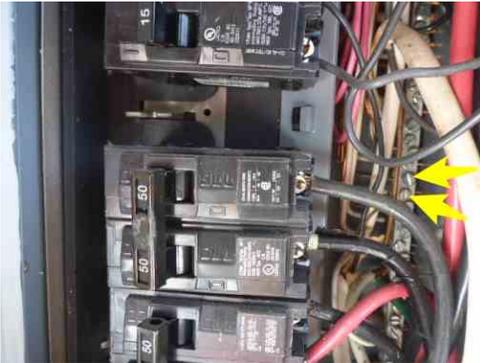
SC 169: The neutral wires and the grounding wires are connected to the same busbar. This is an improper wiring arrangement in a sub panel and needs evaluation and repair by an electrician.

Grounds & Neutral Wires Not Separated at
Garage Sub Panel Bus Bar

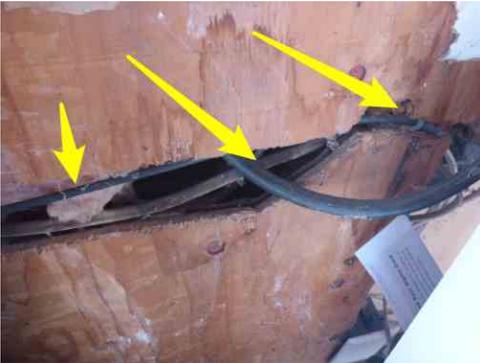
SC 171: Improper wiring in the following locations: garage has loose exposed wires around the sub panel that need to be encased in conduit to protect the wires from physical damage and to be properly supported. Wires are exposed on the garage wall by the sub panel and below the sub panel coming out of the wall and need to be protected in conduit by an electrician.

Exposed Loose Wiring Below Garage Sub Panel Needs Repair/Conduit

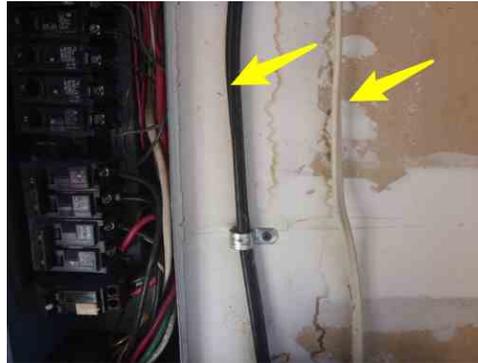
Exposed Garage Wiring Not Encased in Conduit Needs Repair

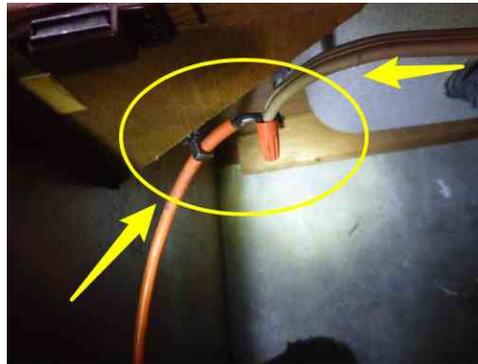
The kitchen cabinet has open spliced wires that lack conduit and a junction box and need service as noted in the report photos. The kitchen pantry light is also improperly wired and has exposed wiring that needs repair. Have further evaluation and repair by an electrician along with any costs of repair prior to close of contingencies.

Kitchen Cabinet w/ Loose Dishwasher Wires Spliced Outside of a Junction Box & No Conduit= Fire Hazard

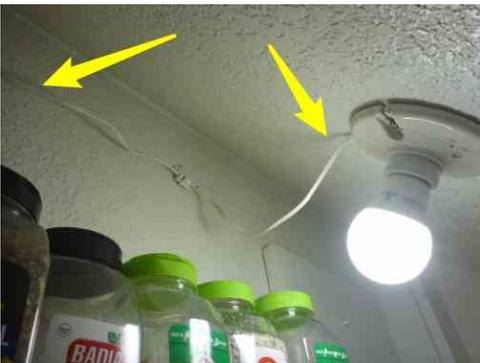
Kitchen Pantry Light Improperly Wired & Needs Service

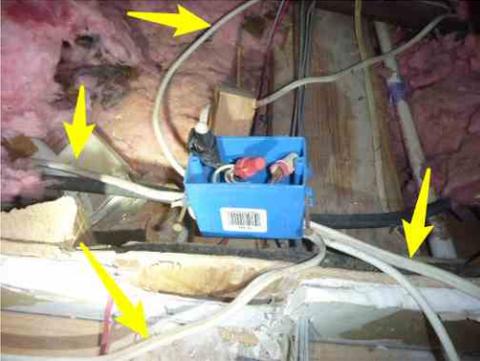
SC 172: The exposed wiring within six feet of the garage attic access opening is not protected from damage and needs service. There are exposed wires in the garage attic that are not properly terminated in a junction box and need service as this is a fire hazard as noted in the report photo.

Exposed Wires w/in 6' of Attic Access Need to be Cleared.

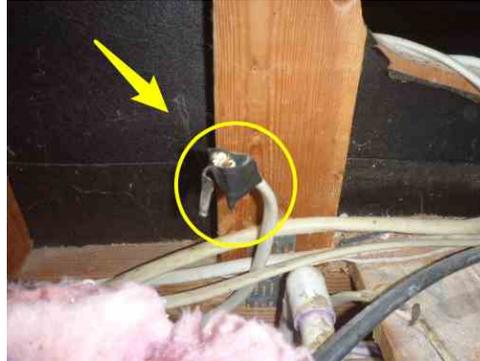
Garage Attic Wiring Not Properly Terminated in a Junction Box = Fire Hazard

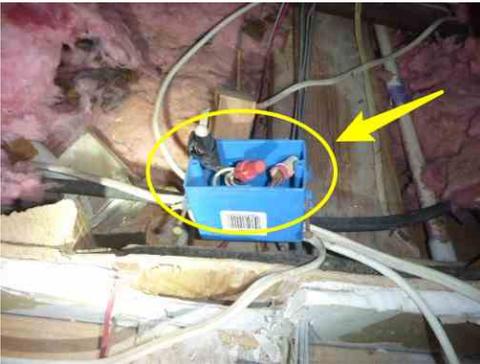
SC 173: Open junction boxes with exposed wire connections were noted in the garage attic area and need covers installed as this is a fire hazard.

Garage Attic w/ Open Junction Boxes That Need Cover Plates Installed To Prevent a Fire Hazard

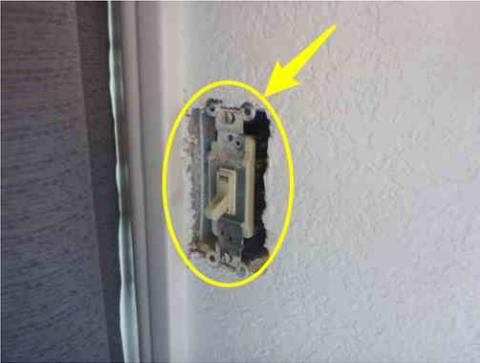
SC 176: Switch covers are damaged/missing at the following locations: living room and needs a cover plate installed.

Switch Cover Plate Missing at Living Room
Needs Installation.

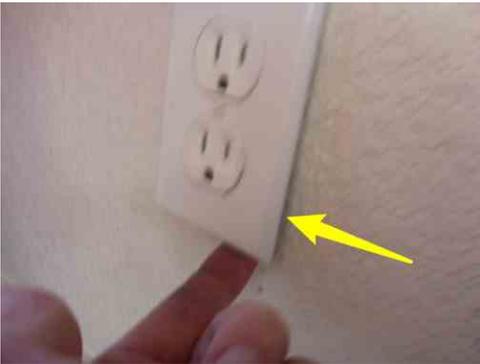
CR 177: There were loose receptacles that need to be secured to the wall as noted in living area left of the fireplace.

Loose Outlets Need to be Secured Left of the
Living Rm Fireplace

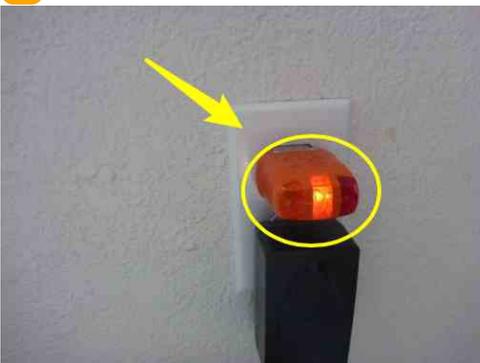
CR 178: The downstairs bedroom has open ground connections at the outlet and needs service.

Ungrounded Outlet at Downstairs Bedroom
Need Service

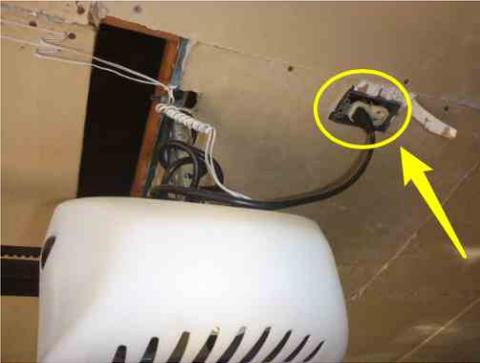
CR 179: Receptacle cover plates are missing as noted at the garage ceiling and need to be installed where necessary.

Garage Ceiling Outlet Missing Cover Plate & Needs Installation

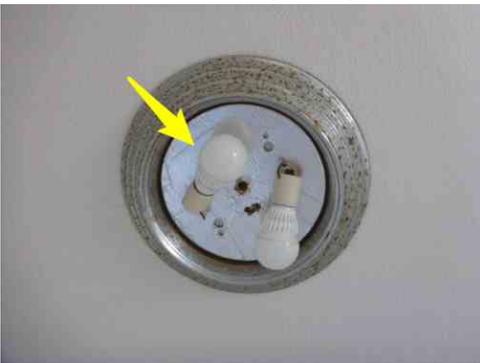
FE 180: The lights are functional but some are missing lens covers and others need bulbs replaced to confirm they are all functional. Have serviced and retest to confirm these are all functional. Install lens covers where missing on light fixtures as noted in the upstairs primary bathroom.

Missing Lens Cover at Primary Bathroom Light

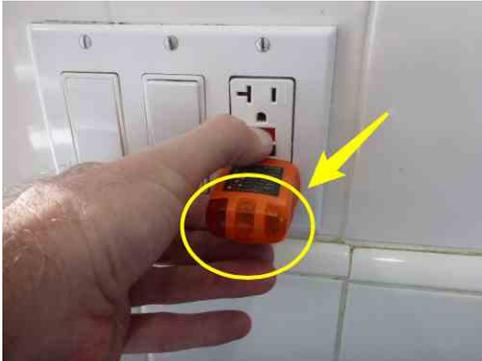
SC 182: GFCI protection devices are located in the following areas: Bathrooms, Exterior, Kitchen, and garage. The kitchen GFCI outlet is not resetting and needs service as it ties to other outlet in the kitchen which should all be GFCI protected. Today's standards of practice require GFCI (ground fault circuit interrupter) protection at the laundry outlets, all exterior outlets, all kitchen outlets, bathrooms and near any water source outlets and these areas are recommended to be upgraded if they are not already as a safety upgrade.

Kitchen GFCI Protected Outlet Not Resetting
& Needs Service

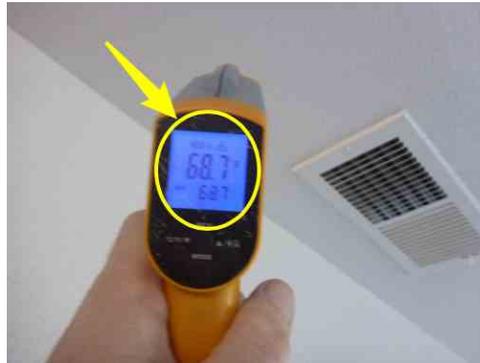
CR 200: The AC temperature differential between the supply and return air grills is less than 18 degrees and is not functioning properly and needs further evaluation by an HVAC specialist for any costs of repair prior to close of contingencies.

Ambient Air Temperature at 68.7 Degrees &
System Not Cooling Properly

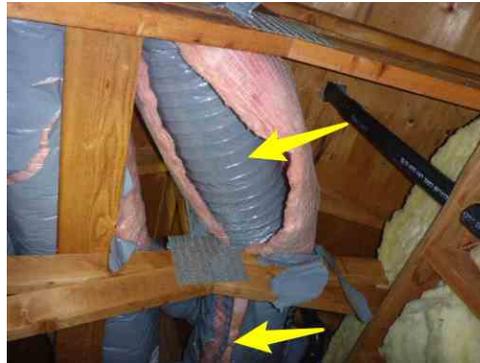
CR 206: The outer plastic covering on the conditioned air ducts is deteriorated. These need repair or replacement by an HVAC specialist.

Attic Ducts w/ UV Damaged Outer Plastic
Cover Need Repair/Replacement

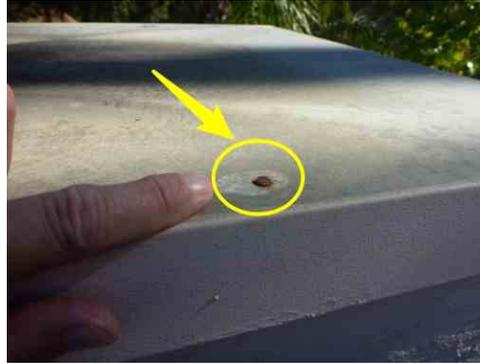
CR 212: Evidence of ponding water on the chimney metal cap for the right side chimney at the living room. These condition(s) are conducive to moisture intrusion and deterioration. The metal chimney cap should be properly sloped to shed water and prevent ponding that can cause rust and leaks. Reseal the nail heads at the top of the metal cap to prevent water intrusion below as well. Have serviced by a chimney specialist.

Reseal Chimney Cap Nail Heads To Prevent Water Intrusion Below

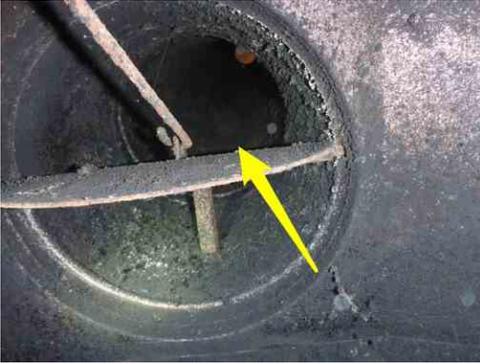
SC 216: The visible area of the flue is dirty. We recommend the flue and related components be cleaned by an appropriate professional in the appropriate trade.

Dirty Fireplace Flues Need Chimneys Cleaned
by Specialist

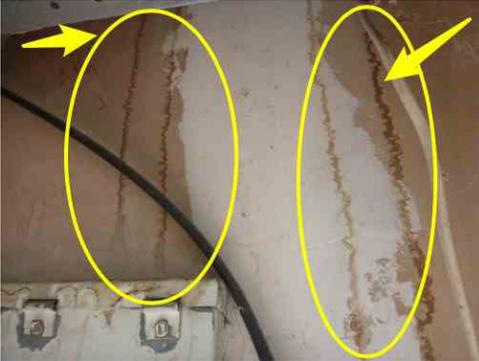
FE 226: Moisture stains are visible on the wall(s)/ceiling at the garage that appear to be prior to the re roof and should be confirmed by the sellers as having all been repaired for any past leaks. This area was dry at the time of the inspection.

Garage Moisture Stains on the Walls Appear Prior to Re Roof Dry During Inspection

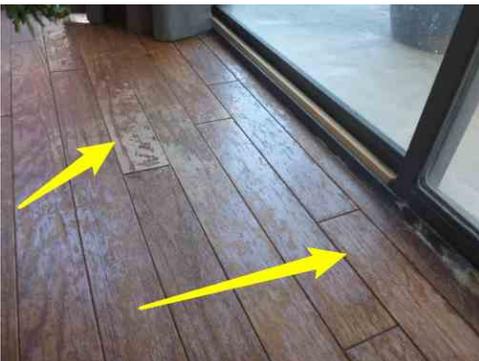
CR 231: The wood flooring is worn at the surface and needs refinishing in areas as noted by the sliding glass door areas where moisture is more prevalent coming in and out of the house.

Worn Wood Floors Need Refinishing to Protect the Wood From Further Deterioration

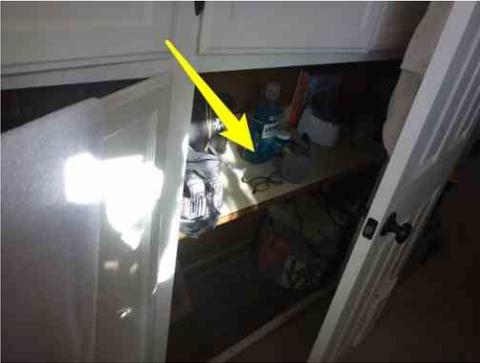
240: Cabinet Doors are missing at the upstairs hall bathroom.

Upstairs Hall Bathroom Cabinet Doors Missing

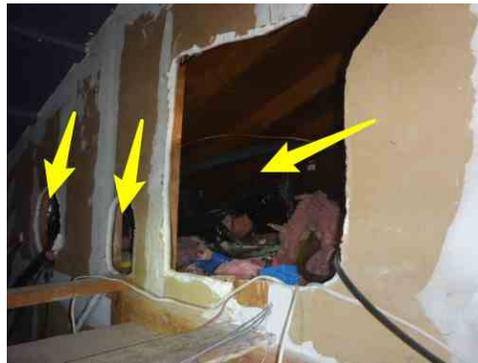
Holes in Garage Firewall Need Repair to Maintain Fire Separation Between Attic/Garage

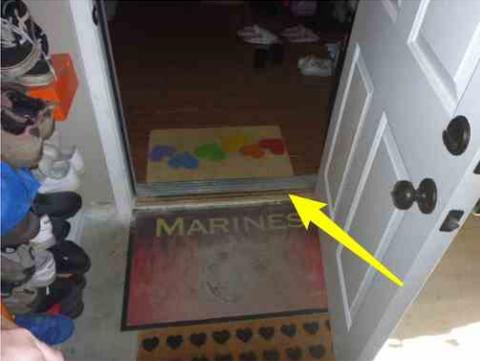
SC 274: The garage interior door is not of a fire-resistant type and needs to be replaced. The present standards call for the door between the garage and living space to be a fire-resistant door and be self-closing & latching.

SC 275: The garage fire-resistant door automatic closing-device is damaged/defective/missing. The fire-resistant door did not close and latch shut by itself. This can void a fire insurance claim and needs to be replaced with a rated fire door that self closes and self latches shut.

Garage Firewall Door Not Rated for Firewall &
Not Self Closing Self Latching Shut
