# Inspection Report

**Property Address:**  
51 Quinta Court  
Paso Robles CA 93446

1/15/2026

**Harper Homes: Home Inspection Services**

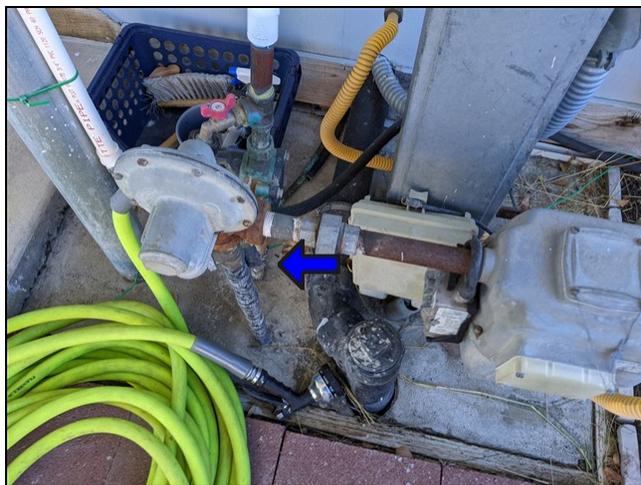
4.4 Item 1(Picture)

INFORMATIONAL NOTE

The water shutoff is located at the right exterior of the home. To turn the water off turn the handle perpendicular to the piping.
