THE REAL ESTATE
INSPECTION COMPANY

HOME INSPECTION

11493 Nantucket Pkwy
San Diego, CA 92130

02/10/2026

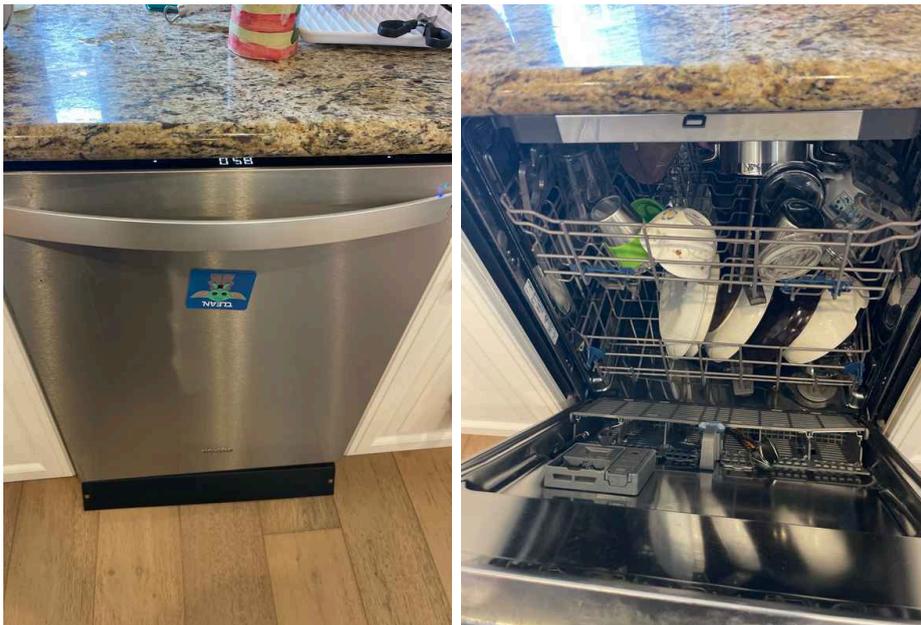
DISHWASHER: Dishwasher - Aged

Note: The dishwasher appears to be past its expected service life. The average life of a dishwasher is 10 years. Some units may last for more or less than 10 years depending on quality and usage. To see a complete list of life expectancies for just about every component in a house, please visit our list of Life Expectancy.

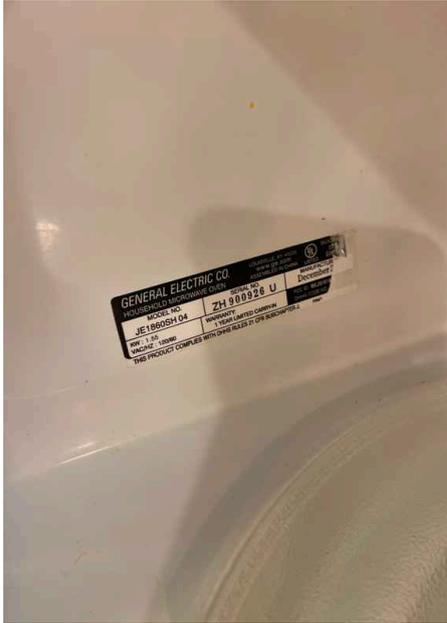
Microwave

MICROWAVE COOKING EQUIPMENT (Built-in): MICROWAVE - AGED

Note: The microwave is an older unit. (more than 9 years) with visible rust/deterioration at the interior. According to InterNACHI the average life span of a microwave is 9 years. See <https://www.nachi.org/life-expectancy.htm>

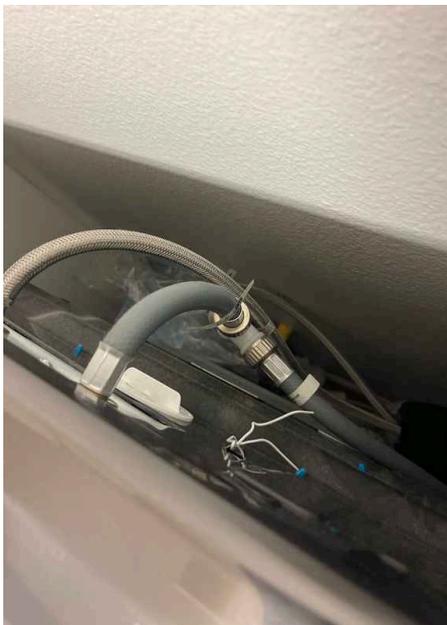
Rubber Hoses

WASHER/DRYER: Washer Hoses Replace

Washer hoses are a common source of flooding in a home. We recommend installing new braided steel washer hoses to reduce the risk of leaks caused by burst hoses in the house. Any hoses left in the house or more than 5 years old should be replaced.

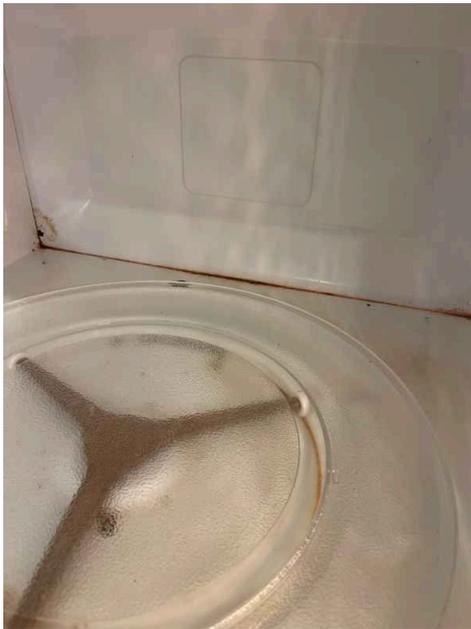
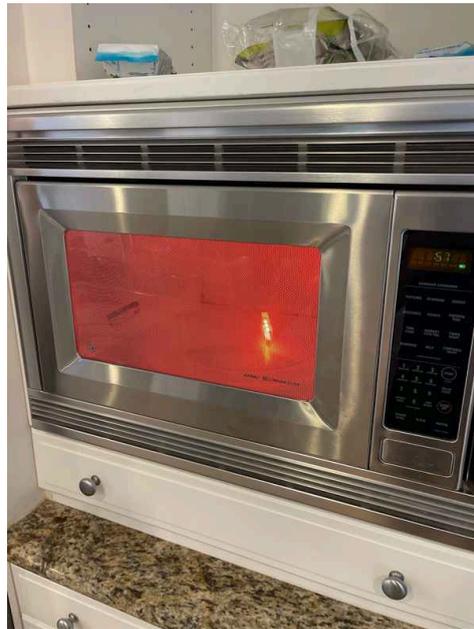
MICROWAVE - RUST/DETRIORATION

Microwave was operational. Rust/deterioration were visible in the microwave. The unit may have limited life remaining.

Contact the seller for more info

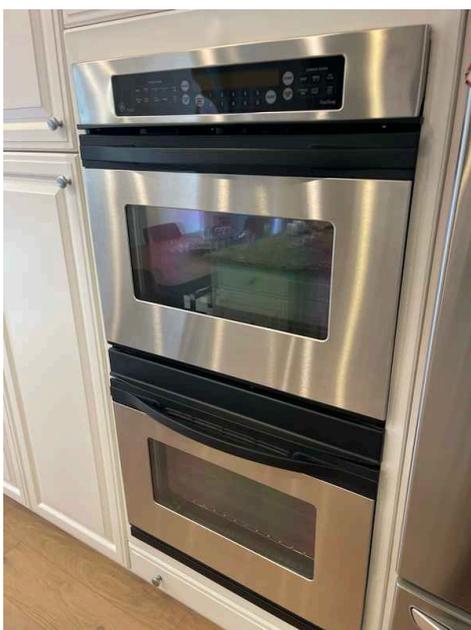
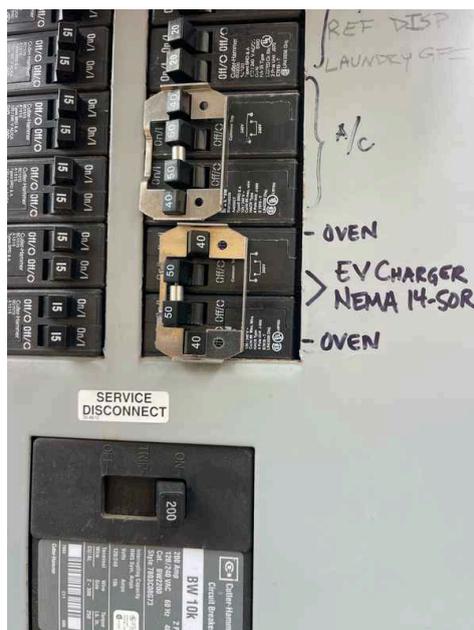
Kitchen

2.7.1 WALL OVEN

The wall ovens are inoperable. Breaker off at panel. We recommend further evaluation with repairs or replacement.

Contact a qualified appliance repair professional.

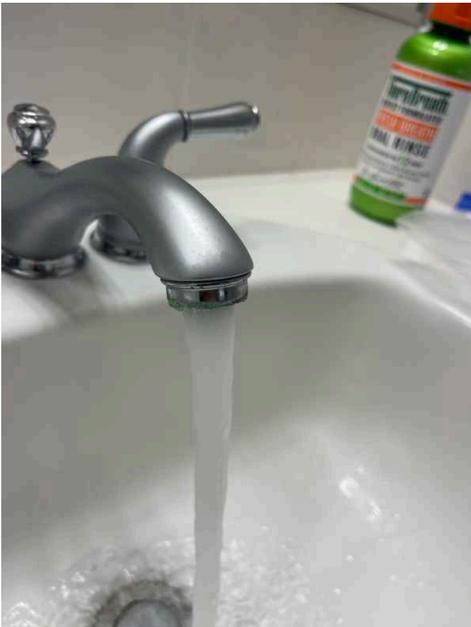
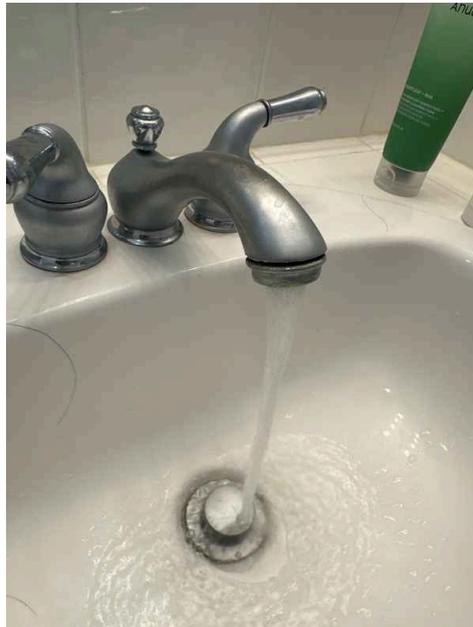
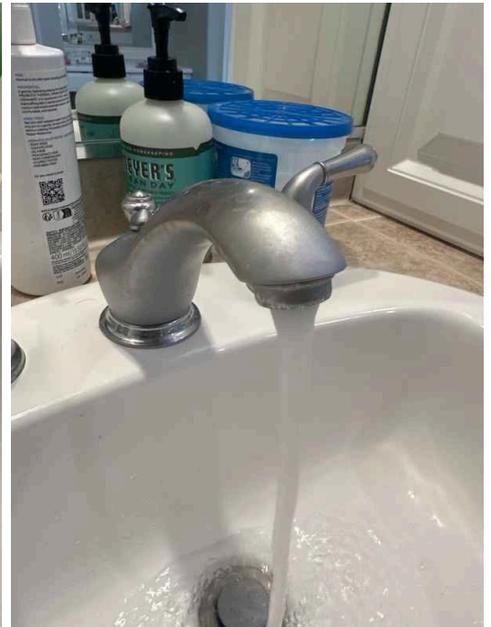
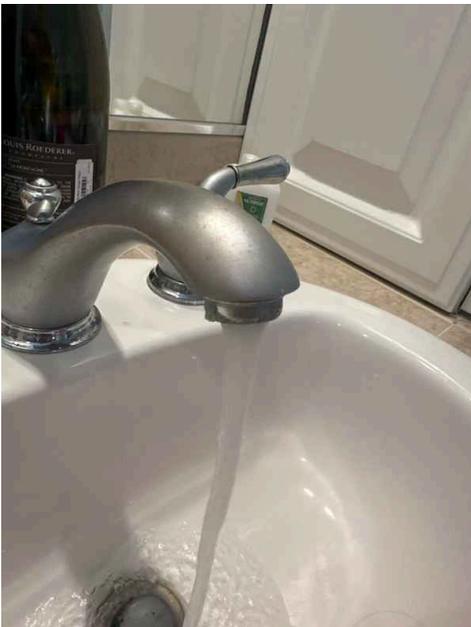
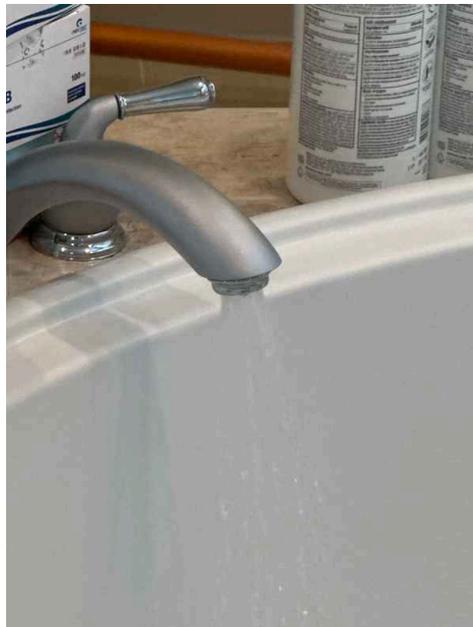
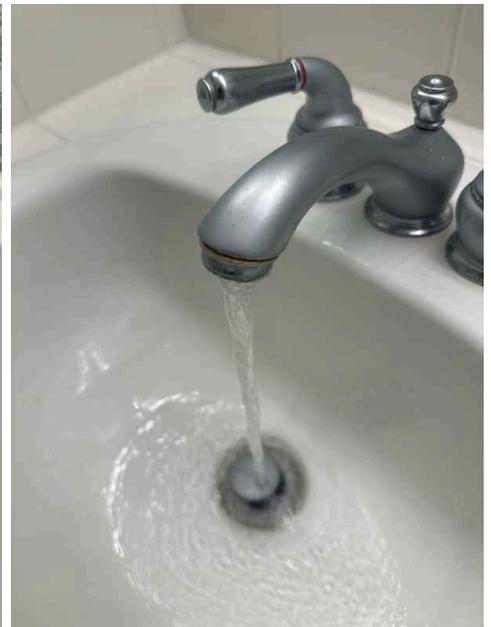
AERATORS-CORRODED/CLOGGED

The sink/tub faucet aerators were corroded or clogged. This causes low flow or a coarse flow of water that is more likely to splash out of the sink. We recommend replacement of the aerator or faucet as needed.

Contact a qualified professional.

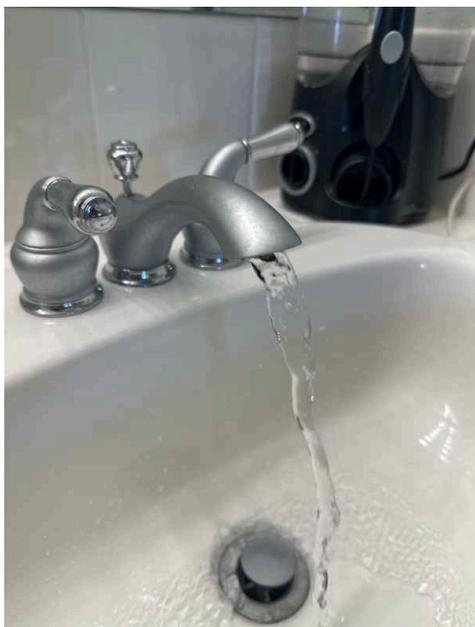
Upstairs Hall Bathroom (Right Sink)

AERATOR - MISSING

The aerator is missing from the faucet at the sink. This causes a coarse flow of water that is more likely to splash out of the sink. We recommend replacement of the aerator.

Contact a qualified professional.

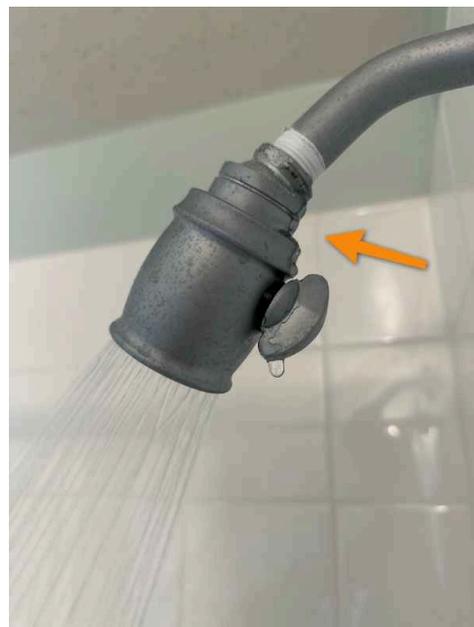
Upstairs En-suite Bathroom

SHOWER HEAD - LEAKS FROM CONNECTION

Water leaks from the shower head connection to the hose or shower arm when operated. We recommend repair as needed by a qualified plumber to prevent excessive amounts of water from exiting the shower enclosure.

Contact a qualified professional.

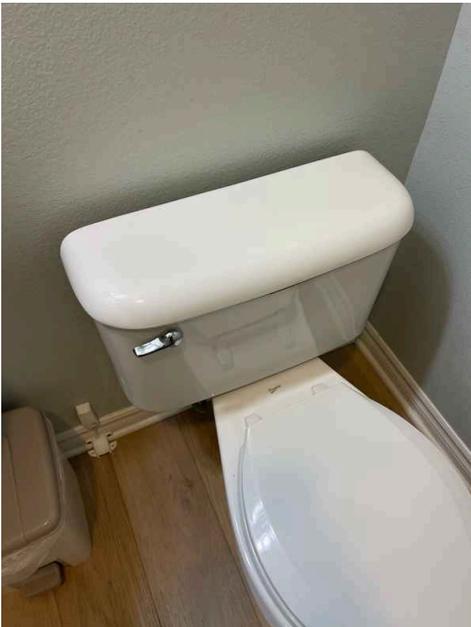
Half Bathroom

TOILET - TANK LOOSE ON BOWL

Toilet tank was loose on bowl. No leaks were observed at time of inspection. We advise having the toilet tank secured by a licensed plumber to avoid leaks.

Contact a qualified professional.

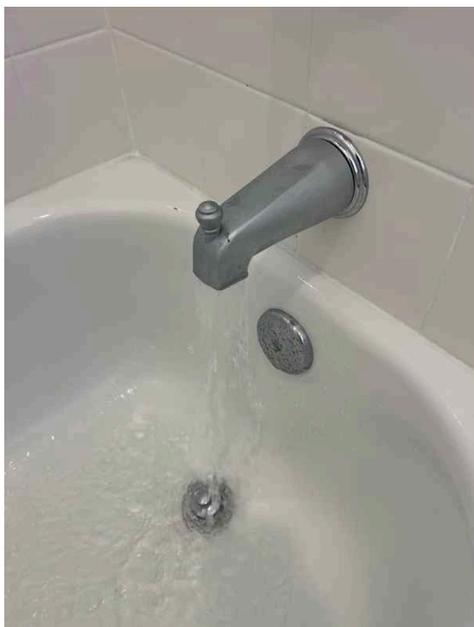
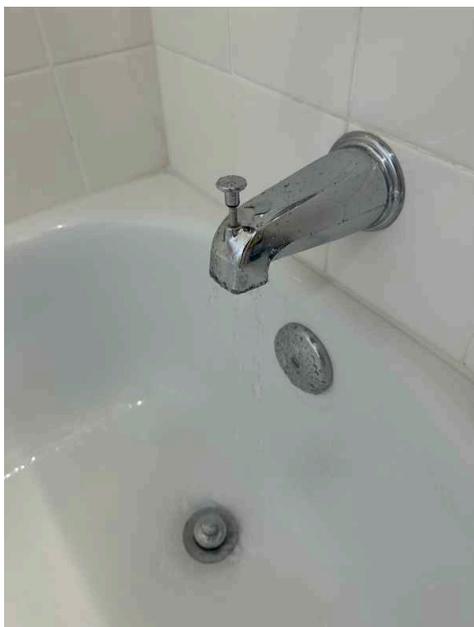
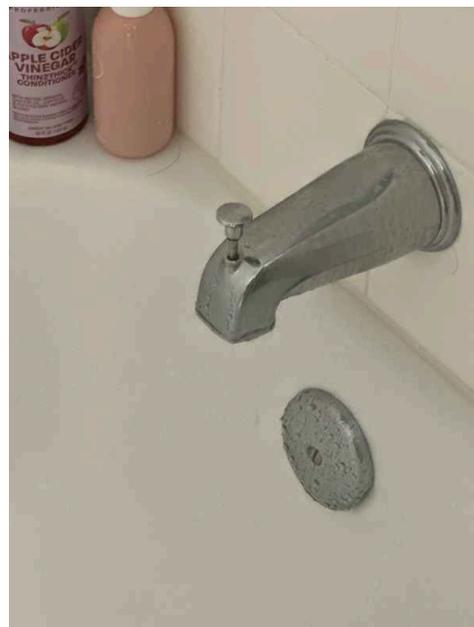
TUB DIVERTERS - DEFECTIVE

The tub diverters were defective. This is likely due to hard water deposit build up on the tub spout mechanism. We recommend necessary corrections by a licensed plumber.

Contact a qualified plumbing contractor.

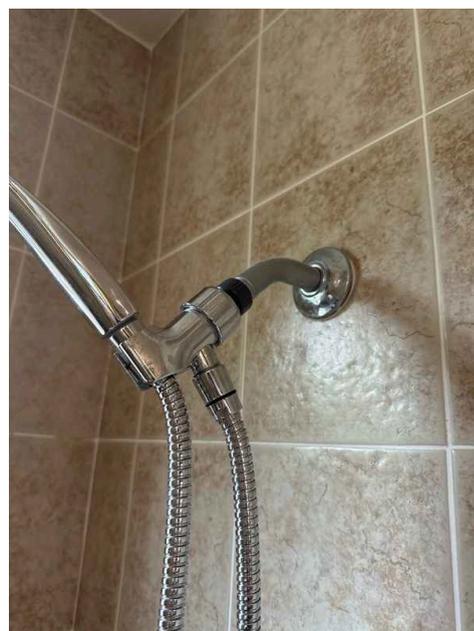
Master Bathroom

LOOSE PIPE IN WALL

Loose shower pipe was detected in the wall. Poorly secured pipes can leak due to the stress put on solder joints and fixtures. We recommend further review and correction by a licensed plumber.

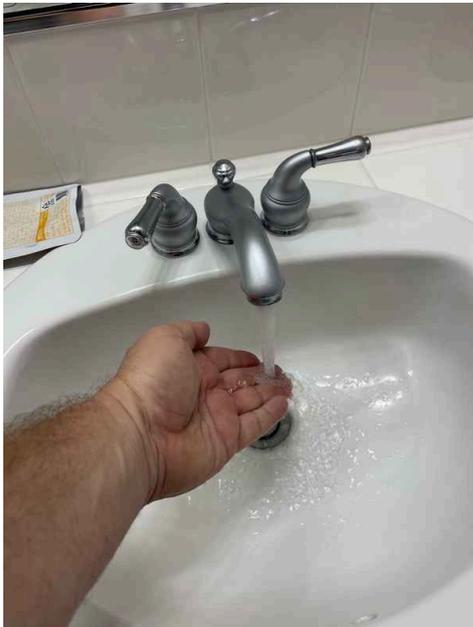
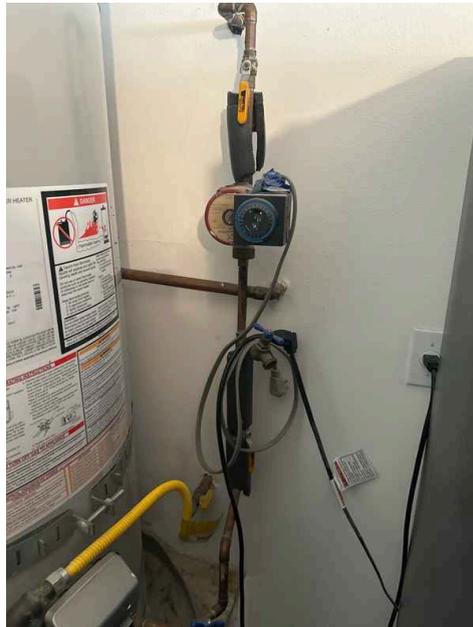
Water at plumbing fixtures required an unusually long time for water to get hot. This is often a result of the plumbing fixture being located too far from the water heater. We recommend plugging back in recirculating pump and testing and if needed consulting with a qualified plumbing contractor.

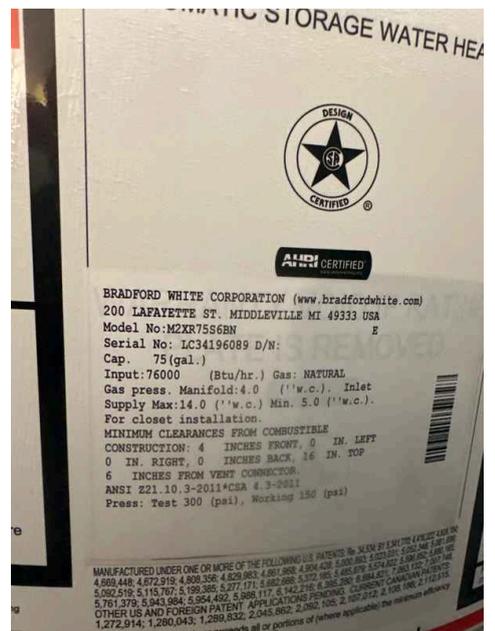
2014

The water heater is an older unit (10 years+), and repairs or even failure can be expected. The hard water in Southern California can contribute to early failure. In addition to avoiding leaks, a new water heater can save you money through more efficient operation. Advise replacing the water heater as preventative maintenance. We recommend that keep a good home warranty in place which covers the water heater. For more information visit: <http://www.nachi.org/lifespan-water-heater.htm>

Contact a qualified plumbing contractor.

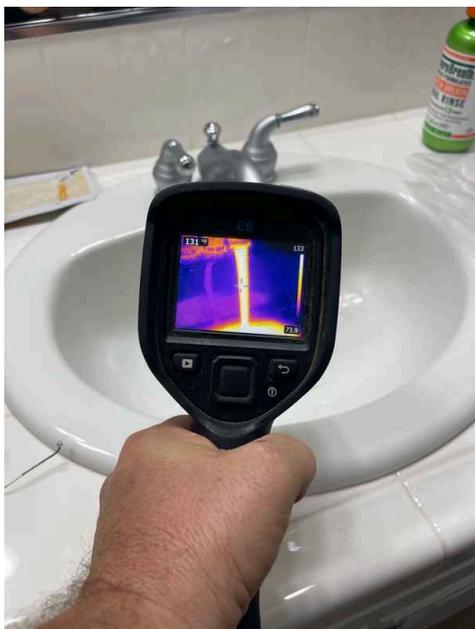
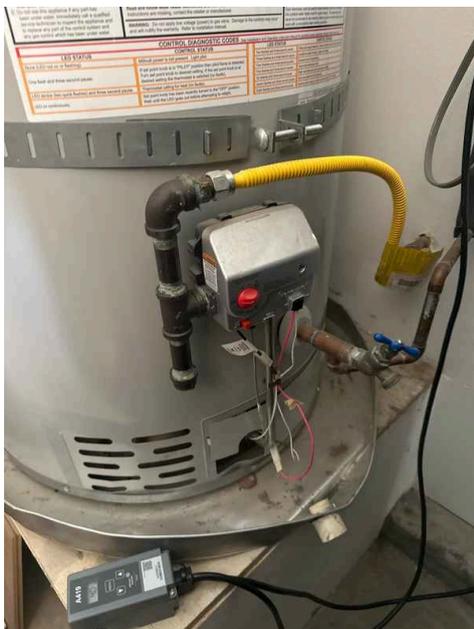
The water temperature was tested at the faucets and was high. Water temperatures above 125 degrees can cause scalding or burns. Most water heater manufacturers recommend setting the water heater controls at 120 degrees for optimum efficiency. Lowering the water heater output temperature will reduce your utility bills. According to the U.S. Department of Energy, for each 10-degree reduction in water temperature, you can save between 3 and 5 percent in energy costs. Note: If you have an older dishwasher that doesn't preheat the water, manufacturers recommended setting water heater temperature at 140 degrees. This is to ensure sanitary dishes.

Recommended DIY Project

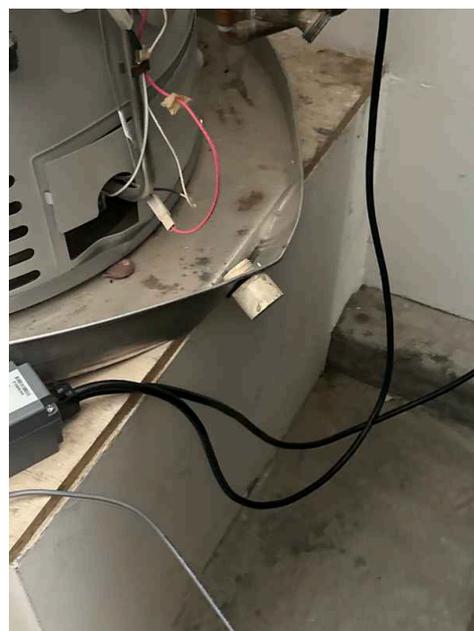
Garage

NO DISCHARGE@LEAK PAN

The leak pan under the water heater is bent and missing a discharge pipe to the exterior or drain.

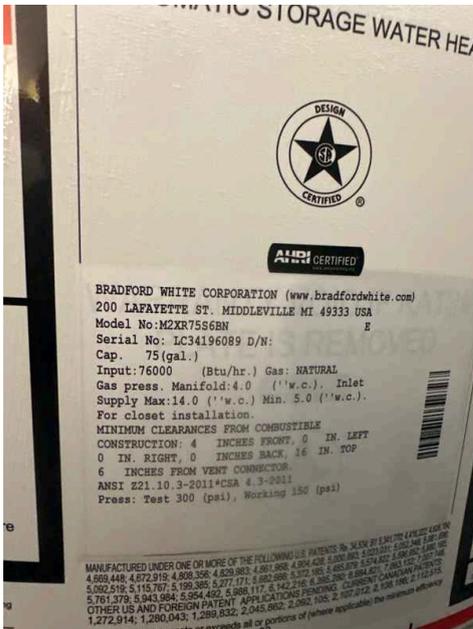
75 Gal

Safety Recommendation: Water heaters with a capacity of 50+ gallons 3-4 straps are required in earthquake regions 3 and 4 which includes San Diego County. While this may not be required in some areas, we recommend installing additional straps by a qualified person for seismic safety.

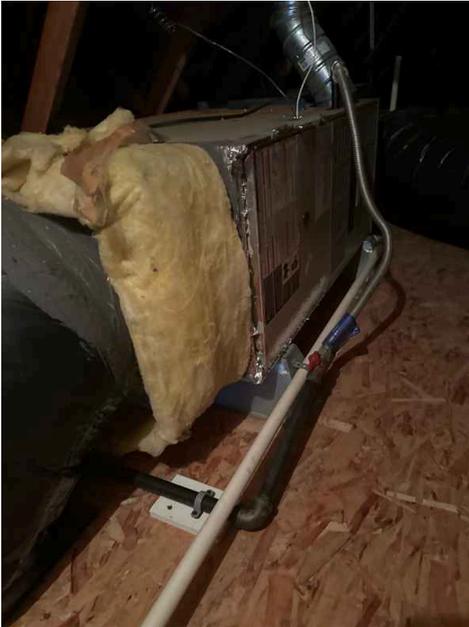
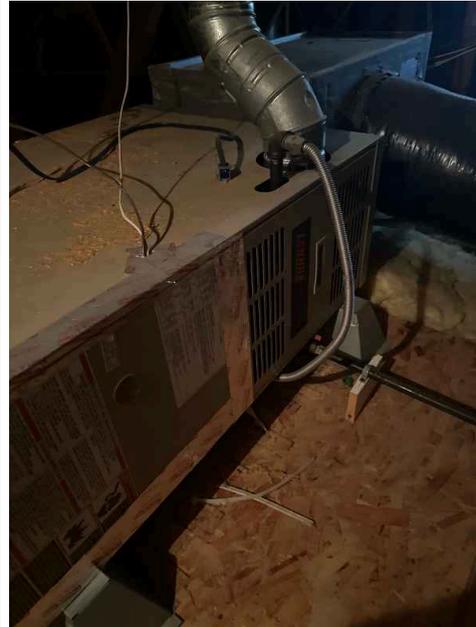
Attic

The gas supply pipes at the furnaces contained no sediment trap. A sediment trap is generally recommended by the manufacturer. The purpose of a sediment trap is to prevent particulates or moisture from condensation from entering and clogging the water heater/furnace gas valve, which can cause the water heater/furnace to shut down.

Recommendation

Contact a qualified professional.

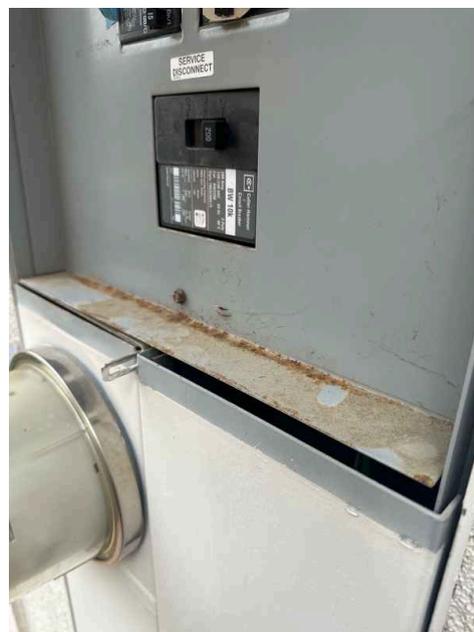
Main Panel

RUST IN PANEL

Rust noted in the main electric panel. Rust can cause breakers to become unreliable or cause poor connections. Unable to determine the source of the water. We advise further evaluation and necessary corrections by a licensed electrician.

Recommendation

Contact a qualified electrical contractor.

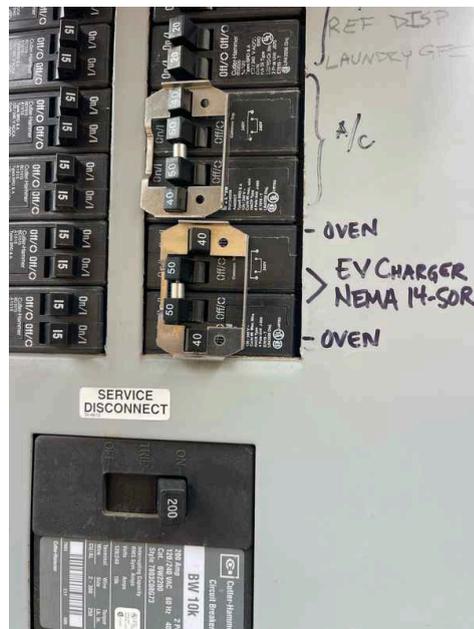
Main Panel

One or more circuit breakers were off at time of inspection. Home inspectors do not turn on, operate or re-set over-current protection devices (circuit breaker). Any circuit breaker that is off can indicate a failure of that circuit. Turning on breakers that are off can be a safety hazard. We advise review with seller and/or licensed electrician to determine why breaker(s) have been turned off.

Recommendation

Contact the seller for more info

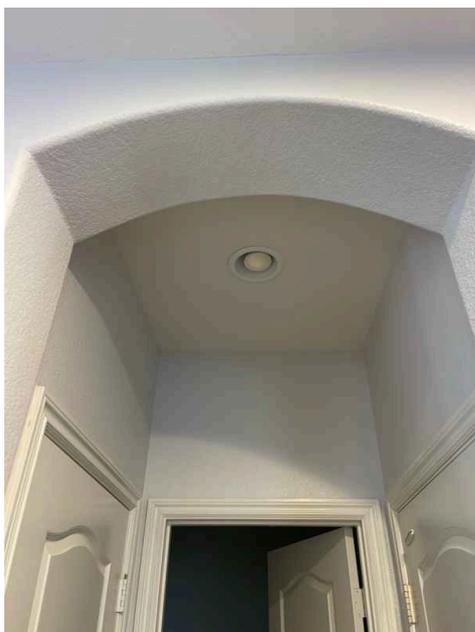
Front Hallway

The lights did not function possibly due to bad bulb. Occasionally there is something wrong with the fixture which cannot be determined without working bulbs. We recommend asking the seller to demonstrate that the light is working prior to the end of the inspection contingency period, or changing the bulb and testing again.

Recommendation

Contact a qualified professional.

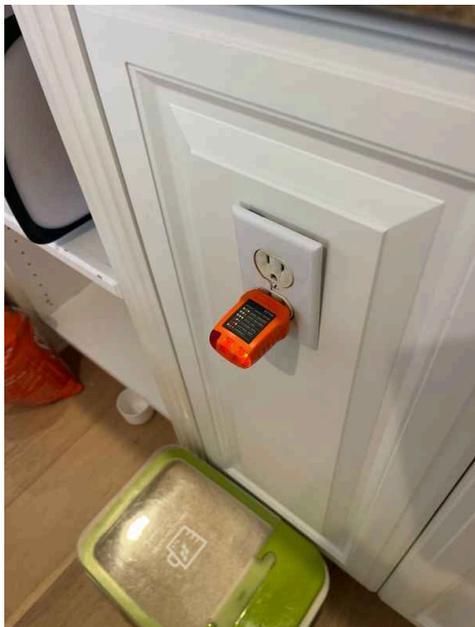
Kitchen

RECEPTACLES - LOOSE

Receptacle was loose in the wall/cabinet. This puts stress on the circuit wires which should not be moved. Others may be loose. We recommend securing the junction box properly in the wall by a qualified person.

Recommendation

Contact a qualified professional.

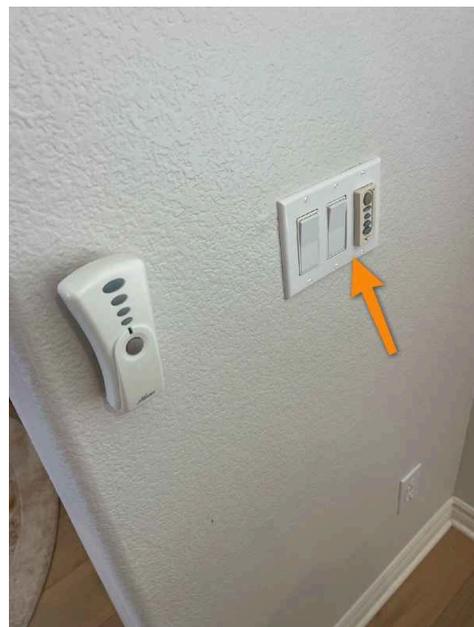
Family Room

SWITCH - BROKEN/NOT FUNCTIONAL

A defective lights/fan switches were noted. All lights fan operated by remote. We recommend repair by a licensed electrician.

Recommendation

Contact a qualified professional.

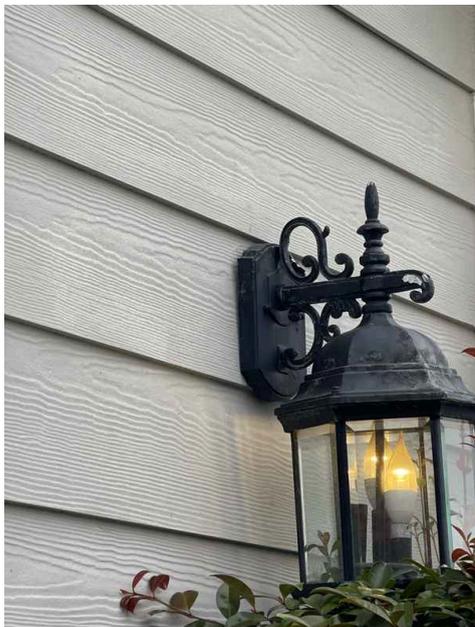
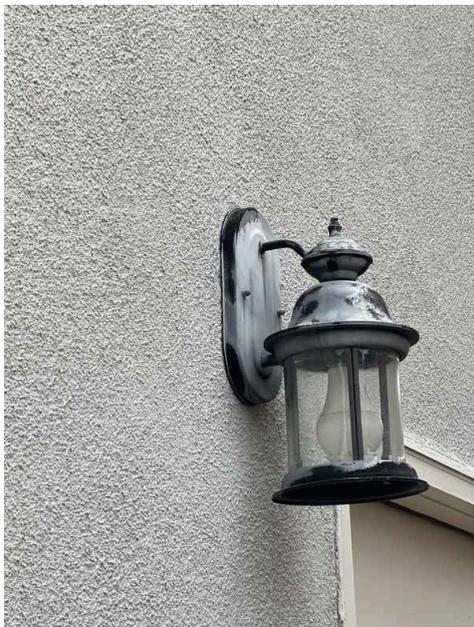
Exterior light fixtures should be sealed with an approved sealant where fixture meets wall to avoid moisture intrusion.

Recommendation

Contact a qualified professional.

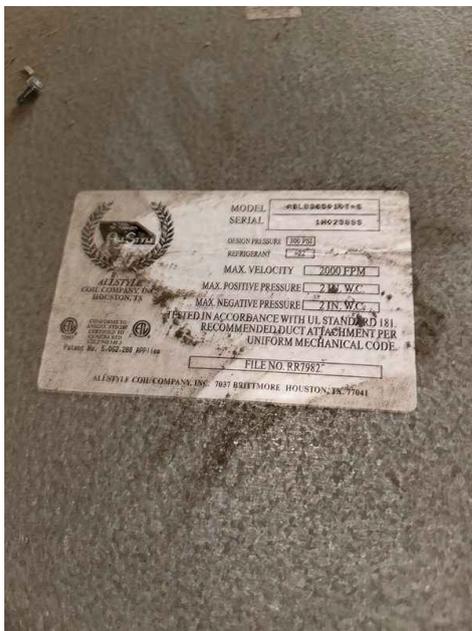
UNIT 1

The furnaces are older units which may be nearing the end of their useful life. Most furnace contractors recommend replacing a furnace when it becomes 20 years old ([Table of Life Expectancy](#)). Since Southern California has a mild climate, furnaces can last longer than industry standards. Since this furnace is aged, we recommend having a licensed furnace contractor inspect the furnace for safety and provide an estimate of life remaining and cost of replacement prior to the end of your contingency period so that you may budget accordingly. Note: We specifically disclaim cracks in furnace heat exchangers because proper evaluation requires invasive, technically exhaustive measures that exceed the scope of the General Home Inspection.

Recommendation

Contact a qualified heating and cooling contractor

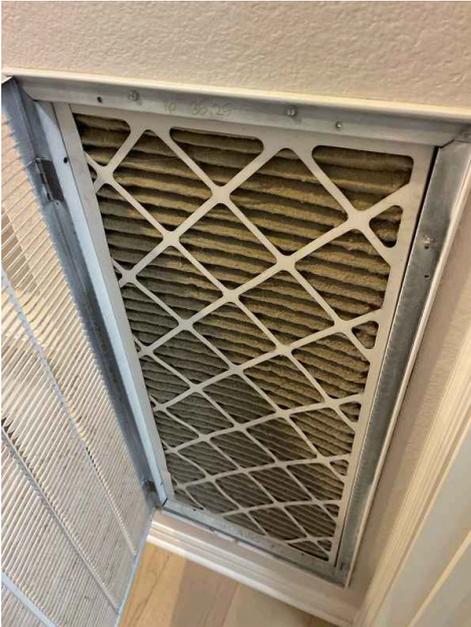
Downstairs Wall Return

FILTERS DIRTY - REPLACE

The air filters for the HVAC systems were dirty. Running the system with a dirty air filter can cause damage to the furnace and air conditioner by reducing the required air flow through the system. A dirty filter also reduces the efficiency of the system, which means it will take longer to heat or cool the home and will increase utility bills. Having a dirty filter also reduces the indoor air quality of the home. Air filters should be changed every 90 days. Cheap disposable fiberglass filters are not recommended, a pleated paper type filter is recommended for better performance and filtration.

Recommendation

Recommended DIY Project

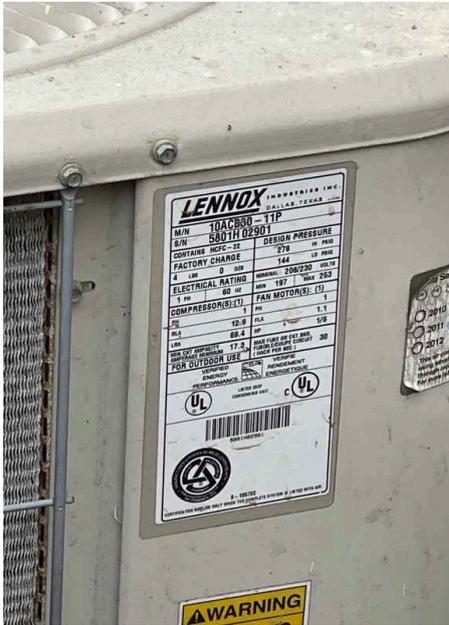
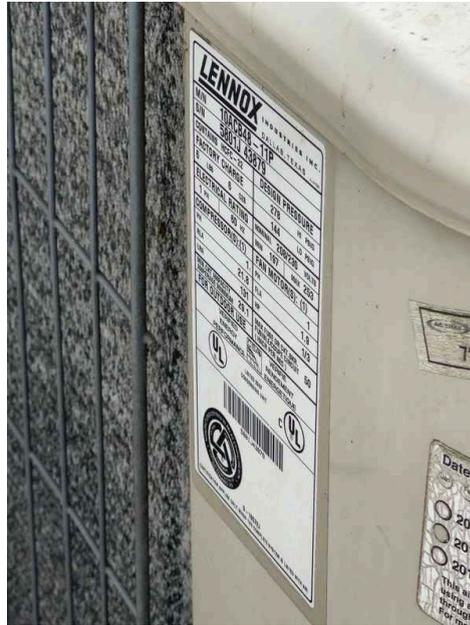
Rear Exterior

The AC systems in this home were manufactured prior to 2010. The refrigerant used prior to 2010, and likely used in this equipment, is HCFC-22 (also known as R-22). The U.S. EPA has deemed HCFC-22 an ozone depleting substance and has banned continued domestic production, or foreign import. Switching to an EPA approved substitute refrigerant is also a costly event not necessarily because of the cost of the refrigerant but because your existing HVAC equipment must be retrofitted to work with any of the approved substitute refrigerants. You may wish to consult with a qualified, licensed HVAC technician/contractor (request a 'section 608 certified' technician) about actual costs and to get a determination of the actual type of refrigerant used in this equipment. EPA website

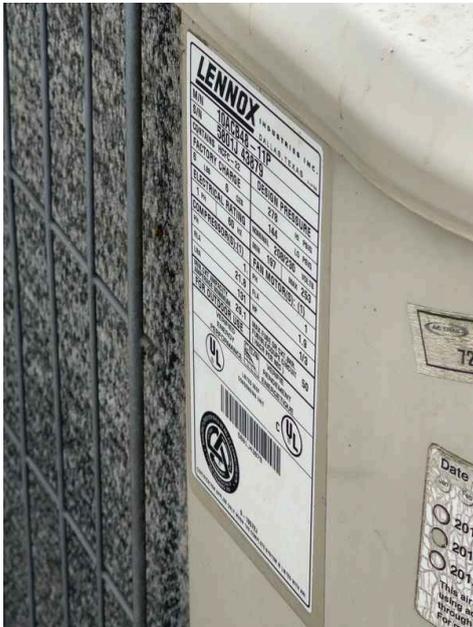
UNIT 1

The AC units are 15 or more years old and may be near the end of their useful life. The average life of an AC unit is 7-15 years ([Table of Life Expectancy](#)). We advise review with a licensed HVAC contractor to determine the life remaining and potential cost to replace so that you can budget accordingly. We further recommend that you keep a good home warranty in place which covers the AC system.

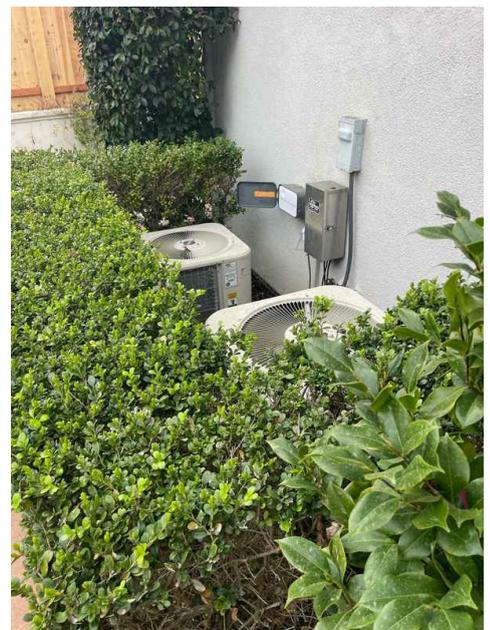
Vegetation is growing on and around the condensing unit.(AC) This can cause damage/deterioration of the unit and reduces the overall performance/efficiency. We recommend trimming the vegetation away from the condensing unit.

Contact a qualified professional.

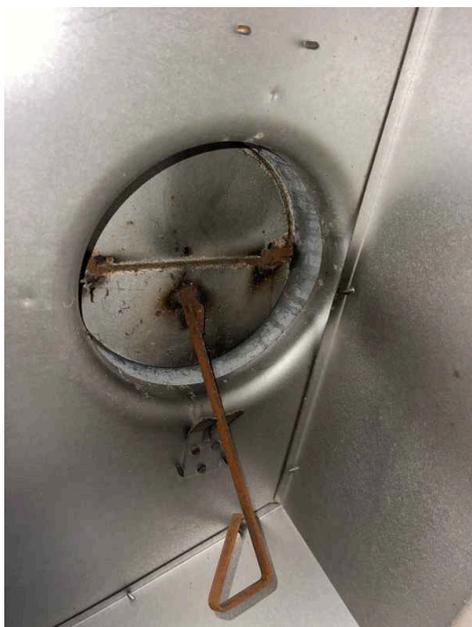
Living Room Fireplace

A damper clamp is required when there is a gas supply to the fireplace(s). This damper clamp prevents the damper from closing all the way as a safety precaution. If the damper is closed, Carbon Monoxide gas can enter the living space which is odorless. We recommend the installation of a damper clamps.

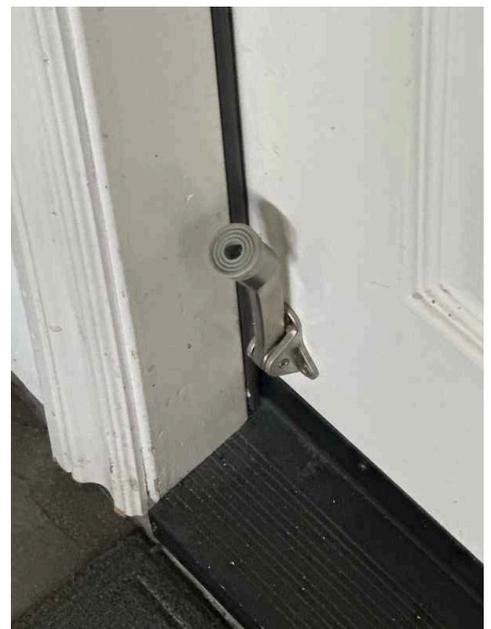
Door Stopper

The door to the garage has a door stopper. The door stopper defeats the auto closer, which is required. We recommend the removal of the door stopper to maintain the integrity of the fire wall and fire door.

Contact a qualified professional.

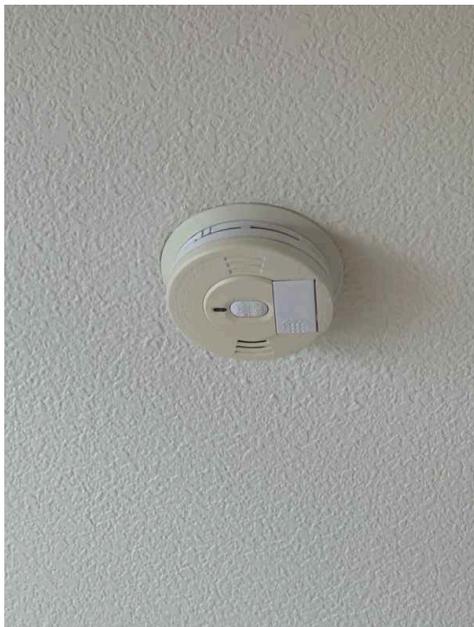
The smoke detectors in the house are old. Studies show that detectors that are more than 10 years old have a high rate of failure. Many old detectors do not have battery backup, and will not work if the electricity is off. The old detectors should be replaced prior to occupancy for safety.

Contact a qualified professional.

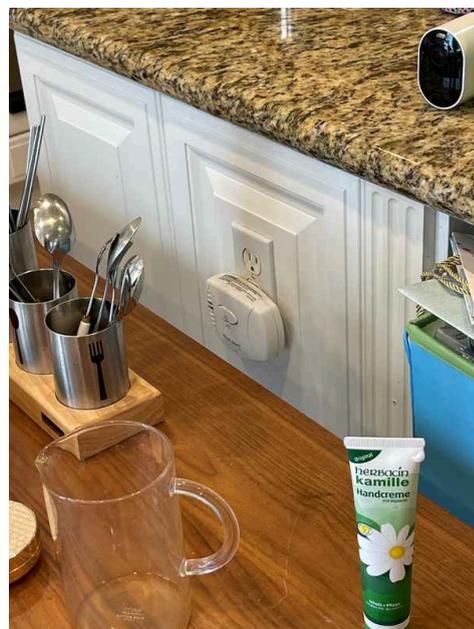
Kitchen

Carbon monoxide detector was poorly placed/located. Carbon monoxide detector should not be located in the same space as combustion appliances such as a kitchen stove. Combustion appliances like furnaces, water heaters and stoves sometimes produce levels of carbon monoxide high enough to activate the alarm of the carbon monoxide detector when the system is first activated. Typically, carbon monoxide levels quickly drop to safe levels. To avoid false alarms, and to protect sleeping areas, we recommend a qualified contractor move the carbon monoxide detector to an appropriate location.

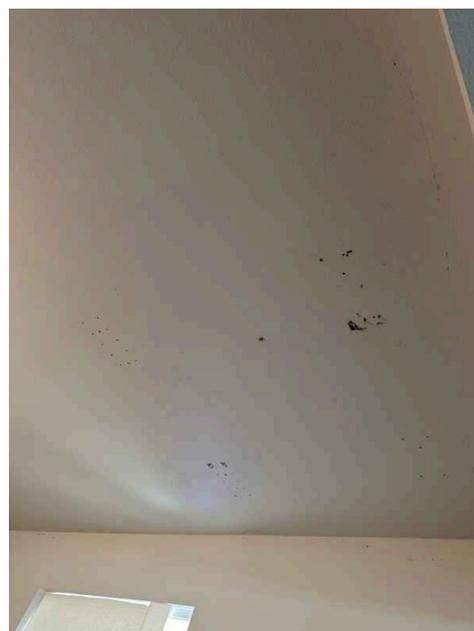
Garage

9.3.2 CEILINGS

STAINS - DRY UNDER ROOF

Water stains were noted on the ceiling which can be from a roof leak. These stains were tested for moisture and were found to be dry at the time of the inspection. Due to lack of recent rain, determining the presence of an active roof leak was not possible. We recommend asking the seller if leaks exist, or if repairs have been performed. Otherwise, a licensed roof contractor should be consulted to perform a roof service and inspection prior to the end of the contingency period.

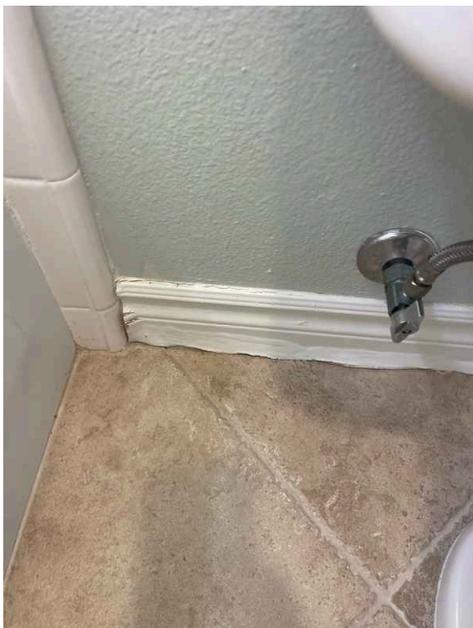
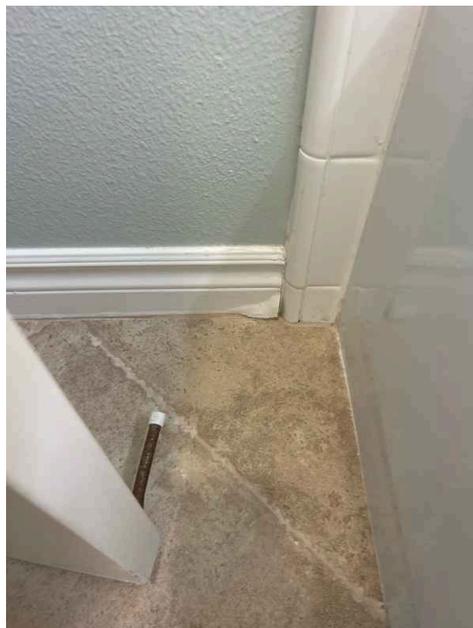
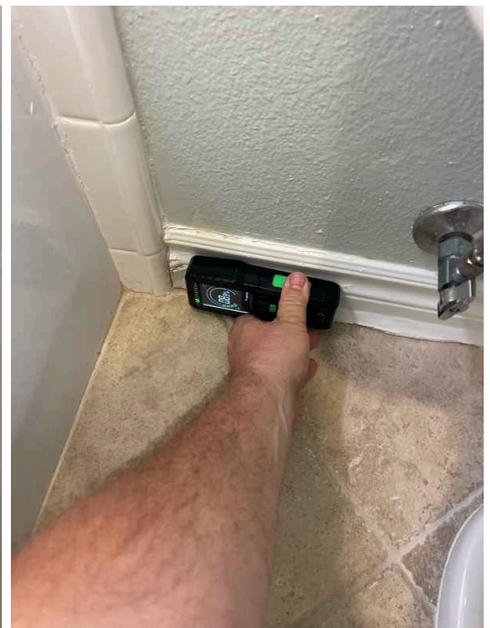
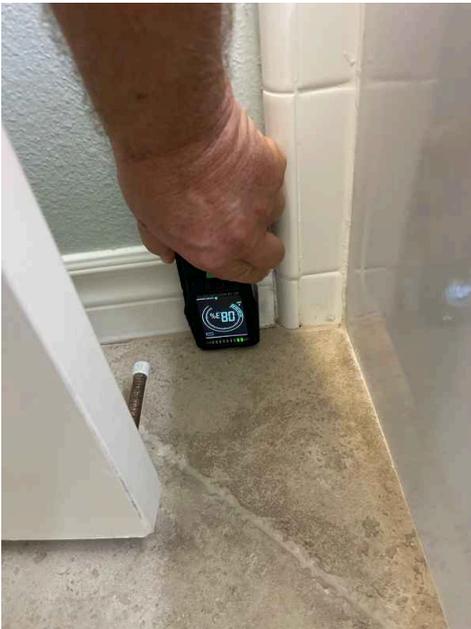
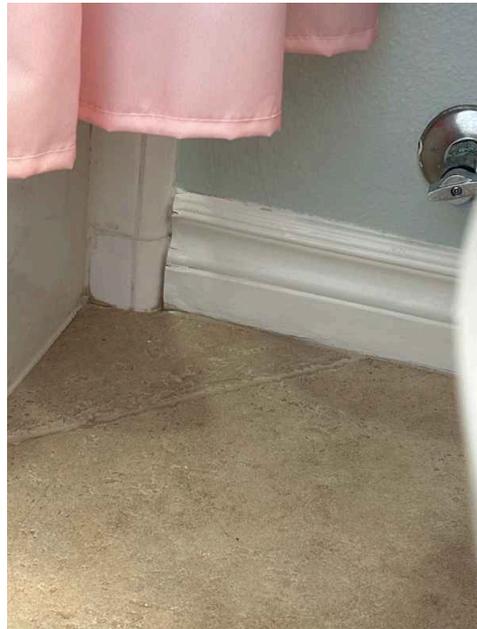
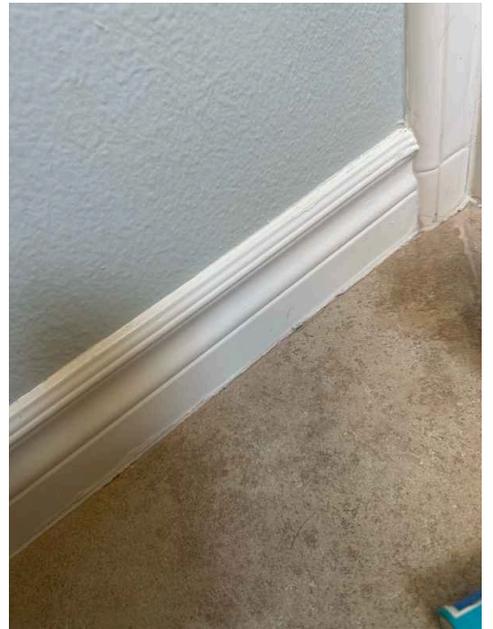
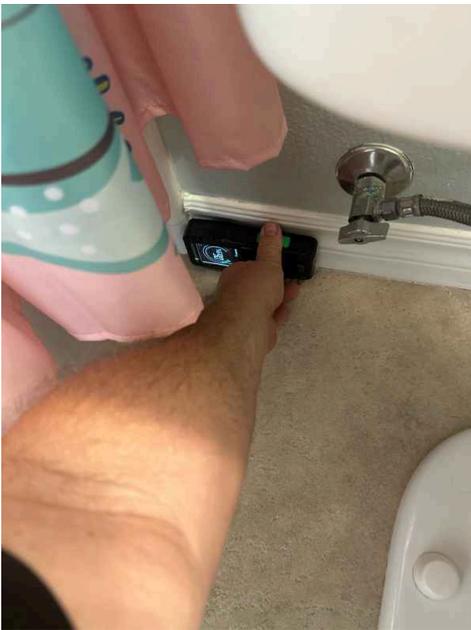
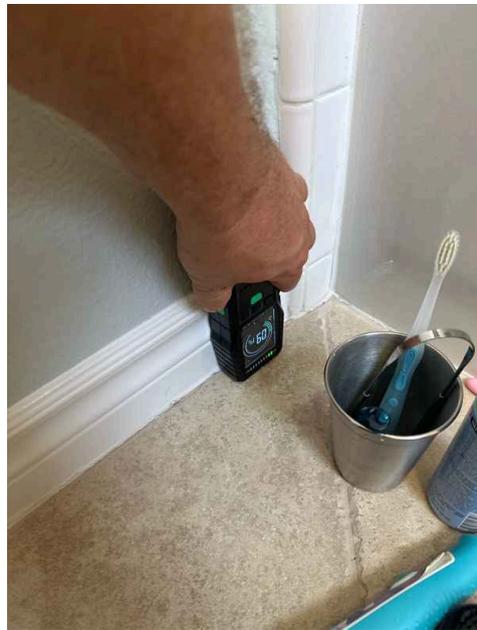
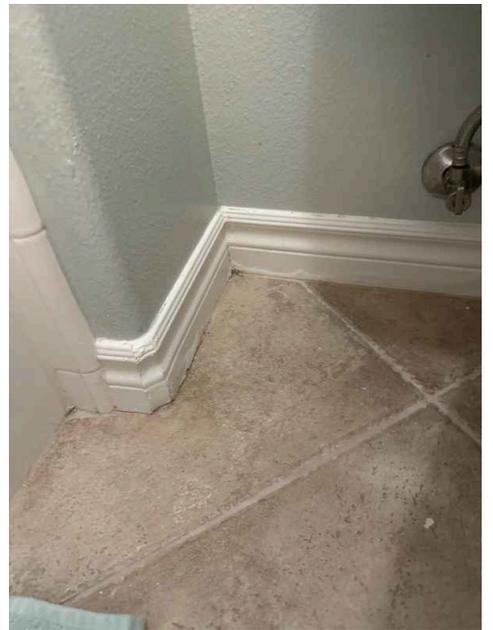
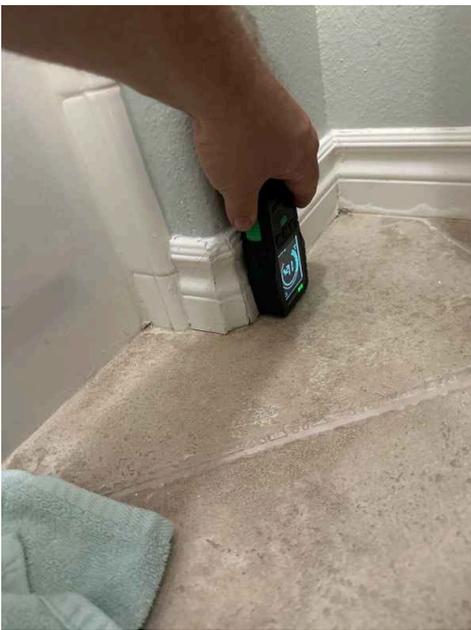
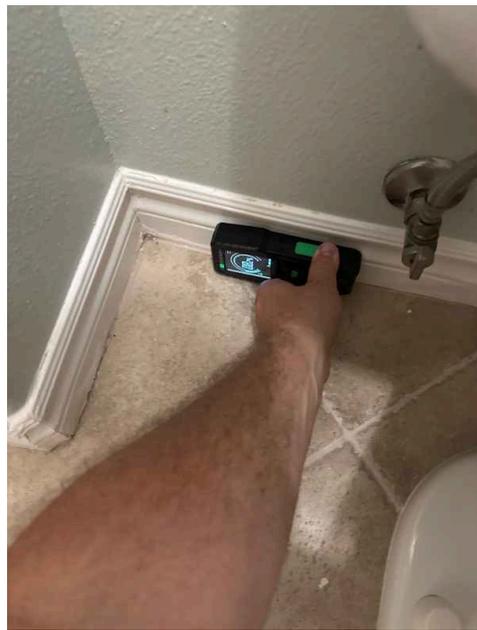
9.4.1 WALLS

The baseboards were damaged/swollen. The swelling was observed consistent with moisture damage. This may be caused by a leak/spill or water escaping from an enclosure or shower curtain. We advise further review and repair with a qualified person.

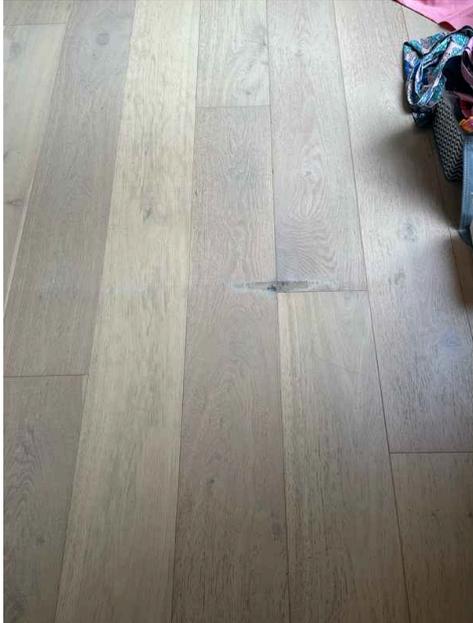
Downstairs Hall/Dining Room

9.5.1 FLOOR COVERINGS

**FLOORS-WORN**

Flooring in the home exhibited surface wear. We recommend that you consult with a qualified flooring contractor to discuss repair and costs for replacement.

Contact a qualified flooring contractor

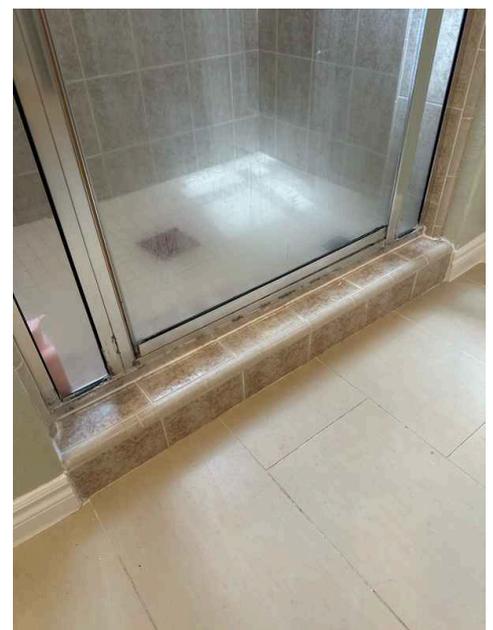
Master Bathroom

9.6.1 TUB/SHOWER

**CORRODED SHOWER DOOR**

Corrosion was noted at shower door(s). We advise cleaning or replacing doors as necessary.

Contact a qualified professional.

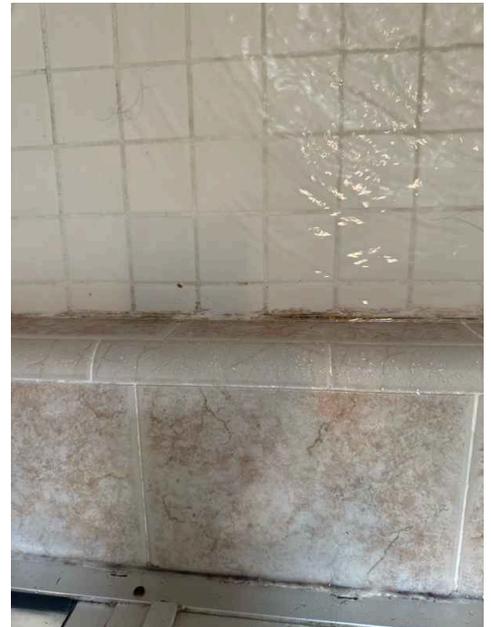
Master Bathroom

9.6.2 TUB/SHOWER ENCLOSURE

Dark staining was observed at caulking in the tub/shower enclosure. This can be caused by a lack of cleaning or an incorrect type of caulking may have been used. We advise having the caulking cleaned or replaced with qualified contractor.

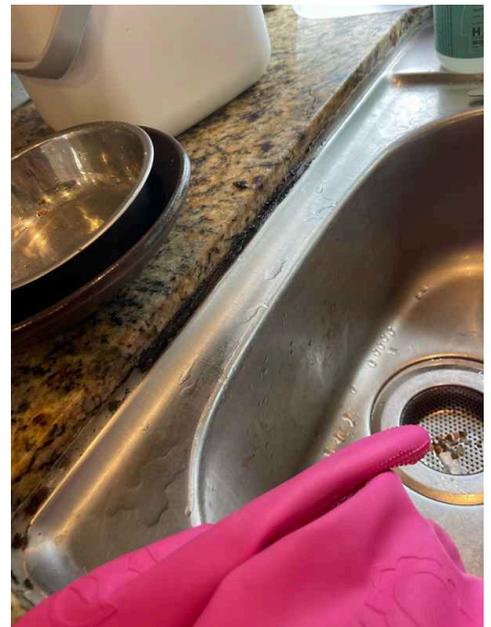
Kitchen

9.6.3 TUB/SHOWER ENCLOSURE

Dark staining was observed at caulking in the sink. This can be caused by lack of cleaning or incorrect type of caulking may have been used. We advise having the caulking cleaned or replaced with qualified contractor.

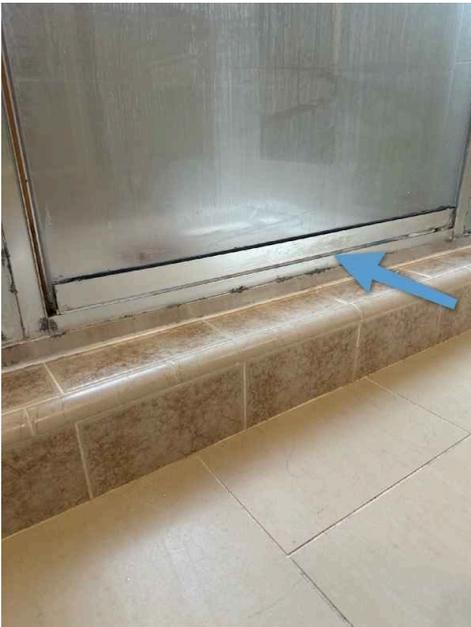
Master Bathroom

9.6.4 TUB/SHOWER ENCLOSURE

The shower door seal/sweep was deteriorated/damaged or missing. This can allow water to exit the shower during use. Replacement of the door seal/sweep is advised.
