THE REAL ESTATE
INSPECTION COMPANY

HOME INSPECTION

11493 Nantucket Pkwy
San Diego, CA 92130

02/10/2026

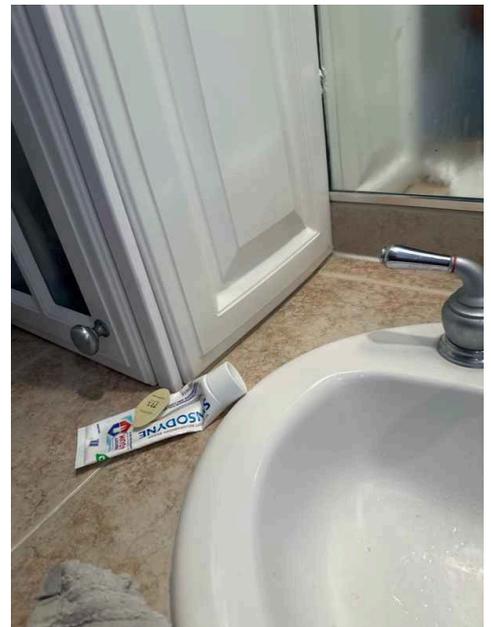
Master Bathroom

9.7.1 COUNTERS AND A REPRESENTATIVE NUMBER OF CABINETS

MISSING BACKSPLASH

No backsplash was installed on the sink. This can allow moisture intrusion below and damage to finishes.

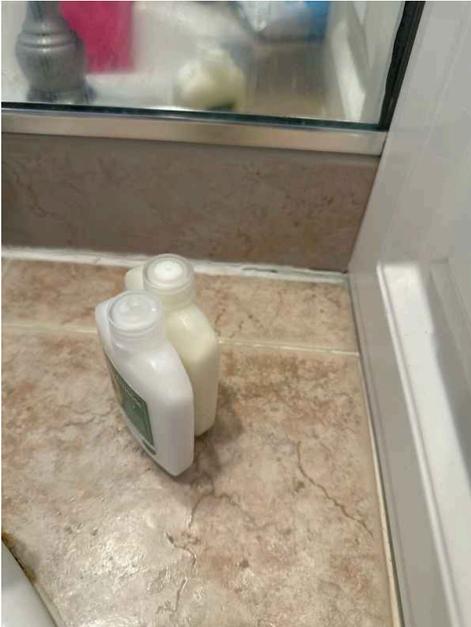
Master Bathroom

9.7.2 COUNTERS AND A REPRESENTATIVE NUMBER OF CABINETS

We recommend caulking along the counter and back splash.

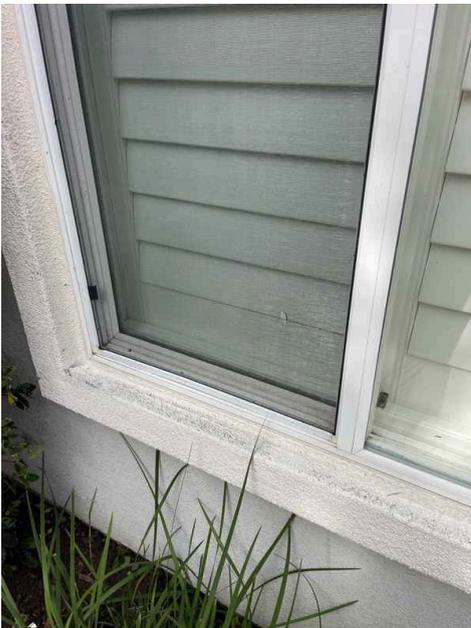
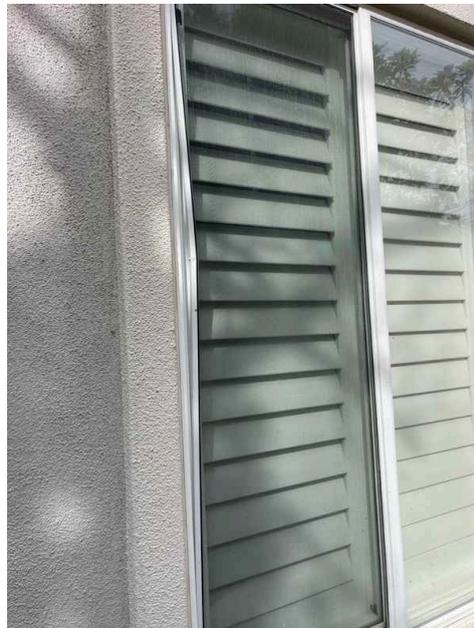
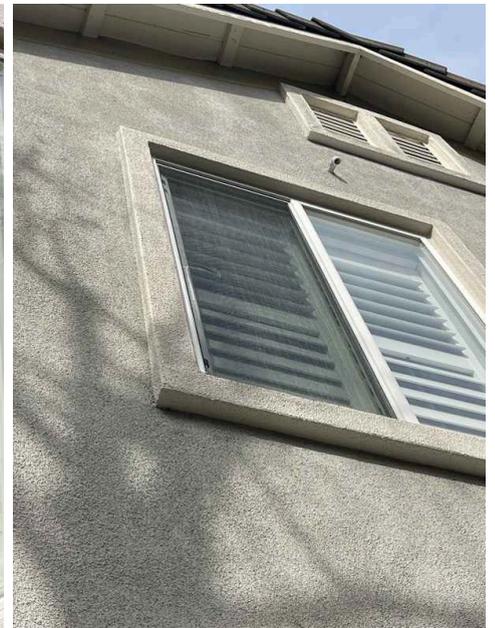
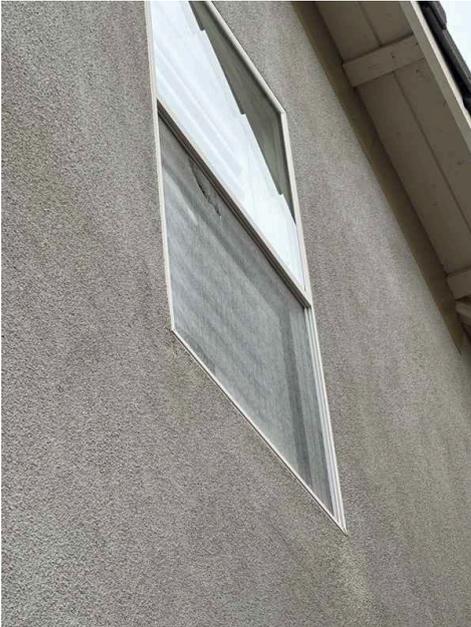
9.10.1 WINDOWS (REPRESENTATIVE NUMBER)

SCREENS - TORN, DAMAGED, MISSING

Several screens are missing or damaged. We recommend repair or replace as needed by a qualified person.

Contact a qualified professional.

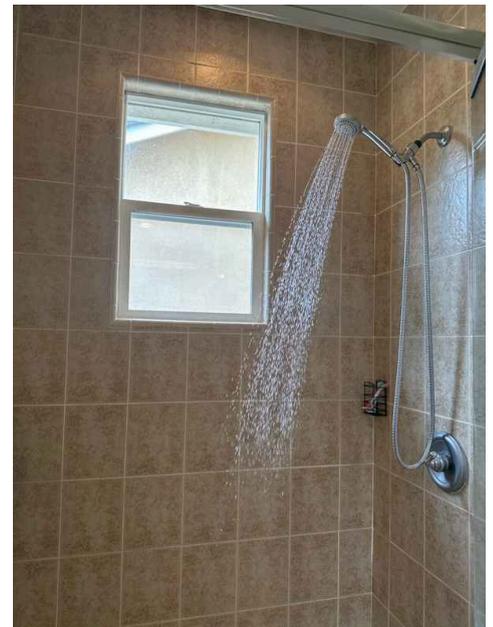
Master Bathroom

9.10.2 WINDOWS (REPRESENTATIVE NUMBER)

A window is installed below the shower head. Window sills are required to be installed at least five feet above the shower floor to prevent water intrusion into the wall below the window. There may be water damage to the wall below the window which is not visible. Determining if water damage exists in the wall behind the shower enclosure is beyond the scope of a home inspection due to its concealed location. We recommend monitoring or removing the window or replacing the window with a smaller window, and enclosing the wall below the window.

Recommend monitoring.

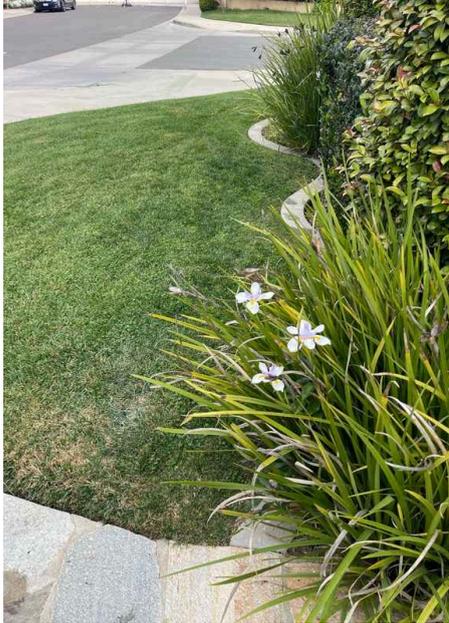
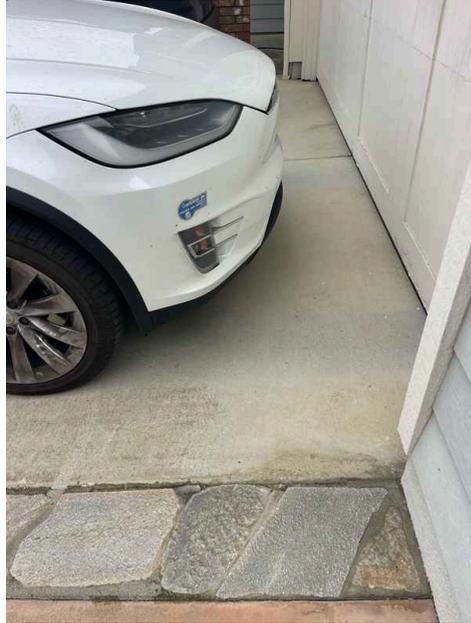
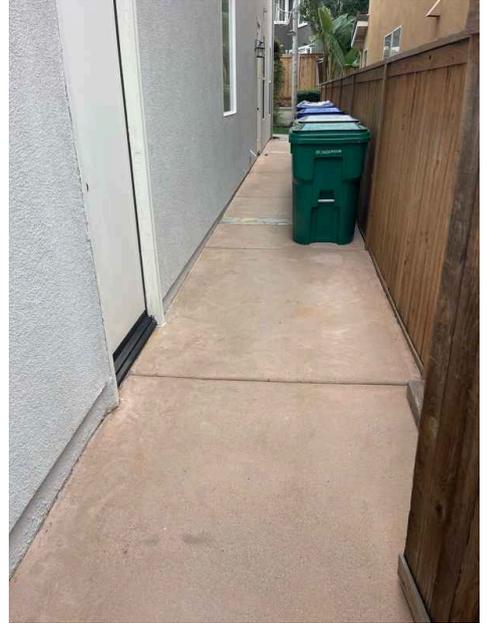
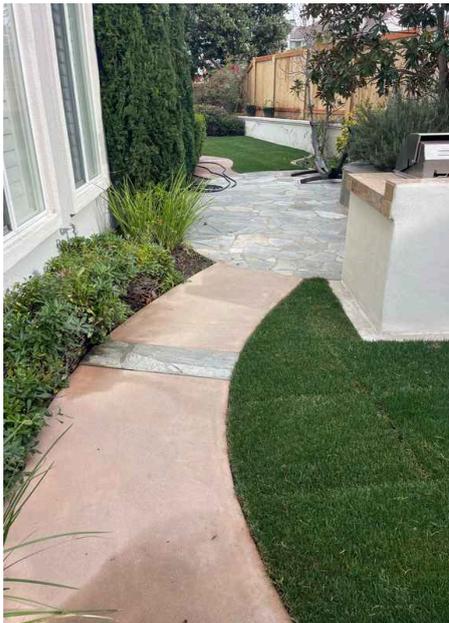
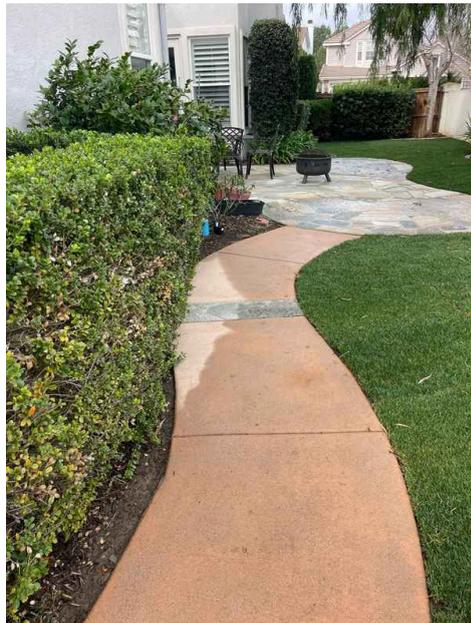
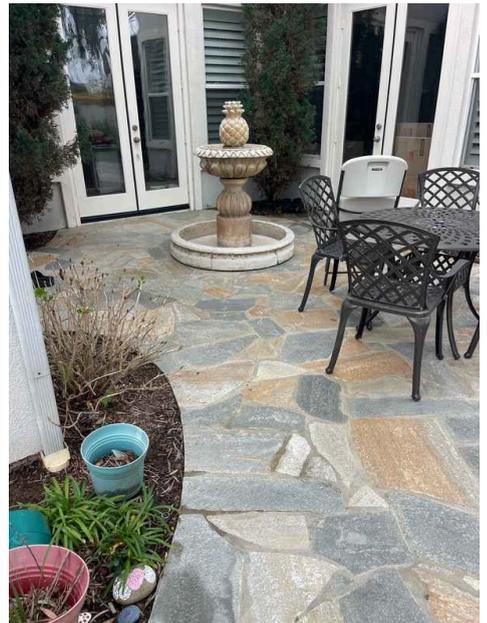
The grading and drainage around the home appeared adequate. However, due to the lack of recent heavy rain, the inspector was unable to determine how the yard will drain during periods of unusually heavy rain.

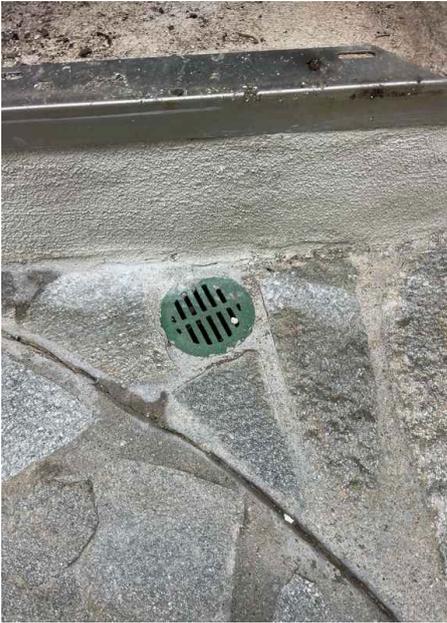
Note: Ground drain lines were visible in the yard. These drains are not tested for functional flow or adequacy. It is important to maintain these drains and prevent debris from entering. We advise periodic clean out by a qualified person.

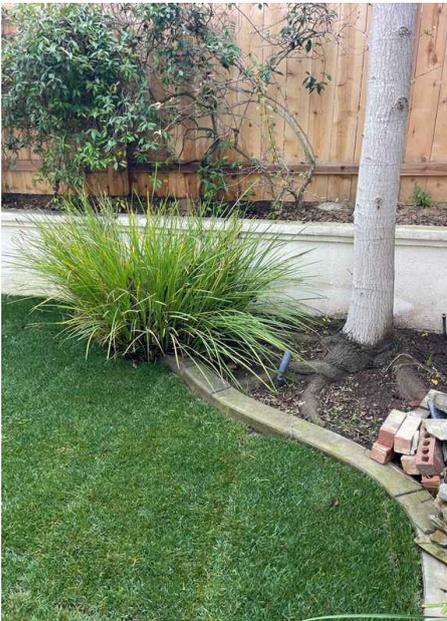
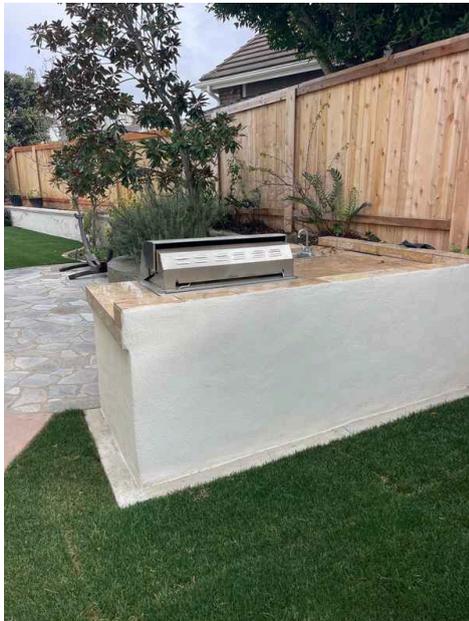
Rear Exterior

Retaining wall present. Wall appears to be in serviceable condition. Note: Confirming that the retaining wall was properly installed, with the required reinforcement and drainage, is not possible within the limited scope of a home inspection.

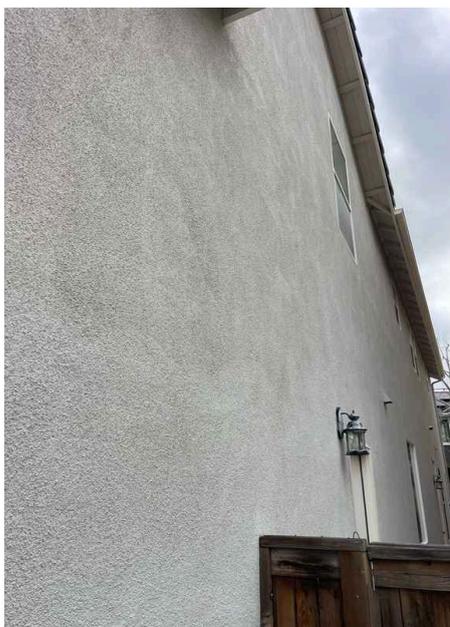
The exterior walls of the home were covered with hard-coat stucco. The Inspector observed no significant deficiencies in the condition of Stucco covering exterior walls.

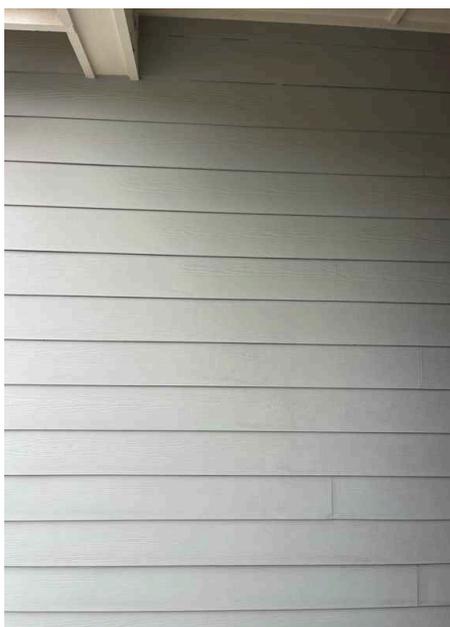
The exterior walls of the home were covered with siding. The Inspector observed no significant deficiencies in the condition of siding covering exterior walls.

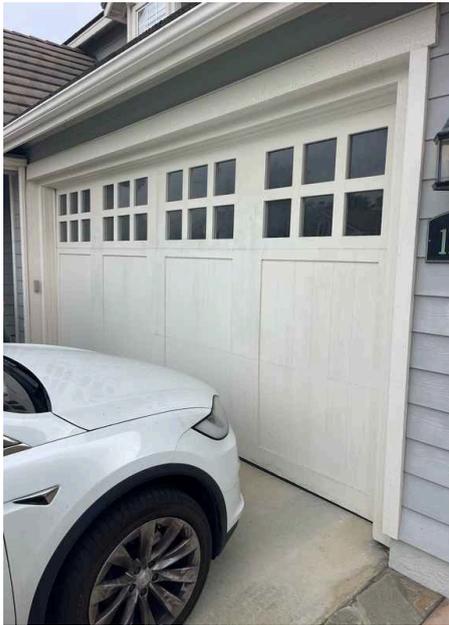
Front Exterior

The garage door hardware including the door, track, and springs appear to be functioning as intended.

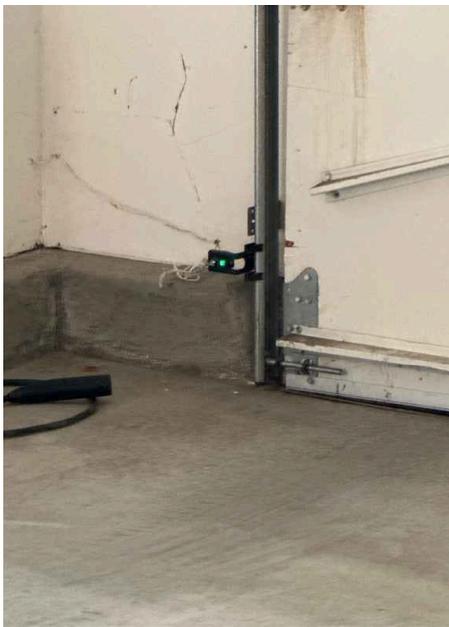
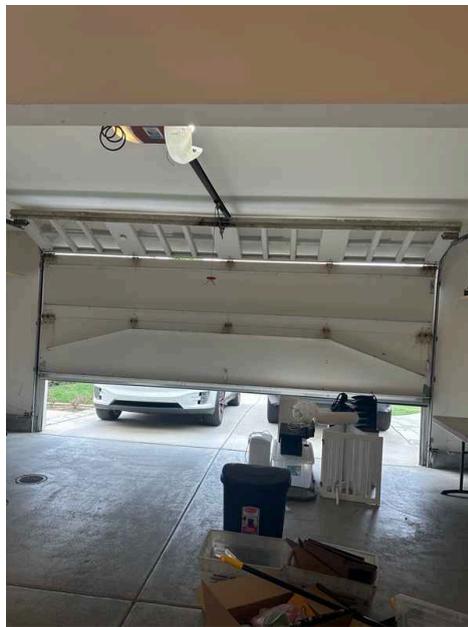
Garage

Sensors are in place and will reverse the garage door.

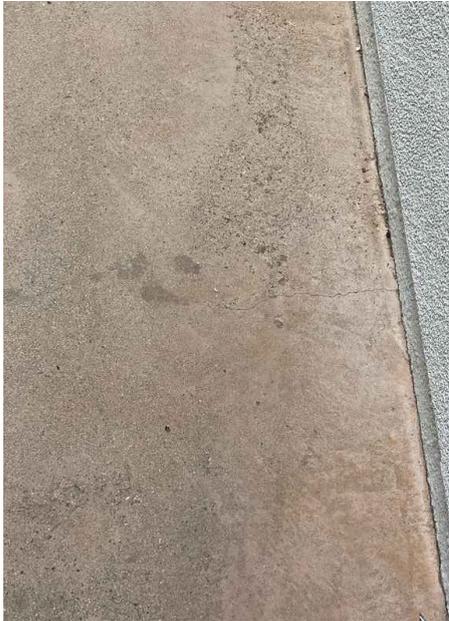
Exterior

Typical shrinkage cracks in concrete were observed. Shrinkage cracks can appear as part of the concrete's natural curing process and are not a structural concern. Cracks in concrete appear for a wide variety of reasons, some of which may not be apparent at the time of the inspection. Cracks less than 1/8-inch that do not exhibit displacement are typically not considered to be an issue unless they appear in conjunction with another condition.

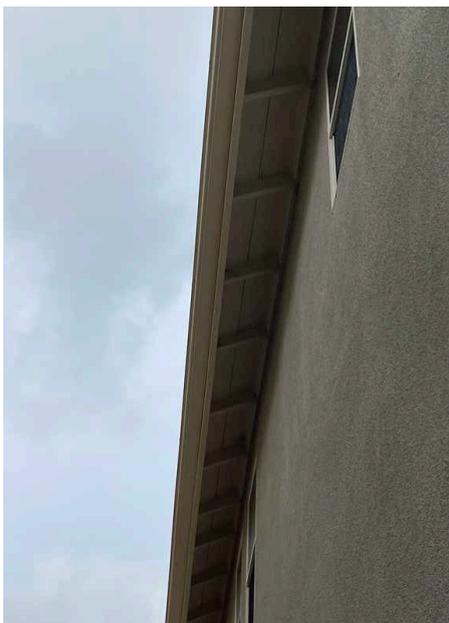
Front/Rear Exterior

At the time of the inspection, the Inspector observed no deficiencies in the condition of the eaves/fascia/soffit.

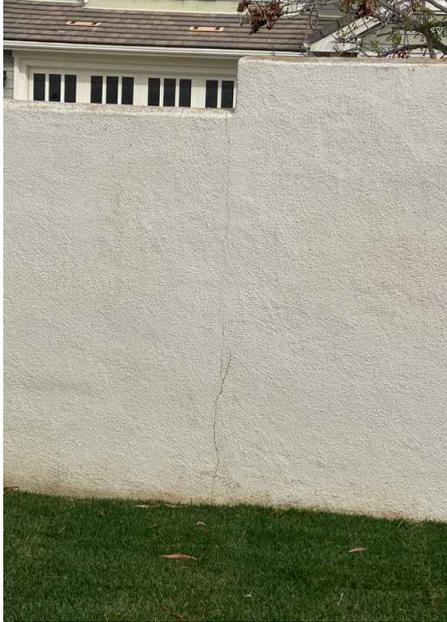
Rear Exterior

Typical shrinkage/settlement crack(s) was observed at the boundary wall. Cracks can appear in a boundary wall for a wide variety of reasons, some of which may not be apparent at the time of the inspection. Cracks less than 1/8-inch that do not exhibit displacement are typically not considered to be an issue unless they appear in conjunction with another condition. Note: The inspector can not observe the footings and is unable to determine if the wall is properly constructed/permitted or determine the potential for future movement.

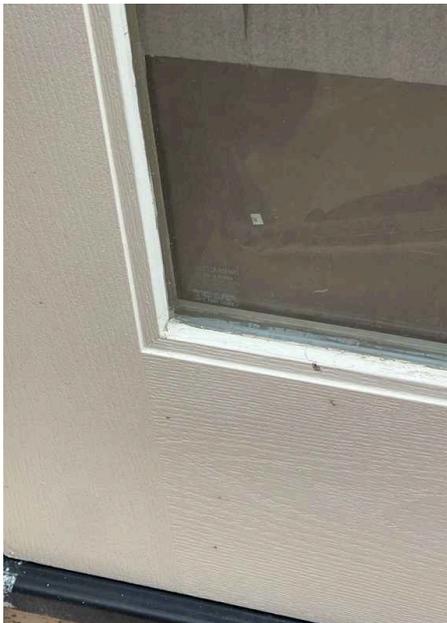
Glass Doors

The glass at the glass doors is tempered, which is indicated by a stamp or marking on the glass.

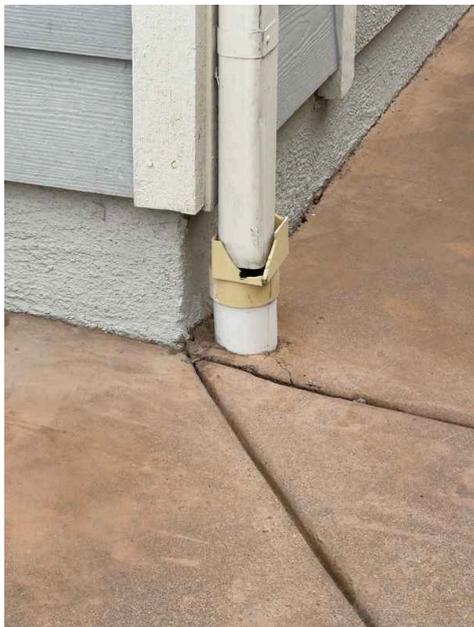
Front Exterior

Yard/gutter drain was noted with damage. This can be problematic during heavy rain or extended irrigation. We recommend repair or replacement.

Contact a qualified professional.

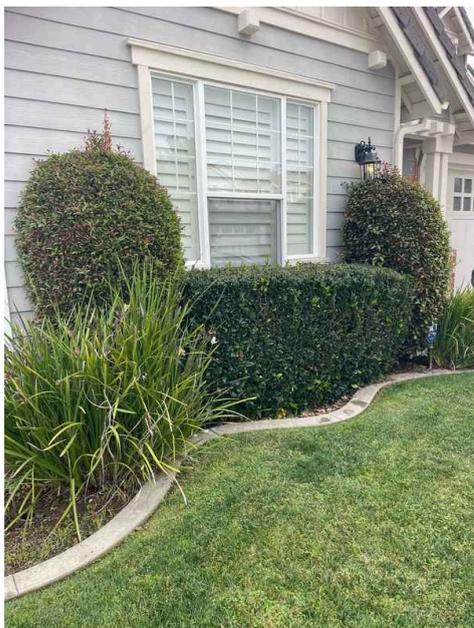
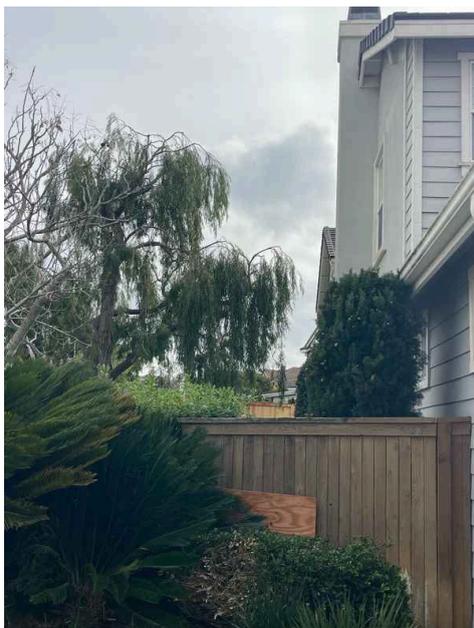
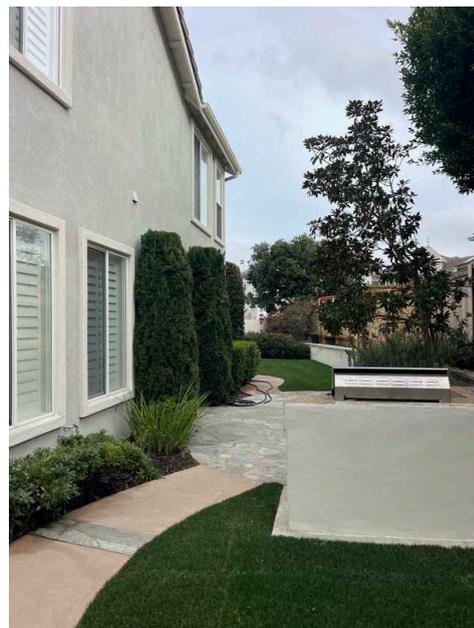
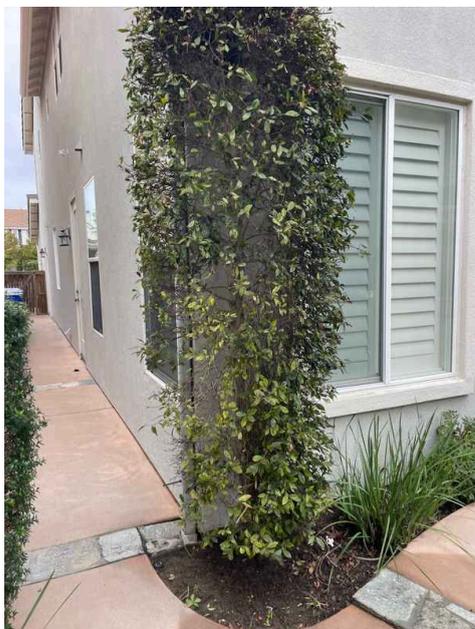
Tree(s) and/or large plants are located too close to the house. Tree limbs/vegetation that are too close to the house can cause damage in several ways. Limbs or vines in contact with roof or hanging near roof should be trimmed to prevent damage to roof and/or to prevent rodent infestation. Also, as the plants grow, damage can occur to the siding, concrete flat work, and to the foundation. We recommend having the foliage removed or trimmed by a qualified professional to prevent damage to the house.

Contact a qualified professional.

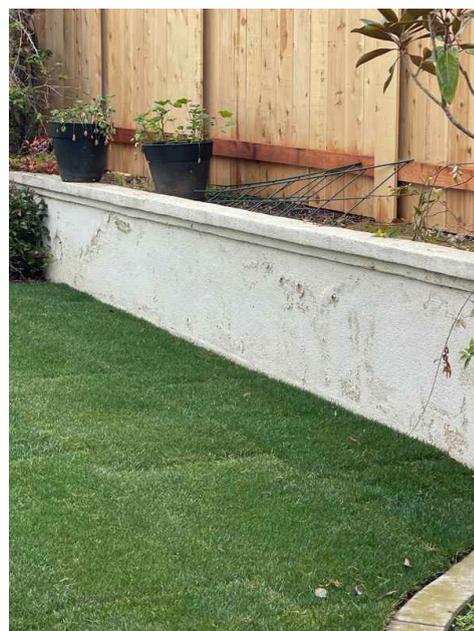
Retaining Wall

There is damaged/ deteriorated stucco observed at several areas. We recommend necessary repairs by a licensed stucco contractor.

Contact a stucco repair contractor

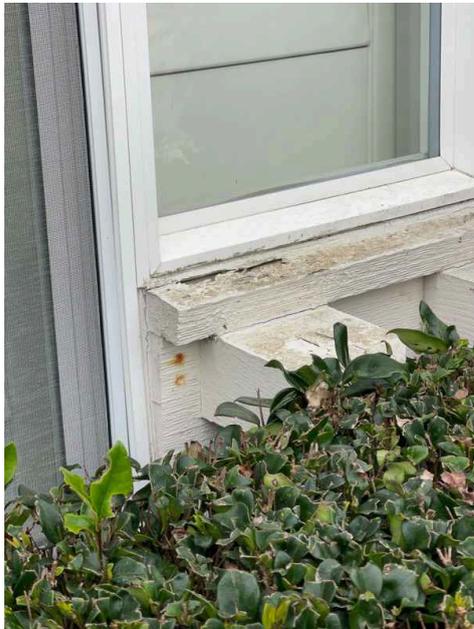
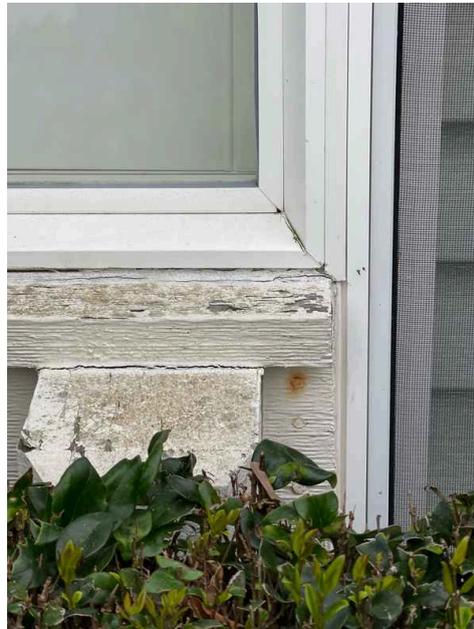
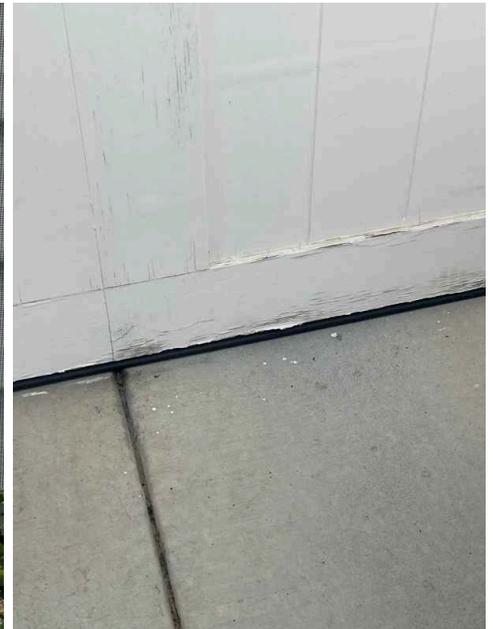
Bare wood or peeling paint was observed and needs primer and paint. Maintaining paint is essential to preventing the wood from damage.

Contact a qualified painting contractor.

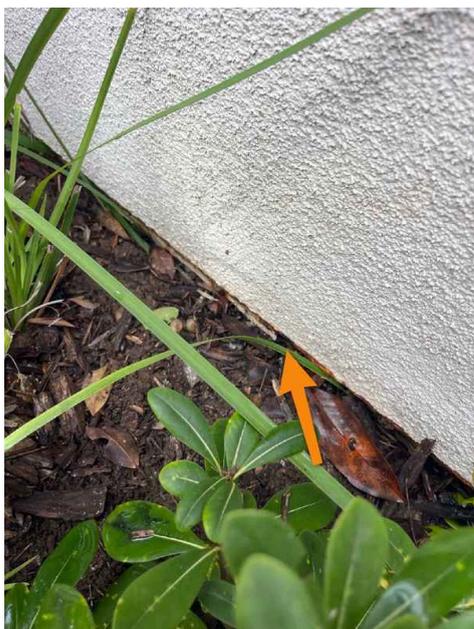
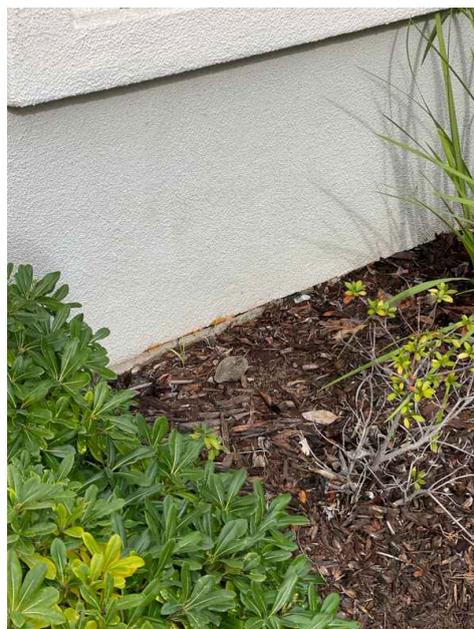
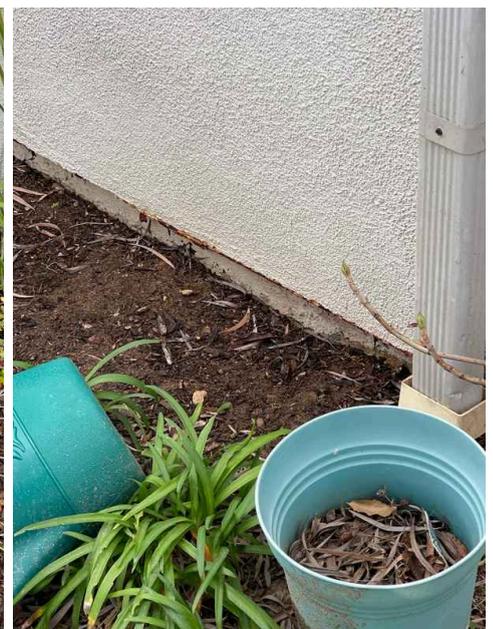
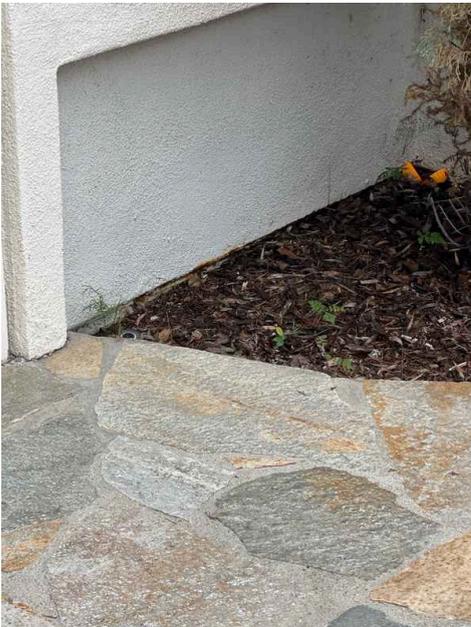
Stucco screed flashing is rusted at the exterior. This may indicate that the sprinklers are spraying the house, or dirt is too close to the screed. The screed is damaged and requires repair/replacement. Recommend obtaining a quotation for this repair prior to the end of your contingency period by a licensed stucco contractor.

Contact a stucco repair contractor

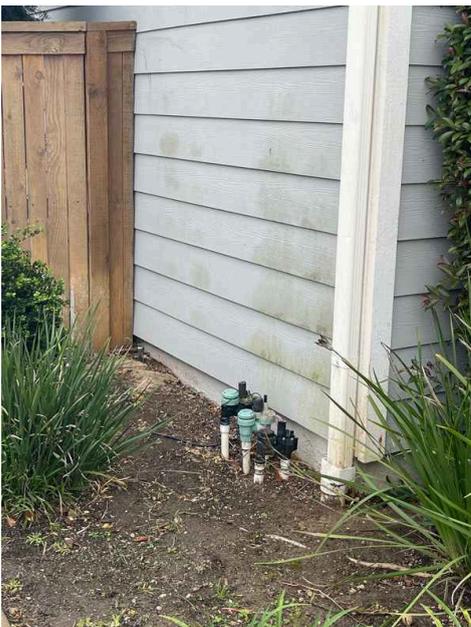
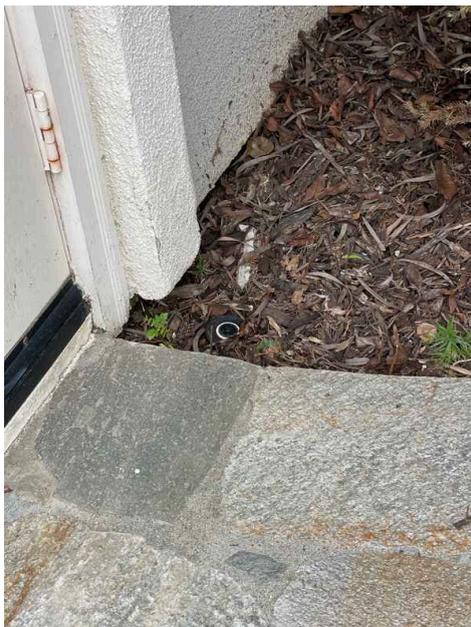
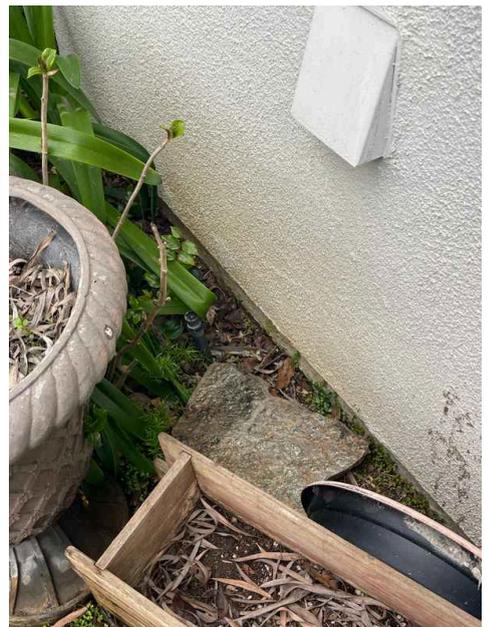
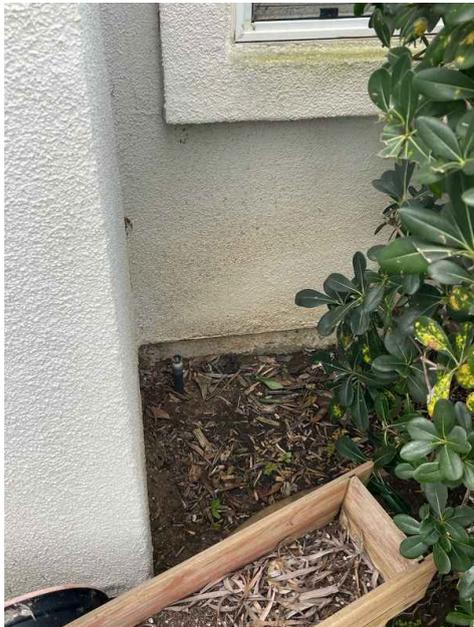
Sprinklers are spraying onto the siding. Long term exposure to water will deteriorate the stucco. We recommend adjusting the sprinklers to spray away from the house, convert the sprinkler heads to a drip system, or create a hardscape zone around the house. There may already be some damage to the underlayment behind the siding. Determining if there is damage to the underlayment is not possible due to the limited visual nature of a home inspection.

Contact a qualified landscaping contractor

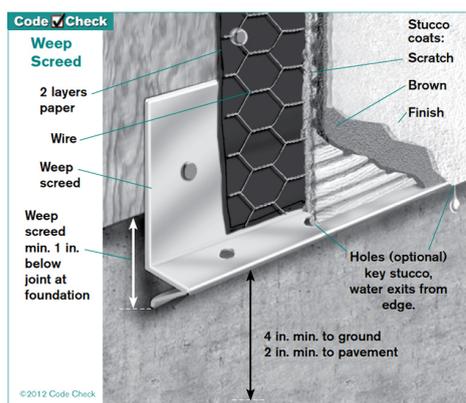
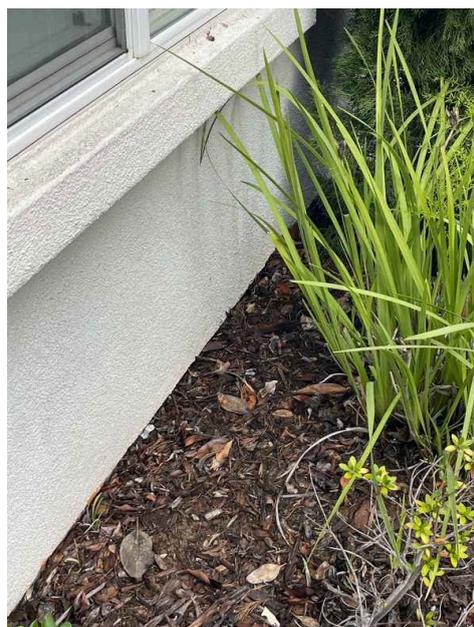
Rear Exterior

Stucco/weep screed was in contact with the ground at exterior. The weep screed is the metal band at the base of the stucco which has holes to allow the stucco to "breathe" and water to "weep" from the stucco. Having the soil above the weep screed can lead to stucco damage due to limited airflow. We recommend a ground clearance of four inches where possible to allow for proper drainage and for ventilation of the stucco walls. Dirt in contact with the stucco can promote deterioration, including rot, pest infestation, and water intrusion during rain. We recommend further evaluation and correction by a qualified landscape contractor.

Contact a qualified professional.

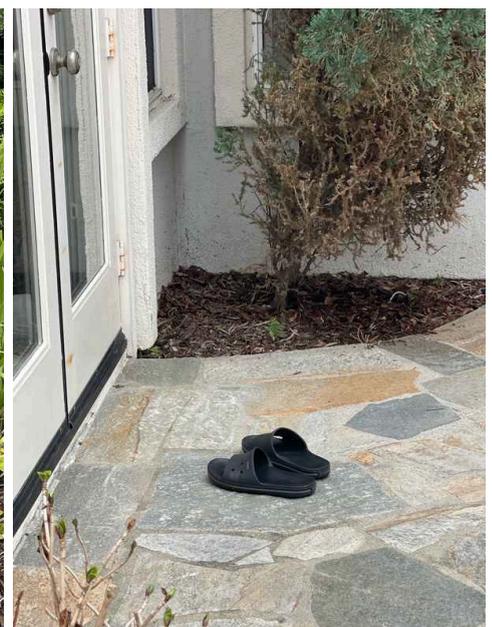
Rear Exterior

**WOOD DAMAGE
DOOR(S)/FRAME**

Some damaged wood was observed at the exterior door(s)/frames. We recommend referring to the pest inspection report for a detailed evaluation of the wood.

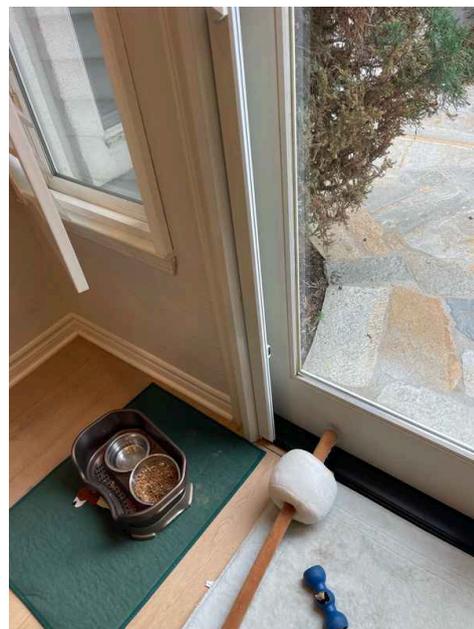
Kitchen

**WEATHER-STRIPPING
DAMAGED/MISSING**

The exterior door weather-stripping is damaged or missing. We advise replacement.

Contact a qualified door repair/installation contractor.

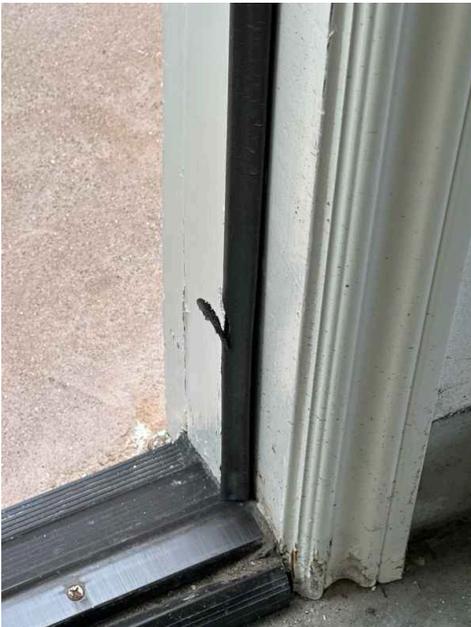
Garage Exterior Door

Exterior doors stick/rub on the frames or thresholds. We advise repair by a qualified person.

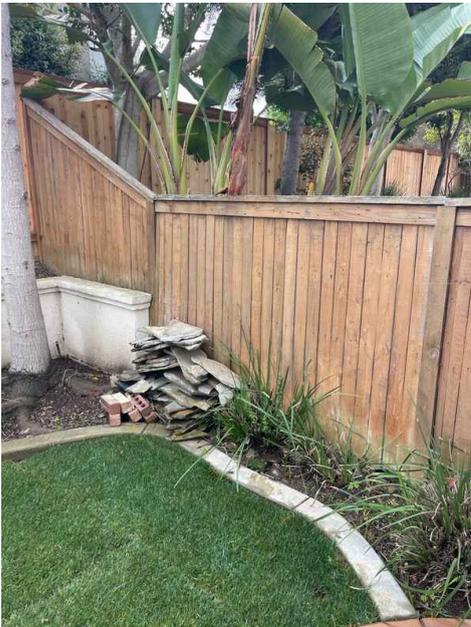
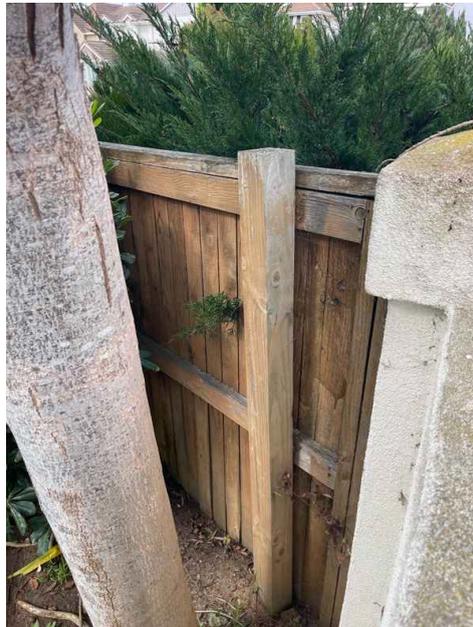
DETERIORATED/DAMAGED- GENERAL

Boundary/Landscape walls exhibited significant damage or deterioration at the time of the inspection. Repair or replacement can be costly. We recommend further evaluation and repair or replacement by a qualified contractor.

Contact a qualified professional.

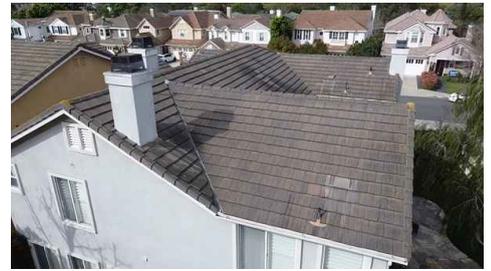
The tile roof appears to be 25 years old or more. Tile roofs of this age may have an underlayment that is near the end of its expected life. It is important to understand that the underlayment commonly known as "tar paper" has a life span that may be limited to 25 years depending on the quality of materials, installation, sun exposure, ventilation of the attic, and maintenance. Replacing the underlayment can be costly. Since home inspectors do not lift roof tiles, you should have the roof evaluated by a licensed roof contractor to obtain an estimate of life remaining or the cost of repair/replacement before the close of your contingency period.

Contact a qualified roofing professional.

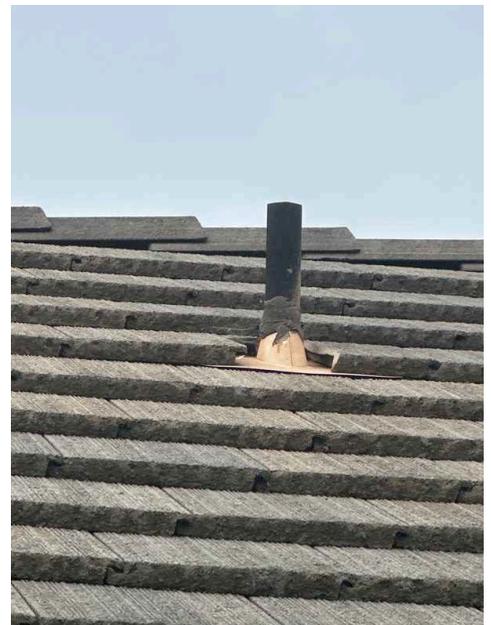
SEALANT CRACKED - VENTS

The sealant around flashings is cracked. We advise further corrections by a licensed roofer.

Contact a qualified roofing professional.

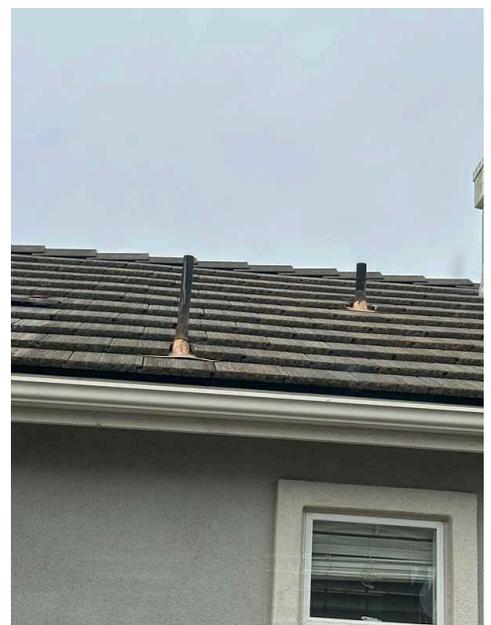
Sheet metal flashings and ABS plumbing vents were not painted. Paint is required at the ABS vents and recommended at exterior sheet metal. We advise corrections with qualified painter.

Contact a qualified painting contractor.

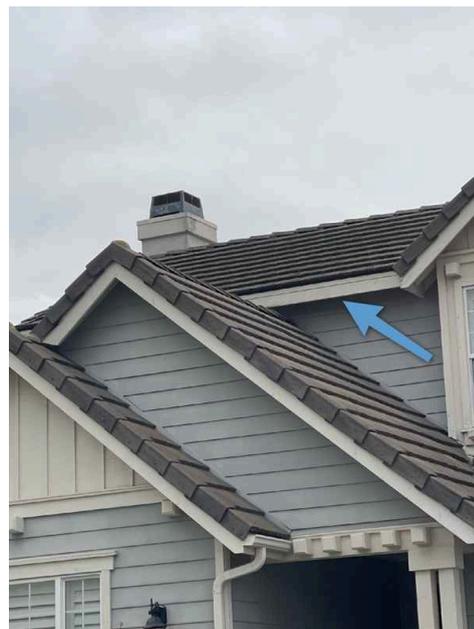
Some rain gutters and downspouts are present. A complete rain gutter system helps control water flow and keeps moisture away from the foundation. We recommend installing gutters and downspouts to prevent erosion or water intrusion by diverting runoff away from the house. During heavy rain, a large quantity of water runs off of the roof. Much of this water splashes up against the house including doors and thresholds. This is a common area to find damaged wood due to excessive water exposure. Since doors are not waterproof, water can enter the living space.

Contact a qualified gutter contractor

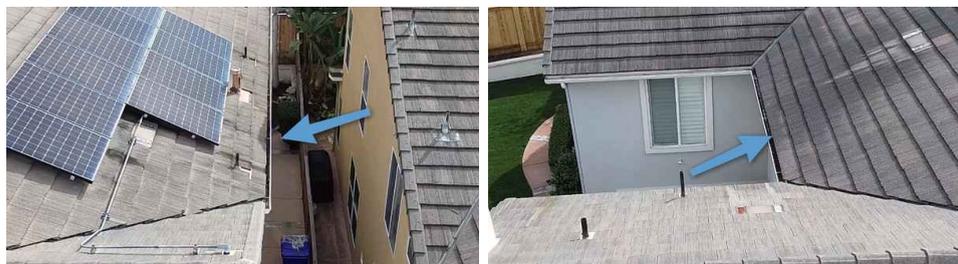
Gutters require cleaning. We recommend having them cleaned by a qualified person.

Contact a qualified professional.

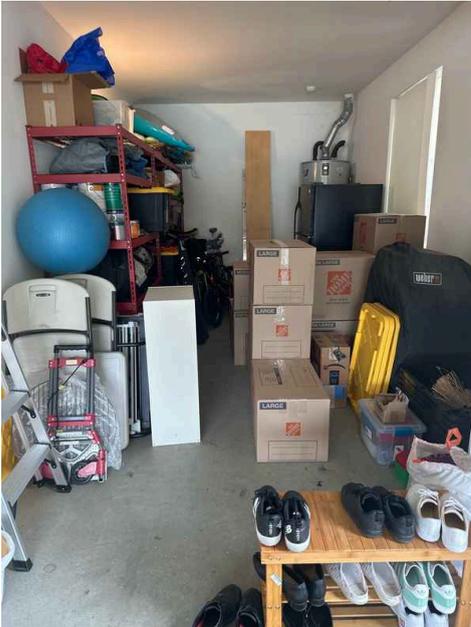
Garage

Some areas of the exterior wall and foundation are not visible due to being blocked, concealed by stored items against the house. We recommend having these items removed and inspecting these areas for concealed defects prior to the end of your contingency period.

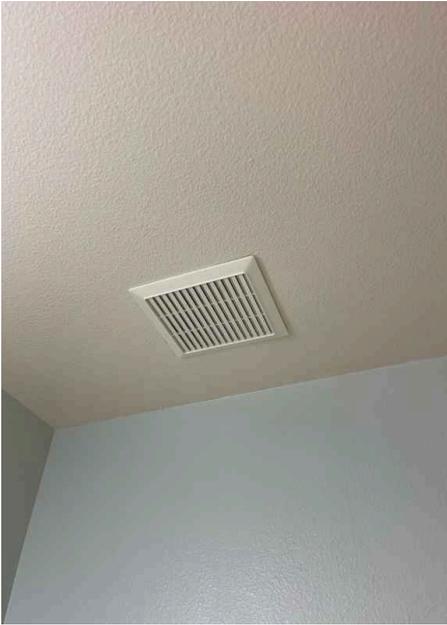
Half Bathroom

Note: The bathroom exhaust fans appears to be original and older than their expected service life. The average life of a bathroom exhaust fan is 20 years. Some units may last for more or less than 20 years depending on quality and usage. To see a complete list of life expectancies for just about every component in a house, please visit our list of Life Expectancy.

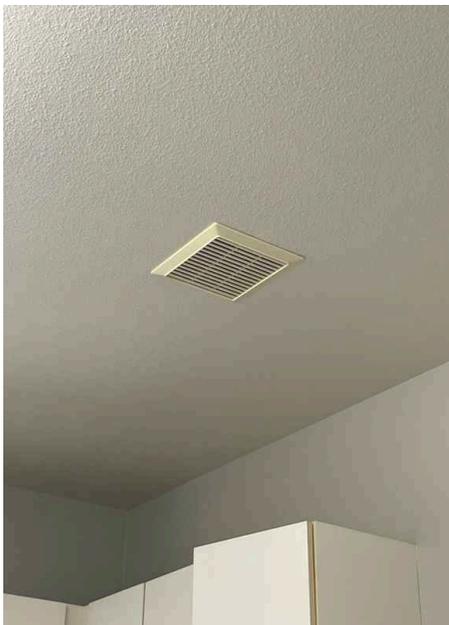
Laundry Room

The exhaust fan appears to be older than its expected service life. The average life of an exhaust fan is 20 years. Some units may last for more or less than 20 years depending on quality and usage. To see a complete list of life expectancies for just about every component in a house, please visit our list of Life Expectancy.

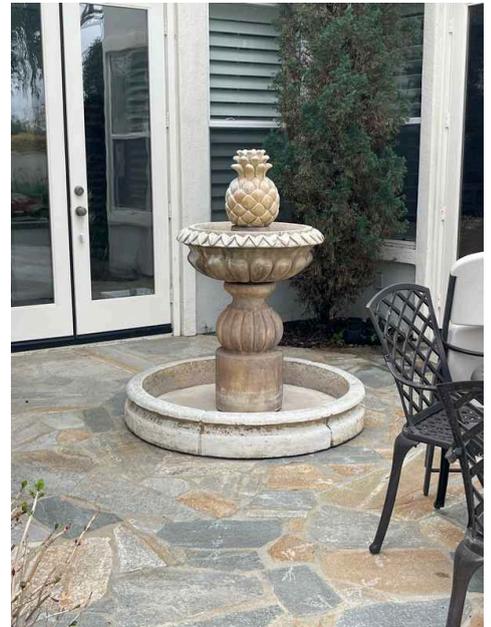
Rear Exterior

The home was equipped with a fountain that was inoperable/off at the time of the inspection. Inspection of water features lies beyond the scope of the General Home Inspection. We recommend further review of this system with a qualified landscape contractor to determine function.

Contact a qualified professional.
