HOME INSPECTION

4422 Point Degada
Oceanside, CA 92058

02/11/2026

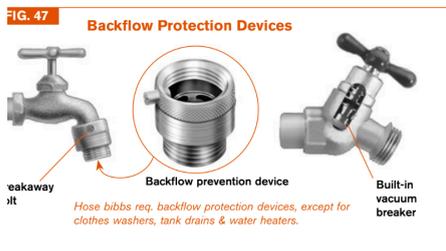
HOSE SPIGOT: Anti-Siphon - None

Anti-siphon or anti-backflow valves are not present at the exterior hose spigots. These are safety devices that prevent contaminated water from flowing into the house water supply. Current standards require the installation of anti-siphon valves to keep your drinking water clean. We recommend installation for your health and safety.

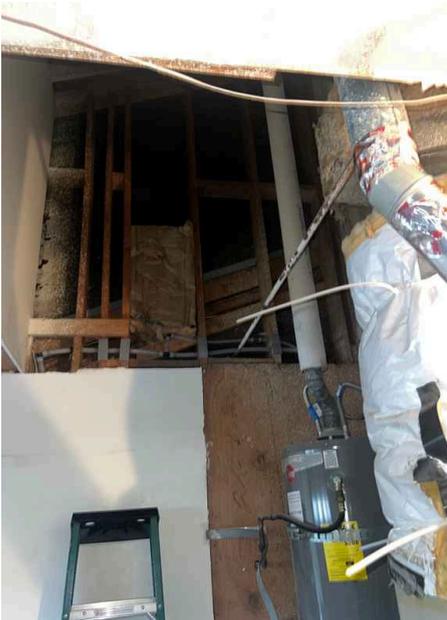
**WATER SUPPLY AND DISTRIBUTION SYSTEM: PEX - Re-Pipe**

This home has had a re-pipe, indicating past leaks may have occurred in the distribution piping. The original supply piping was abandoned and new pipes were installed where visible. PEX non-metallic water distribution lines have been installed when re-piped. Our inspection is limited to the visible connectors and pipes. We advise reviewing with the seller for repair history.

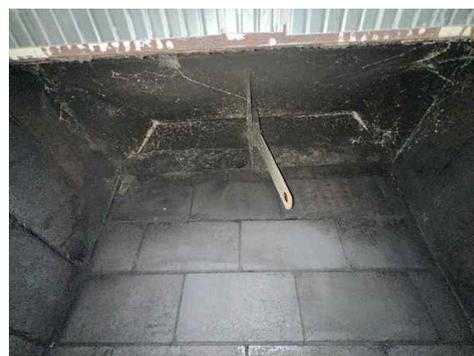
Creosote/soot build-up was noted at the chimney. We advise obtaining professional cleaning.

Contact a qualified chimney sweep.

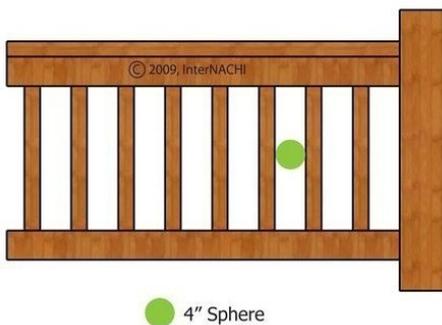
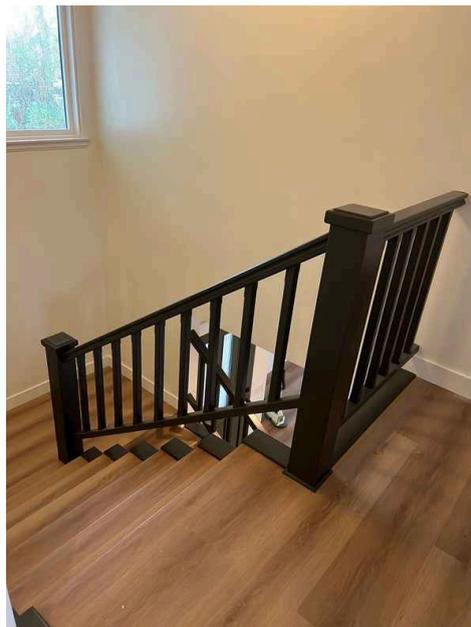
While the railing/baluster spacing may have been standard at time of construction, it does not comply with current safety standards. The large openings can allow pets or children to fall through, or become entrapped. We recommend installing additional balusters, or other form of barrier to prevent injuries.

Contact a qualified professional.

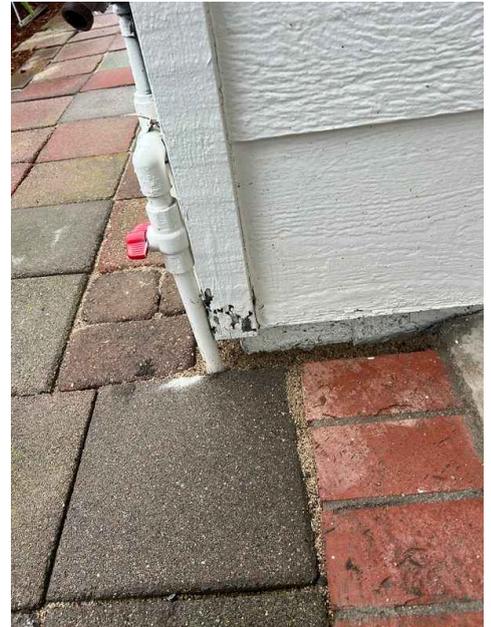
Left front corner

Some damaged wood was observed at the exterior. We recommend referring to the pest inspection report for a detailed evaluation of the wood and repair with qualified contractor.

Contact a qualified pest control specialist.

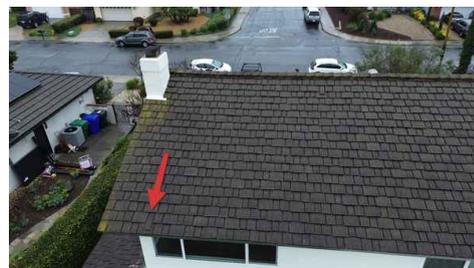
SLIPPED TILES

Slipped tile(s) were noted. Out-of-place roof tiles will allow the sun to deteriorate the underlayment and can cause leaking if not corrected. We advise evaluation/necessary corrections by a licensed roofer. You may wish to consult a roofer prior to the end of your contingency period to obtain an estimate and to fully understand the extent of repairs needed.

Contact a qualified roofing professional.

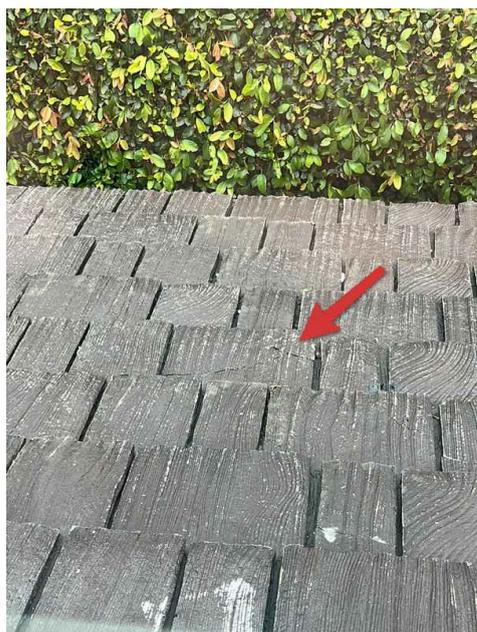
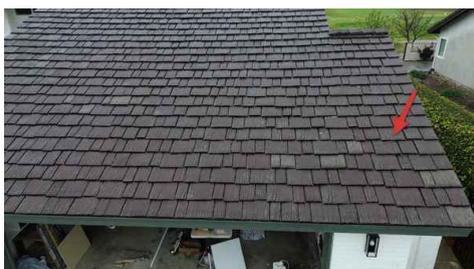
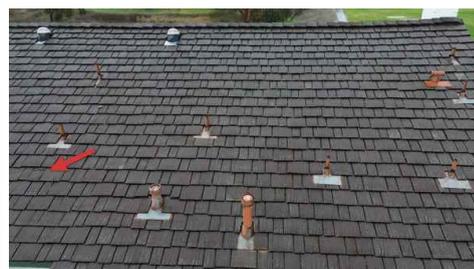
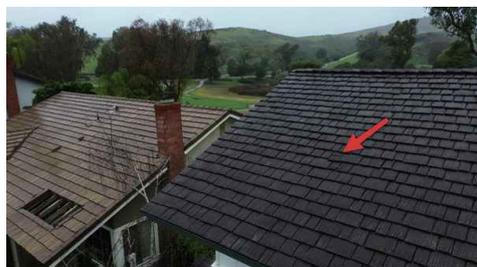
CRACKED TILE(S)

Cracked roof tile(s) noted. We advise maintenance review of the entire roof and necessary corrections by a licensed roofer. You may wish to consult a licensed roofer prior to the end of your contingency period to obtain an estimate and to fully understand the extent of repairs needed.

Contact a qualified roofing professional.

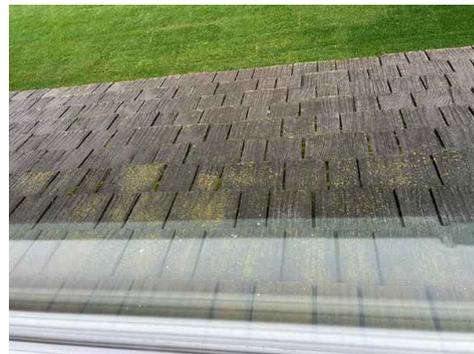
Roof covering exhibited large amounts of biological growth such as moss, lichen, or algae. Biological growth can retain moisture, potentially causing damage in areas in which the temperature drops below freezing during the winter. To extend the long-term expected service life of the roof covering, we recommend professional cleaning by a qualified roofing contractor.

Contact a qualified professional.

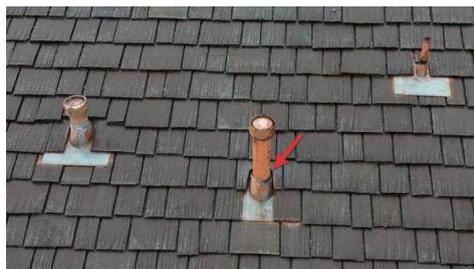
SEALANT CRACKED - VENTS

The sealant around flashings is cracked. We advise further corrections by a licensed roofer.

Note: Moisture was noted inside the furnace - possibly related to vent maintenance. We advise further review with a licensed roofer or HVAC contractor to determine source of moisture and estimate to repair.

Contact a qualified roofing professional.

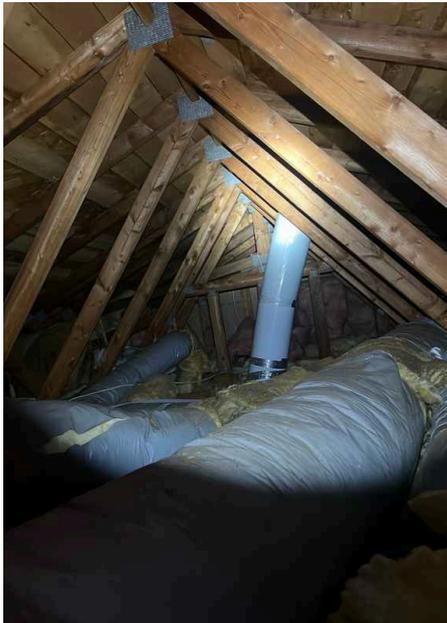
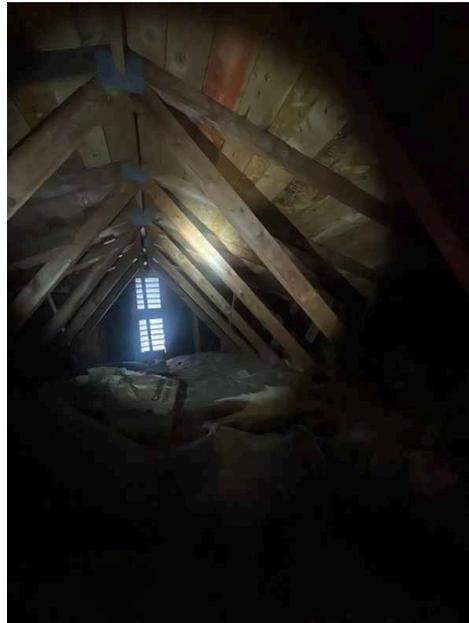
ROOF STRUCTURE AND ATTIC: Attic Structure - Inspected

At the time of the inspection, the Inspector observed no deficiencies in the condition of the attic structural framing.

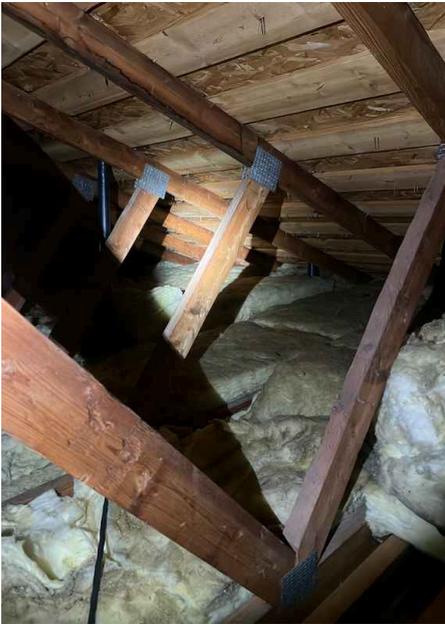
INSULATION AND VAPOR RETARDERS (in unfinished spaces): Insulation - Inspected

Insulation in the attic appears to be functioning as intended.

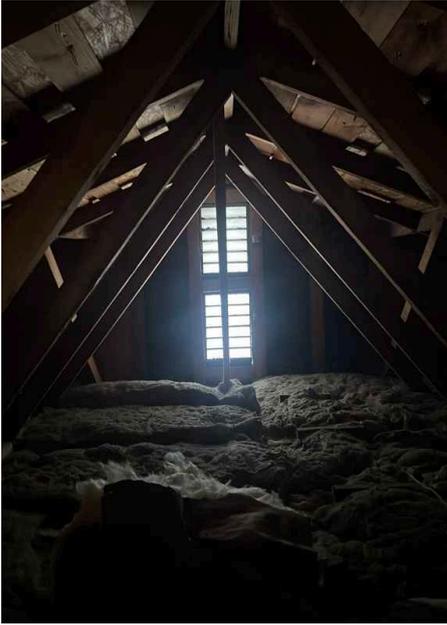
VENTILATION OF ATTIC: Attic ventilation - Inspected

Attic venting appeared to be sufficient at the time of the inspection.

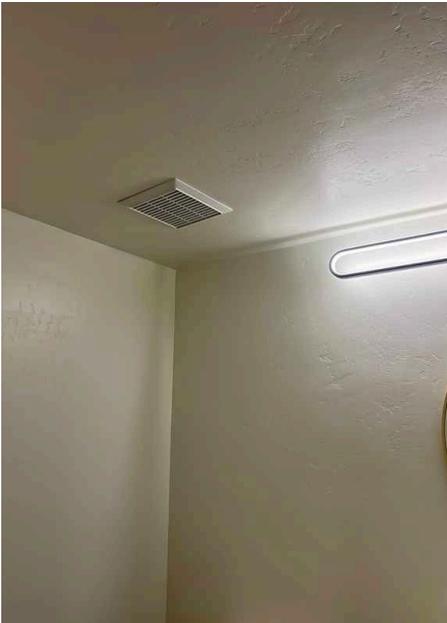
**BATHROOM VENTING: Exhaust Fans - Tested**

The exhaust fan(s) were tested and were functional at the time of inspection. (This is not an exhaustive test, and does not evaluate the performance or effectiveness of the vent(s).)

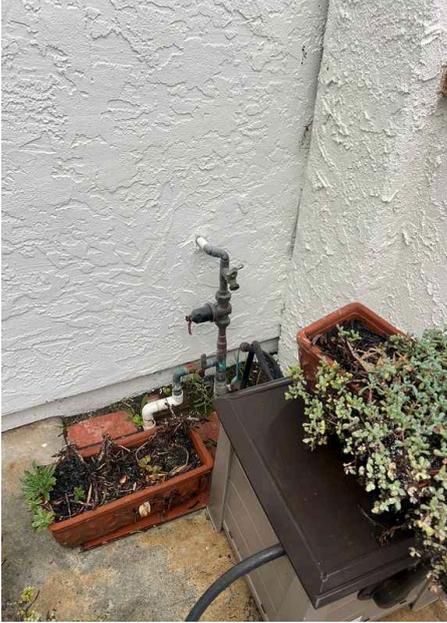
MAIN WATER SHUT-OFF DEVICE: Location - Front

The main water shut-off valve is located at the front exterior wall of the house.

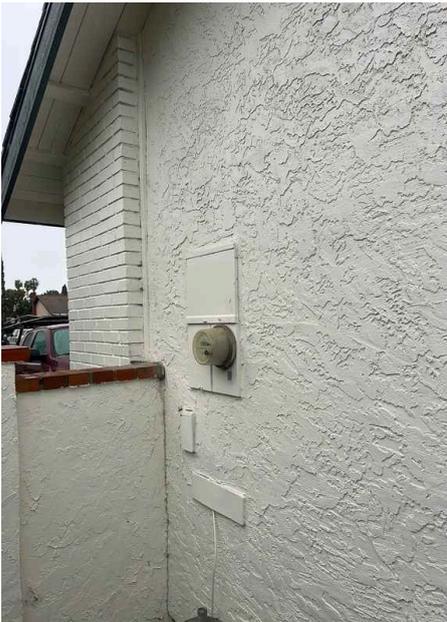
**MAIN PANEL AND DISTRIBUTION PANELS: Main - Right**

The main Electrical panel is located at the right exterior side of the house (facing front).

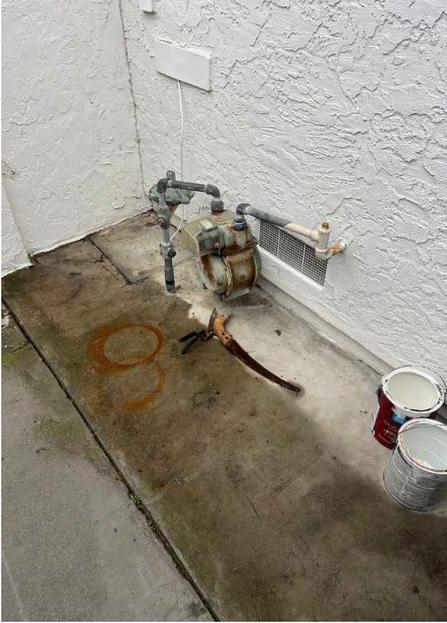
MAIN GAS SHUT OFF VALVE: Gas shut off - Right

The main gas shut-off valve is located at the gas meter at the right side of the house (facing the front).
